# AI-Assisted Electrical Installation Inspector

Upload a site photograph or video walkthrough to receive a preliminary compliance assessment under SS 638: Code of Practice for Electrical Installations.

# Electrical Installation Inspection — SS 638 Preliminary Assessment

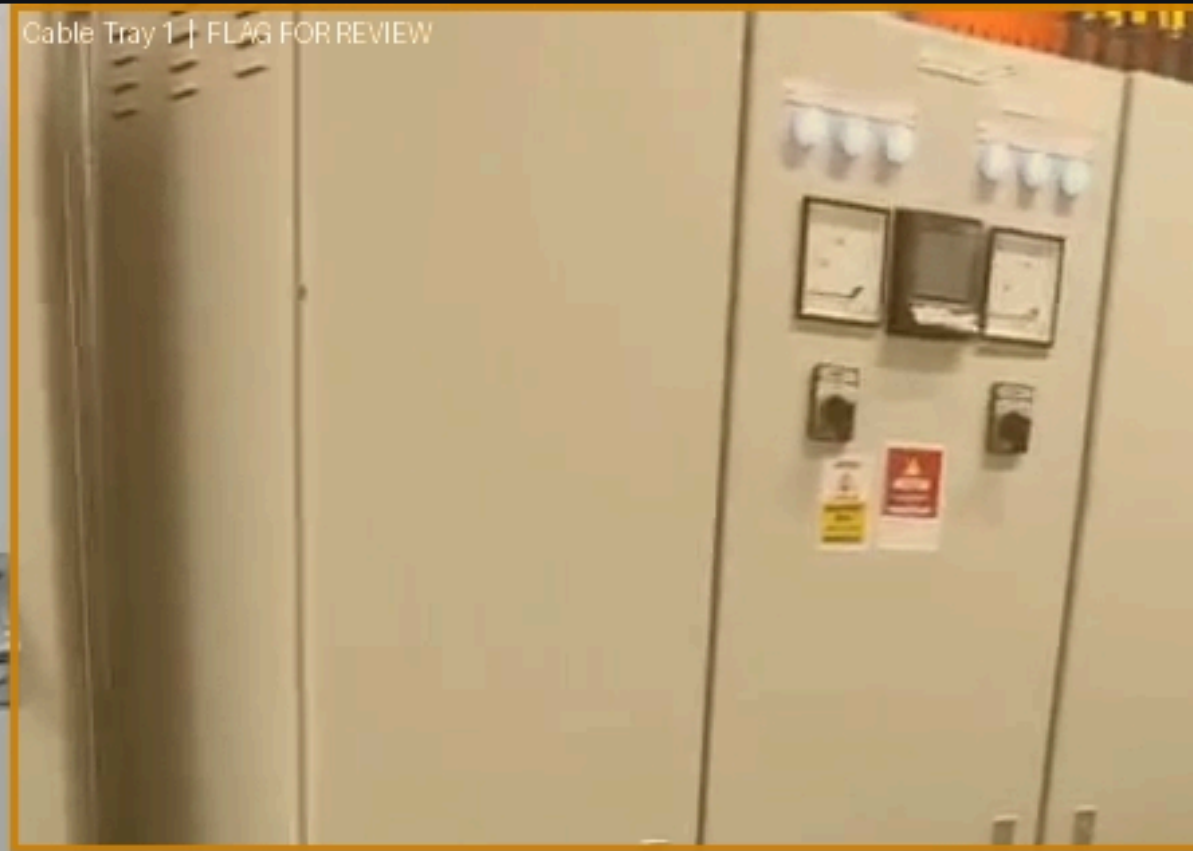
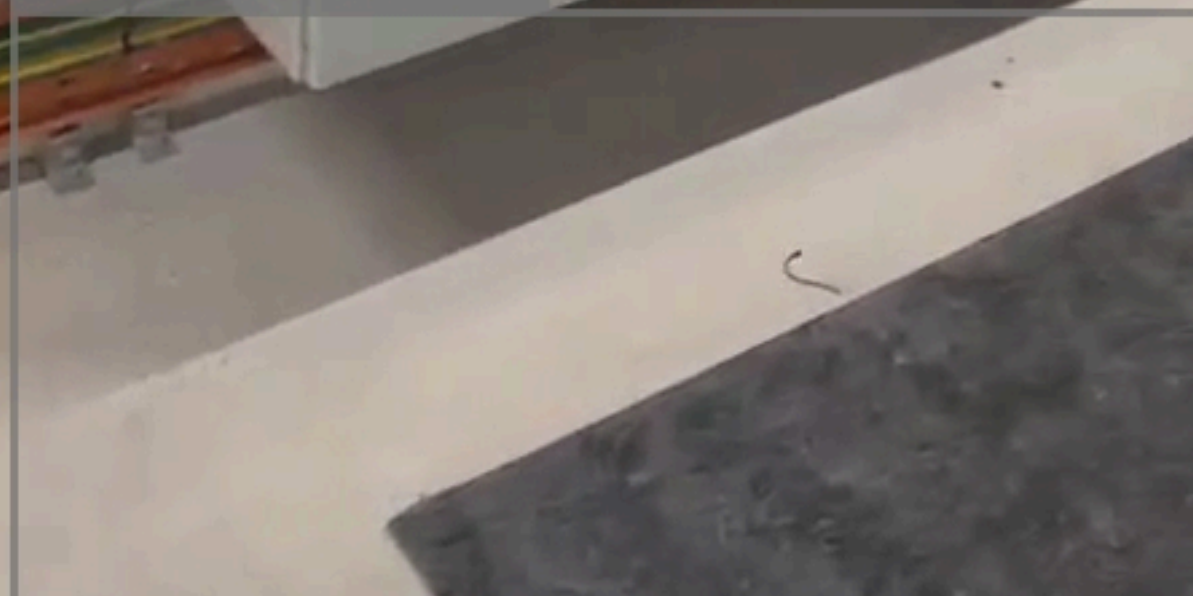
- Fill level** — Multiple cables (red, orange, and others) are visible bunched together at the tray entry beneath the cabinets. The full cross-section of the tray is **not clearly visible** (partially obscured by the cabinet base and shadow), so a reliable 40% fill determination cannot be made. **CANNOT DETERMINE.**
- Tray condition** — No visible crushing, cracking, or deformation in the portion shown, but the tray run is largely hidden in shadow and behind the cabinet plinth. Insufficient view for a complete condition assessment. **CANNOT DETERMINE.**
- Earth continuity conductor** — No clearly identifiable green-and-yellow conductor can be distinguished running alongside the live conductors in the visible portion. The cabling appears to be red/orange phase or numbered conductors. **FLAG FOR REVIEW** (absence not confirmed — view obscured).

Verdict: FLAG FOR REVIEW

- **Floor cables:** NO — no loose/unsecured cables are seen lying free across the floor. There is a thin dark line on the right side of the floor that could be a single cable/wire, but it is not clearly within an installation area and is ambiguous. The main cabling is contained within the floor-level tray, not loose.
- **Overall: FLAG FOR REVIEW**
- **Summary:** Only one cable tray/trunking run is visible and it is substantially obscured by shadow and the switchboard plinth, preventing reliable verification of fill level, condition, and the presence of an earth continuity conductor. A closer follow-up inspection with the tray fully exposed is required before any pass/fail determination can be issued.

*Note: This is a preliminary visual assessment only. The majority of the image shows the closed switchboard cabinet doors, behind which internal cabling cannot be inspected. A full inspection requires open access to all trunking and tray runs.*
