EL image report

UNIVERSITY of
TASMANIA

Predicted Power Degradation: 0.936

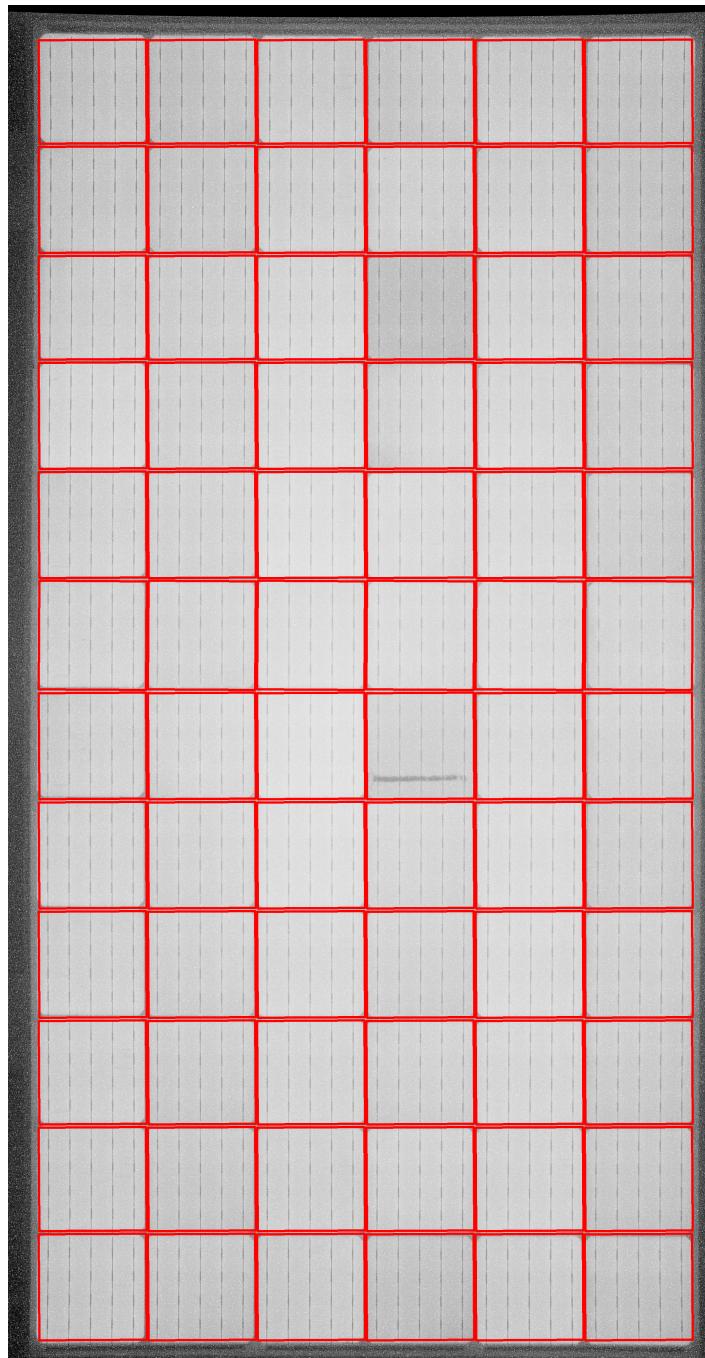
Predicted Power Degradation: 0.936

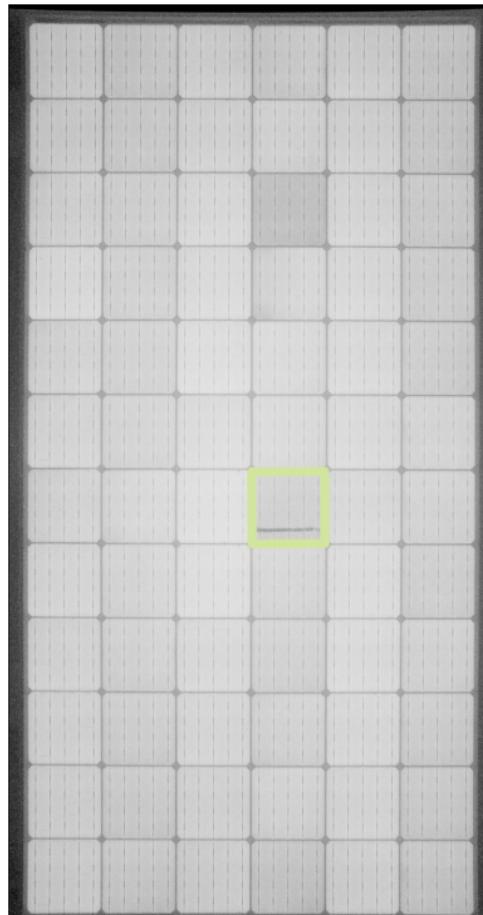
Good Classification

Predicted Power Degradation: 0.936

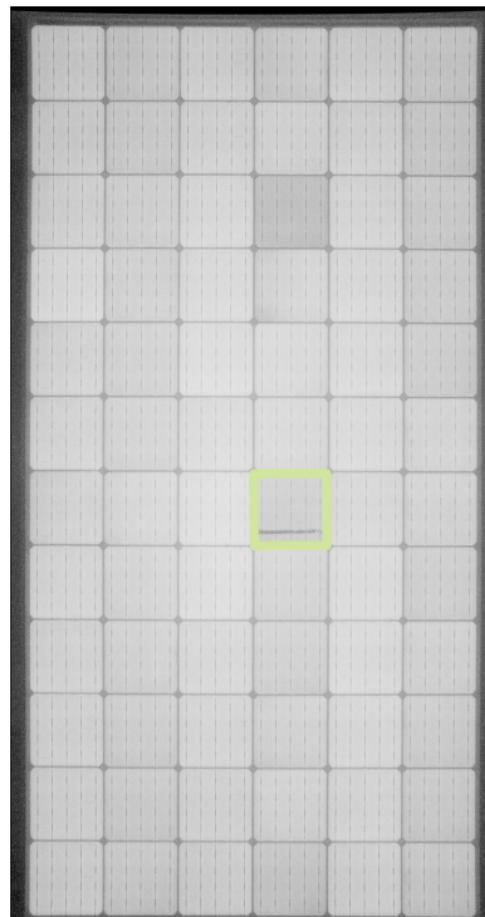
Crack Classification

Predicted Power Degradation: 0.936
