*The Jaycee Arboretum &
Senator Roch Riverwalk*

*Conceptual Site Master
Plan*

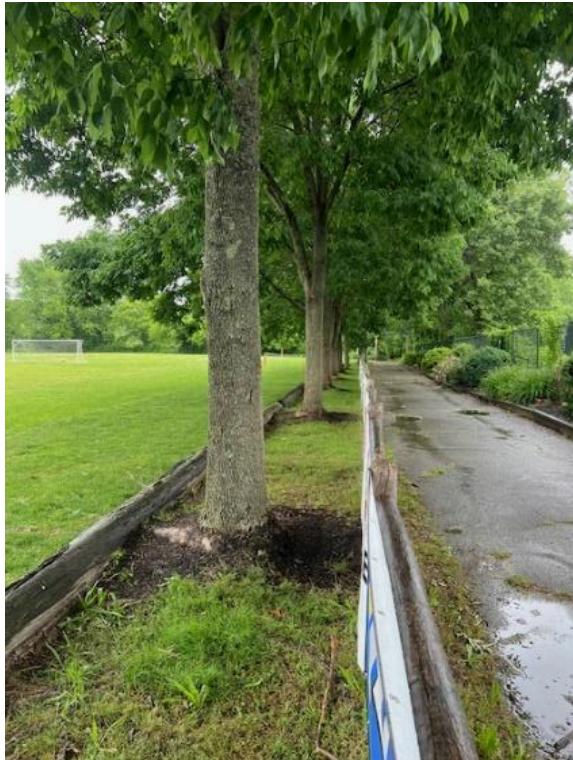
View of the allee of Green Ash trees.

As discussed previously, the Green Ash trees are likely infected with the Emerald Ash Borer which will ultimately kill the trees. Therefore, the team recommends replacing every other Green Ash along the north-side of the arboretum with another deciduous tree such as silver maples, river birch or tulip poplar. Then in the coming years, the remaining Green Ash's would be replaced with the same deciduous trees. Finally, the arboretum contains an abundance of flowering perennials and is separated on the south-side from the neighboring property by a chain link fence. Unfortunately, the area to the south-side of the fence lacks visual appeal and takes away from the beauty of the arboretum. Therefore, the URI RCDL recommends planting a non-invasive vine such as Climbing Hydrangea, Trumpet Honeysuckle or some variety of Clematis along the fence that would eventually cover the fence and help to obstruct the unsightly view.

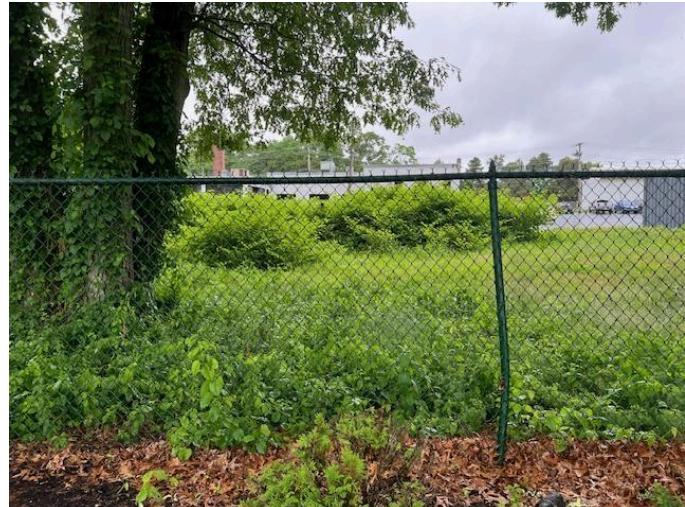
View of the chain link fence and property on south-side of arboretum.

Finally, to address the unsightly neighboring property to the south-side of the arboretum, the URI RCDL recommends planting a non-invasive vine such as Climbing hydrangea, Trumpet honeysuckle or some variety of Clematis along the fence. The perspective to the left shows the fence covered with climbing hydrangea but any of the options below would make a beautiful display while restricting the view of the adjacent lot. Covering the fence with a vine has the added benefit of creating a sense of enclosure for visitors walking through the arboretum.

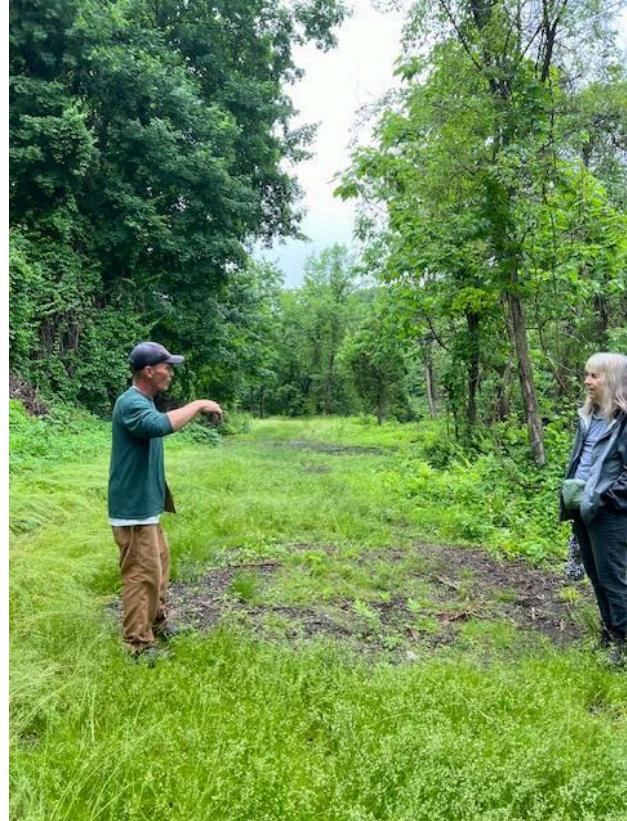
View of the eroded part of the Riverwalk near the fishing area.

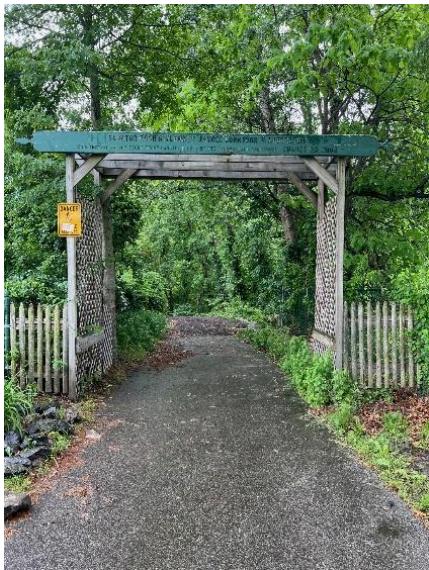
The team is aware that the Boy Scouts constructed the wooden entry structure into the Riverwalk in 2003. Unfortunately, the structure is showing its age and needs updating. Therefore, the URI RCDL recommends replacing the entry structure with a new wooden structure as shown below. The structure features the old green sign created by the Boy Scouts and the design and shape of this structure would be the basis for any new signs placed throughout the area.

View of existing Riverwalk entry.

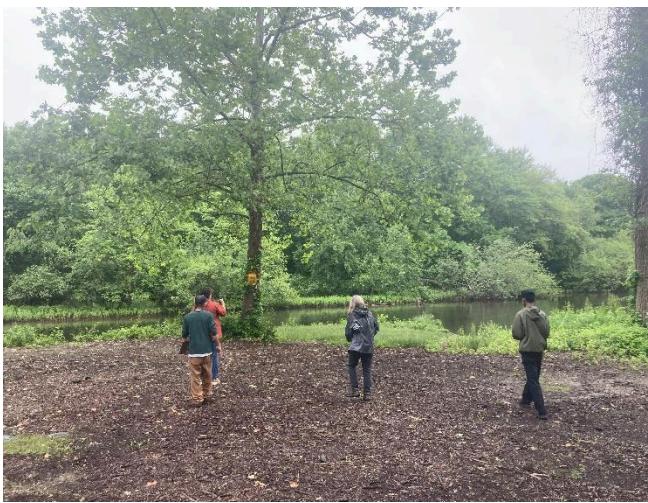
View of existing fishing area near the Pawtuxet.

In the fishing area, the URI RCDL recommends installing a boardwalk over the area of the Riverwalk that gets washed out and muddy. In the fishing area itself, the team suggests maintaining the simplicity of the area but adding picnic benches and additional seating so visitors can spend more time in that area, enjoying the beauty of the river. The URI RCDL also recommends adding riprap or some other type of bank stabilization material along the riverbank to help prevent additional erosion. The team also suggests adding a small dock, that would extend into the river. This would be a great spot for visitors to enjoy the Pawtuxet and provides access for emergency services needing to come into the area via the water.

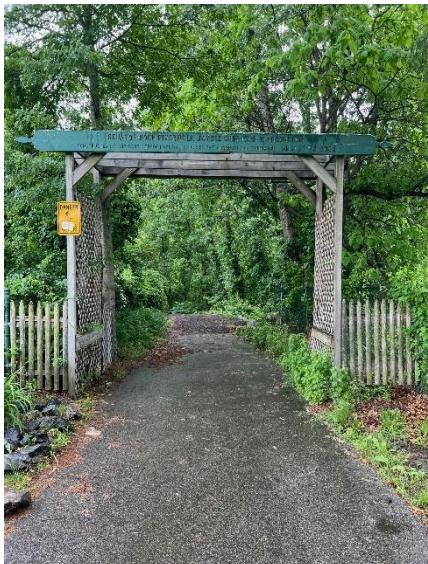
As discussed in the first concept, the original Riverwalk entry structure is in disrepair and needs to be replaced. Therefore, the URI RCDL recommends replacing the entry structure with a stone arch, using the same type of stones as the entry sign and prominently featuring the original Boy Scout sign. The design and shape of this structure would also be the basis for any new signs placed throughout the area.

View of existing Riverwalk entry.

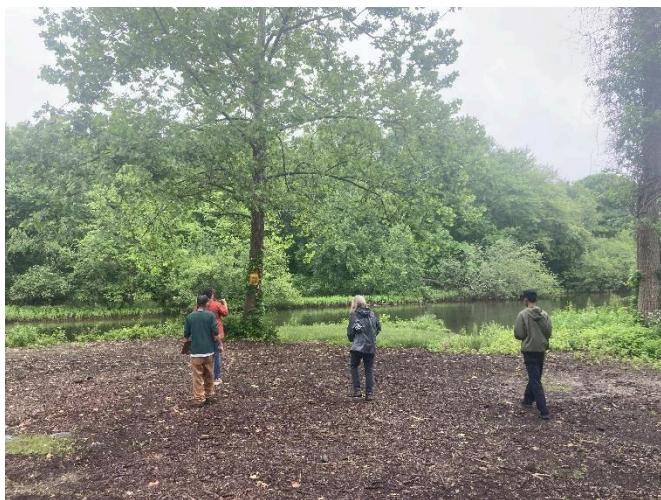
View of existing fishing area near the Pawtuxet River.

For the fishing area in this concept, the URI RCDL suggests stabilizing the bank with riprap or some other type of bank stabilization material to help prevent additional erosion. The team recommends creating a raised platform that would entirely cover the fishing area and the section of the Riverwalk that washes away. It would also extend slightly over the riprap and provide a place for boats to tie up, if necessary. This approach offers a more permanent solution to the impacts of flooding within the area while also providing a stable, dry area for visitors to enjoy the river.

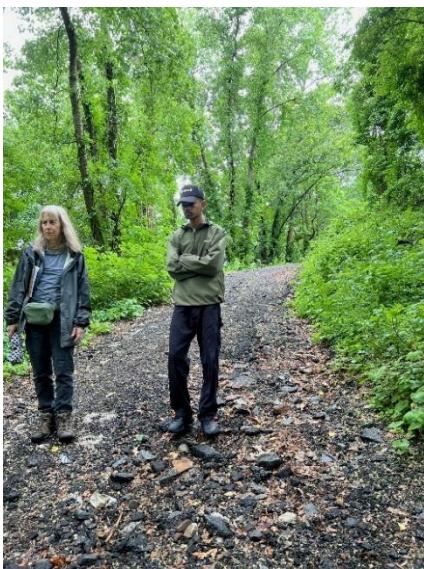
Existing Riverwalk path.

The Riverwalk path itself is currently surfaced with recycled asphalt. While there is an abundance of this material available to the Town of West Warwick and it is a more inexpensive option than other materials, it does not compact well and washes away due to storm water runoff. In addition, the asphalt contains pollutants which are being carried to the Pawtuxet River by stormwater runoff. Therefore, the URI RCDL recommends replacing the recycled asphalt with a more compatible, non-toxic material.
