Home Inspection Report

PROPERTY INSPECTED:
55 Dagmar Avenue
Toronto, ON M4M 1V9

Date of Inspection: 06/15/2022

Inspection No. 141126-1708

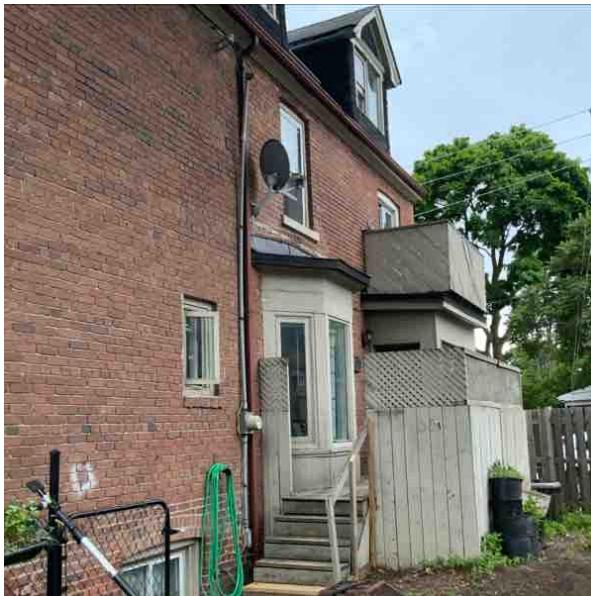
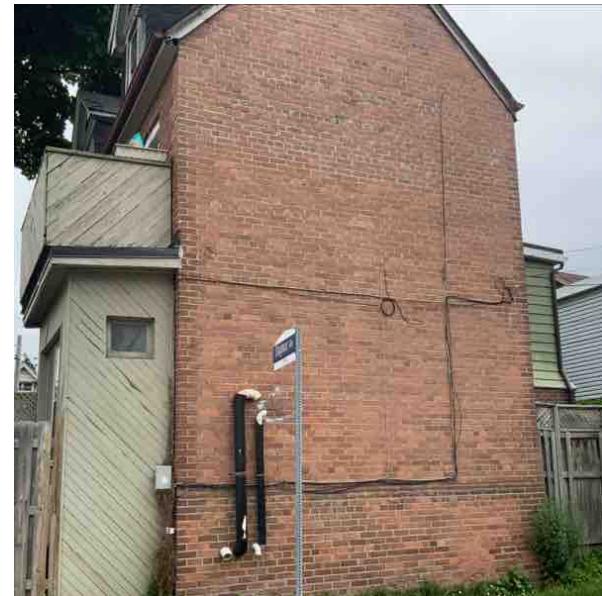
3.1 Exterior General Comments

- Exterior wall elevations were inspected with binoculars from ground level.
- 3.1.1 The exterior components were inspected from the ground level. Any visible issues, along with other pertinent comments, are listed below.
Example views of the exterior can be seen in the picture(s) below.

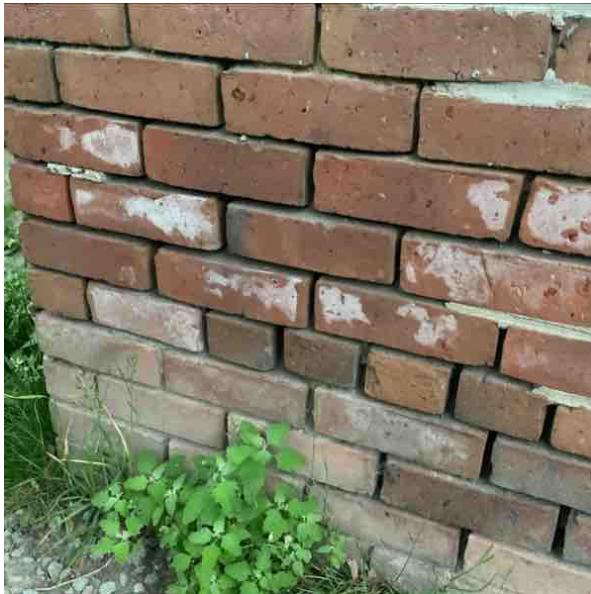
3.3.2 Surface deterioration of brick/mortar noted is common at this age. Repair worn areas, repoint open joints to repel water, reduce further deterioration. Anticipate occasional repairs as part of owning an old property.

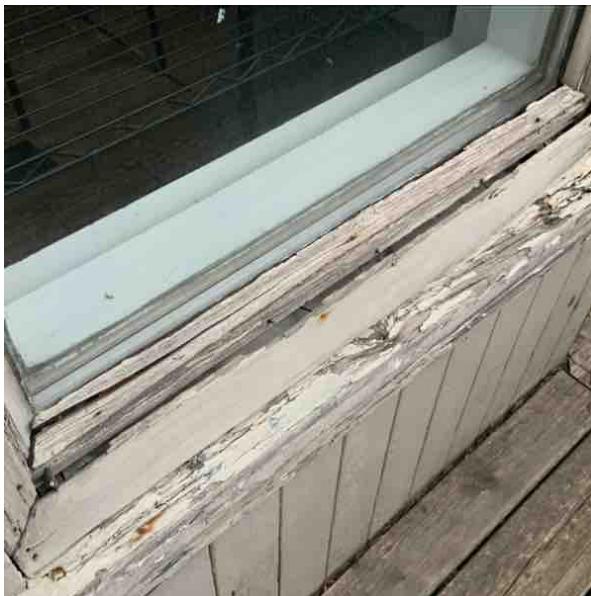
3.5.2 Wood rot identified in areas. This should be repaired or replaced soon to minimize additional damage.

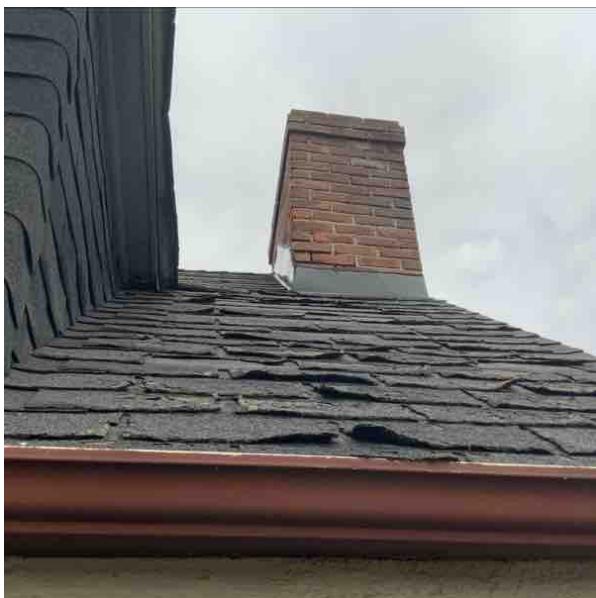
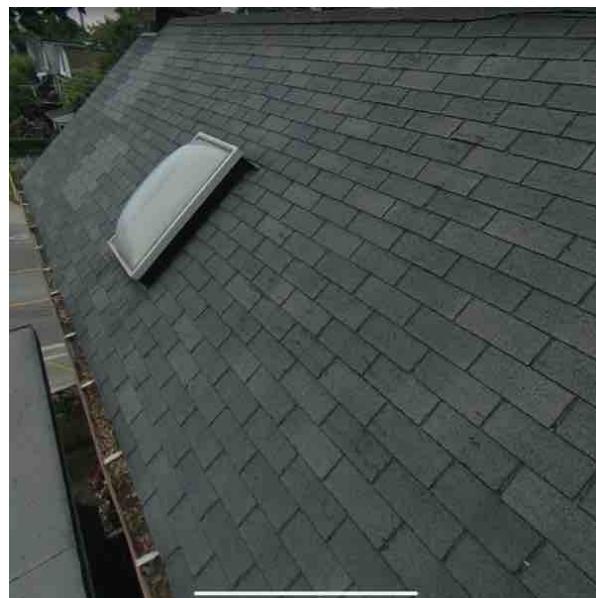
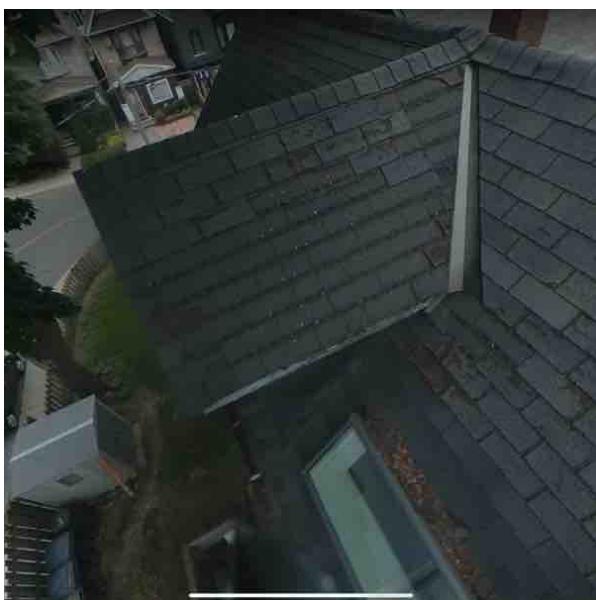
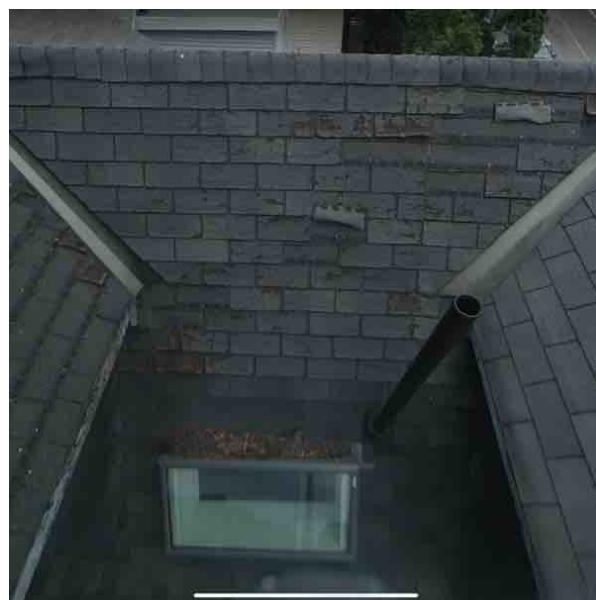
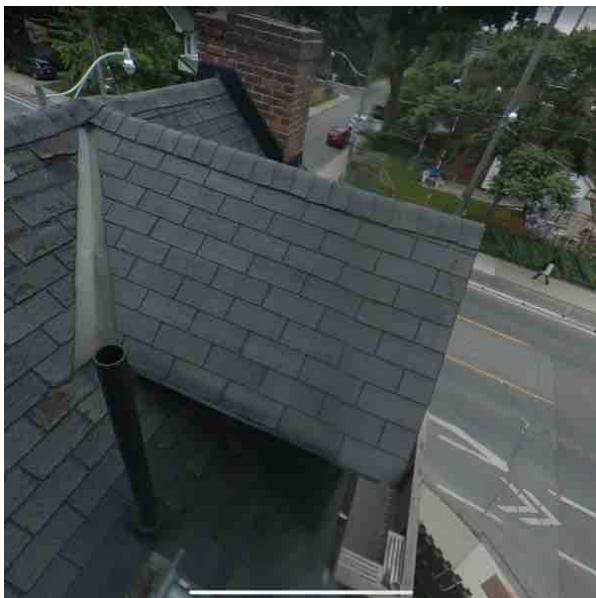
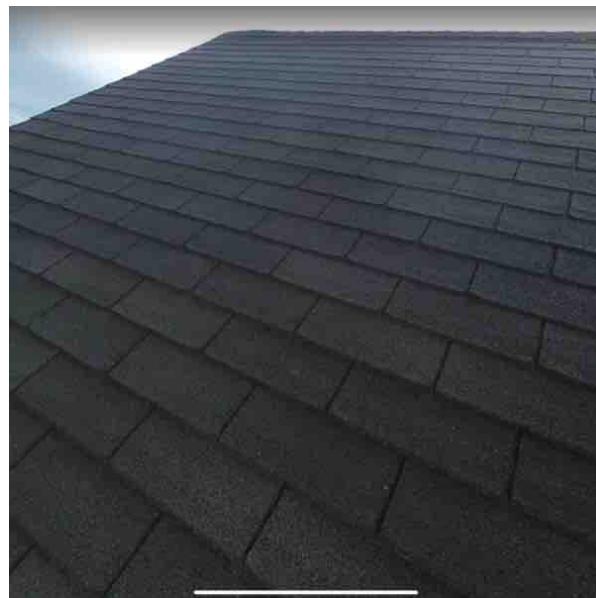
4.4.1 The roof covering has reached the end of its service life. Recommend Replacement**4.5 Flat Surface(s)**

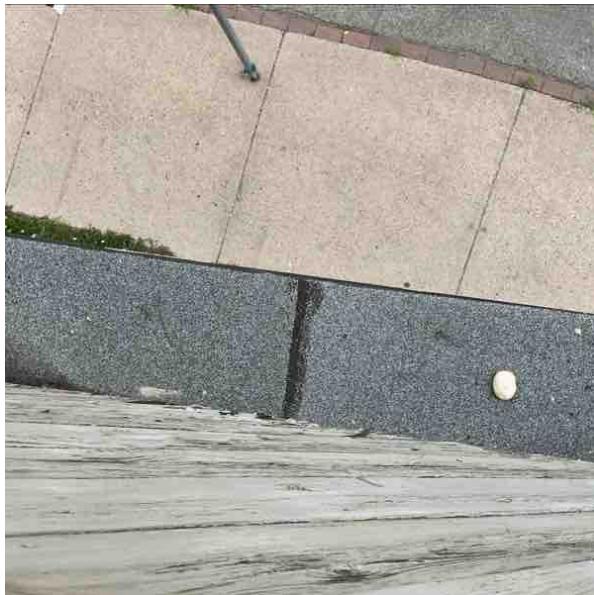
4.5.1 Flat roof membrane inspection is limited by deck cover. Portion visible appears to be in adequate condition .

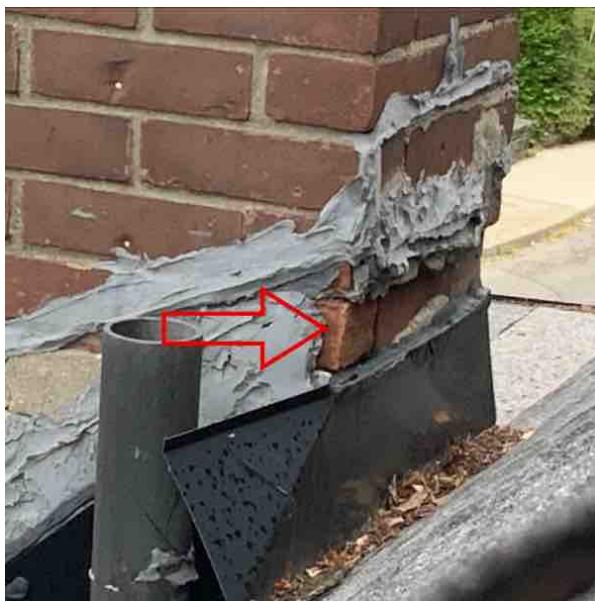
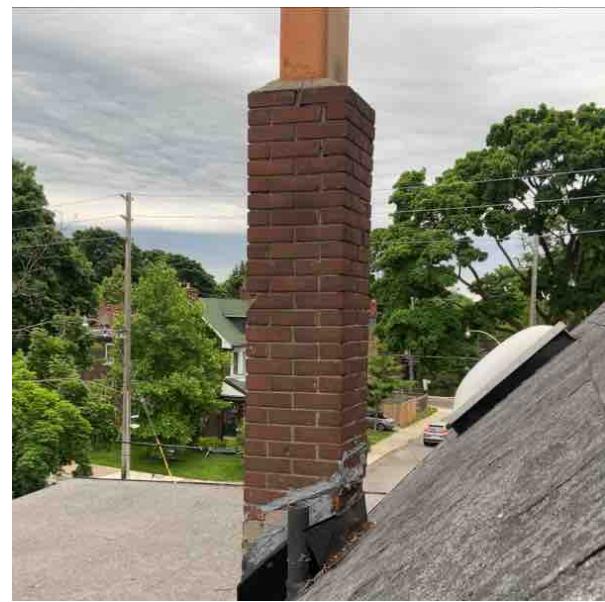
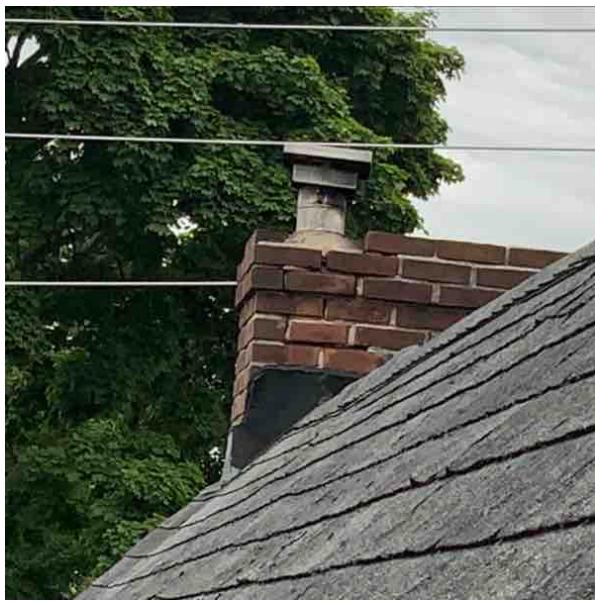
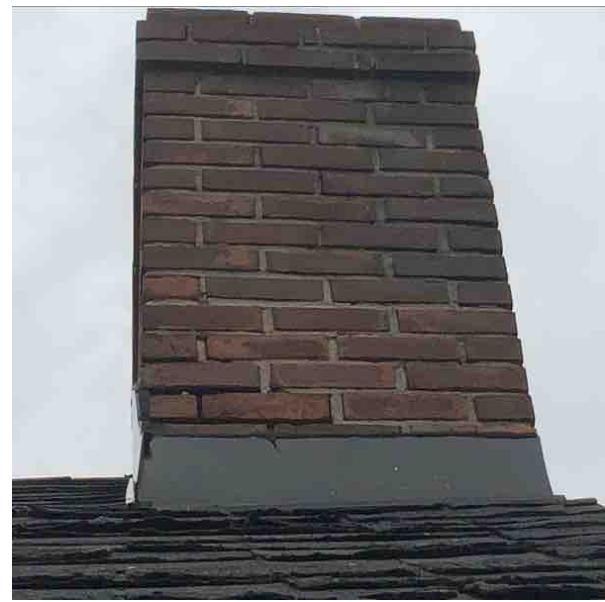
4.8.2 Several of the chimney bricks are spalling and there is mortar loss. Recommend replacing brick and mortar as required to prevent water entry
South chimney vents fireplace.
East chimney does not appear to be in use

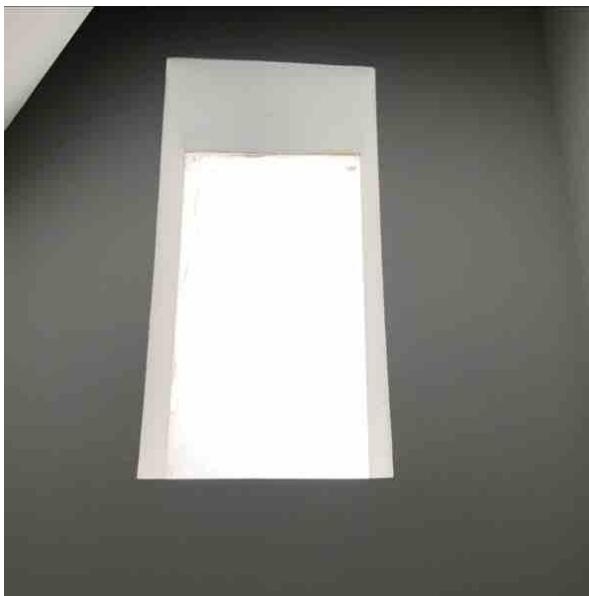
4.9.1 No visible moisture at interior of skylights

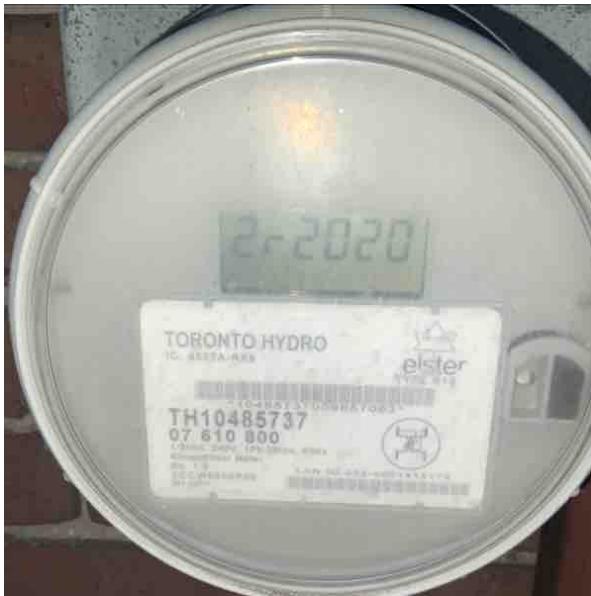
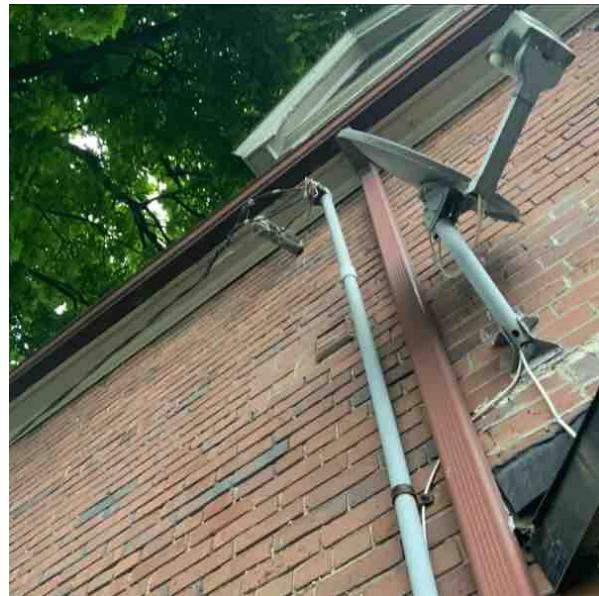
7.2.1 Electrical service to home is by overhead cables. (**Exterior Right**)

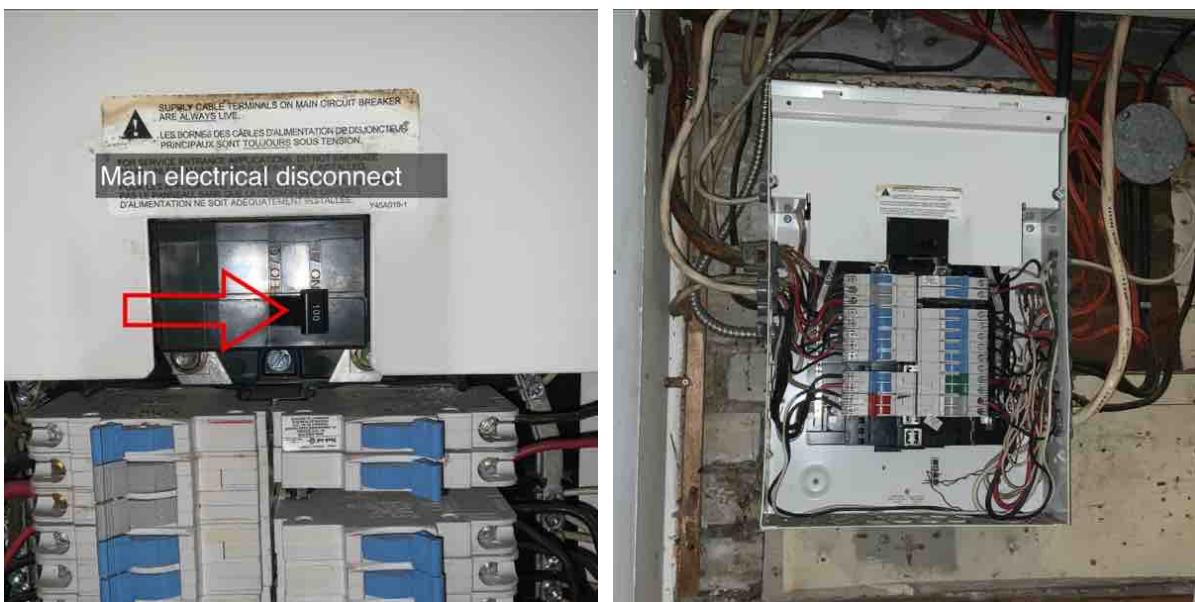
7.4.2 Main disconnect noted in picture

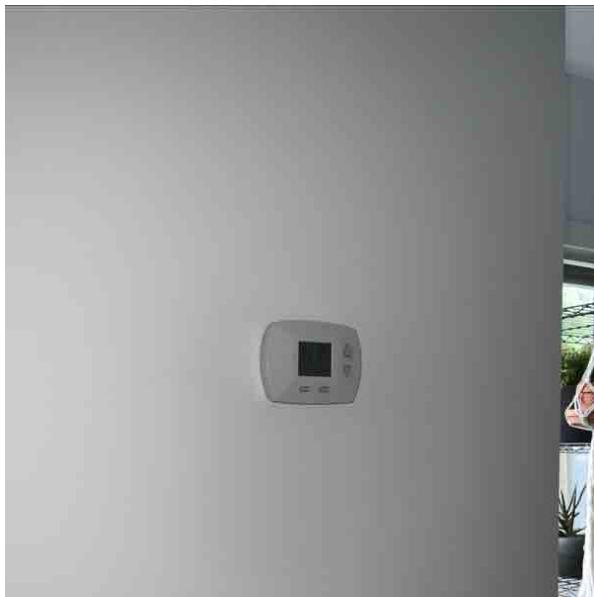
8.2 Thermostat(s)

8.2.1 Located on main floor

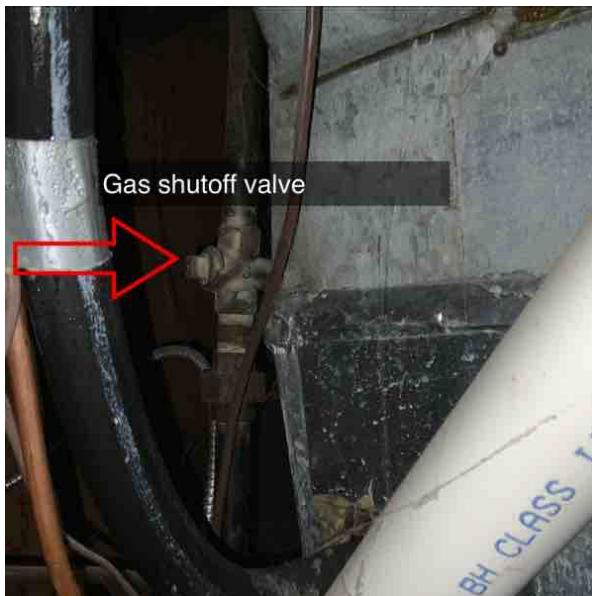
8.3 Energy Source(s)

8.3.1 Gas shutoff valve is located at the unit.

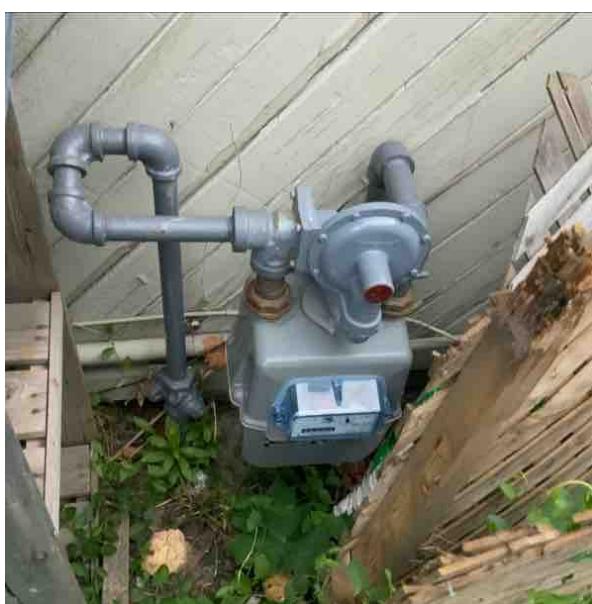
**8.4 Meter**

8.4.1 Located at right side of home

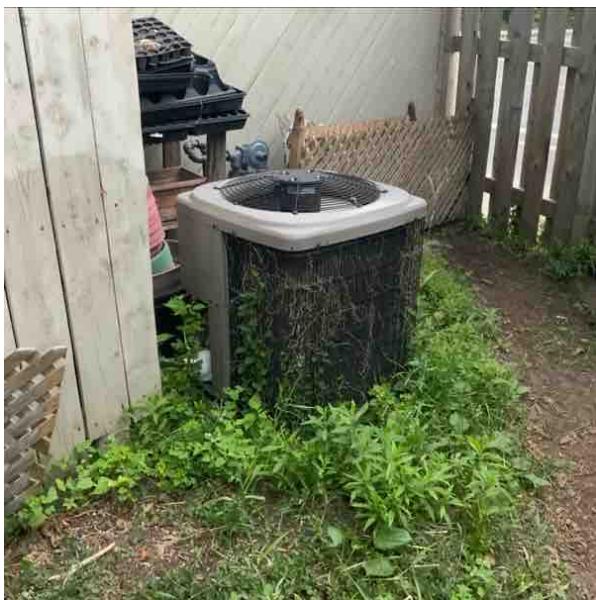
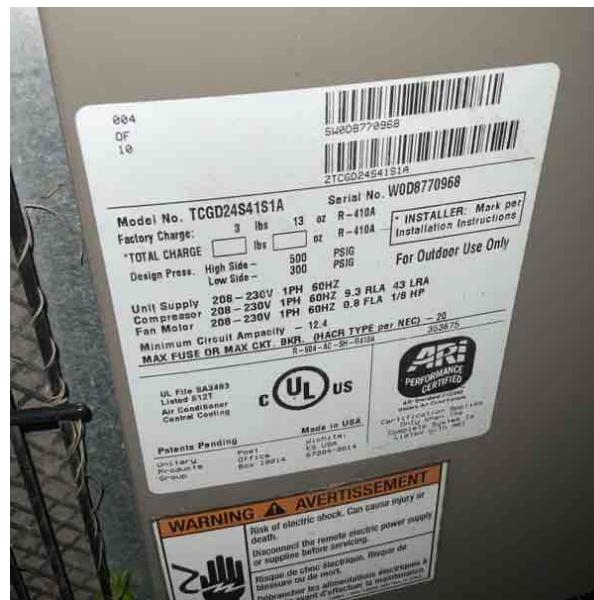
8.5.2 Air conditioner is dated 2008 and is functional (Exterior Right)

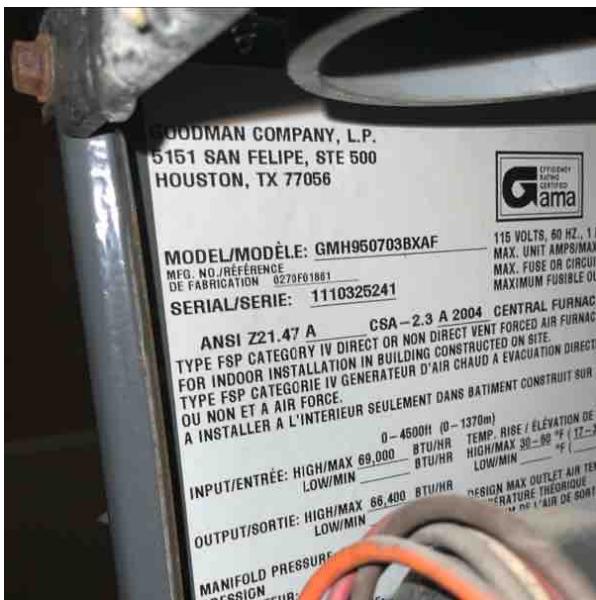
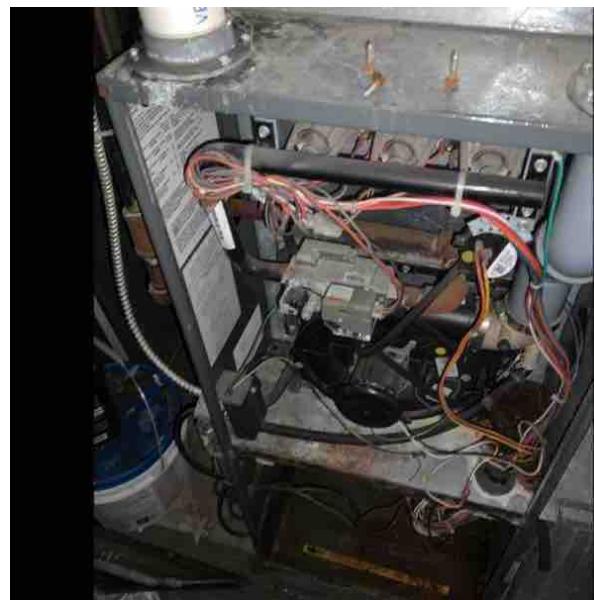
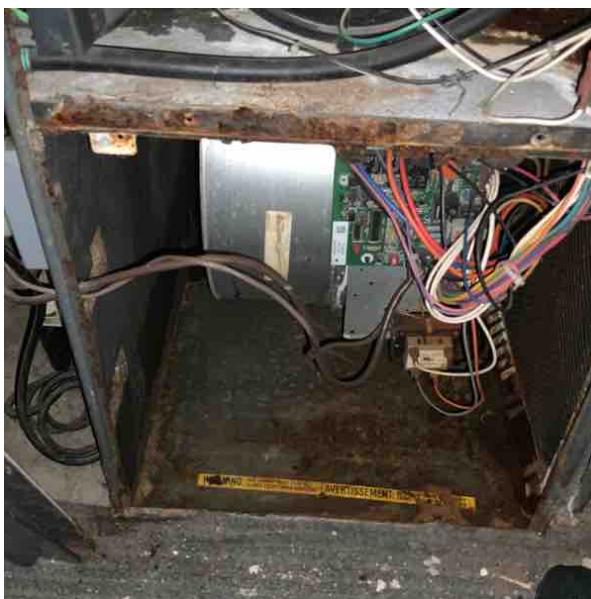
8.6.2 High efficiency furnace is dated 2011 and is functional

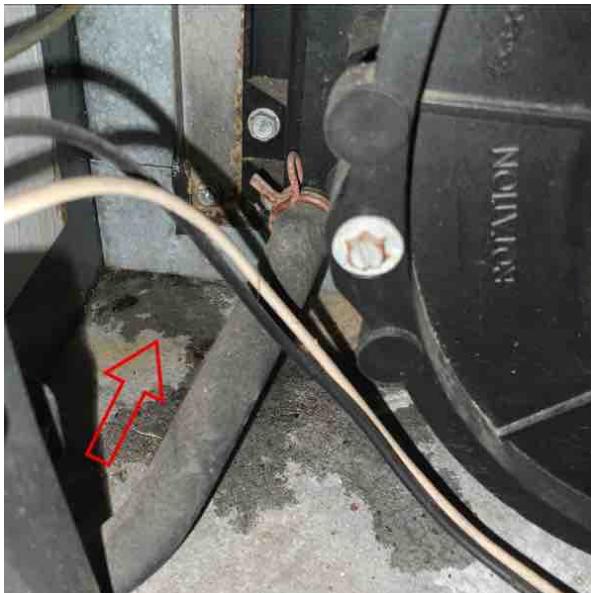
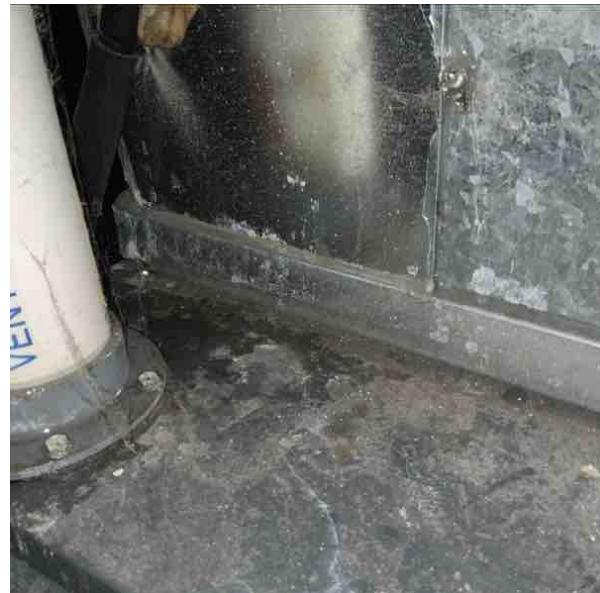
8.6.3 There is water leakage inside the furnace coming from the air conditioner lines. Recommend having the serviced ASAP to prevent damage to furnace (**Basement**)

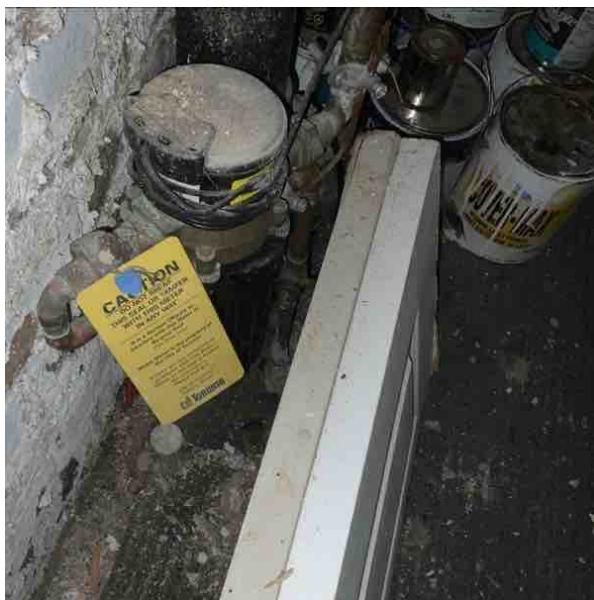
9.2.3 Main shutoff valve handle is missing. This should be corrected so you can shut the house water supply off in an emergency. (**Basement**)

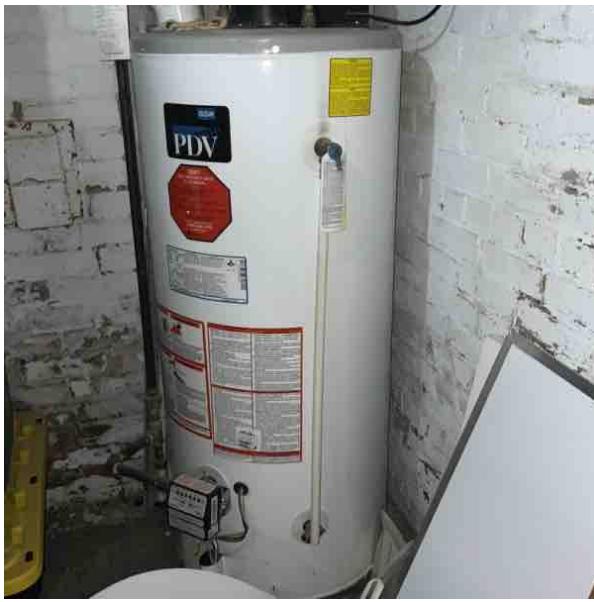
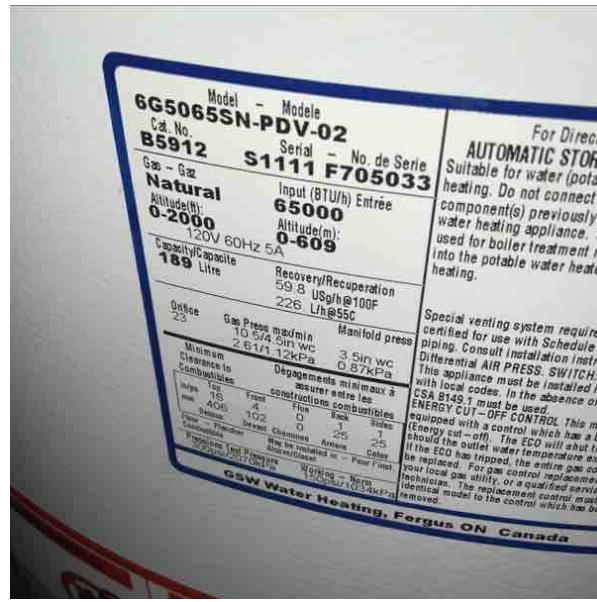
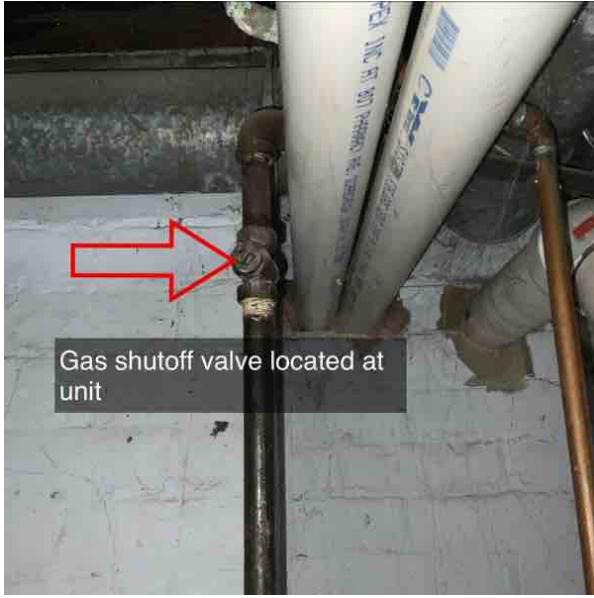
9.5.2 Water heater is dated 2011 and is functional

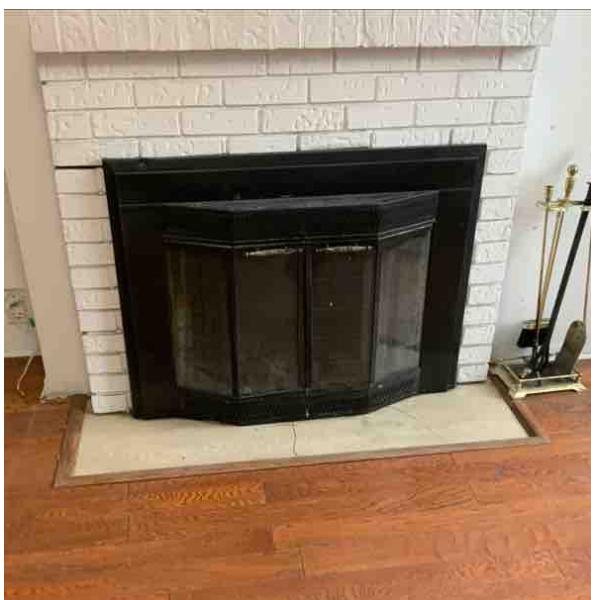
- 11.1.1 Contact a qualified WETT inspector to further investigate prior to usage to ensure safety of system.
(Second floor)

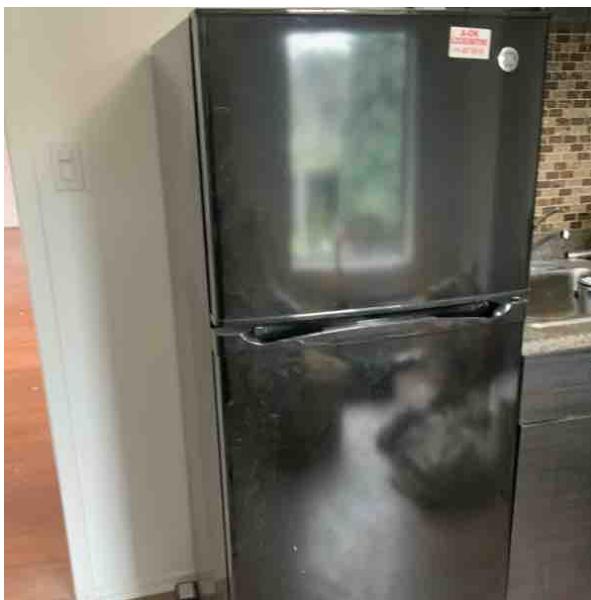
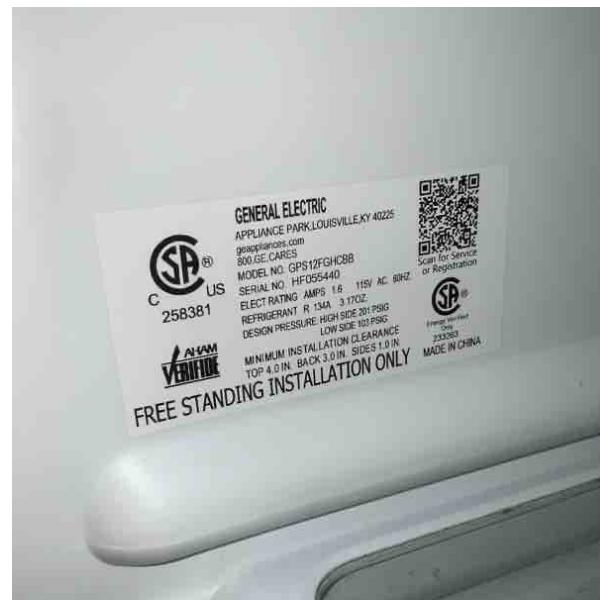
12.2 Refrigerator

- 12.2.1 Functional General Electric (Second floor)

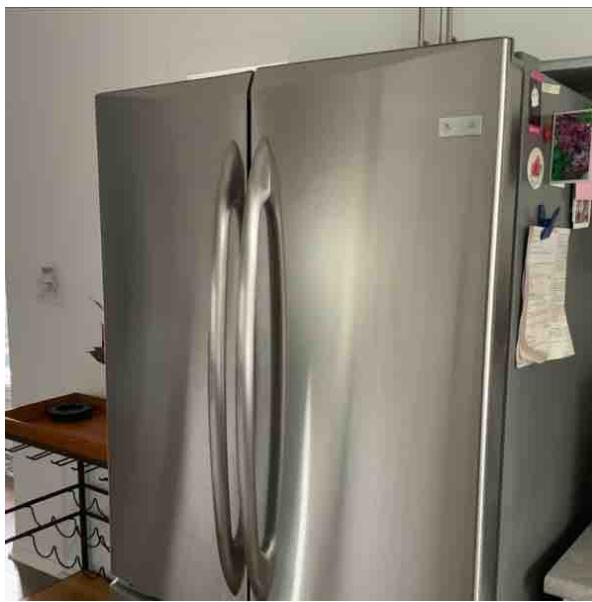
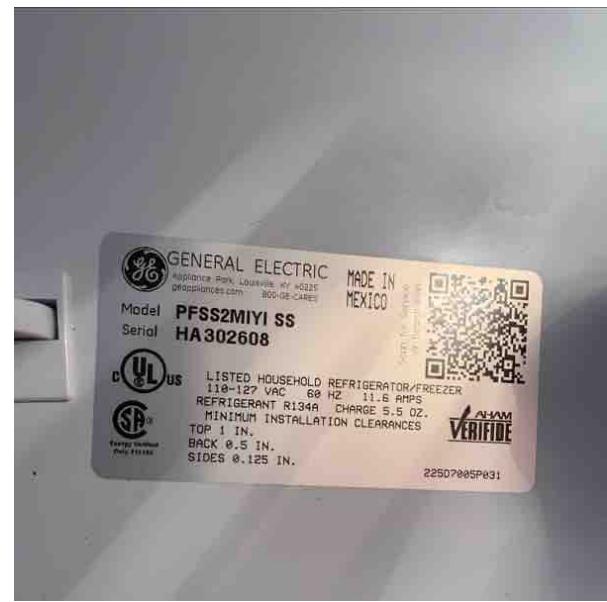
12.2.2 General Electric refrigerator is functional (**Main floor**)

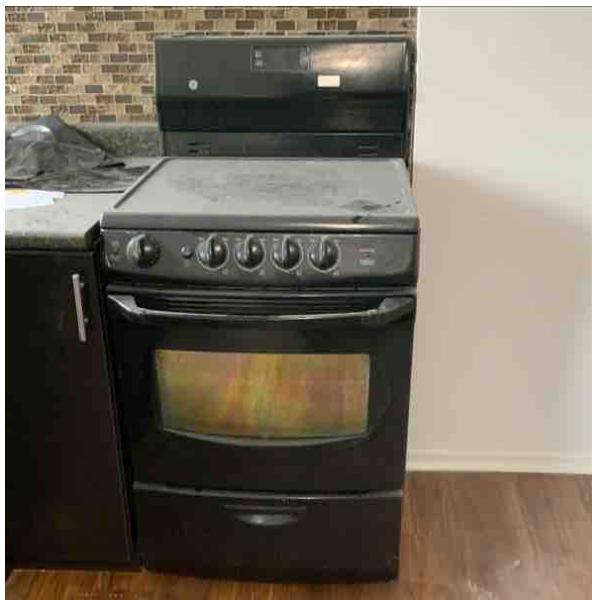
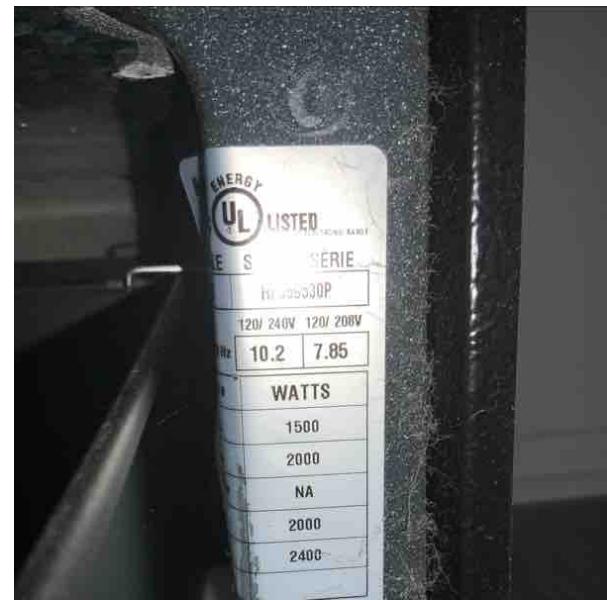
12.3.1 GE electric range

Not functional at time of inspection (**Second floor**)

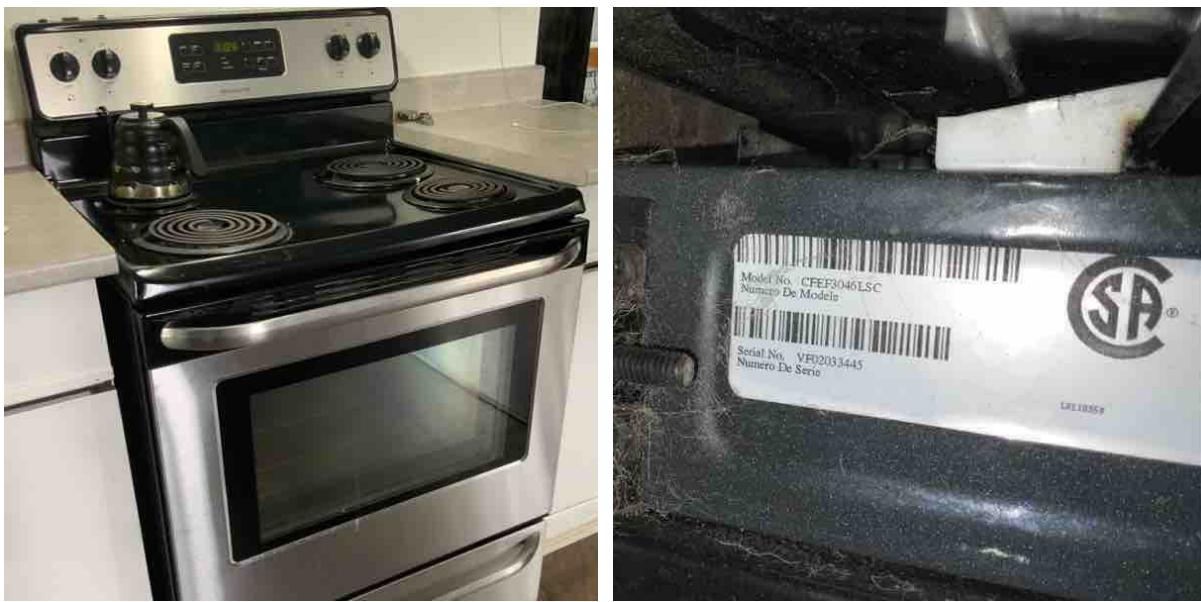
12.3.2 Frigidaire electric range is functional (**Main floor**)

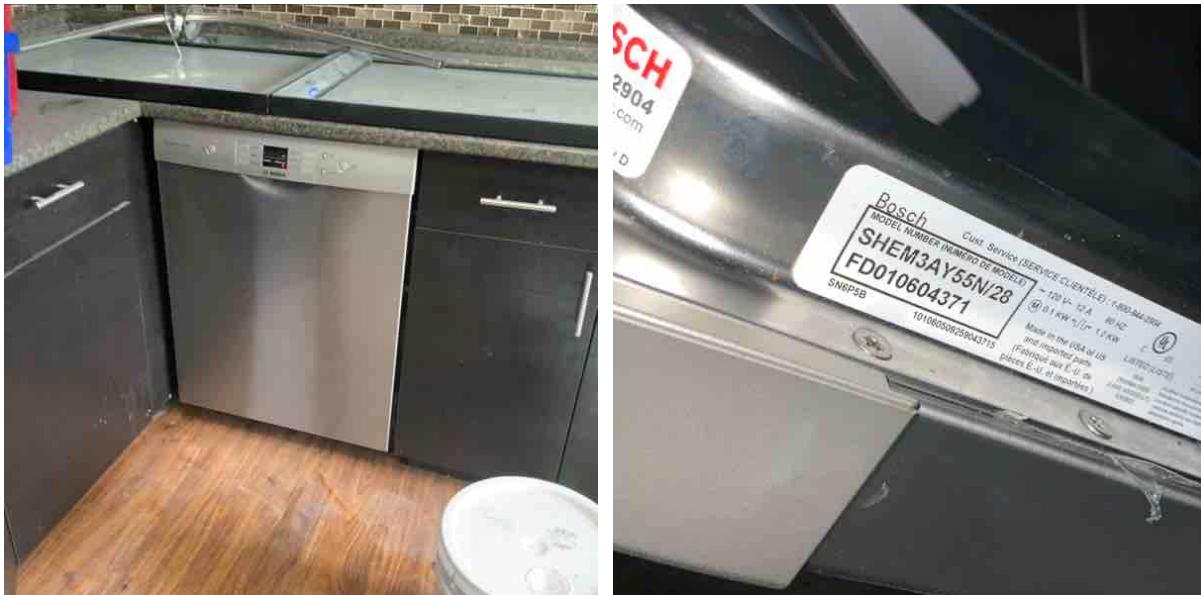
12.5.1 Bosch functional dishwasher (**Second floor**)

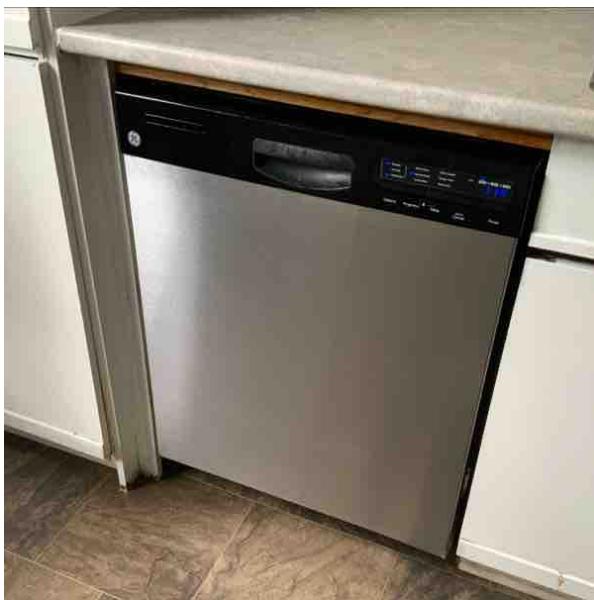
12.5.2 General Electric dishwasher is functional (**Main floor**)

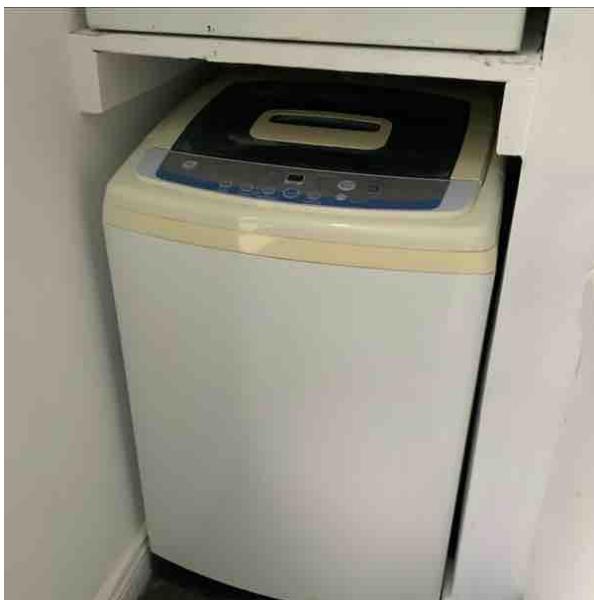
12.6.1 General Electric washer is functional (**Second floor**)

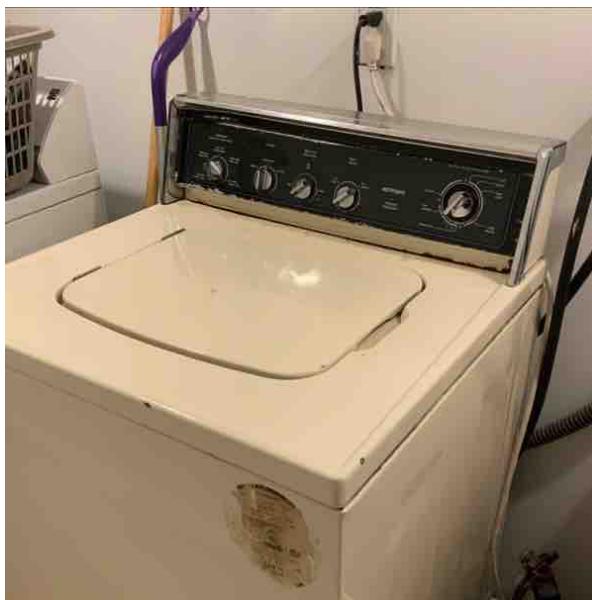
12.6.2 Hotpoint functional washer (Basement**)**

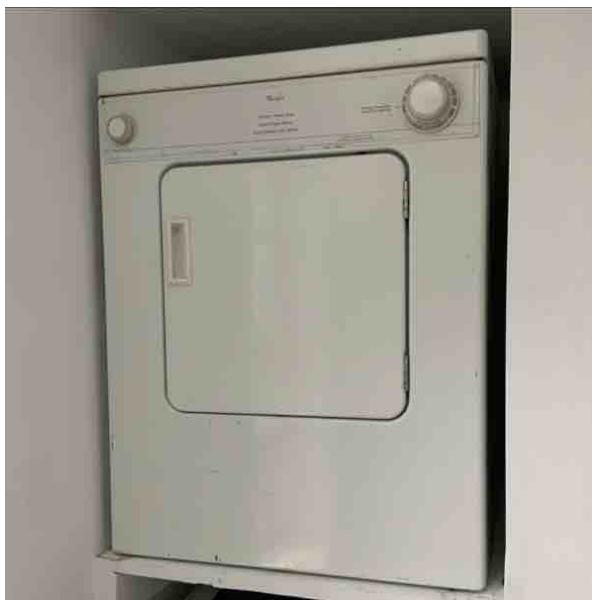
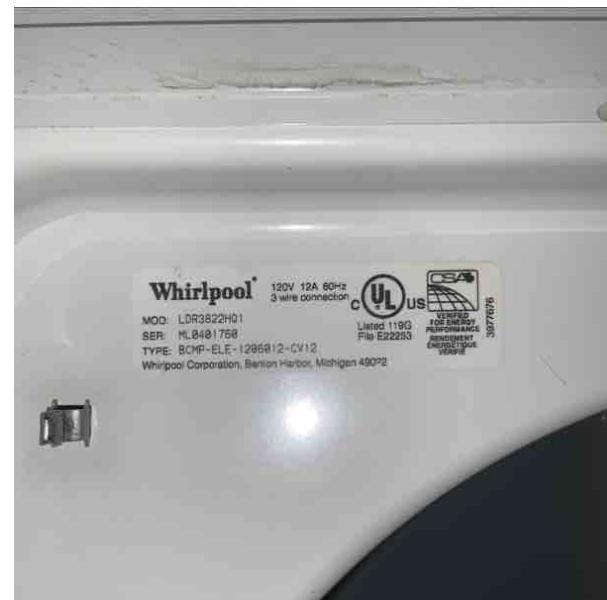
**12.7 Clothes Dryer****12.7.1 Whirlpool dryer is functional (**Second floor**)**

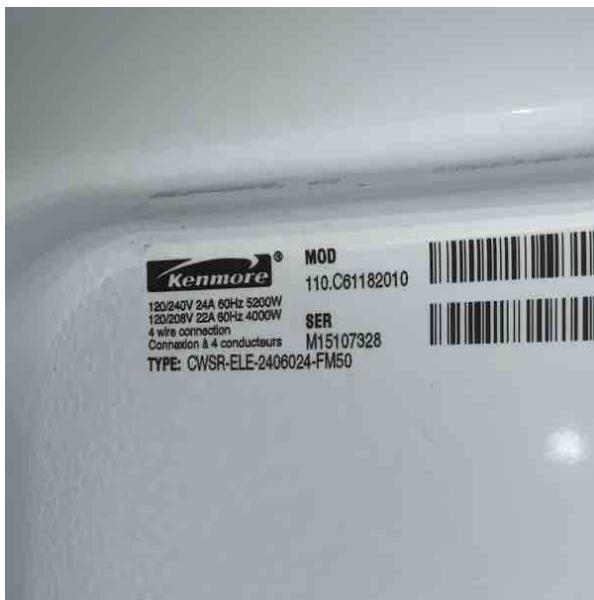
12.7.2 Kenmore functional dryer (**Basement**)
