## Study of damage and repair of blades of a 300 kW wind turbine

Energy 33 (2008) 1068-1083

J.C. Marín\*, A. Barroso, F. París, J. Cañas

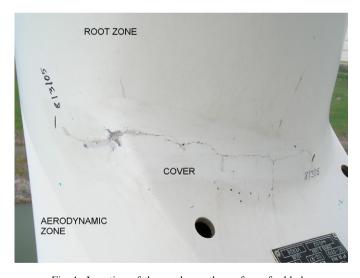
A picture of the typical damage found in a blade, in the form of cracks on the external surface, is presented in Fig. 1. The crack is located in the transition zone between the root of the blade and the zone of aerofoil profile. The cross-sectional section of the blade in the aerodynamic

Fig. 1. Location of the cracks on the surface of a blade.

Although the evolution of damage is difficult to establish, the crack observed in the inspection (see Fig. 1) is formed by several well-differentiated parts: (a) the part that runs through the cover (slices 8 and 9), which affects the whole thickness of a laminate without resistant function, (b) the continuation of this part on slice 7 which only affects the external layers of the laminate, with breaking of unidirectional fibres and multiple delaminations (as can be observed in Fig. 3c), (c) the part corresponding to slices 5 and 6 in which the whole thickness is damaged (as observed in Fig. 3d) and finally (d) slice 4, where the actual crack front is located, as no appreciable damage is observed at the side facing slice 3. Notice that the fabrication defects observed appear at slices 8 and 9, slices 5 and 6 where the damage starts to develop being free of initial manufacturing defect.

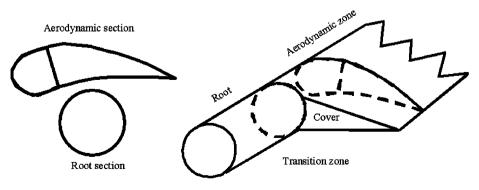
Fig. 2. Scheme of the blade geometry.

zone is a thin-walled section that reproduces the aerofoil profile and presents a vertical partition (denominated spline) that divides the section into two cells: leading edge and trailing edge (Fig. 2). The cross section in the root zone is practically cylindrical.

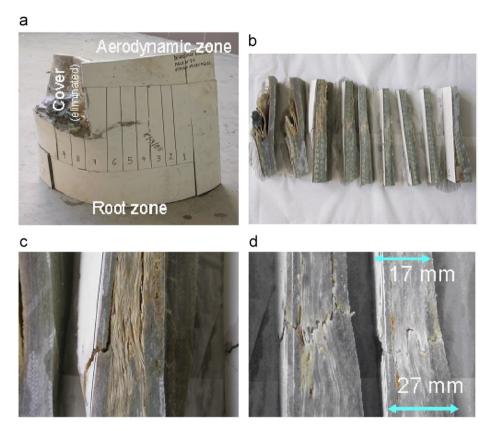
In order to have a visual inspection of the failure area, it is divided into slices of 2–3 cm width, as shown in Fig. 3a and b, so that the progression of the internal damage can be observed. A detail of the damaged area at slice number 7 is shown in Fig. 3c, whereas those areas corresponding to slices number 6 (left) and number 5 (right) are shown in Fig. 3d.

- An *a posteriori* lamination over the gel coat on the external surface and centred in the area of the crack (see Fig. 3d) can be observed.
- An abrupt change in the thickness of the laminate exists in the area of the crack (see Fig. 3b and d for more details) the difference of thickness being in some cases (slice 5) up to 10 mm, from 17 to 27 mm, over a distance of only 150 mm.
- The presence of areas with lack of resin (see Fig. 3b and c).
- A debonding is observed between the spline and the aerodynamic walls (when the whole set is looked at from the upper part).

Fig. 3. Details of the internal damage suffered by the blade.

It is in these slices (5 and 6) that, after the inspection carried out in Section 2, a more marked transition in thickness can be observed (Fig. 3). This abrupt change of thickness produces an eccentricity in the transmission of the load, generating bending moments that make the laminate not work uniformly over the whole thickness. Additionally, the unidirectional layers that are present in both laminates suffer misalignment in the longitudinal orientation of the fibre. This misalignment, under compression, can accentuate the failure mechanisms associated to local micro-buckling of the fibre.

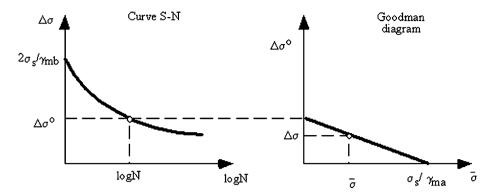
Fig. 7. S-N curve and Goodman diagram.

Substituting the expression of the Goodman diagram in the S-N curve, the expression that provides  $N_i$  for a determined stress range is obtained:

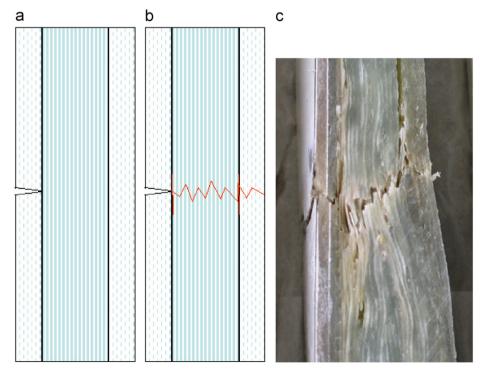
Finally, it is necessary to take into consideration that when the laminate is going to suffer the failure of the resistant layer, the external layer presents a crack, motivated by the effect of the concentrator, described in Section 3.2, on the weak laminate of the cover, as is indicated in Fig. 10a.

Fig. 10. Scheme of the progression of the crack in the laminate: (a) crack in the superficial layer, (b) crack in the resistant layer and (c) view of the real crack.

The nature of the observed failure seems to be due to a fatigue mechanism. The configuration of the observed cracks seems to indicate that first a superficial crack (Fig. 10a) appeared, probably around the weakest point (corner between the cover and the root) due to the stress

concentration, this crack progressing throughout the superficial layer and inducing delamination between this superficial layer and the resistant laminate. Later on, in the zone where there was an abrupt change of thickness, the presence of the superficial crack together with the effect of the concentrator and the effect of the change in thickness gave rise to the stress state necessary to generate a crack in the resistant laminate (Fig. 10b), which completely broke the laminate, as is observed in Fig. 10c.

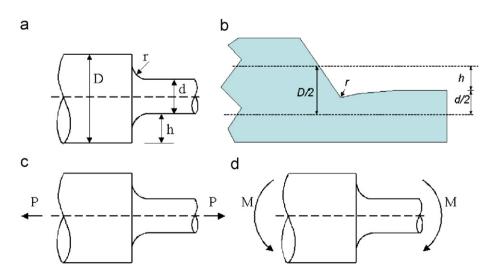
Fig. 11. Geometric scheme of the concentrator. a: simplified scheme; b: blade dimensions; c: tension problem; d: bending problem.

The obtained values are of a similar order of magnitude to those associated to a geometric concentrator like the one appearing at the root of the blade. In order to evaluate quantitatively the range of values of this concentrator, solutions of similar problems (see Fig. 11a) can be found in the literature [14, pp. 286–287]. In particular, two problems with similar geometry to the real concentrator have been taken, corresponding to tension (Fig. 11c) and bending (Fig. 11d) loads.

The parameters on which the stress concentration factor depends can be estimated, for the dimensions of the blade (Fig. 11b), within the following ranges:

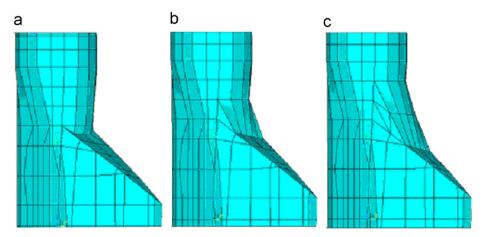
Fig. 12. (a) Original geometry, (b) modified geometry 1 and (c) modified geometry 2.

In order to release the stress state in the zone of influence of the concentrator, a lateral triangle of resistant material that smoothes the re-entrant corner (see Fig. 12b) in the zone where the crack appeared will be introduced. This modification obviously goes along with the modification of the elements that connect the root with the cover. In detail, the modification of the original model consists of:

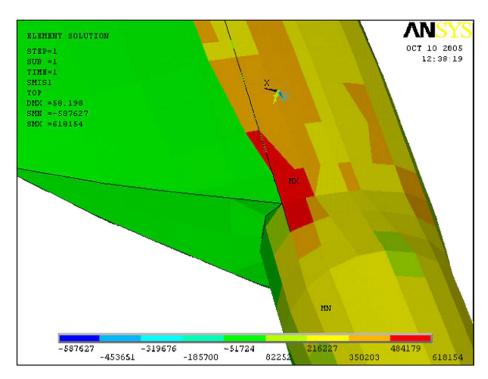
Fig. 14.  $N_x$  efforts in the original configuration of the blade.

The values of  $N_x$  obtained for the load case N1.0 and for the original geometry of the blade are represented in Fig. 14, for the face in tension of the blade, where the damages were observed. The zone represented is the one where  $N_x$  reaches the highest values, due to the presence of the concentrator. It has to be clarified that, quantitatively speaking, the values of  $N_x$  calculated have meaning only for comparison purposes between similar meshes, since the theoretical nominal value of  $N_x$  at the vertex of the reentrant corner is infinite, the values obtained being strongly dependent on the discretization carried out at the neighbourhood of the corner.

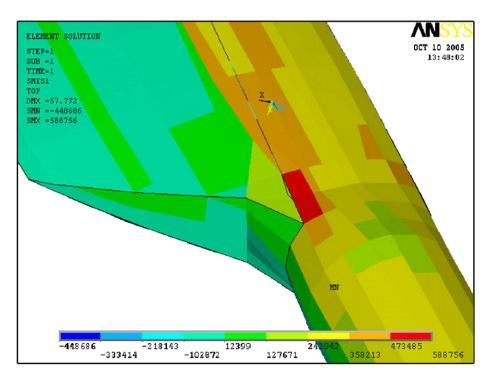
Fig. 15.  $N_x$  efforts corresponding to configuration 1.

The values of  $N_x$  obtained for load case N1.0 and for the modified geometry (configuration 1) are shown in Fig. 15. The modification produces two effects on the stress state. First a reduction in the level of stress at the neighbourhood of the corner of the original configuration, and second the

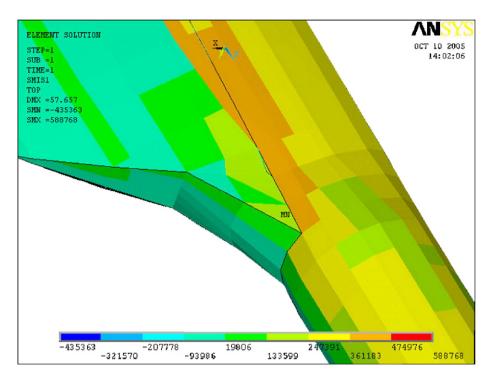
Fig. 16.  $N_x$  efforts corresponding to configuration 2.

The values of  $N_x$  obtained for the load case N1.0 and for the modified geometry (configuration 2) are represented in Fig. 16. Observation of Fig. 16 leads to the same conclusions as in the case of Fig. 16, the redistribution of stresses in the elements adjacent to the triangle introduced being even greater than in configuration 1.

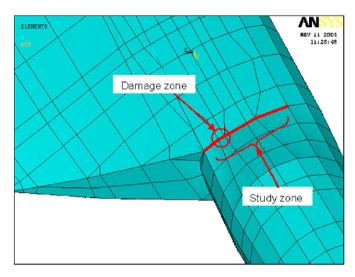
Fig. 17. Line under study and damage zone locations.

To evaluate the influence of the modifications performed in the stress state, it has to be taken into account that the comparison of the results has to be made far enough from the vertex of the corner to leave the results unaffected by the nominal corner singularity. Additionally, the value of  $N_x$  must be compared in the area where the damage appeared, this area being represented in Fig. 17, over the original configuration geometry.

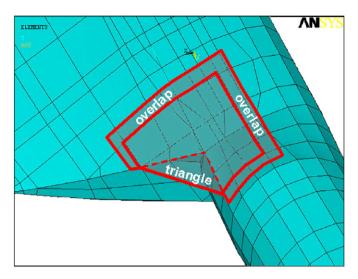
Fig. 21. Scheme of the configuration of reinforcement and the overlaps.

must overlap the previous one by a certain length along the whole periphery (see Fig. 21). In this way a progressive transmission of loads takes place from the blade to the triangular surface so that the surface can develop its resistant function.
