# Increasing road network resilience to the impacts of ground movement due to climate change: a case study from Lincolnshire, UK

Anna May Harrison<sup>1\*</sup>, Mark Heaton<sup>2</sup> and David C. Entwistle<sup>1</sup>

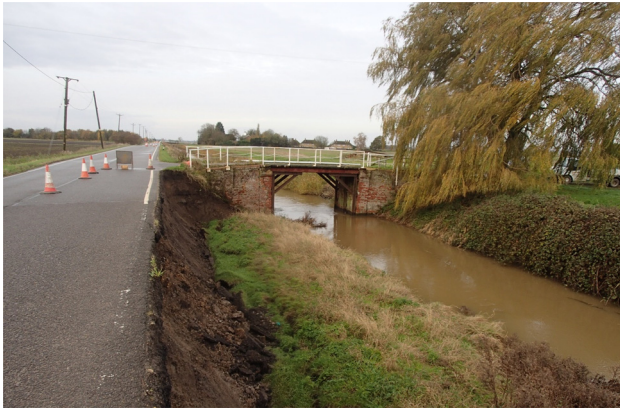
Flooding resulting in embankment and ditch slope failures has increased in occurrence recently due to more frequent high-intensity rainfall events. For example, a bank failure occurred in November 2019 at Fodderdyke Bank, following a high-intensity rainfall event, causing the bank to become quickly saturated. This caused the adjacent highway to become unstable as the minimal subgrade to the carriageway slipped away as part of the bank failure ([Fig. 5](#)).

**Fig. 5.** Landslide in a large ditch adjacent to road, causing road subsidence and closure for repairs in autumn 2019. Fodderdyke Bank, Midville. © Mark Heaton, Lincolnshire County Council.

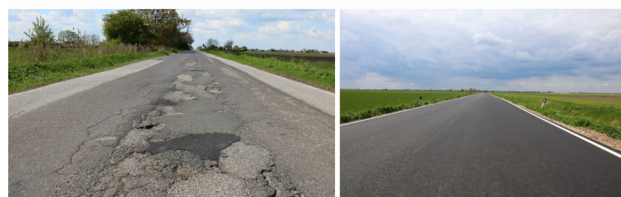
During the last decade, splitting along the longitudinal section (Fig. 7), undulations, deformation including localized shears, slope movement and other subsequent highway failures have developed. Due to the worsening state of the road, it became relatively unsafe for travelling on at speed. In 2015 a road traffic incident took place; tragically, this resulted in a fatality, and a lower speed limit was enforced until repair work could be completed. Mitigation work was successfully completed by the local authority during 2018. Although overlays had been the typical repair method, a different approach was used to increase the life of the road and reduce future maintenance requirements. This entailed recycling of the existing road surface; therefore, not introducing additional load. Due to the length of this road this is a rolling programme with works being undertaken each year. It is still ongoing, giving the highway authority the opportunity to review, monitor and make fine adjustments to the design, whilst continuing its research.

The Environment Agency (EA) LiDAR scan data (Fig. 7) show the lower ground to the north of Fodderdyke, which coincides with the highly compressible peat deposits. These are topographically similar to the tidal flat deposits to the south, which are also susceptible to consolidation due to loading and shrinkage due to a reduction in water, although this movement is less than found in the peat as they have a lower natural water content and show less ground movement. The roddons cross the area from north and south, raising the ground surface, appearing as 'inverted channels'. North of the road, compression of the peat deposits has led to the land surface lowering, and therefore a lowering of the overlying roddons. Due to less movement in the tidal flat deposits to the south of the road, the roddons have a comparably slightly higher elevation to the south compared to the north. However, in all locations, roddons provide a positive topographical feature. The presence of deposits with different lithology and characteristics along the road leads to large variation in the amount of movement seen.

Considering the increasing SMDs projected for the area, and the higher subsidence susceptibility of the peat deposits, the difference in elevation is expected to increase, causing further road damage where peat deposits meet the road and differential movement occurs. The

**Fig. 7.** (Top) Superficial geological map. (Middle) LiDAR image. © Environment Agency copyright and/or database right 2022. All rights reserved. (Bottom left) Previous road damage and patching work at Fodderdyke western stretch (May 2018). BGS © UKRI 2018. (Bottom right) Present-day post road repair Fodderdyke eastern stretch (May 2018). BGS © UKRI 2018.

presence of roddons leads to further heterogeneity in the underlying ground conditions and increased undulations along the road.

The road surface is impermeable and restricts ingress of water directly beneath it. The presence of ditches either side of the road means that a larger surface area is exposed, driving enhanced changes in water content. As the adjacent ground experiences annual fluctuations in water content, and resulting volume changes, the soil water content beneath the road remains relatively constant, sealed off from external variations. This leads to a soil water content gradient from the edge to the centre of the road, and a gradual drying out of the outer edges of the road over time. This drying causes a decrease in soil water content and pressure, leading to volume reduction and longitudinal deformation parallel to the edge of the road, as can be seen in Figure 7. This process is further exacerbated by heavy loading from vehicles travelling along the road, and the carriageway being informally widened over time, so load is being applied nearer to the break in slope. Once deformation has occurred, these weak zones are broken up by deformation cracks that allow water ingress, causing further damage through localized changes in water content and freeze–thaw processes. Acting locally, within a few metres, the presence of vegetation, such as trees and large bushes, exacerbates these processes due to evapotranspiration.

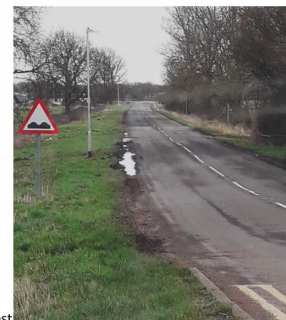
In September 2020, Lincolnshire County Council undertook windowless sample holes, drilling to a maximum depth of 4.5 m, at four points along the stretch of road (Fig. 8). The road surface had a consistent 40 cm of asphalt, underlain by *c.* 60 cm of fill and sub-base. The depth of peat in the boreholes beneath the road ranges from 1 to 3 m, showing large variability between each of the sites; with WS4 recording much shallower peat than WS1–WS3 (Figs 9–12). The deposits underlying the peat at all four sample holes are clayey peats and clays with rare organics, considered to be glaciolacustrine deposits. These are much thicker in WS4 than at the other three locations. Sand with flint gravel is at depth in all four holes, located at around 2 m depth at WS1–WS3 and at almost 4 m at WS4. The LiDAR image (Fig. 8) indicates the presence of a roddon at WS1 and the old River Ancholme passing through WS4.

**Fig. 8.** Brandy Wharf. (Top) Superficial geological map. (Middle) LiDAR data. © Environment Agency copyright and/or database right (2022). All rights reserved. (Second to bottom) Photograph of case study site, looking west, showing the undulating road surface (September 2020) © Mark Heaton, Lincolnshire County Council. (Bottom) Sample hole locations. ©Lincolnshire County Council.

At sites WS1–WS3, the peat is deeper, and the road has experienced more subsidence and damage than at WS4, due to the high compressibility of the peat. In addition, the underlying glaciolacustrine deposits, with a varying organic content, increase in depth towards the east (WS4), leading to further variations in compressibility along the short stretch of road. With the presence of roddons and the old river course passing over the site, the variable and

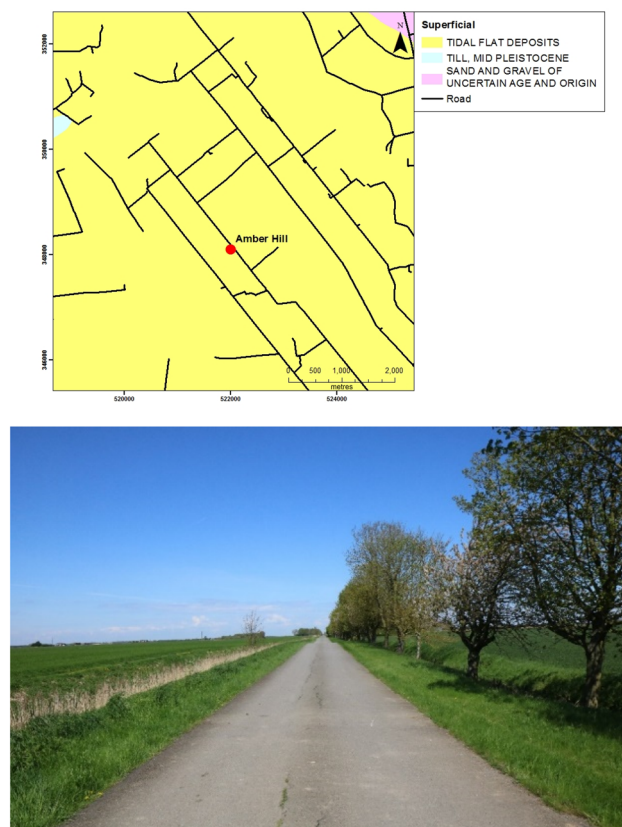
Longitudinal cracking has occurred down the centre of the carriage way, as can be seen in Figure 14.

Changes in water management, causing fluctuations in pump volumes in the winter due to changes in precipitation and changes in agricultural practice, including field irrigation during dry winters, has led to lower water levels in ditches and drying out of the embankment, much more so than in the recent past. As seen in Figure 14, trees are established adjacent to the drainage ditch. As water

**Fig. 14.** Amber Hill. (Top) Superficial geological map. (Bottom) Photograph taken in May 2018 showing longitudinal cracking along the centre of the road. BGS © UKRI 2018.

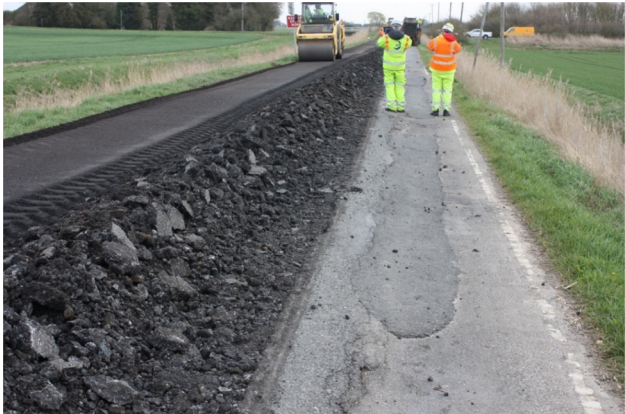
Fig. 21. Shaping and compaction of the pulverized existing road surface at Fodderdyke Bank (March 2018). © Mark Heaton, Lincolnshire County Council.

Following extensive investigation and review of previous trials undertaken by Lincolnshire County Council, the recommendation for repair work at Fodderdyke (Case Study Site 1) was:

- (a) to pulverize the existing road to a depth of *c.* 250 mm;
- (b) shape and compact the pulverized material to make a new and increased thickness sub-base;
- (c) lay 60 mm of AC20 binder course material (asphaltic concrete with a maximum aggregate size of 20 mm),
- (d) lay and pin a steel reinforcing grid over the whole width, including overlaps at the joints;
- (e) lay 60 mm of AC20 binder course material; and
- (f) lay 40 mm of 40 mm surface course.

Remedial work at Fodderdyke was carried out during 2018 (Figs 21–23), reflecting the knowledge of the underlying road conditions, their geotechnical properties and the impact of projected climate scenarios on susceptibility to movement in the future. Recognizing the addition of added weight would cause more compression, the existing road surface was recycled. A mesh was included, covering the width of the road, enabling it to move as a single entity and thus experience less differential movement, resulting in less surface cracking. Although this initial repair work was costlier and took longer than the traditional patching, this informed decision-making was targeted and defensible. It alleviates the requirement of abundant future repair work and associated road closures with their resultant economic costs, demonstrating improvements both financially for the authority

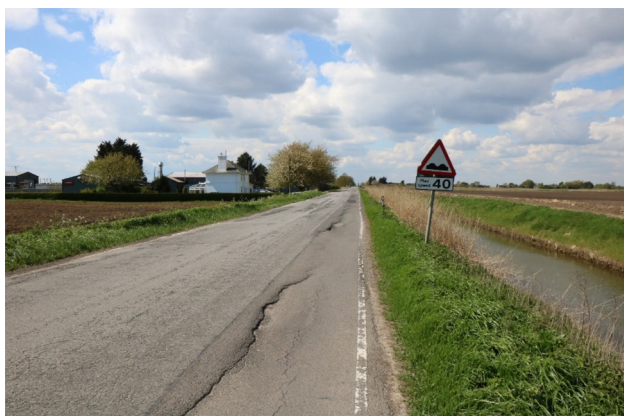
**Fig. 22.** Station Road (western end of Fodderdyke), Eastville, underlain by tidal flat deposits (May 2018). BGS © UKRI 2018.

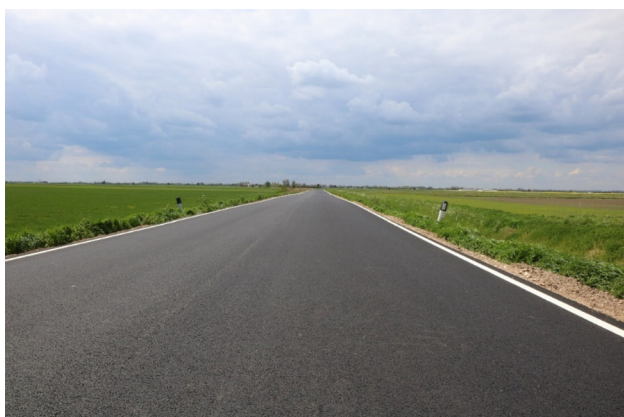
**Fig. 23.** Fodderdyke (eastern end of Fodderdyke) following resurfacing using the new recycling method (May 2018). BGS © UKRI 2018.
