#### Maine Route 117

August 2010

(5.0-inch HMA overlay, 19-mm base and 12.5-mm wearing course, Advant-Edger and TransTech Shoulder Wedge Maker)

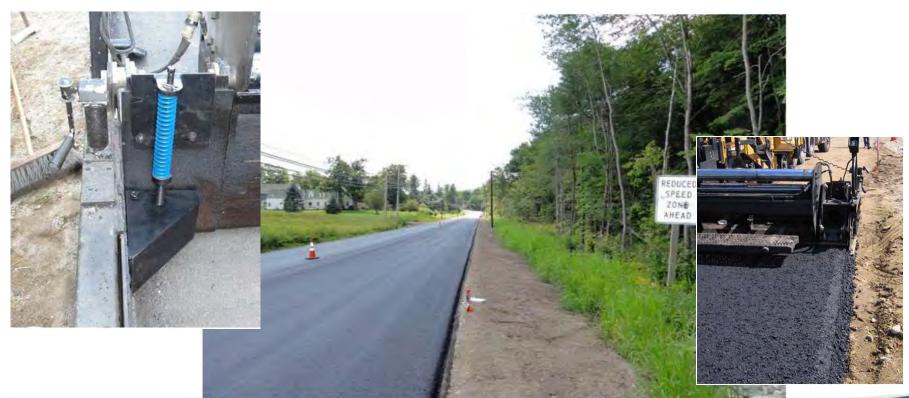
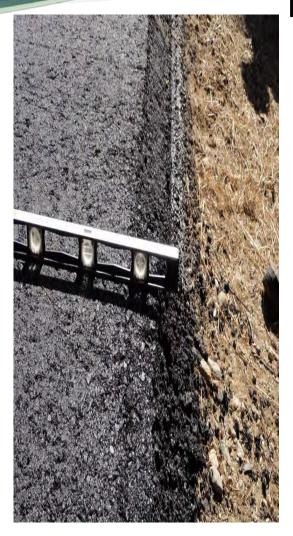
#### Maine Route 117

- Safety edge formed on both lifts.
- Safety edge increased pavement total width by about 8 inches.
- ➤ Safety edge and control (no safety edge) section densities were similar.
- ➤ Advant-Edger average slope was 54°.
- TransTech Shoulder Wedge Maker average slope was 45°.

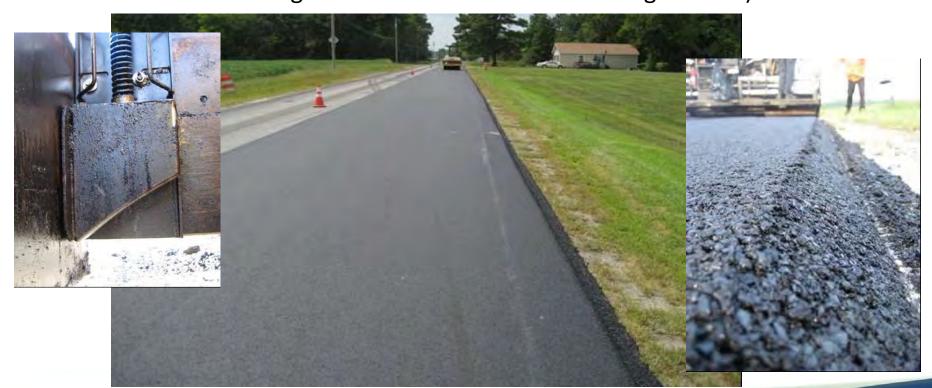
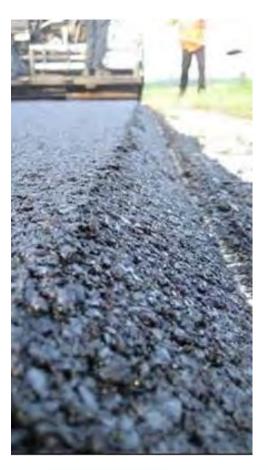
### Old Furnace Road, Delaware

- > Shoulders were graded to prevent edge contamination.
- > Safety edge density was 2.3% higher than the control (no safety edge) section.
- ➤ TransTech Shoulder Wedge Maker average slope was 37°
- ➤ Advant-Edger average slope was 48°.
- ➤ Mix tenderness likely increased the slope made by the Advant-Edger.

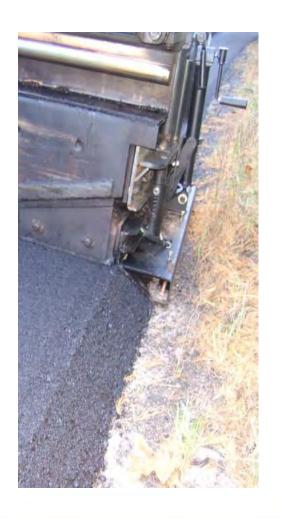
### Wisconsin State Hwy 55

- > Carlson devices were simple to attach and operate.
- ➤ Carlson devices produced a smooth, sealed sloped surface.
- ➤ Control section (no safety edge) edge density was 1.6% higher than the safety edge sections.
- > Average slope from both devices was 35°.

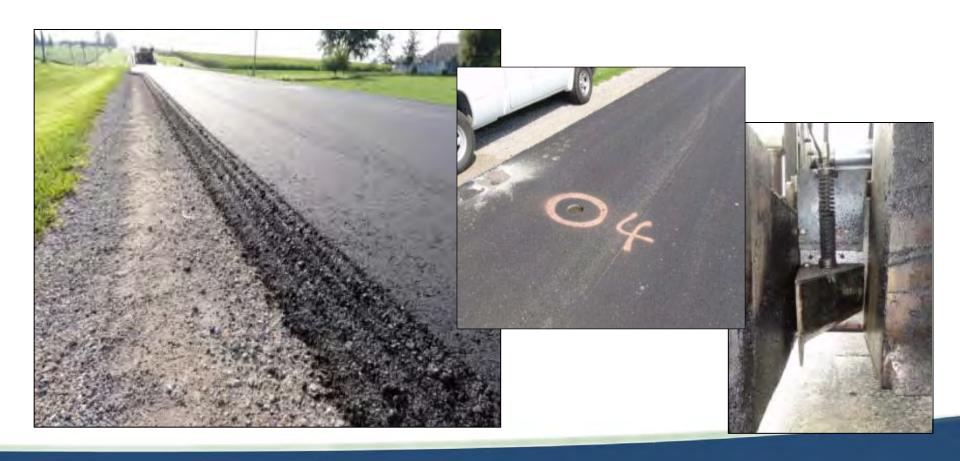
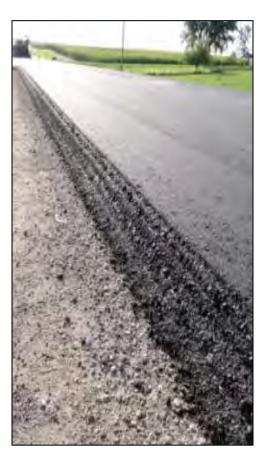
## Jasper County Road F62, Iowa

- > Safety edge was formed on all 3 lifts.
- > Each lift was offset.
- To maintain slope breakdown and intermediate rollers did not compact the safety edge.
- ➤ Control section (no safety edge) edge density was 5.3% higher than the safety edge sections. Control section edge was compacted by rollers.
- > Average slope was 38°.

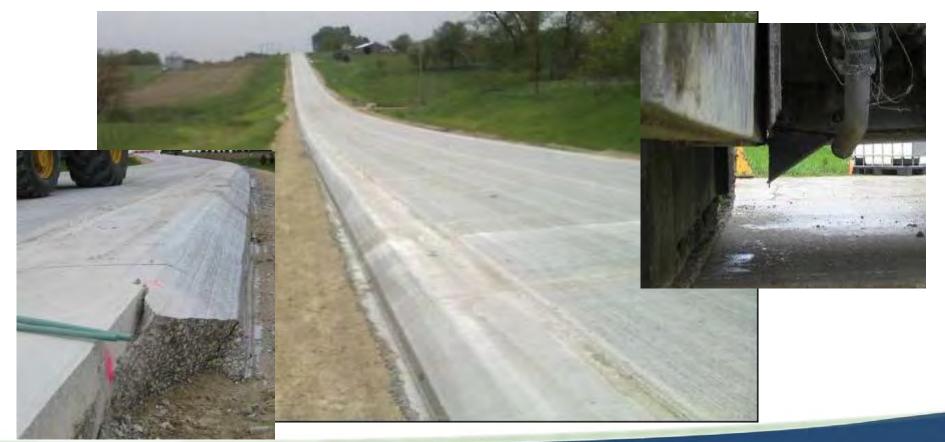
### Linn/Jones County Hwy E34, Iowa

- > Screed was modified to create the safety edge shape.
- Additional labor required at intersections.
- Transverse joint sawcuts stopped at the sloped face of the safety edge. Joints formed correctly through the safety edge.
- > Average slope was 31.5°.
- ➤ Concrete modulus values and air voids at the edge and interior were reasonably uniform.

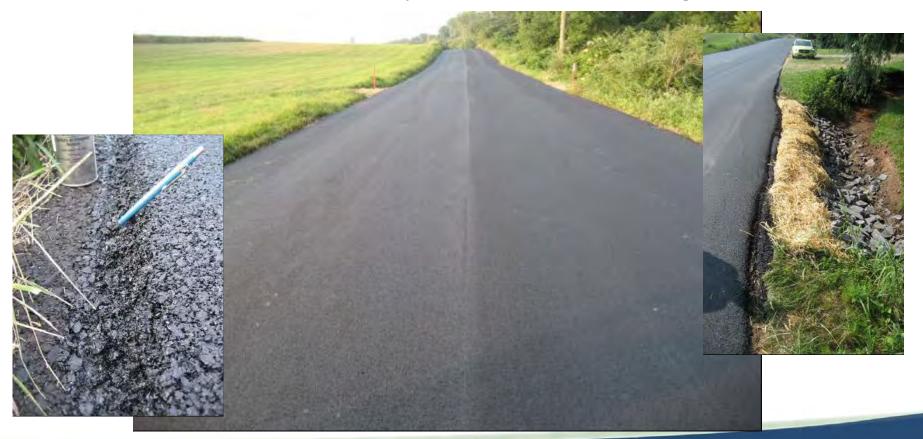
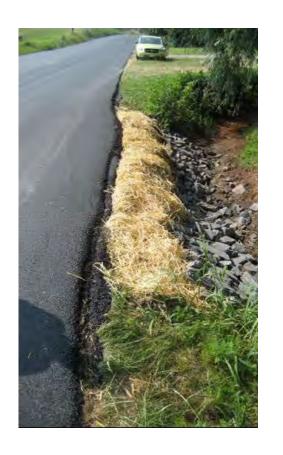
### Pennsylvania State Road 2009

- ➤ Narrow roadway/shoulder conditions.
- ➤ End gate occasionally plowed up grass and soil into the safety edge.
- > The sloped surface had a coarse/open texture.
- ➤ Safety edge density was 3.9% higher than the control (no safety edge) sections.
- > The average slope was 48°.

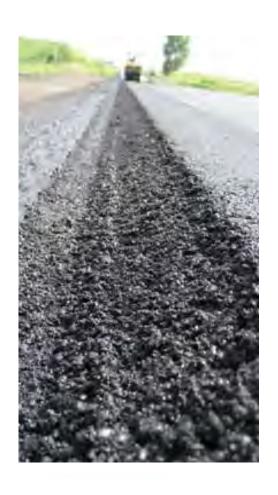
#### Nebraska State Route 10

- > Rolling did not steepen the slope.
- ➤ Safety edge and control (no safety edge) section densities were similar.
- > Average slope was 34°.

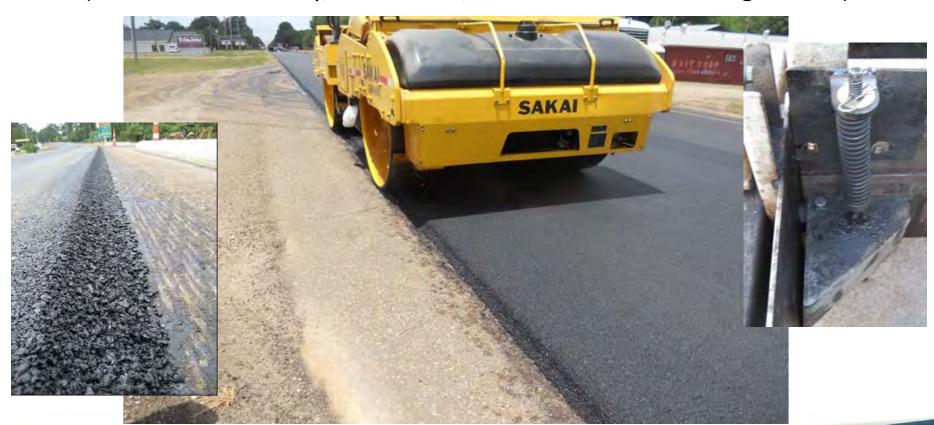
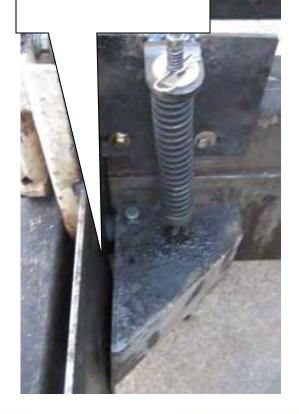
### Mississippi State Road 182

Note the gap between the safety edge device and the end plate.

- The slope before and after rolling was about the same.
- ➤ Safety edge density was 1.8% higher than the control (no safety edge) section.
- Average slope was 37°.
- The shaft of the edge device was bent and created a gap between the end gate. The gap may have increased slope.
