# GPM Property Management

## MOVE-OUT INSPECTION REPORT — PROPINSPECAI PROTOTYPE (LIVING ROOM)

| Property | 1554 Brest, Lincoln Park, MI |
| Job | 121939 |

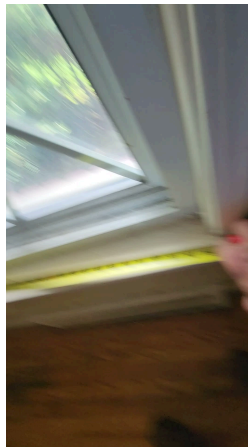
**Room dimensions — tape measure reading**

**Room Dimensions:** 14 ft × 11½ ft *(source: narrated by inspector, confirmed via tape measure visible in video)*

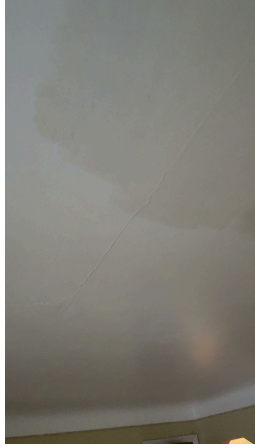
| Item | Condition | Assigned To | Recommended Action | Trade Category | Priority | Tenant Damage |
|---|---|---|---|---|---|---|
| Ceiling | Damaged | <b>Outside Vendor</b> | Repair crack, paint ceiling | Painting/Drywall | Before next occupancy | <input type="checkbox"/> |

**Ceiling — crack**

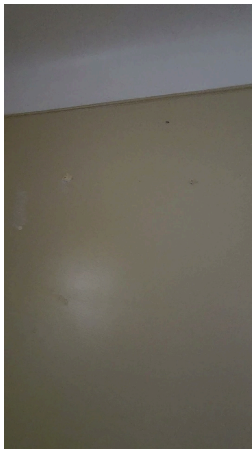
| Item | Condition | Assigned To | Recommended Action | Trade Category | Priority | Tenant Damage |
|---|---|---|---|---|---|---|
| Walls | Damaged | <b>Outside Vendor</b> | Repair holes/patches, then paint | Painting/Drywall | Before next occupancy | <input type="checkbox"/> |

**Walls — condition**

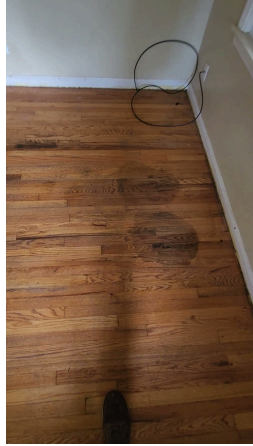
| Item | Condition | Assigned To | Recommended Action | Trade Category | Priority | Tenant Damage |
|---|---|---|---|---|---|---|
| Hardwood flooring | Damaged | <b>Outside Vendor</b> | Clean / refinish affected area (method to be confirmed on-site) | Flooring | Before next occupancy | <input type="checkbox"/> |

**Hardwood flooring — staining**
