Recreation Center

Case Study Snapshot: UCSB Recreation Center

Case Study Overview

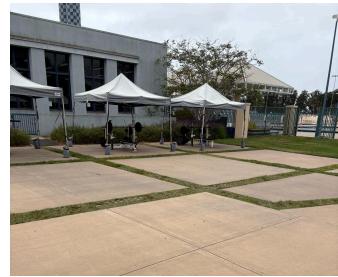
Slanted permeable concrete tiles.

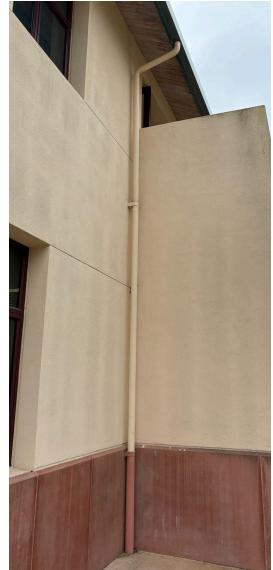
Roof gutter with a downspout built into the ground

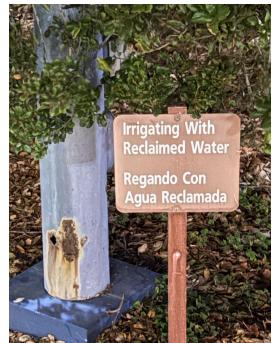
Irrigation with reclaimed water

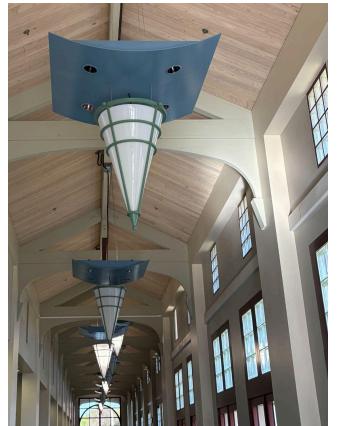
The Recreation Center uses window films to maintain indoor temperature efficiency. The pool is equipped with an aforementioned aquatic pump which circulates water according to the time of day, based on the occupancy in the pool for that time, rather than simply pumping full-blast at all hours of the day.¹ Overnight covers are kept on the pools to keep temperatures from dropping too low in order to save energy and reduce daytime heating. Lastly, all indoor lights are LEDs and most fixtures are equipped with time-of-day settings to take advantage of natural daylight in areas with ample window coverage. However, some inefficiencies remain as lights in the office wing remain on at night even when unoccupied, and both weight rooms have all lights on during the day despite having sufficient natural light from windows.

Time of day setting on lights and sufficient sunlight.

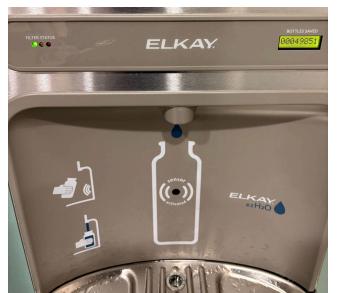
Water refill station with data on plastic water bottles save.

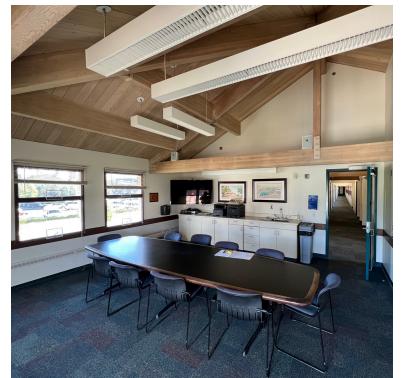
Use of carpet tiles, time of day sensors on lights, and windows in office wing room.
