HEALTH & SAFETY FILE

BMS EQUIPMENT UPGRADE

**EXCHEQUER COURT
33 ST MARY AXE
LONDON
EC3A 8AA**

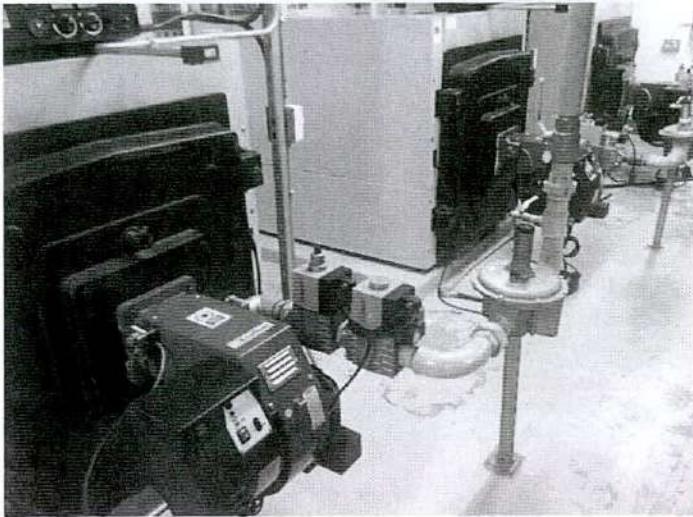
Site Address	Exchequer Court		
Building, Floor	Main, Basement	ACM	Gaskets (rope/woven)
Room Name	Boiler Room	Precise Location	To Boilers
Sample No.	S009	Amount	4 no

ACM	Gaskets (rope/woven)	Total Risk Score	4
Condition	Low (Some Minor Damage)	Risk Category	Very Low
Surface Treatment	Sealed		
Asbestos Type	Chrysotile	Action	Manage
Comments	Leave in situ and do not disturb. Ensure all employees, contractors and tenants who are likely to come into contact with the ACM are made aware.

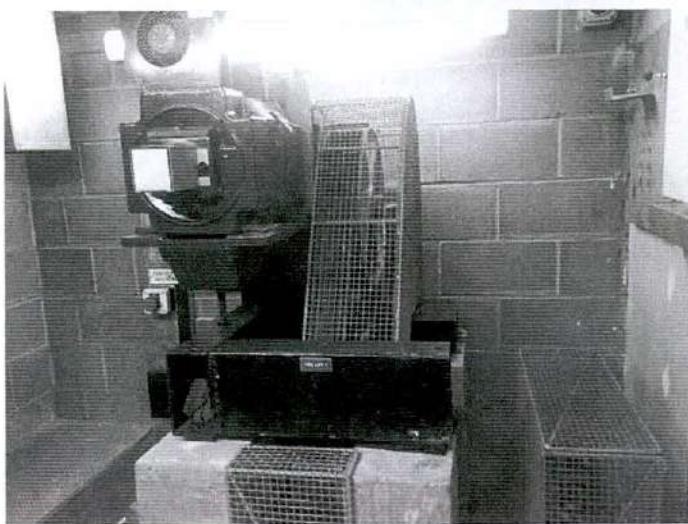
Site Address	Exchequer Court		
Building, Floor	Main, 7th Floor	ACM	Cement Product
Room Name	Lift Motor Room (South)	Precise Location	Brake Shoes to Lift Motor
Sample No.	P22	Amount	2 no

ACM	Cement Product	Total Risk Score	4
Condition	Low (Some Minor Damage)	Risk Category	Very Low
Surface Treatment	Sealed		
Asbestos Type	Chrysotile	Action	Manage
Comments	Leave in situ and do not disturb. Ensure all employees, contractors and tenants who are likely to come into contact with the ACM are made aware.

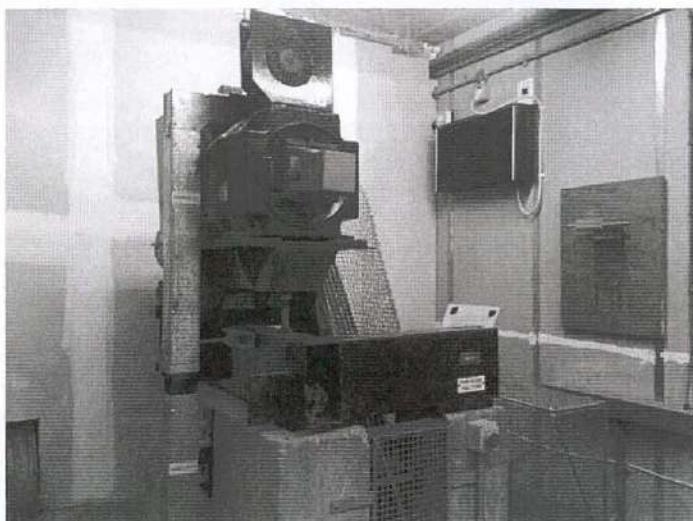
Site Address	Exchequer Court		
Building, Floor	Main, 7th Floor	ACM	Cement Product
Room Name	Lift Motor Room (North)	Precise Location	Brake Shoes to Lift Motor
Sample No.	P21	Amount	2 no

ACM	Cement Product	Total Risk Score	4
Condition	Low (Some Minor Damage)	Risk Category	Very Low
Surface Treatment	Sealed		
Asbestos Type	Chrysotile	Action	Manage
Comments	Leave in situ and do not disturb. Ensure all employees, contractors and tenants who are likely to come into contact with the ACM are made aware.

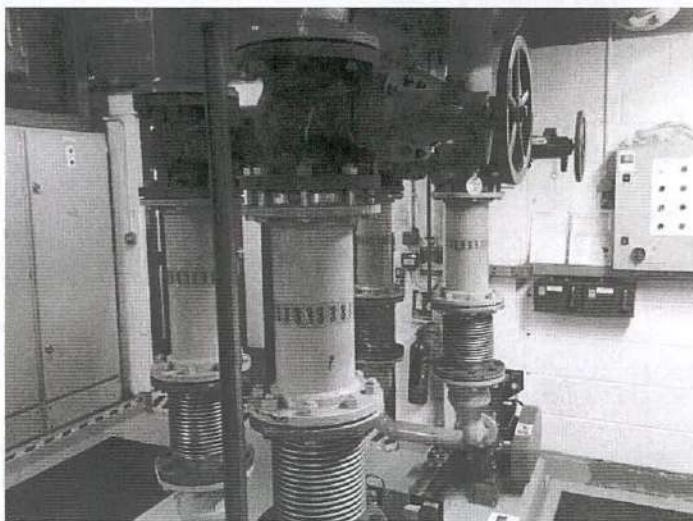
Site Address	Exchequer Court		
Building, Floor	Main, Basement	ACM	Gaskets (compressed)
Room Name	Boiler Room	Precise Location	Within Pipework Flanges
Sample No.	S008	Amount	Throughout

ACM	Gaskets (compressed)	Total Risk Score	3
Condition	Low (Some Minor Damage)	Risk Category	Very Low
Surface Treatment	Self-Sealed		
Asbestos Type	Chrysotile	Action	Manage
Comments	Leave in situ and do not disturb. Ensure all employees, contractors and tenants who are likely to come into contact with the ACM are made aware.

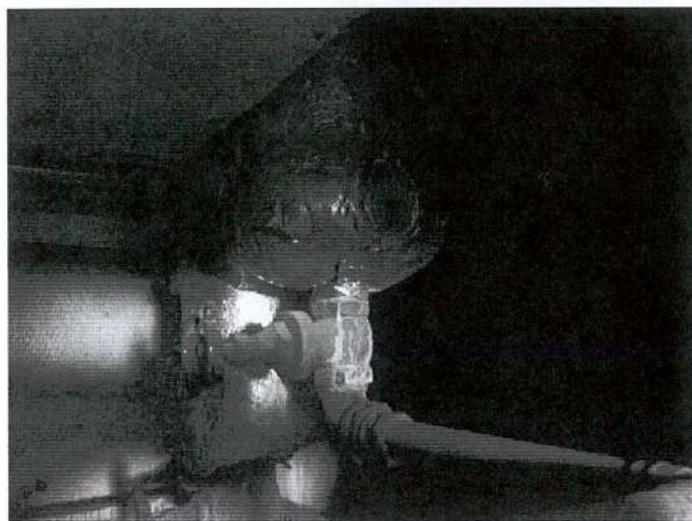
Site Address	Exchequer Court		
Building, Floor	Main, Basement	ACM	Gaskets (compressed)
Room Name	Sprinkler Room	Precise Location	Within Pipework Flanges
Sample No.	S002	Amount	10 no

ACM	Gaskets (compressed)	Total Risk Score	3
Condition	Low (Some Minor Damage)	Risk Category	Very Low
Surface Treatment	Self-Sealed		
Asbestos Type	Chrysotile	Action	Manage
Comments	Leave in situ and do not disturb. Ensure all employees, contractors and tenants who are likely to come into contact with the ACM are made aware.

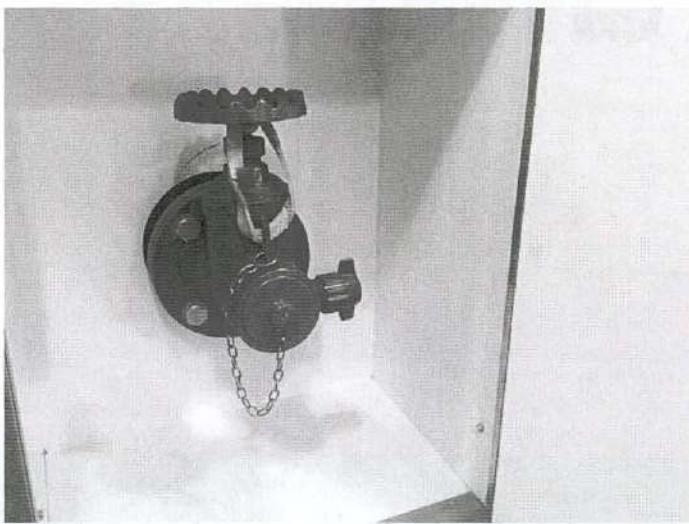
Site Address	Exchequer Court		
Building, Floor	Main, 7th Floor	ACM	Gaskets (compressed)
Room Name	North & South Dry Risers	Precise Location	Within Pipework Flanges
Sample No.	S019	Amount	Throughout Risers

ACM	Gaskets (compressed)	Total Risk Score	3
Condition	Low (Some Minor Damage)	Risk Category	Very Low
Surface Treatment	Self-Sealed		
Asbestos Type	Chrysotile	Action	Manage
Comments	Leave in situ and do not disturb. Ensure all employees, contractors and tenants who are likely to come into contact with the ACM are made aware.
