**Exchequer Court
25-51 St.Mary Axe and
9 St.Helen's Place
London EC3**

**Appraisal and Testing
of Retained Elements**

PHASE 6 REPORT

GARDEN AREA STRUCTURES

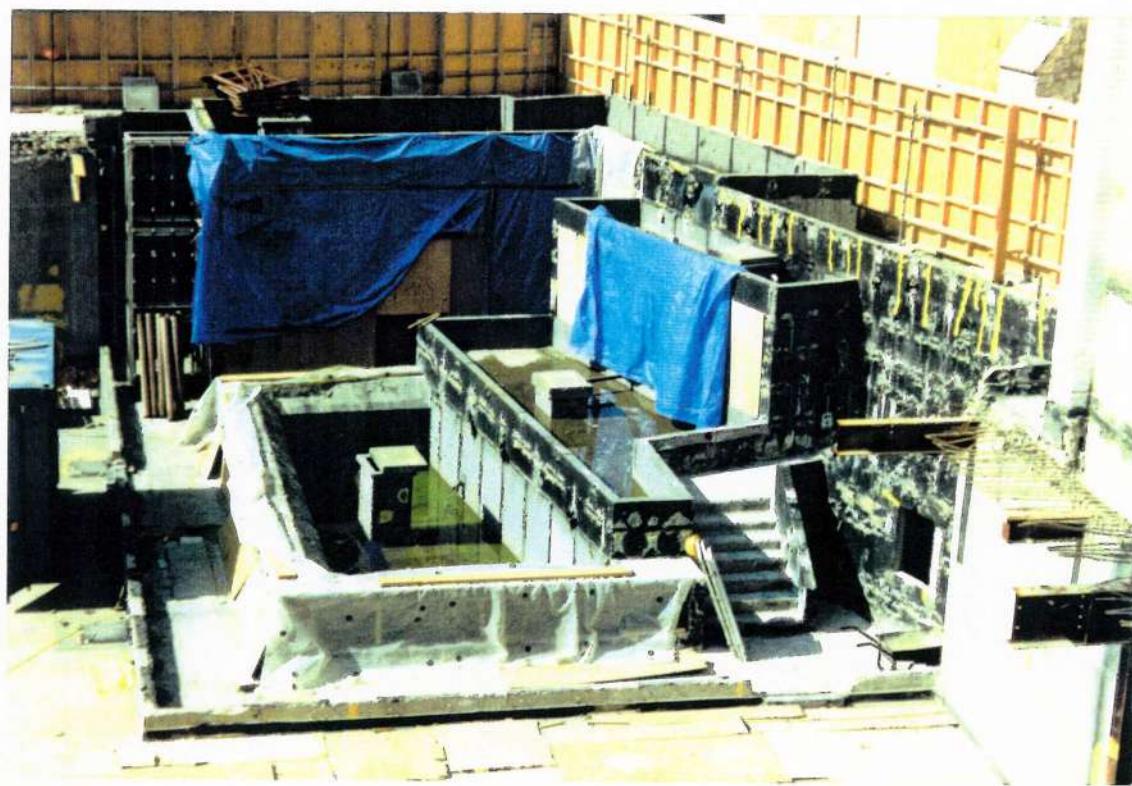
The waterproofing membrane was also dressed up the surfaces of all walls forming the four planters, prohibiting inspection of these surfaces. In addition all other external elevations of walls were covered by a black bitumastic type paint, which could have concealed minor defects and cracks (see Plates 2 and 7).

Plate 2 - General view of the garden from the north (EC/TL1/2)

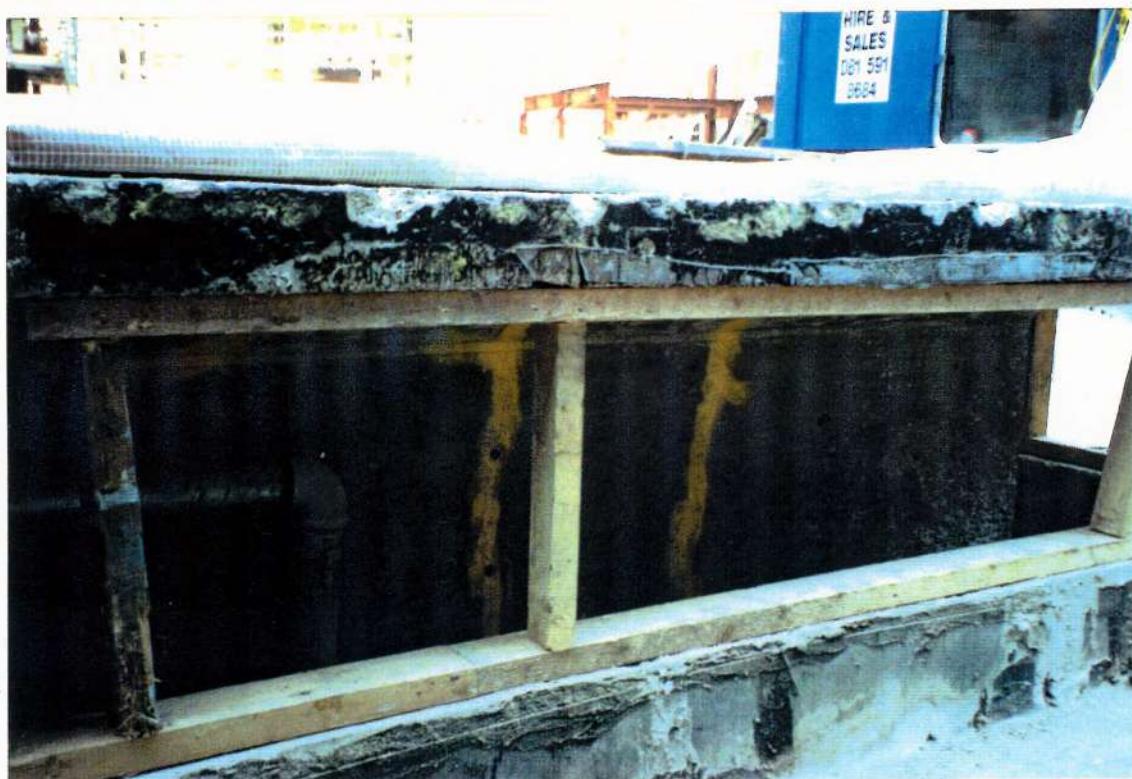
Figure 7 and Plates 3 to 6 indicate a pattern of generally vertical cracks in walls A, B and C around Planter D. It is thought that early age restrained movement is at least partly the cause of this cracking, possibly exacerbated by the bomb blast and demolition works. However, it should be noted that the cracks incline inwards at both ends of each wall and if the factors above were the only causes, one would have expected the opposite with the cracks fanning outwards. It is therefore possible that there are further reasons for the cracking in this instance. These walls appear to be acting as beams, and the action of shear may have also influenced the cracking in these elements. The structural design would need checking to confirm this but nevertheless, the cracking would appear not to be significant.

Plate 3 - Wall A, south elevation (EC/TL1/5)

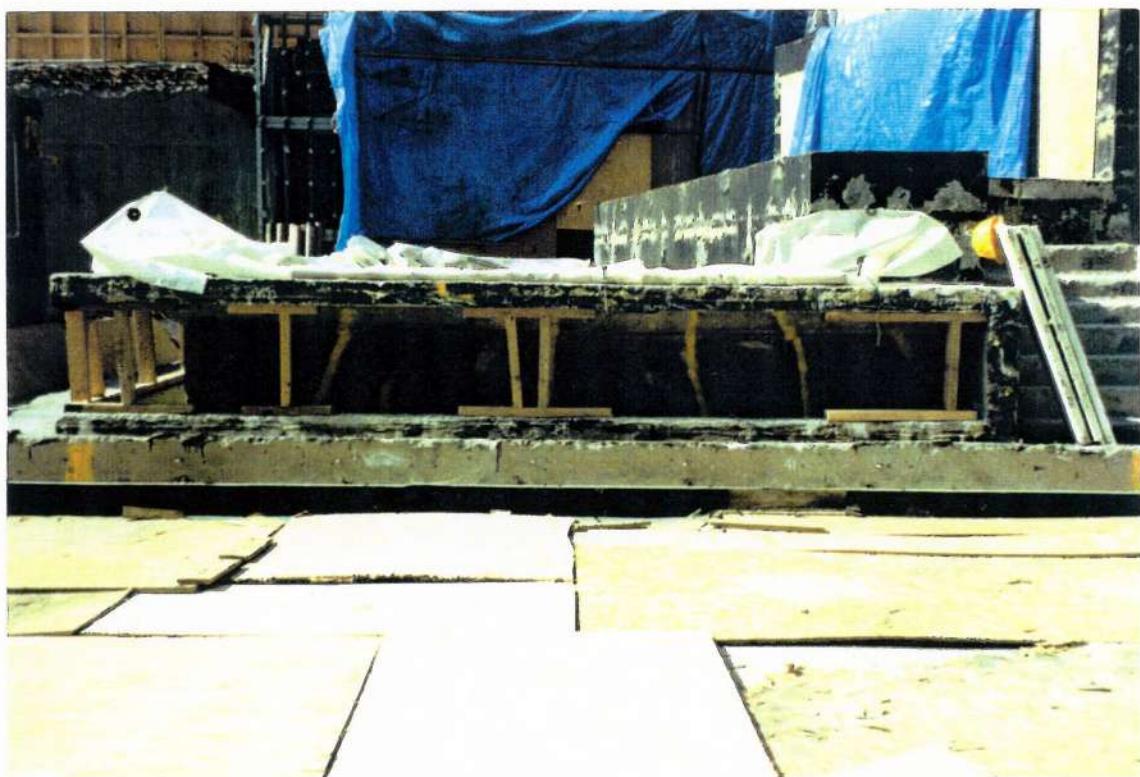
Plate 4 - Wall C, north elevation (EC/TL1/3)

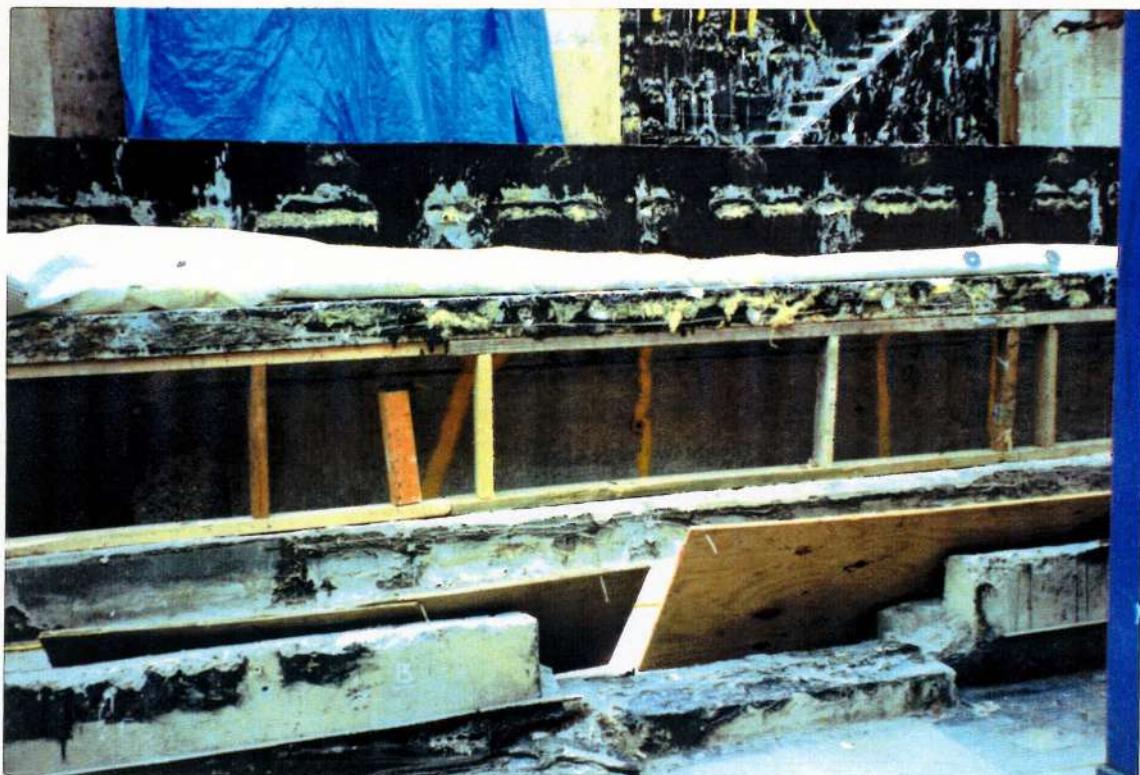
Plate 5 - Wall B, east elevation, south end (EC/TL1/7)

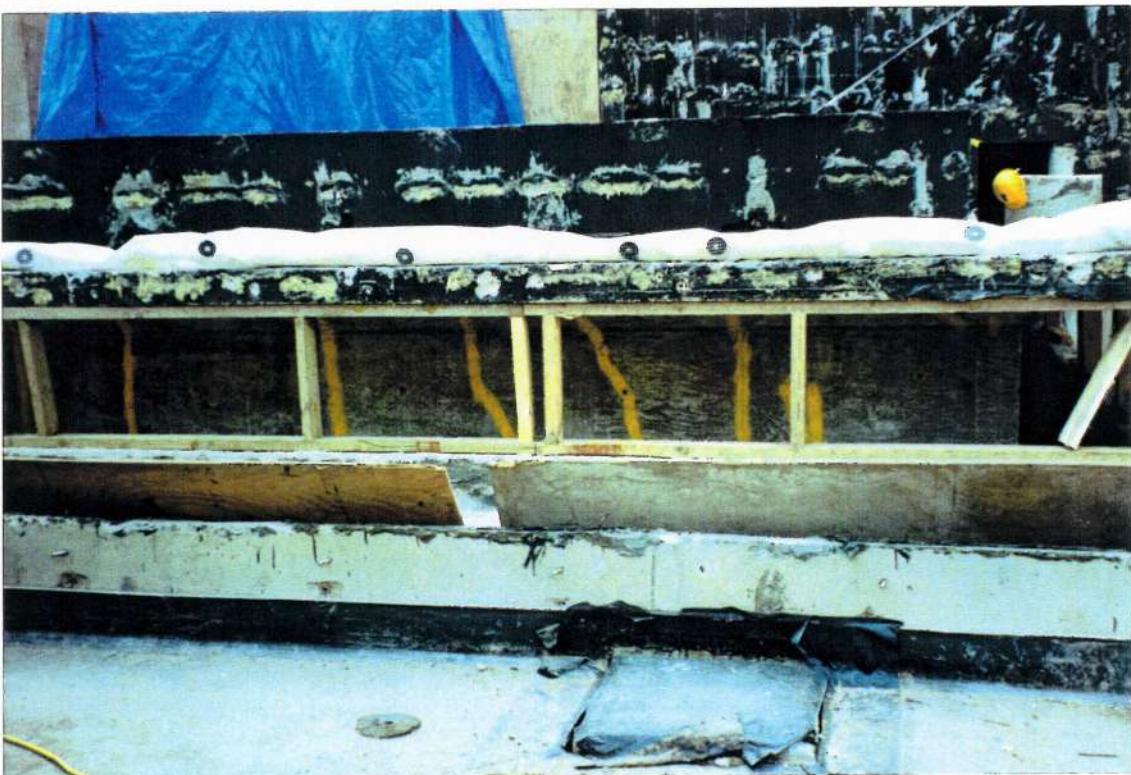
Plate 6 - Wall B, east elevation, north end (EC/TL1/6)

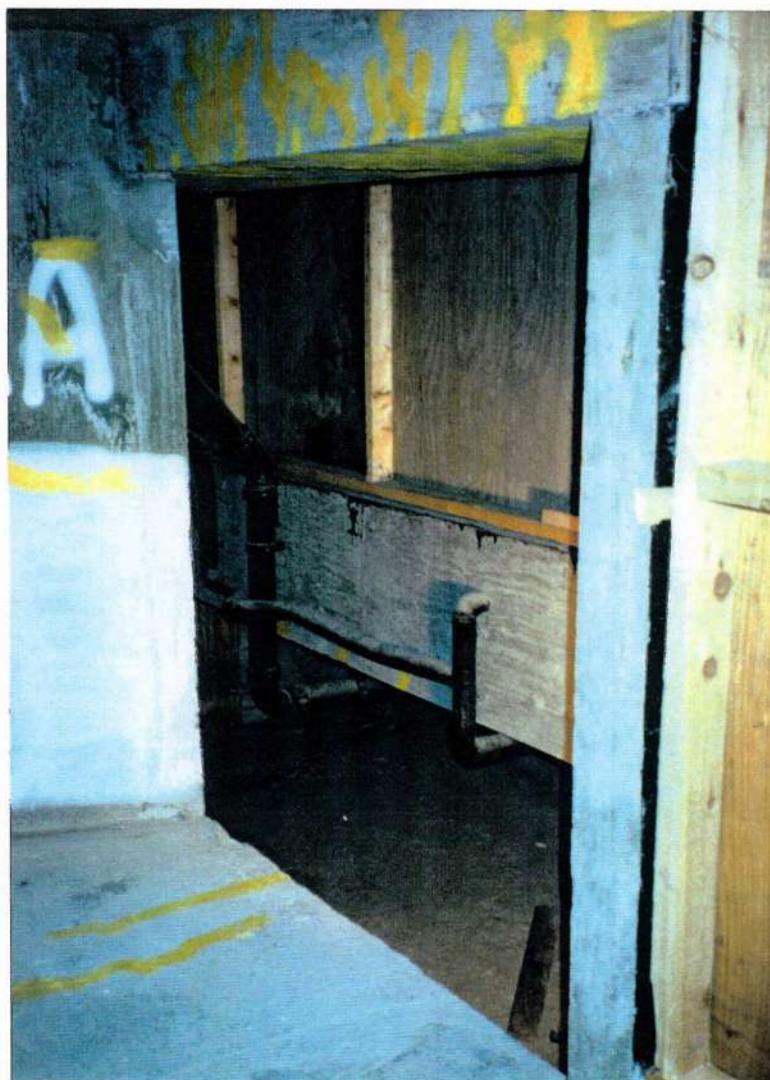
On some concrete surfaces there were small areas of crazing with very fine cracks of width less than 0.1mm at average centres of 150mm. The largest such area was the Level 0 slab soffit to Planter B and locally wall L, at grid X4 to X5/Y20½. (see Figures 6 and 13 and Plate 8). Further small areas are evident on wall G, south elevation (Figure 11, Plate 9) and in the Level 0 soffit to Planter A at grid X1 to X2/Y18 to Y19 (Figure 6, Plate 11). This crazing is likely to be the result of some early age construction phenomenon, eg formwork preparation, and is considered to be insignificant.

Plate 8 - View from under planter A, showing parts of Planter B soffit,
Walls L, M & T, and top of level -1 slab (EC/TL1/9)

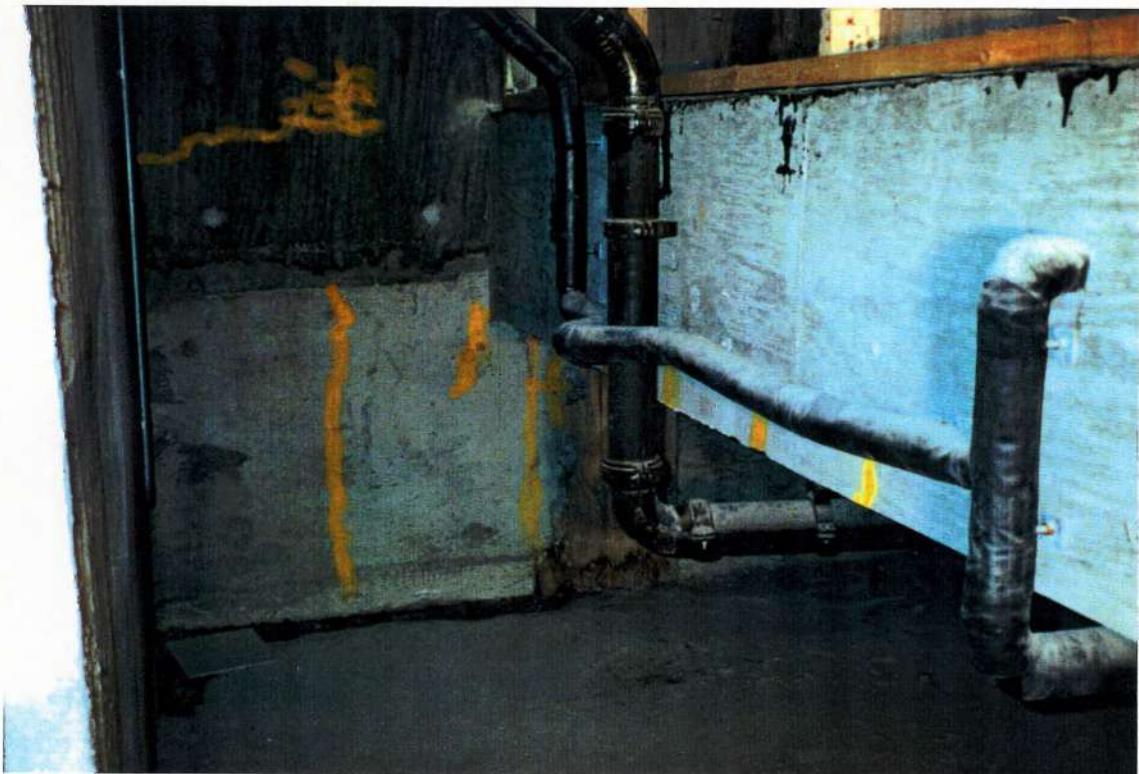
Plate 9 - Wall G south elevation, Wall T west elevation at north end, and part level -1 slab
(EC/TL1/10)

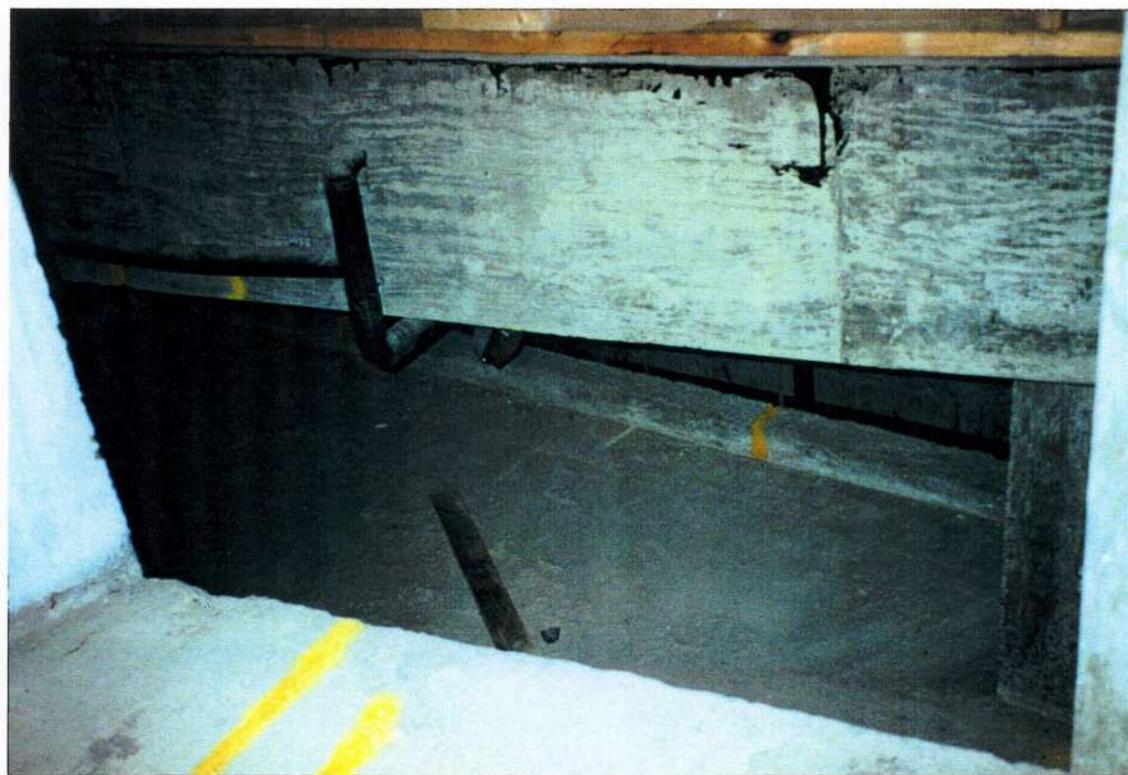
Plate 10 - Wall T west elevation at south end, and part of level -1 slab (EC/TL1/8)

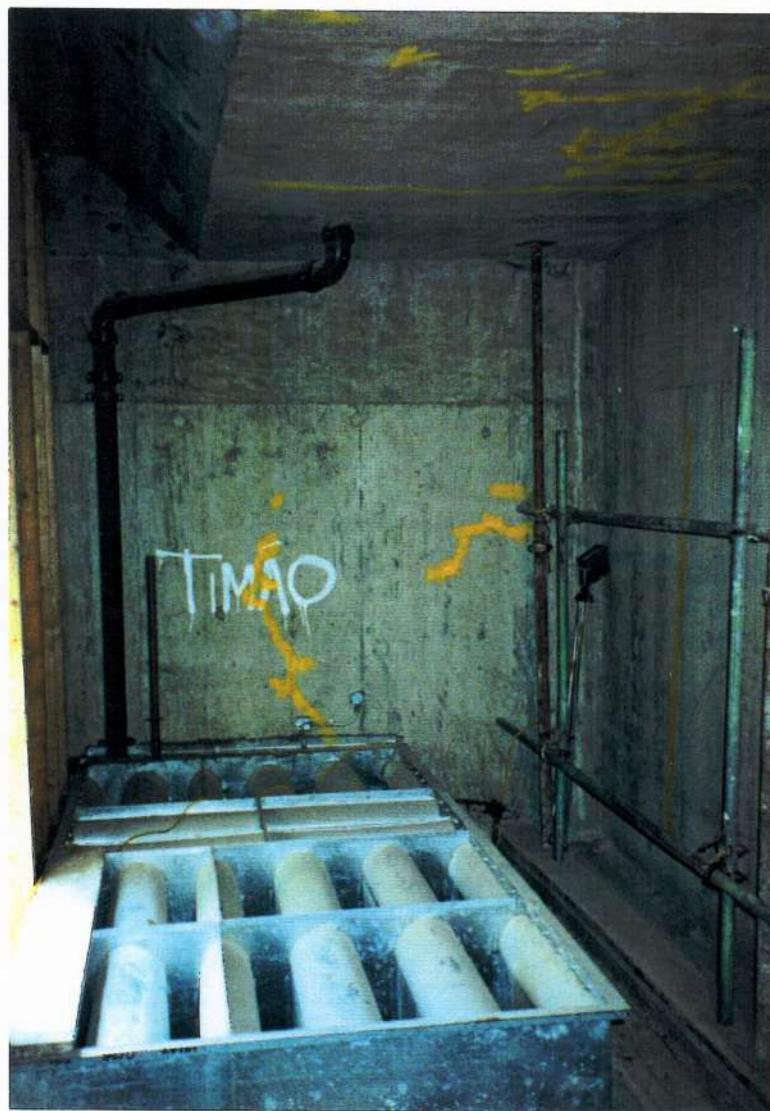
Plate 12 - Wall P, west elevation (EC/TL1/12)

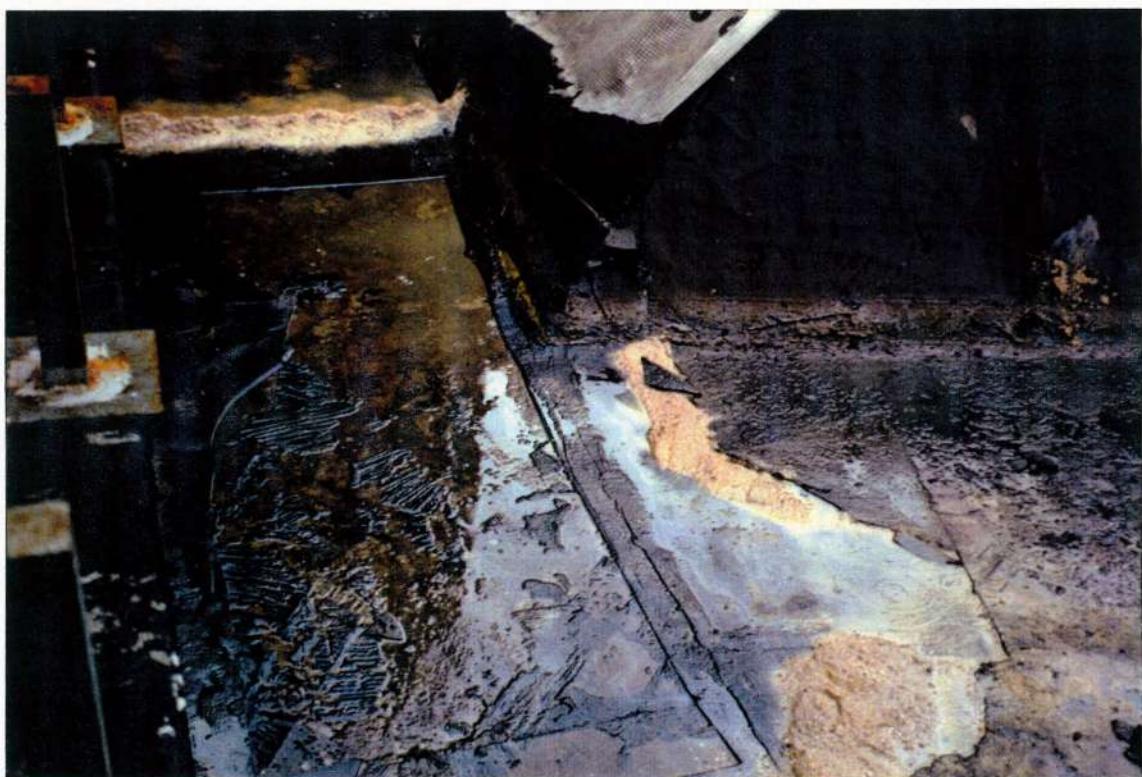
At grid X2/Y21 for an area of about 1m², the "Hydrotech" waterproofing membrane was removed to allow visual inspection of the concrete surface underneath. One reason for selecting this particular area was that the soffit inspection revealed two cracks which, at 0.2 and 0.3mm wide, were relatively wider than all other cracks in the slab soffits. See Figures 3 & 6, and Plates 13 & 14.

Following removal of the membrane the surface was swept clear and although damp, no visible defects were evident in the top surface.

The concrete surface was exposed for a period of about 2 hours throughout which it was raining continually. Consequently the surface was always damp and for about ¾ hour, water ponded upto 10mm deep on the exposed slab. The slab soffit was inspected at various times during and after this period, and no traces of dampness or leakage were observed.

Plate 13 - Area of 'Hydrotech' membrane removed in Planter A at grid X2/Y21 (EC/PP6/6)

Following the investigations and informal water test the exposed slab area was made good with Hydrotech by specialist contractors. It is intended as part of the general reconstruction works for all the Planters to be re-lined with an additional Hydrotech membrane to ensure the long term integrity of the protection, as noted in the Waterman Partnership "Schedule of Remedial Works" Phase 6 Item 1.0 therein refers.

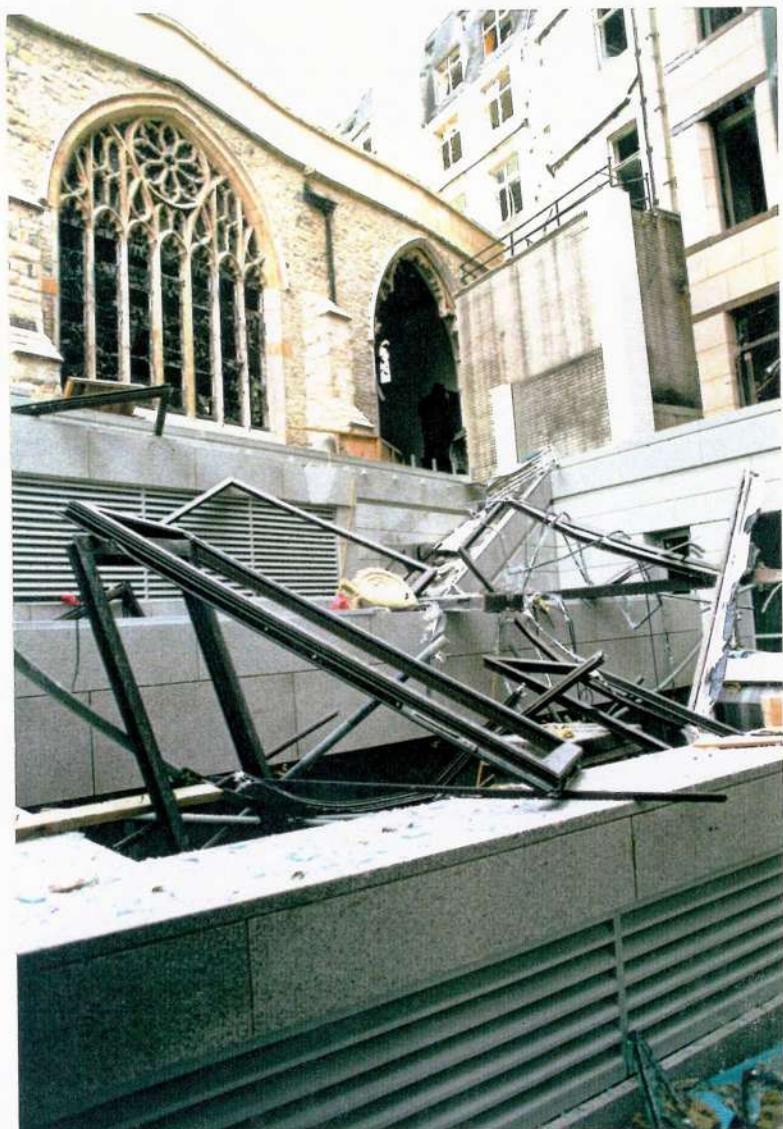
Plate 2.0, taken on the same day as Plate 1.0 shows the east elevation of Planters 'C' and 'D'. Note the lack of gross damage to much of the stonework although there were numerous surface defects found as a result of flying debris, e.g. metal window frames.

PLATE 2.0 GARDEN AREA, VIEW WEST, POST EXPLOSION, APRIL 1992
