## **ADDENDUM NO. 1 TO ADA/PROWAG CIVIL RIGHTS GRIEVANCE**

City of Bloomington, Indiana

**717 S. Henderson Street — Supplemental Submission: Pedestrians Were Routed to a Non-Compliant Sidewalk**

**Re:** Addendum No. 1 to ADA/PROWAG Complaint dated July 7, 2026 — 717 S. Henderson Street

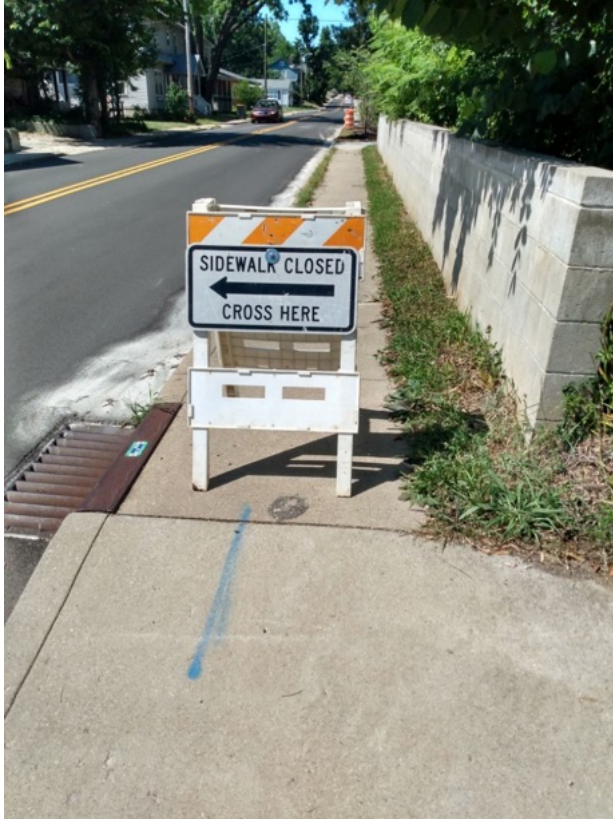
On or about July 14, 2026, as part of the construction to bring the sidewalk into compliance, signage was placed at the south approach directing pedestrians to cross to the opposite (west) side of S. Henderson Street (Fig. 7).

*Fig. 7: Signage placed at the south approach directing pedestrians to cross S. Henderson Street, observed on or about July 14, 2026 (complainant's photograph).*

As explained in Section 2.5 of the Complaint, the complainant does not consider the west side a meaningful accessible alternate route. The complainant requests that the City confirm what accessible temporary pedestrian access route, if any, was provided and maintained during the construction described above, consistent with the obligation described in Section 6 of the Complaint.

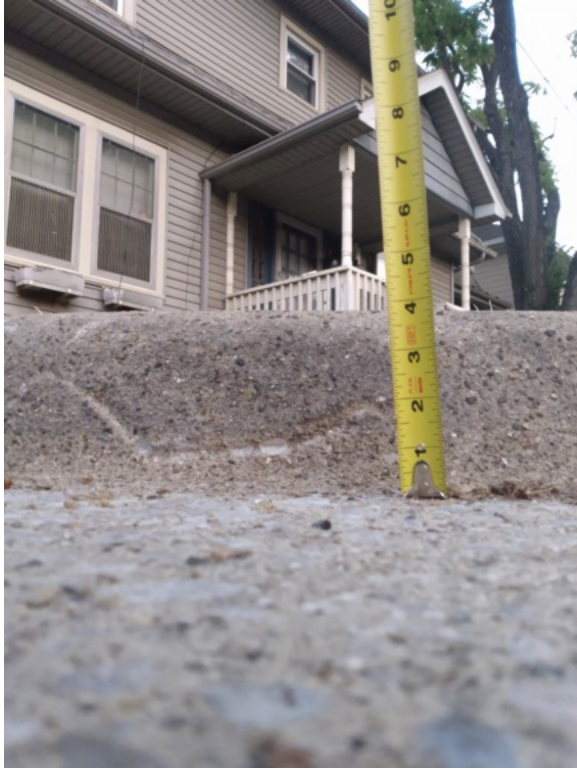
*Fig. 8: First alley-cut drop on the west-side route, measuring over 3 inches (complainant's photograph).*

Both drops substantially exceed the maximum permitted under PROWAG R302.6.2 and would require a compliant sloped transition rather than an abrupt drop.

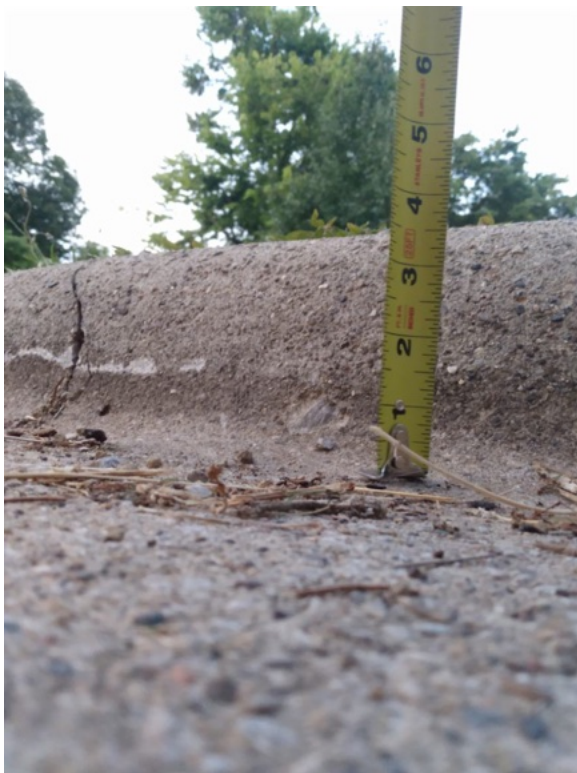
*Fig. 9: Second alley-cut drop on the west-side route, also measuring over 3 inches (complainant's photograph).*

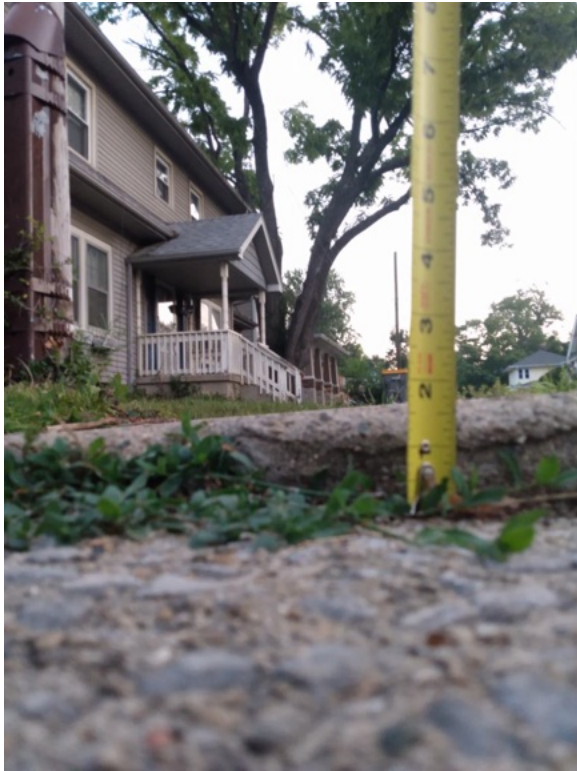
*Fig. 10: Vertical surface discontinuity on the west-side route, well in excess of the 1/2-inch maximum (complainant's photograph).*

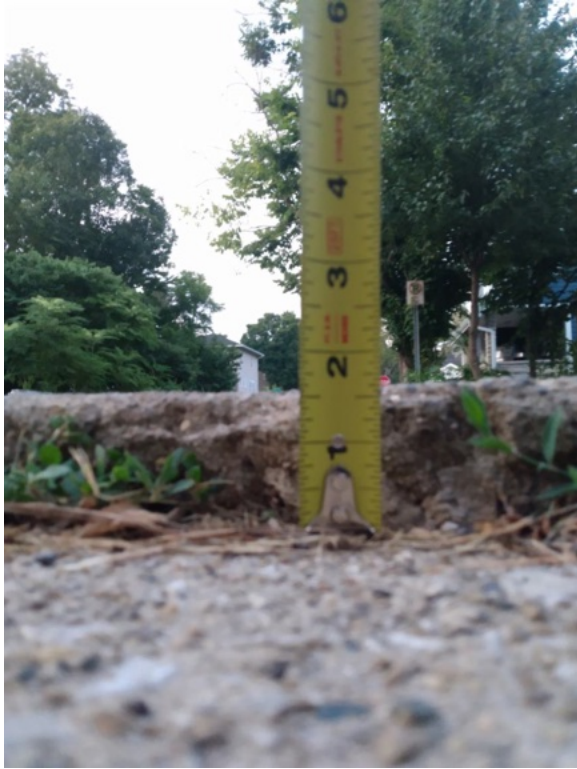
*Fig. 11: A second vertical surface discontinuity on the west-side route, well in excess of the 1/2-inch maximum (complainant's photograph).*

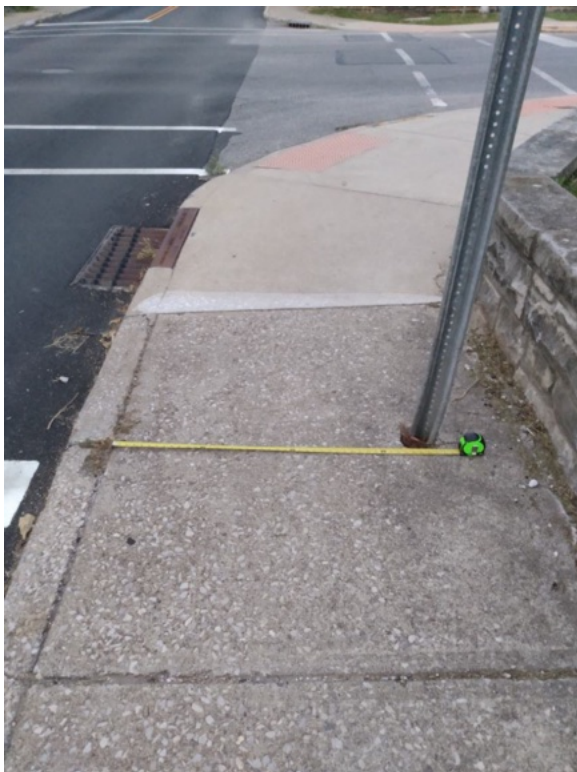
*Fig. 12: A stop-sign post standard on the west-side route, reducing the walkway (complainant's photograph).*

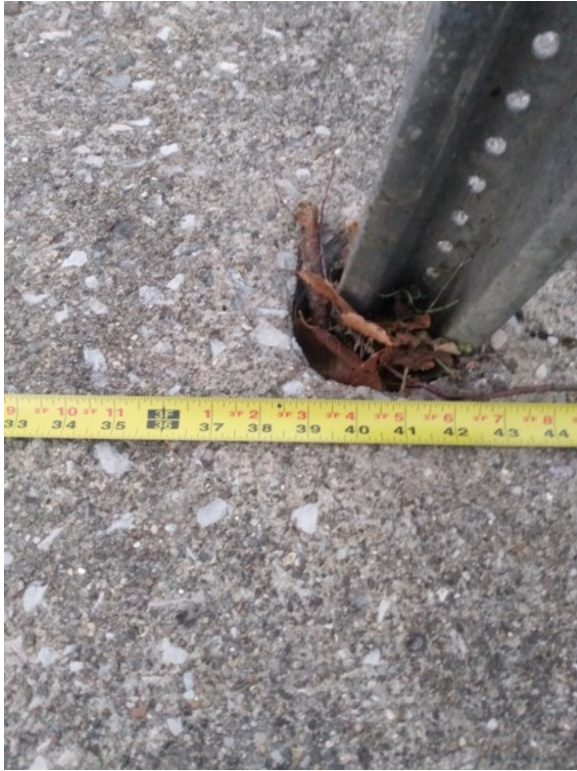
*Fig. 13: Measurement showing the sign post reduces the continuous clear width to approximately 39 inches, below the 48-inch minimum required by PROWAG R302.3 (complainant's photograph).*

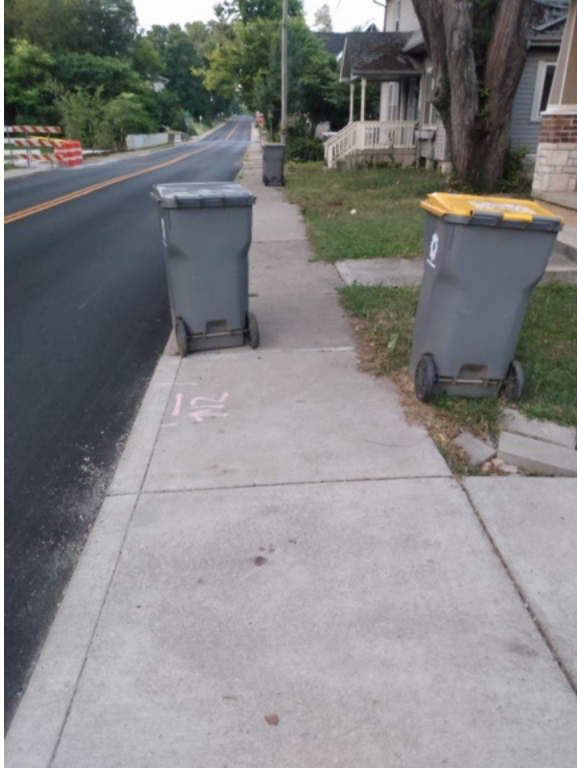
*Fig. 14: Waste and recycling containers obstructing the west-side route (complainant's photograph).*

Collection for this route occurred the preceding Monday; both photographs were taken the following Thursday, indicating the containers were left obstructing the walkway for several days rather than only during active collection.

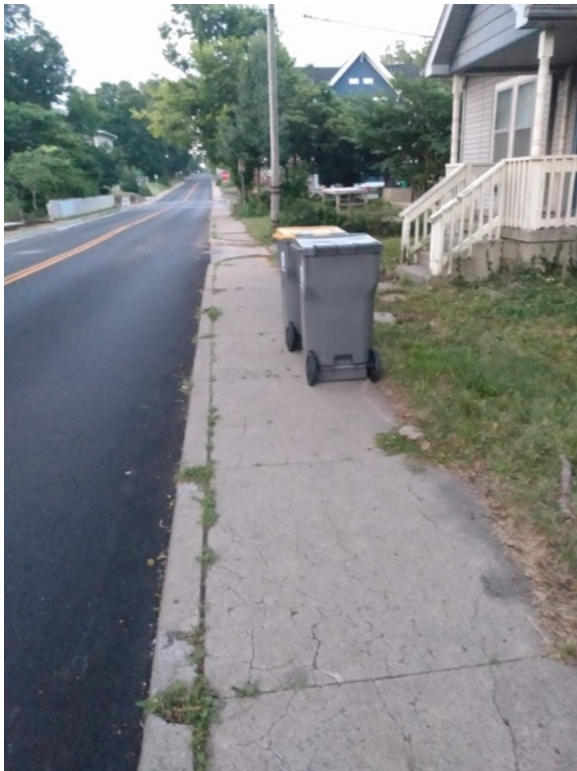
*Fig. 15: A second location where waste and recycling containers obstruct the west-side route (complainant's photograph).*
