# FORMAL ADA/PROWAG CIVIL RIGHTS GRIEVANCE

City of Bloomington, Indiana

***717 S. Henderson Street — Removal of Accessible Pedestrian Route During Redevelopment; Failure of ADA/PROWAG Review in Planning, Permitting, Construction, and Complaint-Intake Process***

**Date:** July 7, 2026

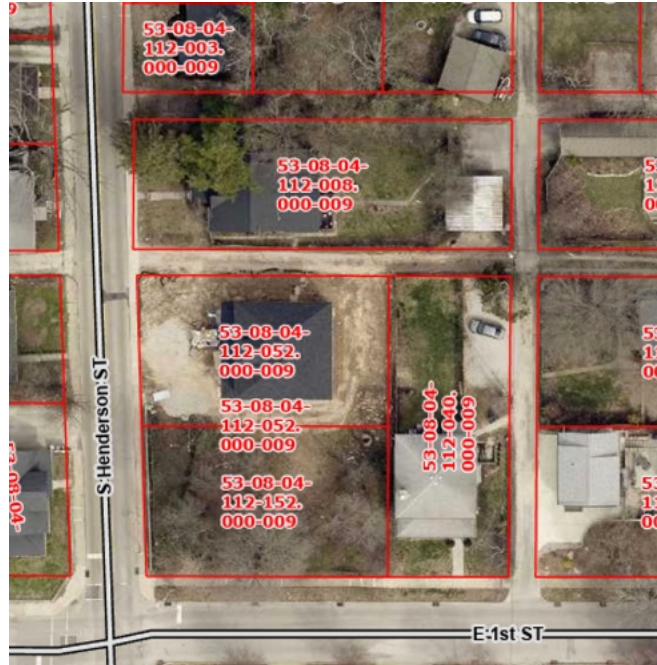
The property at 717 S. Henderson Street was recently redeveloped: an existing house was demolished and replaced with a duplex. The adjoining property to the north, at 715 S. Henderson Street, is a separate parcel. Based on the City's GIS parcel map (Fig. 1), the redeveloped lot is identified as Parcel 53-08-04-112-052.000-009, and the lot immediately to the north is Parcel 53-08-04-112-008.000-009. An alley right-of-way appears to run between these two parcels, separating the redeveloped lot from the parcel to its north, and to continue across Henderson Street to the west side, where it adjoins residences located at 712 and 710 S. Henderson Street.

The complainant requests that the City confirm, as part of its response to this complaint, the dedicated or right-of-way status of this alley, including whether it is platted public right-of-way, a recorded easement, or an unrecorded de facto path. Regardless of its formal platted status, the alley functions as the only pedestrian connection available at this location once the prior continuous sidewalk was interrupted, and the City required or permitted it to serve that function during and after the redevelopment.

*Fig. 1: City of Bloomington GIS parcel map showing the redeveloped lot (53-08-04-112-052.000-009), the adjoining parcel to the north (53-08-04-112-008.000-009), and the alley right-of-way running between them and continuing west across S. Henderson Street (complainant's annotated screen capture).*

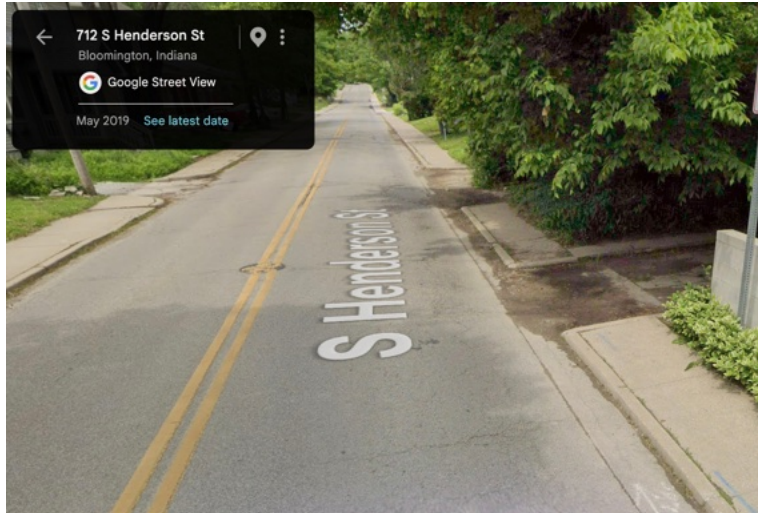
*Fig. 2: Google Street View imagery dated May 2019, 717 S. Henderson on right.*

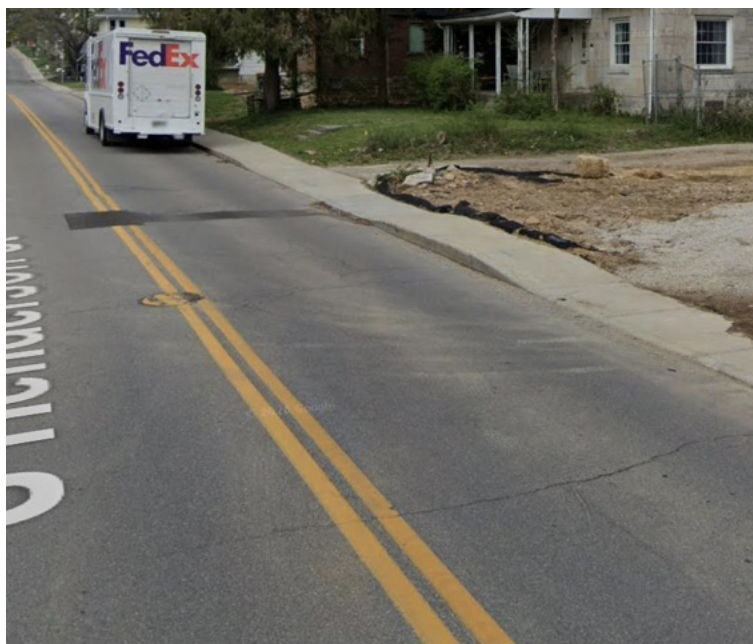
The complainant's understanding of the history of this frontage, based on available Google Street View imagery and direct observation, is as follows. In approximately 2017, and as late as May 2019, the sidewalk condition in this area was discontinuous and did not provide a continuous accessible pedestrian route (Fig. 2). At some point after 2019, and before the 717 S. Henderson redevelopment began, the City or a prior property owner improved the frontage to provide a continuous, direct, paved concrete pedestrian route. Google Maps Street View imagery dated April 2026 — captured after redevelopment had begun but before the sidewalk was relocated — shows that a continuous concrete sidewalk ran in a straight line along this frontage and that the alley crossing was paved at that time (Fig. 3).

*Fig. 3: Google Maps Street View imagery dated April 2026, showing a continuous concrete sidewalk running in a straight line along the 717 S. Henderson frontage with the alley crossing paved, at a point when redevelopment had begun but the sidewalk had not yet been relocated (Google Maps).*

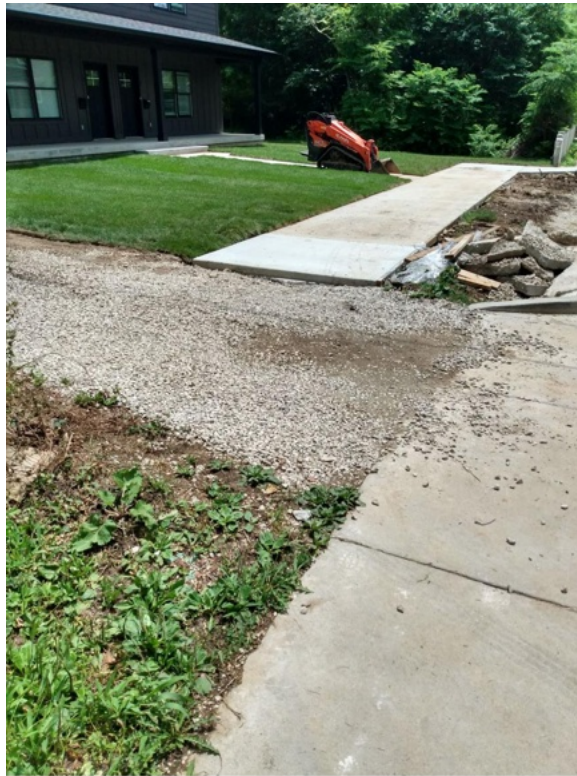
As part of the 717 S. Henderson redevelopment, and consistent with applicable code requirements, the builder reconstructed the sidewalk frontage with a setback from the property line. The complainant does not dispute that a setback was required by code and takes no position on the setback requirement itself. The complaint concerns the pedestrian connection the City permitted or accepted within and beyond that setback area, as observed by the complainant: rather than a continuous compliant sidewalk, the observed condition directs

pedestrians off the new concrete sidewalk, across a loose gravel alley surface, and includes an abrupt vertical drop of greater than 3 inches at or near the transition between the concrete and the gravel (Fig. 4). If the City has since altered or corrected this condition, or considers the project ongoing, that does not change what was permitted and left in place for the period documented in this complaint. A required setback does not, by itself, justify or explain a noncompliant transition and a gravel crossing within the resulting frontage; the City retained discretion over how the connection across that frontage was designed, permitted, and approved.

*Fig. 4: Complainant's photograph, June 2026, showing the condition at 717 S. Henderson Street following the sidewalk reconstruction. The new concrete sidewalk ends at a loose gravel alley crossing, with an abrupt vertical drop at the transition. See Fig. 6 for a close-up photograph of the drop.*

The complainant has not yet obtained running-slope or cross-slope measurements for the transition area, but the visible condition in Fig. 4 raises serious concerns about compliance with PROWAG grade and cross-slope requirements, and the complainant requests that the City's ADA Compliance Officer or another qualified accessibility reviewer inspect and measure the area before it is altered further.

Section 2.3 and Section 3.3 above describe, in combination, the specific respects in which the condition documented at 717 S. Henderson Street fails to comply with PROWAG: a non-firm, non-stable, slip-prone gravel surface in place of a continuous pedestrian access route; an abrupt change in level far in excess of what R302.6.2 permits without a compliant sloped transition; and a route that is not continuous within the meaning of R203.3. The complainant

If the condition described in Section 2.3 has been or will be physically corrected, the City shall confirm in writing the date of correction, the nature of the work performed, and confirmation that the corrected route complies with PROWAG R302.2 (48-inch / 4.0 ft minimum continuous clear width), R302.6 (firm, stable, slip-resistant surface), and R302.6.2 (compliant changes in level, with no abrupt vertical change greater than that permitted without a sloped transition). If the condition has not yet been corrected, the City shall provide a specific construction start date, completion date, and the contractor or City crew assigned.

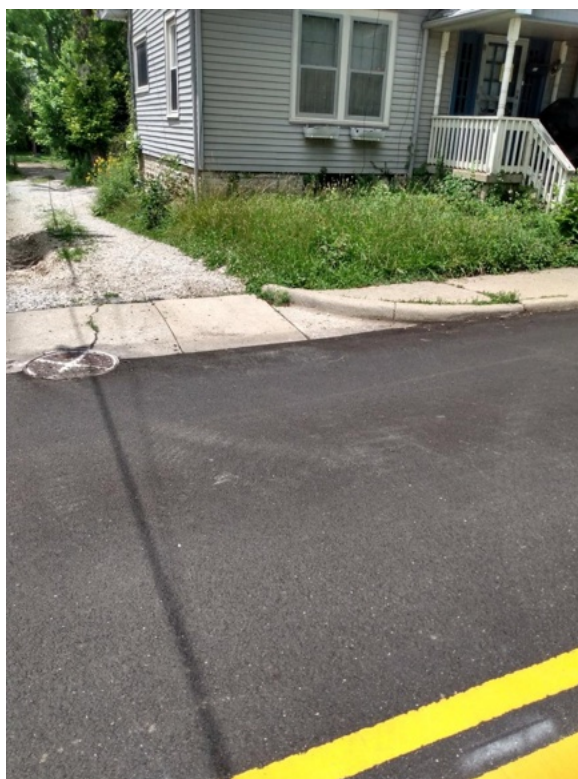
To the extent the City takes the position that pedestrians could simply use the sidewalk on the opposite (west) side of S. Henderson Street, that position does not withstand examination. The west-side sidewalk, at the point where it adjoins the continuation of the same alley right-of-way, itself contains an impassable or noncompliant alley-cut condition (Fig. 5). A pedestrian using a wheelchair or other mobility device who is blocked at 717 S. Henderson cannot simply cross the street to a fully accessible alternate route; the opposite frontage presents a comparable barrier at the same alley crossing.

*Fig. 5: Photograph of the alley-cut condition on the west side of S. Henderson Street, at the continuation of the same alley right-of-way shown in Fig. 1 (complainant's photograph).*

As documented in Section 2.5 and Fig. 5, the west-side sidewalk presents a comparable barrier at the same alley crossing and is not a meaningful accessible alternative.

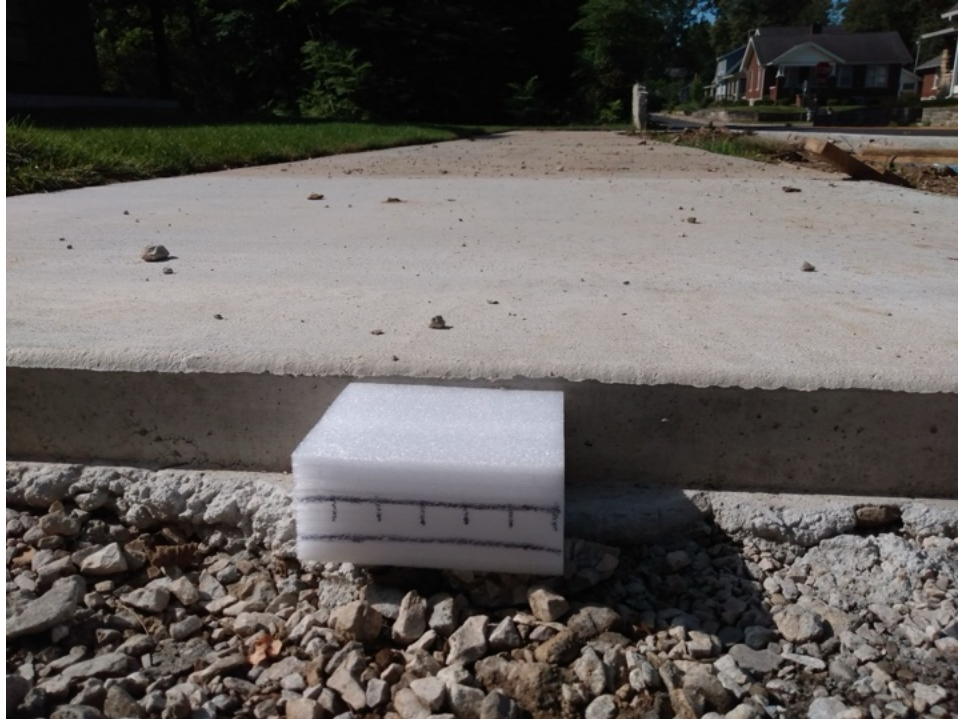
Fig. 6 is a close-up photograph of the vertical drop at the concrete-to-gravel transition on the east side of the crossing (717 S. Henderson Street). The foam block is roughly 2 and 3/4 inches in height. Independent of any precise measurement, the photograph makes plain that the drop is an abrupt change in level well in excess of what PROWAG R302.6.2 permits without a compliant sloped transition. R302.6.2 allows an abrupt vertical change of only up to 0.25 inch (and up to 0.5 inch if beveled); any greater change must be achieved by a sloped transition, not an abrupt drop. The drop is problematic from any viewing angle, and the complainant offers the photograph on that basis rather than as a precise dimensional reading.

*Fig. 6: Close-up photograph of the vertical drop at the concrete-to-gravel transition, east side (717 S. Henderson Street), documenting an abrupt change in level well in excess of what PROWAG R302.6.2 permits without a compliant sloped transition. The foam is roughly 2 and 3/4 inches in height. (complainant's photograph).*
