# FORMAL ADA CIVIL RIGHTS GRIEVANCE

City of Bloomington, Indiana

## Henderson Street / East Second Street — Non-Compliant Curb Ramp Following City Reconstruction (2023)

| Re: | ADA Non-Compliance — Curb Ramp, Northwest Corner of S. Henderson Street and East Second Street: Persistent Gravel Accumulation Rendering Ramp Impassable After City Reconstruction Under the Henderson Greenway Project (Completed July 12, 2023) |

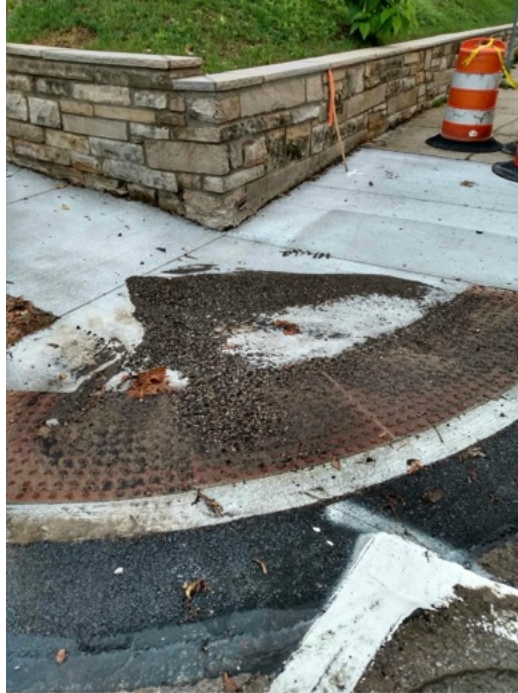
The violation is documented across six dates spanning July 2023 through March 2026. The complainant's photograph from July 3, 2023 — nine days before the project's stated completion date — shows gravel already accumulating in the ramp bowl with what appears to be a construction barrel still on site (Fig. 1, below). The ramp has not been corrected in nearly three years.

*Fig. 1: Complainant's photograph, July 3, 2023 — nine days before project completion date of July 12, 2023. Gravel accumulating in the reconstructed ramp bowl; what appears to be a construction barrel visible at right.*

The complainant's photograph from July 3, 2023 (Fig. 1; Fig. A-7 in Appendix A) was taken nine days before the project completion date of July 12, 2023, with what appears to be a construction barrel still present at the site. Gravel was already accumulating in the ramp bowl. The ramp did not comply with applicable surface accessibility requirements at any documented point following its reconstruction — including before the project was formally closed out.

The City shall correct the gravel accumulation problem at the northwest corner curb ramp at S. Henderson Street and East Second Street such that the ramp surface complies with applicable accessibility standards, including the surface requirements of the 2010 ADA Standards and PROWAG R302.7. Correction shall address the underlying cause — whether drainage geometry, inadequate edge containment, or some other design or construction factor — and shall not consist solely of removing accumulated gravel on a one-time basis.

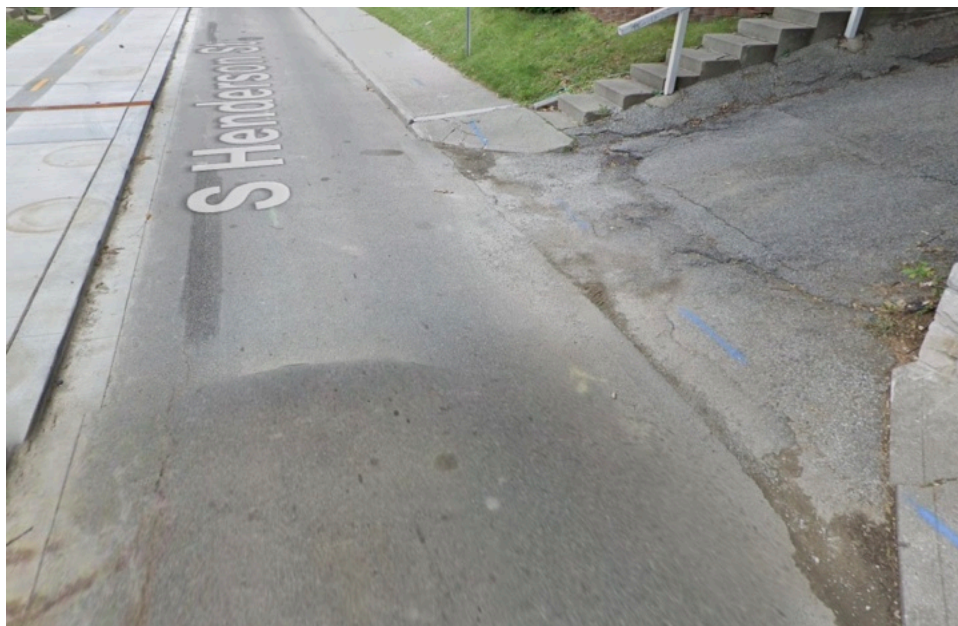
That sidewalk was not improved as part of the Henderson Greenway project, which repaved the street and built the west-side path but left the east-side sidewalk in its existing condition. As documented in Fig. 2 below, the east-side sidewalk presents cracked pavement, gravel intrusion at a driveway crossing, and deteriorated surface conditions. The complainant does not assert in this complaint that the east-side sidewalk independently violates applicable accessibility standards; that question is outside the scope of this grievance. The complainant does observe that a sidewalk exhibiting these conditions — unimproved while the rest of the corridor was under active capital reconstruction — does not constitute an equivalent accessible alternative to a reconstructed, PROWAG-standard curb ramp.

*Fig. 2: East side of S. Henderson St., looking north toward E. Second St. Cracked pavement, gravel intrusion at a driveway crossing, and deteriorated surface conditions are visible. This sidewalk was not corrected by the Henderson Greenway project.*

The complainant observes that the Henderson Greenway project improved the west-side multi-use path and repaved the street while leaving the east-side sidewalk in its existing condition. The complainant requests that the City evaluate the accessibility of the east-side sidewalk of S. Henderson Street between East Second Street and East First Street as part of any corrective action plan for this corridor, and provide its assessment to the complainant. This is offered as a preferred additional remedy and does not condition the Tier 1 remedies.

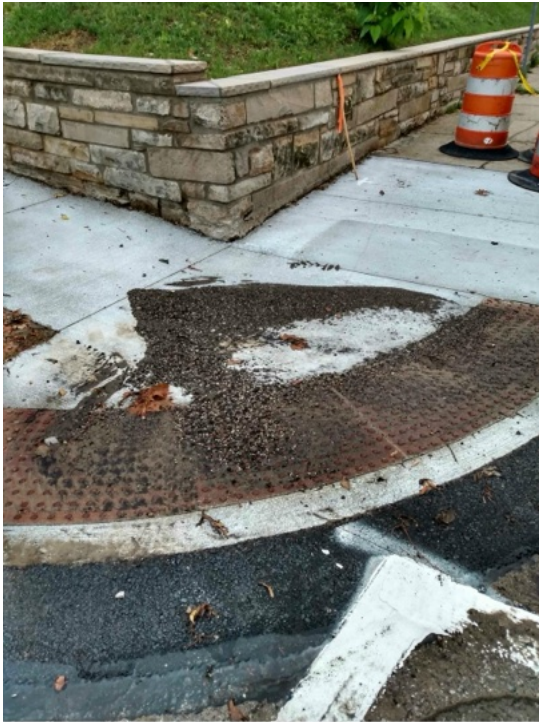
| Figure | Date | Observation |
|---|---|---|
| A-7 / Fig. 1 | July 3, 2023 | Nine days before project completion. Gravel accumulating; what appears to be a construction barrel on site. |

**Fig. A-7 — July 3, 2023.** Complainant's photograph, nine days before project completion. Gravel accumulating in ramp bowl; what appears to be a construction barrel visible at right.

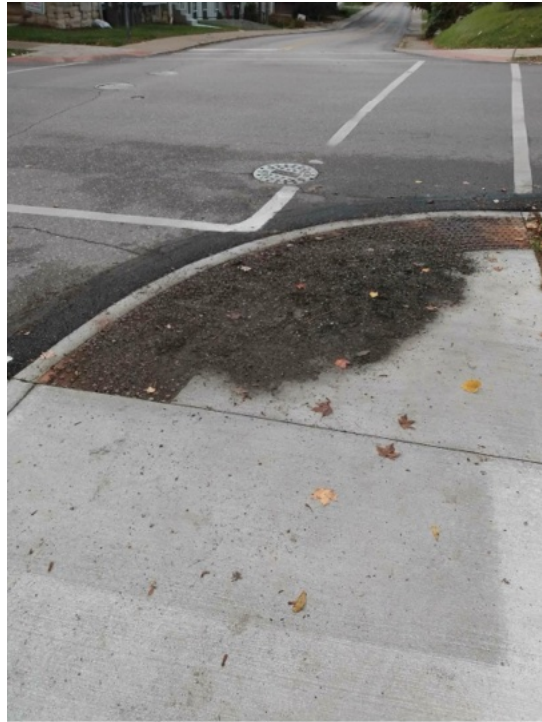
**Fig. A-8 — October 20, 2023.** Complainant's photograph, three months after project completion.

| A-8 | October 20, 2023 | Three months post-completion. Gravel fills ramp bowl. |

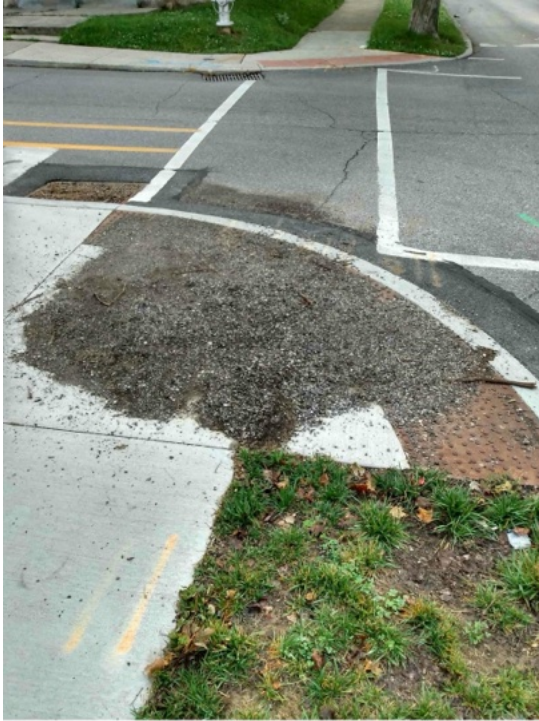
**Fig. A-9 — June 3, 2024.** Complainant's photograph, eleven months after project completion.

| A-9 | June 3, 2024 | Eleven months post-completion. Condition unchanged. |

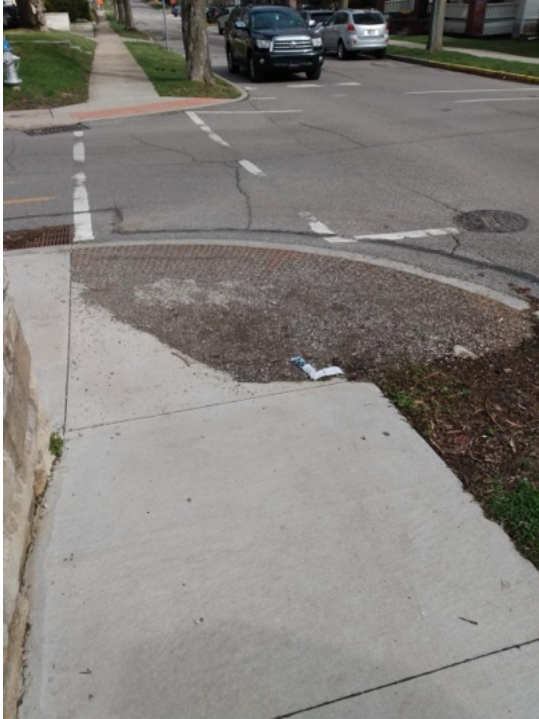
**Fig. A-11 — March 27, 2026.** Complainant's photograph, nearly three years after project

| A-11 | March 27, 2026 | Nearly three years post-completion. Condition materially unchanged from 2023. |

*completion. Condition materially unchanged from  
2023.*

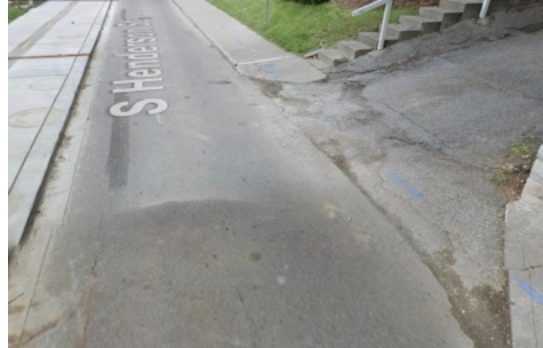
**Fig. A-12 — Apr. 2026.** East side of S. Henderson St., looking north toward E. Second St. Cracked and deteriorated sidewalk surface; driveway crossing with gravel intrusion visible. This sidewalk was not addressed by the Henderson Greenway project.
