# FORMAL ADA CIVIL RIGHTS GRIEVANCE

## City of Bloomington, Indiana

### **E University Street at Alley Crossing (Between S Grant Street and S Henderson Street) — Inaccessible Pedestrian Alley Crossing in the Public Right-of-Way, Documented Continuously from 2007 through 2026**

| <b>Re:</b> | ADA Non-Compliance — Pedestrian Alley Crossing, North Side of E University Street between S Grant Street and S Henderson Street: Inaccessible Crossing Surface Documented Continuously Since 2007; Failure of City Sidewalk Grinding Work to Achieve Compliance at the Cut |

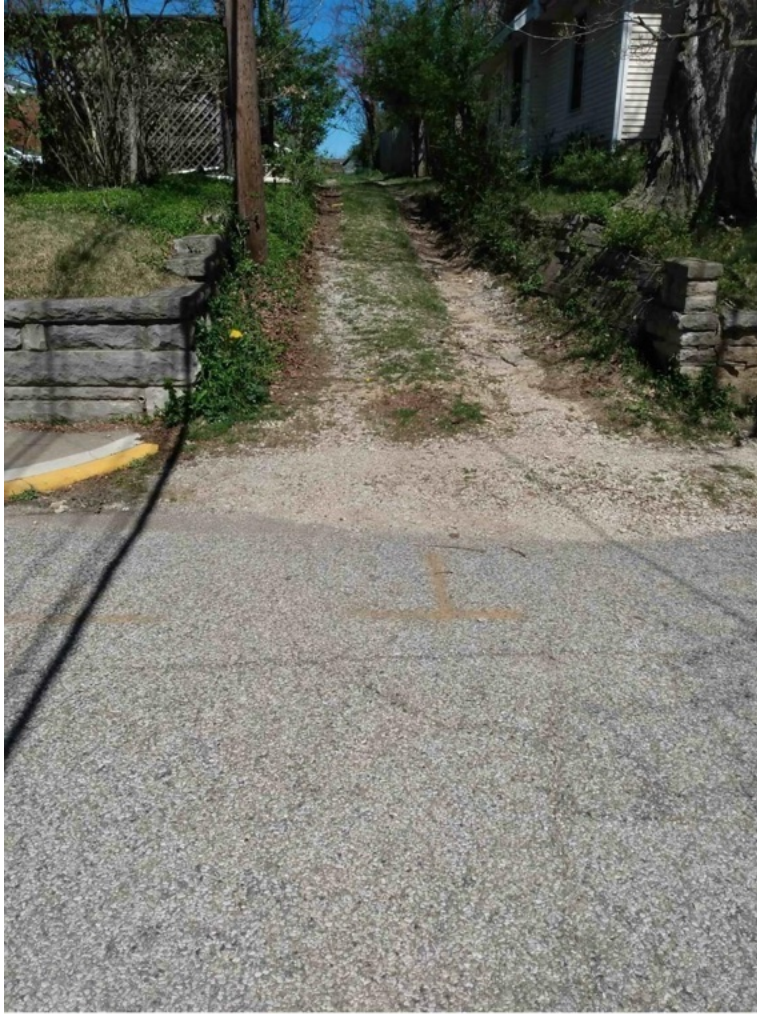
*Fig. 2: Complainant's photograph, April 6, 2026. View looking north from the street edge into the alley at this crossing. The alley surface is loose aggregate throughout; no firm, stable, or slip-resistant surface exists for pedestrian traversal. Stone retaining walls flank the alley on both sides.*

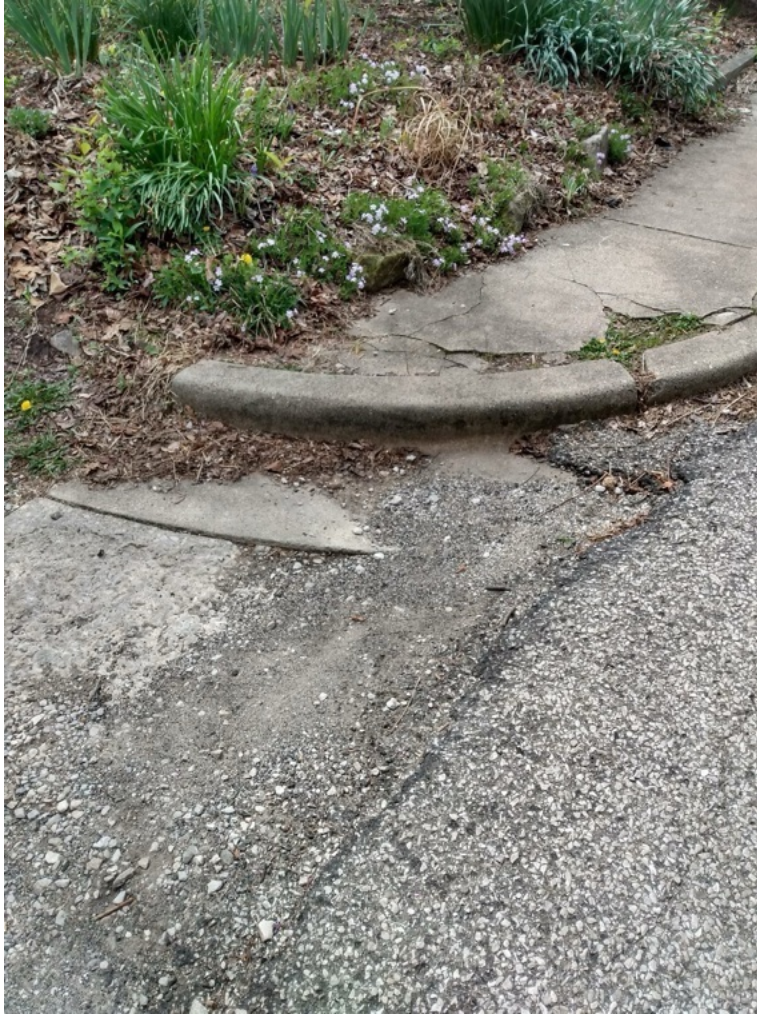
*Fig. 3: Complainant's photograph, April 7, 2026. South side of E University Street at the alley crossing between S Grant Street and S Henderson Street. The sidewalk terminates at a vertical drop of several inches to a loose aggregate alley surface; broken concrete fragment visible at the edge. No ramp, blended transition, or other compliant means of pedestrian traversal exists at this location. This view documents that the south side of E University Street does not provide an accessible alternative route at this alley crossing.*

taken April 7, 2026, documents current conditions. At every documented date, the south-side sidewalk terminates at a loose-aggregate alley surface with no compliant ramp, blended transition, or other means of pedestrian traversal. The April 2026 photograph additionally documents a vertical drop appearing to exceed several inches from a cracked concrete sidewalk panel to the alley surface, with broken concrete at the edge — a drop far in excess of the ½-inch maximum change in level permitted under the 2010 ADA Standards § 303.4 and the corresponding PROWAG provision.

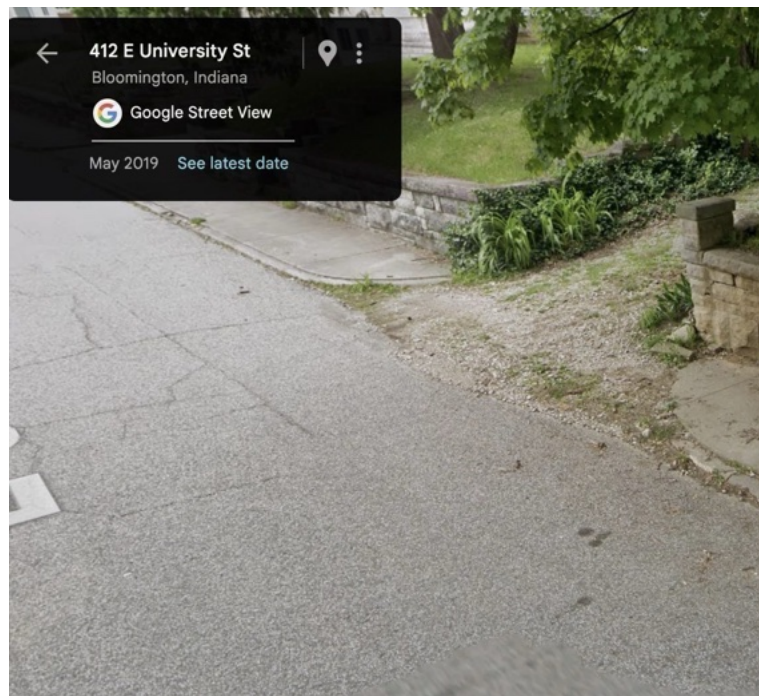
*Fig. A-5 — May 2019. Google Maps Street-level view, north side of E University Street near 412 E University St, at the alley crossing. The sidewalk terminates at a loose-aggregate alley surface; no compliant ramp or transition exists. This image documents the same inaccessible north-side condition nearly twelve years after Fig. A-1.*

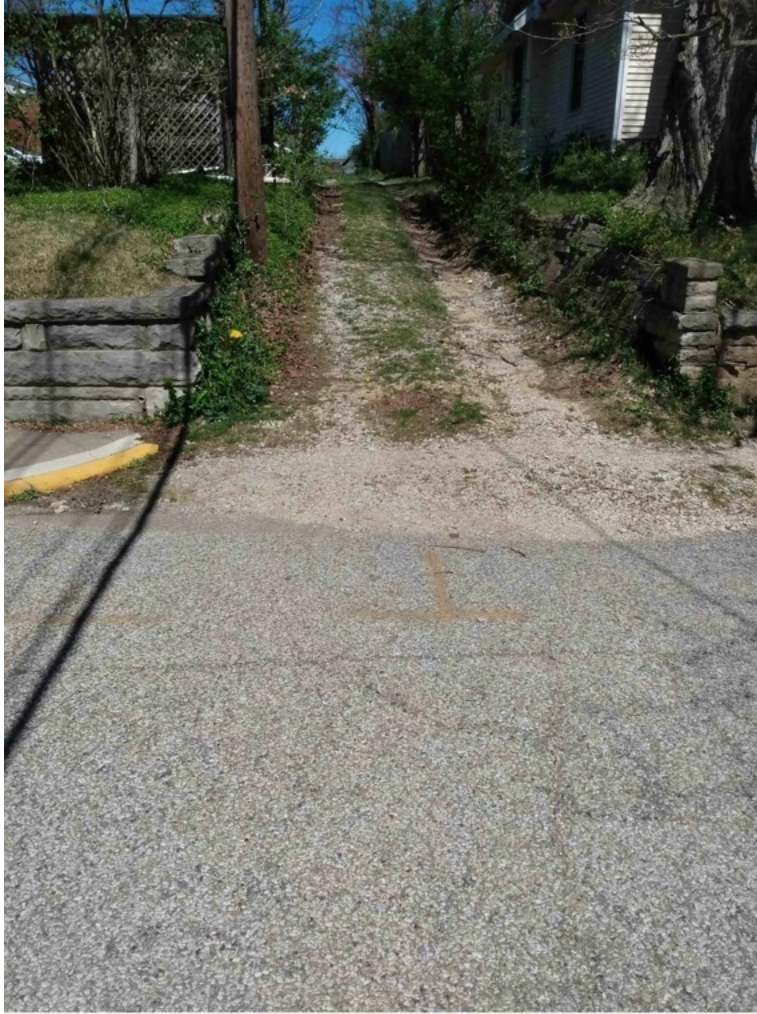
*Fig. A-9 — Apr. 6, 2026. Complainant's photograph. View looking north from the street edge into the alley. Unpaved loose-aggregate surface throughout; no firm, stable, or slip-resistant crossing surface. Stone retaining walls on both sides. Corresponds to Fig. 2 in body text.*

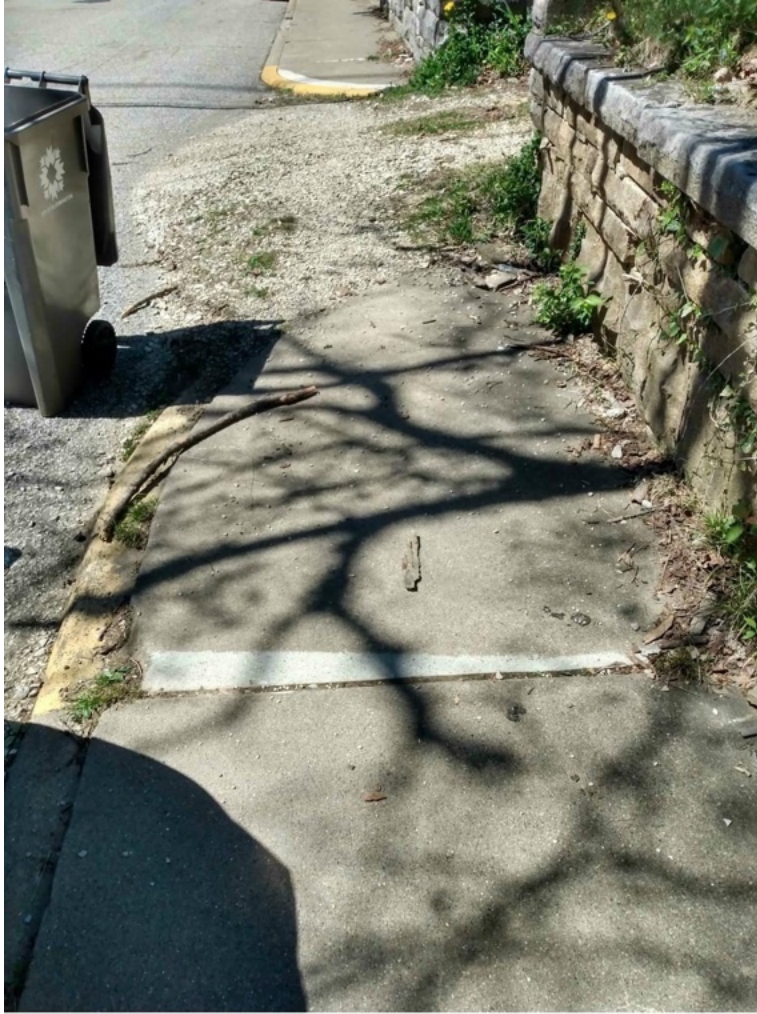
The relevant point for this complaint is not the precise date of the grinding but its scope. The grinding addressed the vertical lip at the transition between the sidewalk and the alley while leaving the alley crossing surface itself entirely unimproved. The result is a facility in which the vertical transition has been reduced while the primary barrier — the absence of a firm, stable, slip-resistant walking surface through the crossing — remains as it was.

*Fig. A-10 — Apr. 6, 2026. Complainant's photograph (HDR). Ground-level view at the alley cut, showing evidence of City sidewalk grinding in the vicinity of the lip on the east side of the alley. Loose gravel on the worked surface and on the surrounding alley surface; stone retaining wall at upper right.*

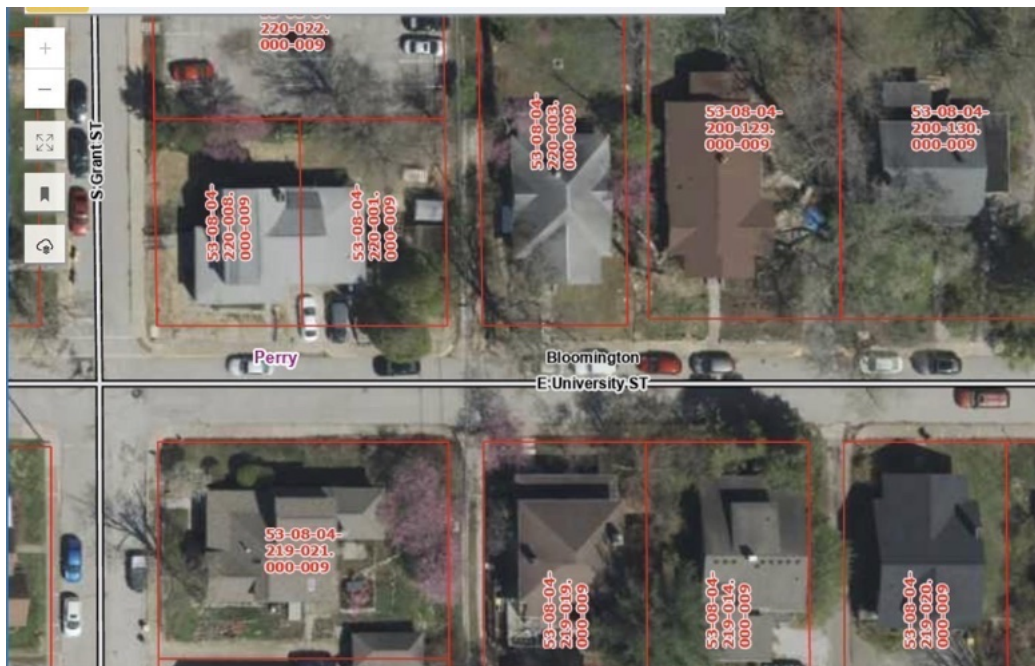
Fig. A-12 — Apr. 2026. Monroe County parcel map, City of Bloomington tax records. E University Street runs horizontally across center; S Grant Street at left. Going east from S Grant Street on the north side of E University Street: parcel 53-08-04-220-008.000-009 (the western house), then parcel 53-08-04-220-001.000-009, then an unenclosed gap, then parcel 53-08-04-220-003.000-009. The unenclosed gap between parcels 001 and 003 is the

*alley. Because the alley space is not incorporated into either abutting parcel, the alley is a separate public right-of-way held by the City.*

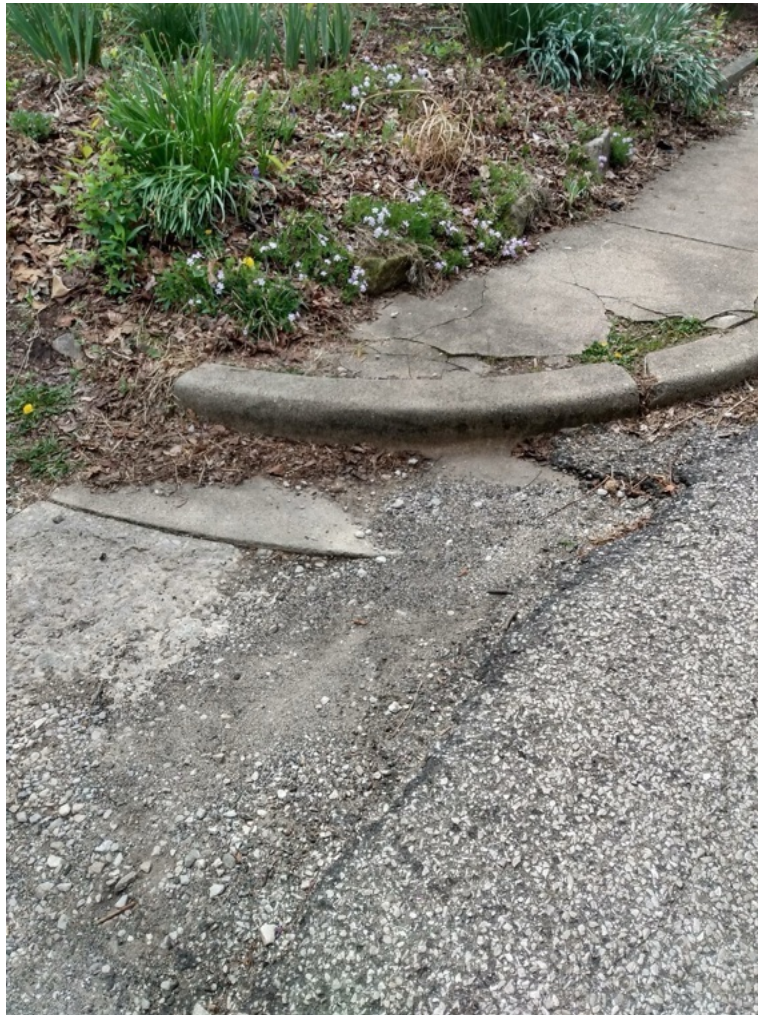
*Fig. A-13 — Apr. 7, 2026. Complainant's photograph. South side of E University Street at the alley crossing between S Grant Street and S Henderson Street. The sidewalk terminates at a vertical drop of several inches to a loose-aggregate alley surface; broken concrete fragment visible at the edge. No ramp, blended transition, or other compliant means of pedestrian traversal exists at this location. Corresponds to Fig. 3 in body text.*
