## **ADDENDUM NO. 1 TO ADA/PROWAG CIVIL RIGHTS GRIEVANCE**

City of Bloomington, Indiana

**717 S. Henderson Street — Supplemental Submission: Pedestrians Were Routed to a Non-Compliant Sidewalk**

**Date:** July 17, 2026

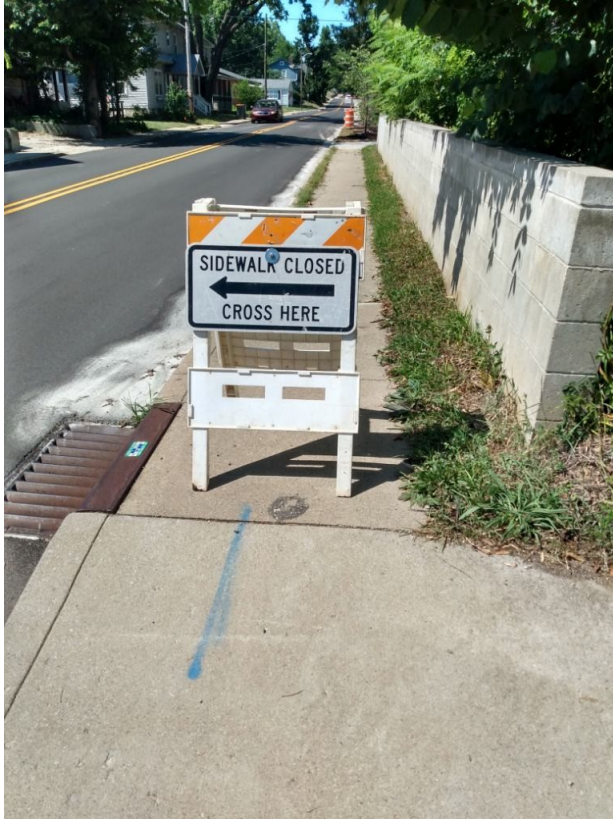
On or about July 14, 2026, as part of the construction to bring the sidewalk into compliance, signage was placed at the south approach directing pedestrians to cross to the opposite (west) side of S. Henderson Street (Fig. 7).

*Fig. 7: Signage placed at the south approach directing pedestrians to cross S. Henderson Street, observed on or about July 14, 2026 (complainant's photograph).*

As explained in Section 2.5 of the Complaint, the complainant does not consider the west side a meaningful accessible alternate route. The complainant requests that the City confirm what accessible temporary pedestrian access route, if any, was provided and maintained during the construction described above, consistent with the obligation described in Section 6 of the Complaint.

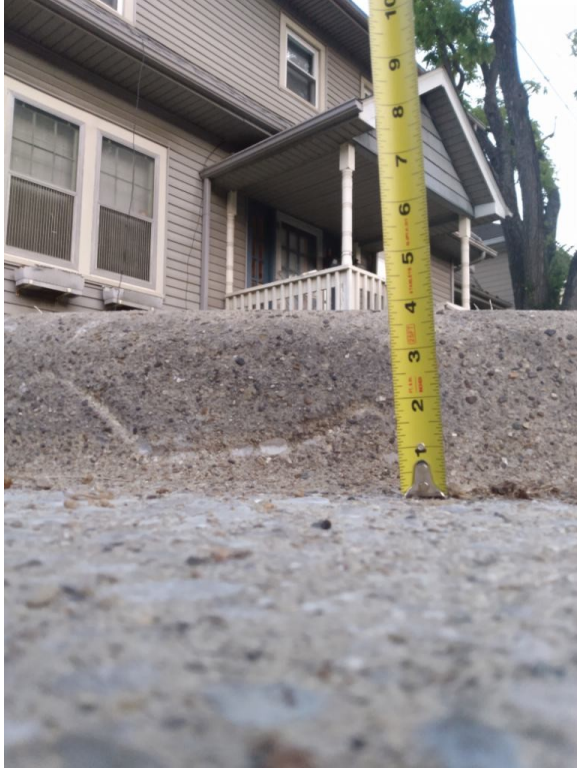
*Fig. 8: First alley-cut drop on the west-side route, measuring over 3 inches (complainant's photograph).*

Both drops substantially exceed the maximum permitted under PROWAG R302.6.2 and would require a compliant sloped transition rather than an abrupt drop.

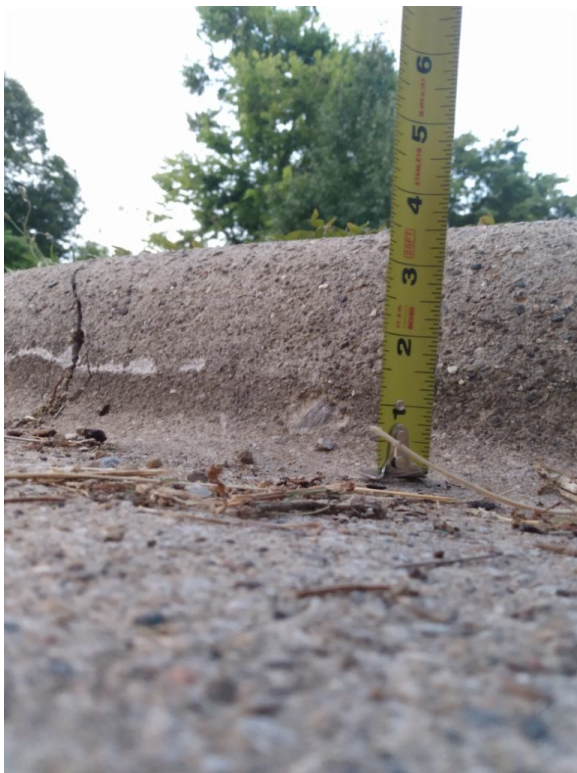
*Fig. 9: Second alley-cut drop on the west-side route, also measuring over 3 inches (complainant's photograph).*

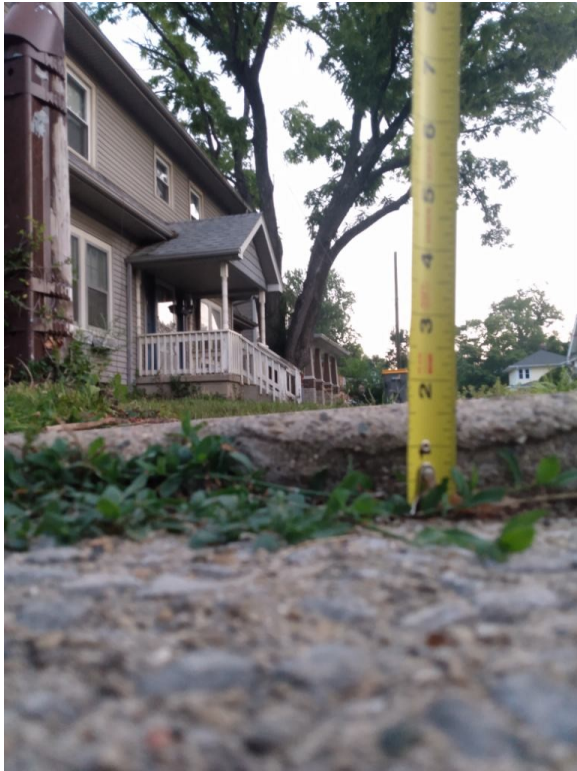
*Fig. 10: Vertical surface discontinuity on the west-side route, well in excess of the 1/2-inch maximum (complainant's photograph).*

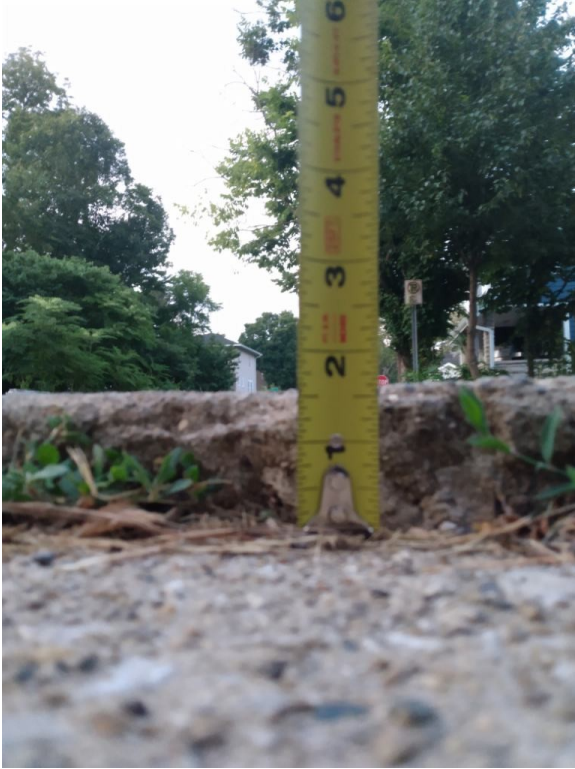
Fig. 11: A second vertical surface discontinuity on the west-side route, well in excess of the 1/2-inch maximum (complainant's photograph).

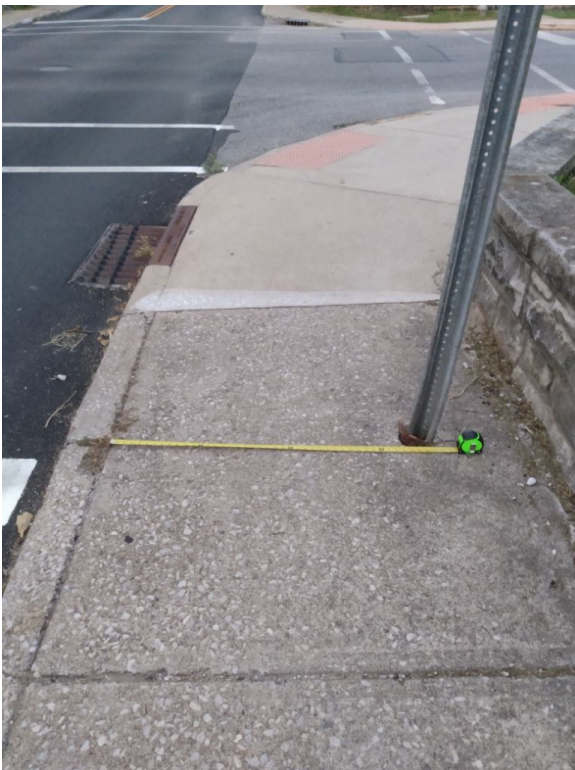
*Fig. 12: A stop-sign post standard on the west-side route, reducing the walkway (complainant's photograph).*

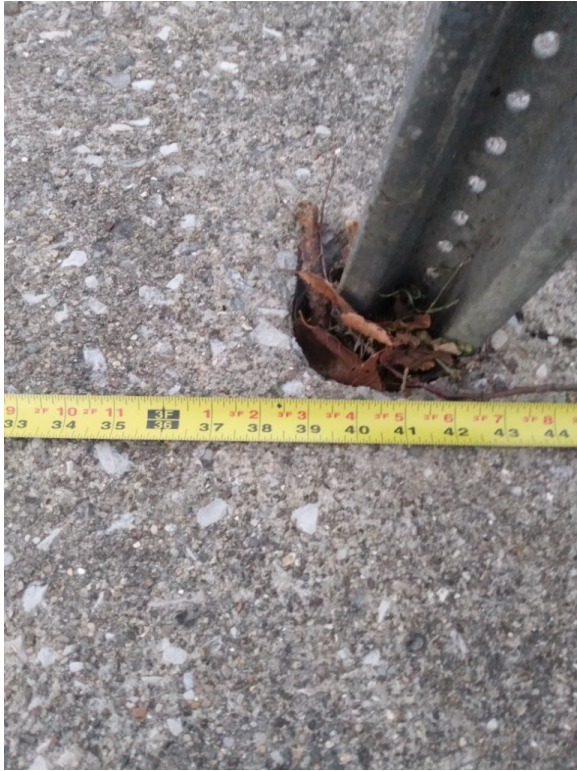
*Fig. 13: Measurement showing the sign post reduces the continuous clear width to approximately 39 inches, below the 48-inch minimum required by PROWAG R302.3 (complainant's photograph).*

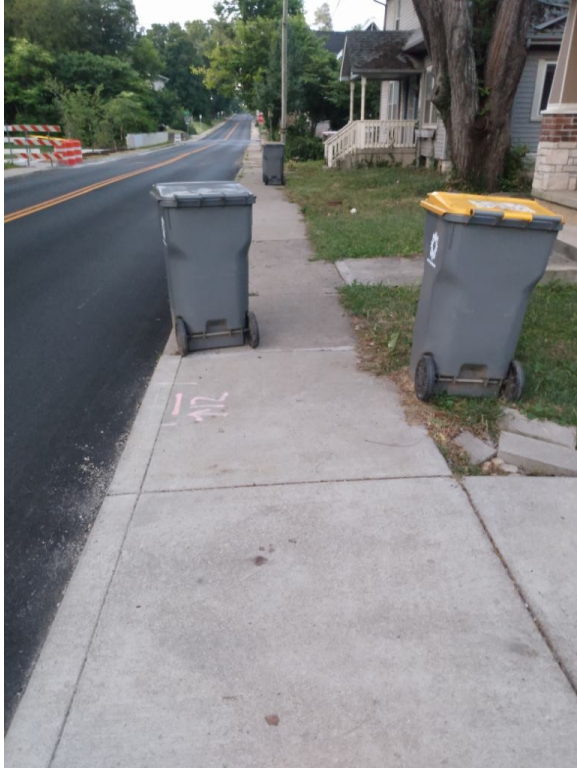
*Fig. 14: Waste and recycling containers obstructing the west-side route (complainant's photograph).*

Collection for this route occurred the preceding Monday; both photographs were taken the following Thursday, indicating the containers were left obstructing the walkway for several days rather than only during active collection.

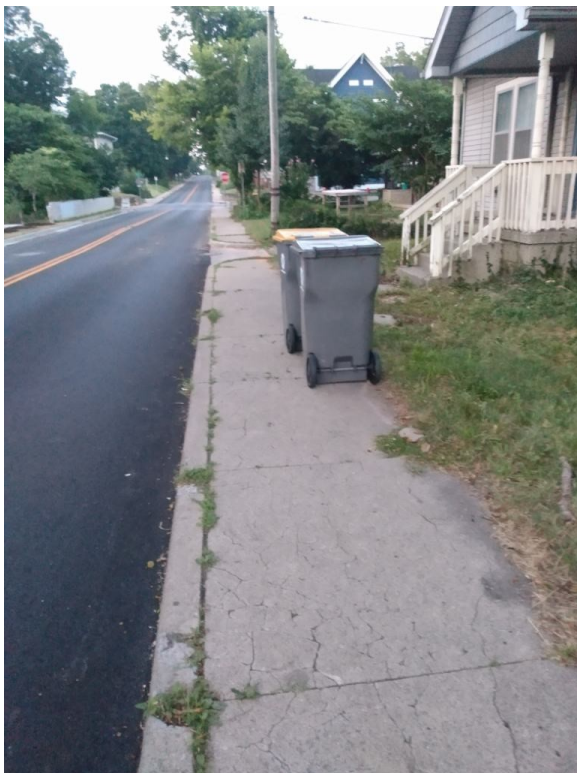
*Fig. 15: A second location where waste and recycling containers obstruct the west-side route (complainant's photograph).*
