# FORMAL ADA/PROWAG CIVIL RIGHTS GRIEVANCE

City of Bloomington, Indiana

***717 S. Henderson Street — Removal of Accessible Pedestrian Route During Redevelopment; Failure of ADA/PROWAG Review in Planning, Permitting, Construction, and Complaint-Intake Process***

**Re:** ADA / PROWAG Non-Compliance — Removal of Accessible Pedestrian Route, 717 S. Henderson Street; Failure to Provide Accessible Alternate Route During Construction; Failure of ADA/PROWAG Review and Complaint-Routing Process

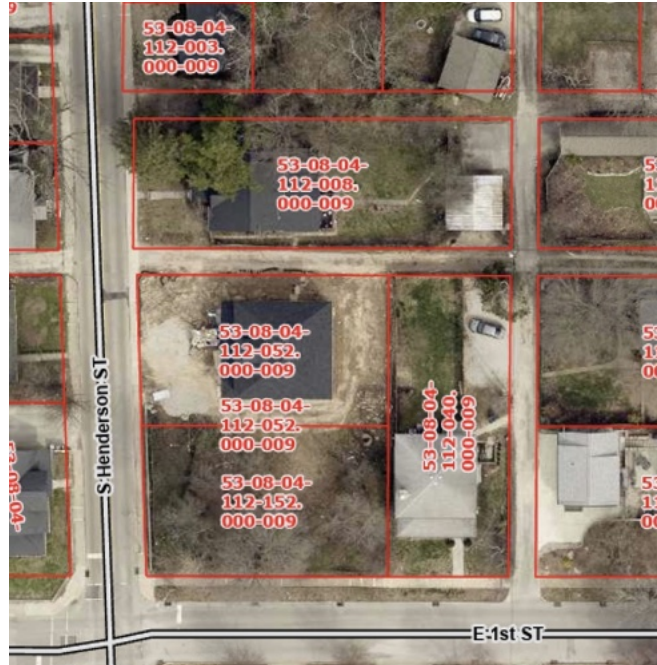
The property at 717 S. Henderson Street was recently redeveloped: an existing house was demolished and replaced with a duplex. The adjoining property to the north, at 715 S. Henderson Street, is a separate parcel. Based on the City's GIS parcel map (Fig. 1), the redeveloped lot is identified as Parcel 53-08-04-112-052.000-009, and the lot immediately to the north is Parcel 53-08-04-112-008.000-009. An alley right-of-way appears to run between these two parcels, separating the redeveloped lot from the parcel to its north, and to continue across Henderson Street to the west side, where it adjoins residences located at 712 and 710 S. Henderson Street.

The complainant requests that the City confirm, as part of its response to this complaint, the dedicated or right-of-way status of this alley, including whether it is platted public right-of-way, a recorded easement, or an unrecorded de facto path. Regardless of its formal platted status, the alley functions as the only pedestrian connection available at this location once the prior continuous sidewalk was interrupted, and the City required or permitted it to serve that function during and after the redevelopment.

*Fig. 1: City of Bloomington GIS parcel map showing the redeveloped lot (53-08-04-112-052.000-009), the adjoining parcel to the north (53-08-04-112-008.000-009), and the alley right-of-way running between them and continuing west across S. Henderson Street (complainant's annotated screen capture).*

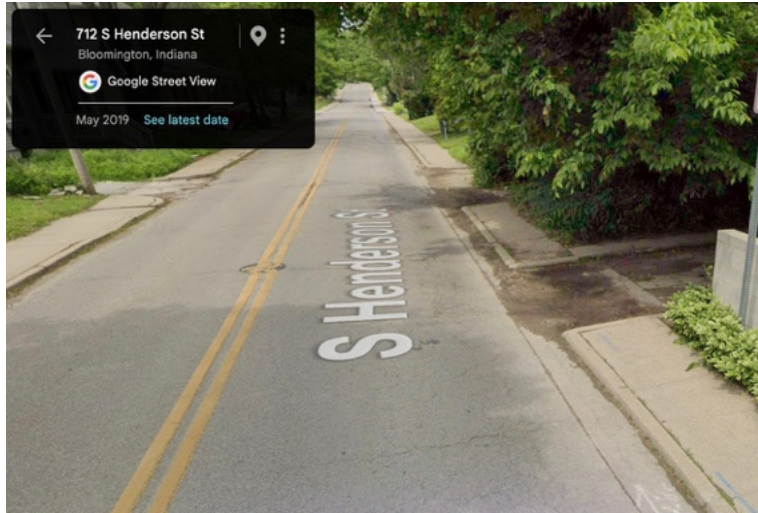
The complainant's understanding of the history of this frontage, based on available Google Street View imagery and direct observation, is as follows. In approximately 2017, and as late as May 2019, the sidewalk condition in this area was discontinuous and did not provide a continuous accessible pedestrian route (Fig. 2). At some point after 2019, and before the 717 S. Henderson redevelopment began, the City or a prior property owner improved the frontage to provide a continuous, direct, paved concrete pedestrian route. Google Maps Street View imagery dated April 2026 — captured after redevelopment had begun but before the sidewalk was relocated — shows that a continuous concrete sidewalk ran in a straight line along this frontage and that the alley crossing was paved at that time (Fig. 3).

*Fig. 2: Google Street View imagery dated May 2019, 717 S. Henderson on right.*

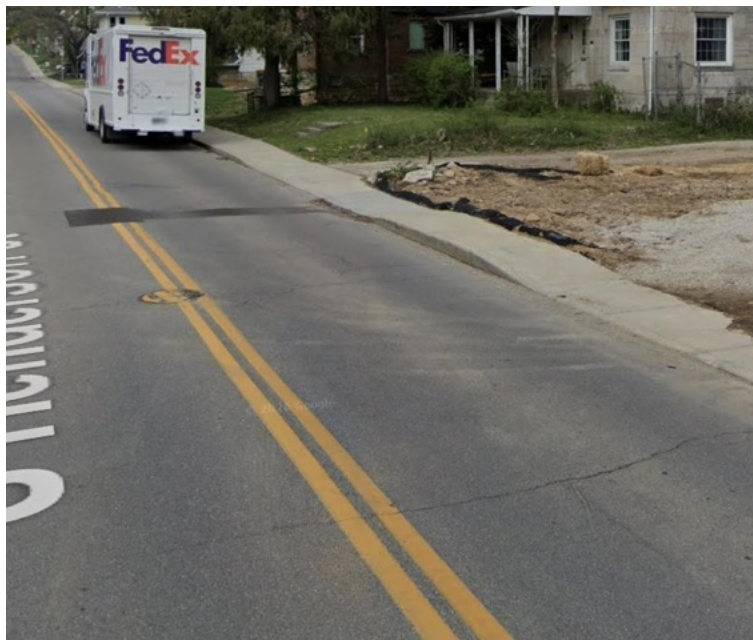
This sequence matters because it establishes that the City had already moved this location toward accessibility compliance by the time the 717 S. Henderson redevelopment began. The redevelopment did not occur at a location where no accessible route had ever existed; it occurred at a location where a continuous accessible route already existed and was then interrupted and replaced by a substantially worse condition.

*Fig. 3: Google Maps Street View imagery dated April 2026, showing a continuous concrete sidewalk running in a straight line along the 717 S. Henderson frontage with the alley crossing paved, at a point when redevelopment had begun but the sidewalk had not yet been relocated (Google Maps).*

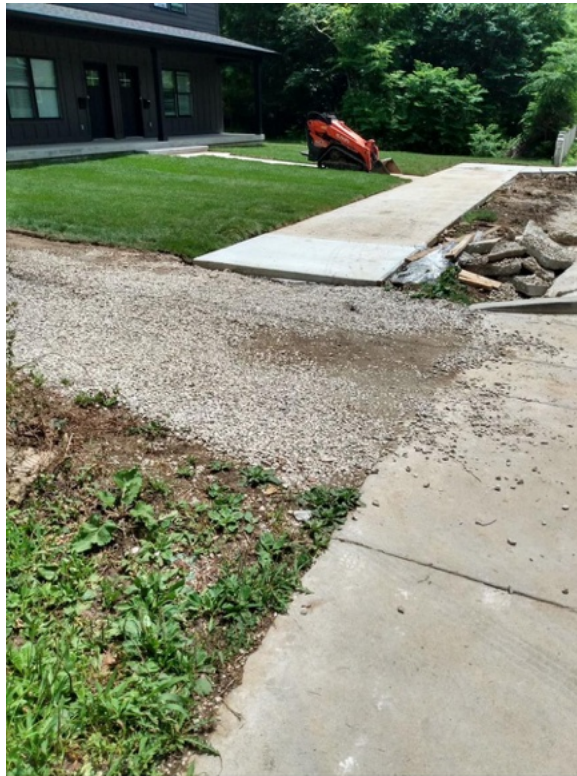
As part of the 717 S. Henderson redevelopment, and consistent with applicable code requirements, the builder reconstructed the sidewalk frontage with a setback from the property line. The complainant does not dispute that a setback was required by code and takes no position on the setback requirement itself. The complaint concerns the pedestrian connection the City permitted or accepted within and beyond that setback area, as observed by the complainant: rather than a continuous compliant sidewalk, the observed condition directs

pedestrians off the new concrete sidewalk, across a loose gravel alley surface, and includes an abrupt vertical drop of greater than 3 inches at or near the transition between the concrete and the gravel (Fig. 4). If the City has since altered or corrected this condition, or considers the project ongoing, that does not change what was permitted and left in place for the period documented in this complaint. A required setback does not, by itself, justify or explain a noncompliant transition and a gravel crossing within the resulting frontage; the City retained discretion over how the connection across that frontage was designed, permitted, and approved.

*Fig. 4: Complainant's photograph, June 2026, showing the condition at 717 S. Henderson Street following the sidewalk reconstruction. The new concrete sidewalk ends at a loose gravel alley crossing, with an abrupt vertical drop at the transition. See Fig. 6 for a close-up photograph of the drop.*

The complainant does not have the precise construction dates and will request them from the City as part of this complaint. Based on the complainant's observation, the condition shown in Fig. 4 was already in place when first noted on approximately June 11, 2026, and remained in that condition for at least several weeks thereafter.

The complainant has not yet obtained running-slope or cross-slope measurements for the transition area, but the visible condition in Fig. 4 raises serious concerns about compliance with PROWAG grade and cross-slope requirements, and the complainant requests that the City's ADA Compliance Officer or another qualified accessibility reviewer inspect and measure the area before it is altered further.

If the condition described in Section 2.3 has been or will be physically corrected, the City shall confirm in writing the date of correction, the nature of the work performed, and confirmation that the corrected route complies with PROWAG R302.2 (48-inch / 4.0 ft minimum continuous clear width), R302.6 (firm, stable, slip-resistant surface), and R302.6.2 (compliant changes in level, with no abrupt vertical change greater than that permitted without a sloped transition). If the condition has not yet been corrected, the City shall provide a specific construction start date, completion date, and the contractor or City crew assigned.

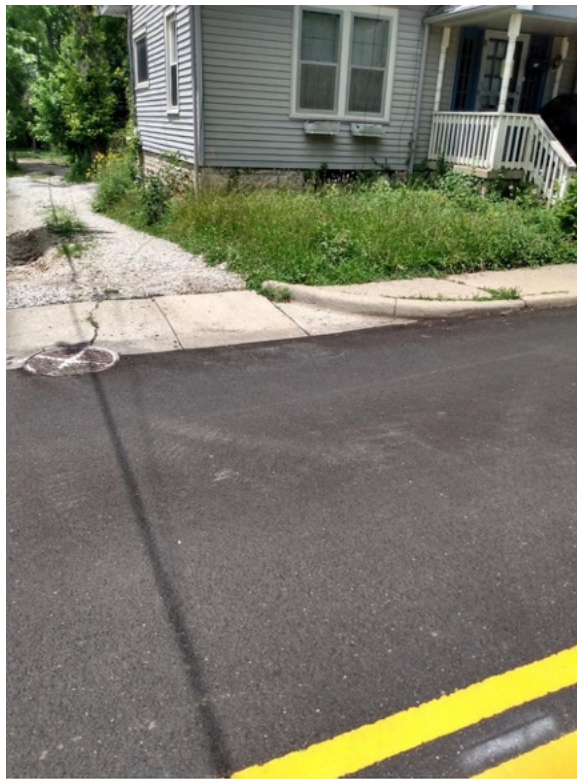
To the extent the City takes the position that pedestrians could simply use the sidewalk on the opposite (west) side of S. Henderson Street, that position does not withstand examination. The west-side sidewalk, at the point where it adjoins the continuation of the same alley right-of-way, itself contains an impassable or noncompliant alley-cut condition (Fig. 5). A pedestrian using a wheelchair or other mobility device who is blocked at 717 S. Henderson cannot simply cross the street to a fully accessible alternate route; the opposite frontage presents a comparable barrier at the same alley crossing.

*Fig. 5: Photograph of the alley-cut condition on the west side of S. Henderson Street, at the continuation of the same alley right-of-way shown in Fig. 1 (complainant's photograph).*

As documented in Section 2.5 and Fig. 5, the west-side sidewalk presents a comparable barrier at the same alley crossing and is not a meaningful accessible alternative.

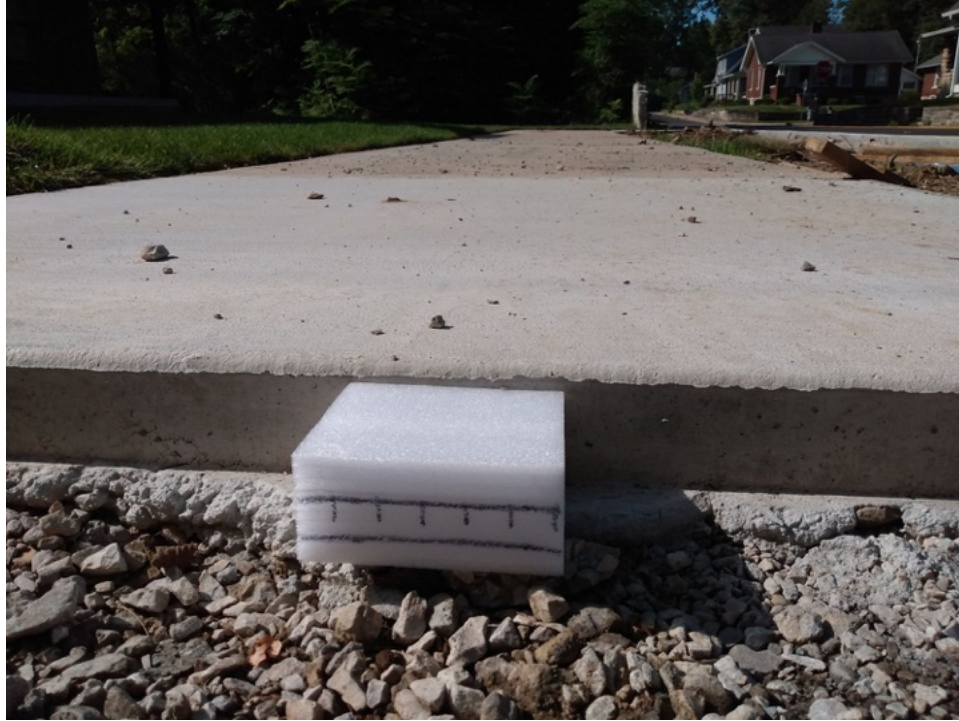
Fig. 6 is a close-up photograph of the vertical drop at the concrete-to-gravel transition on the east side of the crossing (717 S. Henderson Street). The foam block is roughly 2 and 3/4 inches in height. Independent of any precise measurement, the photograph makes plain that the drop is an abrupt change in level well in excess of what PROWAG R302.6.2 permits without a compliant sloped transition. R302.6.2 allows an abrupt vertical change of only up to 0.25 inch (and up to 0.5 inch if beveled); any greater change must be achieved by a sloped transition, not an abrupt drop. The drop is problematic from any viewing angle, and the complainant offers the photograph on that basis rather than as a precise dimensional reading.

*Fig. 6: Close-up photograph of the vertical drop at the concrete-to-gravel transition, east side (717 S. Henderson Street), documenting an abrupt change in level well in excess of what PROWAG R302.6.2 permits without a compliant sloped transition. The foam is roughly 2 and 3/4 inches in height. (complainant's photograph).*

- **R302.6.2 (Changes in Level):** A change in level up to 0.25 inch (6.4 mm) may be vertical; a change between 0.25 inch and 0.5 inch (13 mm) must be beveled; a change greater than 0.5 inch and up to 6 inches must be achieved by a running slope no steeper than 1:12 (8.3%); and a change greater than 6 inches must be provided as a ramp complying with R407. The abrupt vertical drop at this transition, visible in Fig. 4 and shown in close-up in Fig. 6, is a change in level far in excess of what R302.6.2 permits without a compliant sloped transition, and cannot be treated as an acceptable change in level within a pedestrian access route.
