# FORMAL ADA CIVIL RIGHTS GRIEVANCE

## City of Bloomington, Indiana

### **E University Street at Alley Crossing (Between S Grant Street and S Henderson Street) — Inaccessible Pedestrian Alley Crossing in the Public Right-of-Way, Documented Continuously from 2007 through 2026**

| <b>Re:</b> | ADA Non-Compliance — Pedestrian Alley Crossing, North Side of E University Street between S Grant Street and S Henderson Street: Inaccessible Crossing Surface Documented Continuously Since 2007; Failure of City Sidewalk Grinding Work to Achieve Compliance at the Cut |

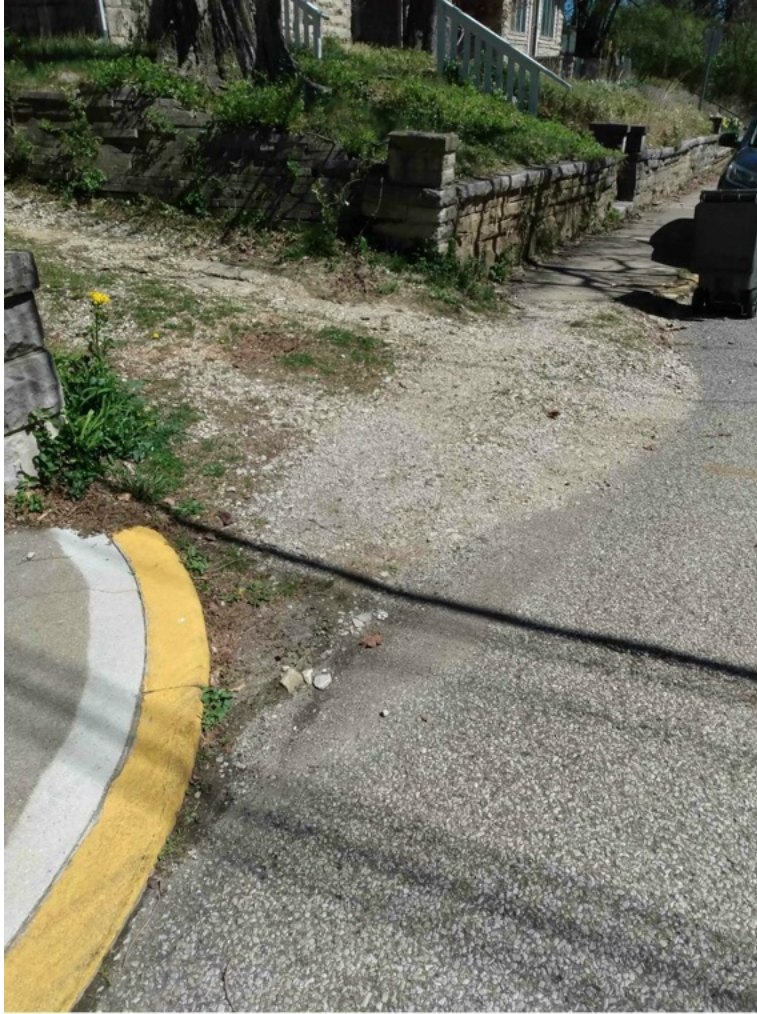
*Fig. 1: Complainant's photograph, April 6, 2026. Ramp at the west edge of the alley crossing, north side of E University Street between S Grant Street and S Henderson Street. Loose gravel visible on and around the ramp surface; evidence of recent City sidewalk grinding visible at the ramp's leading edge; stone retaining wall at right; City-marked trash bin at upper left.*

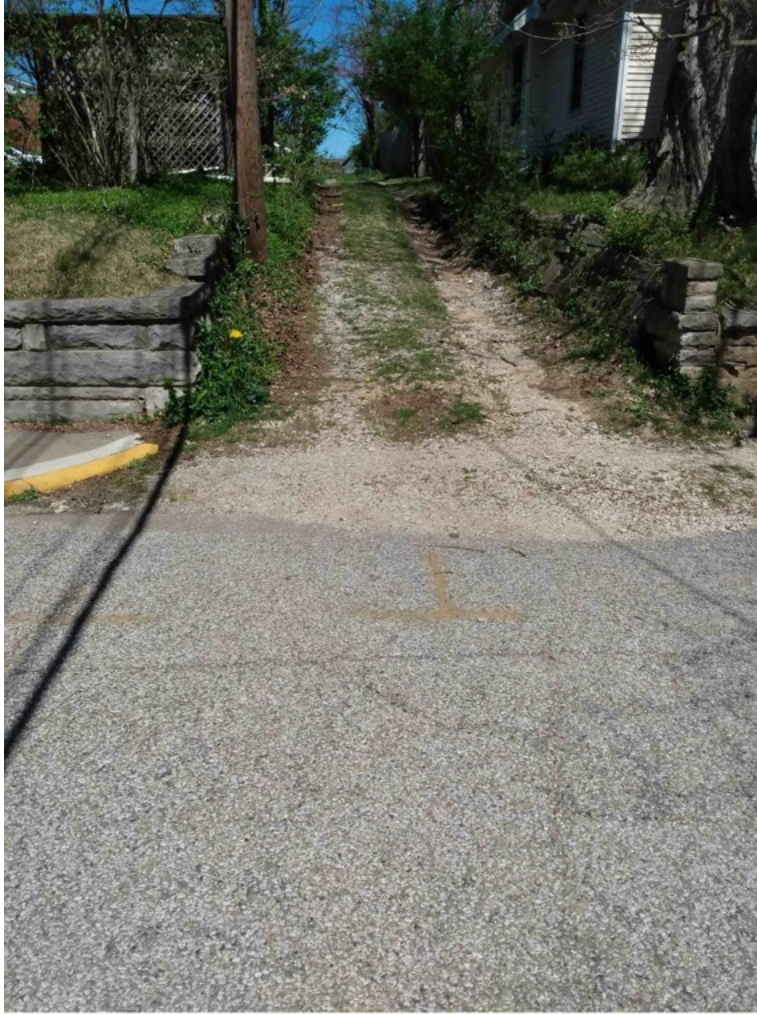
*Fig. 2: Complainant's photograph, April 6, 2026. View looking north from the street edge into the alley at this crossing. The alley surface is loose aggregate throughout; no firm, stable, or slip-resistant surface exists for pedestrian traversal. Stone retaining walls flank the alley on both sides.*

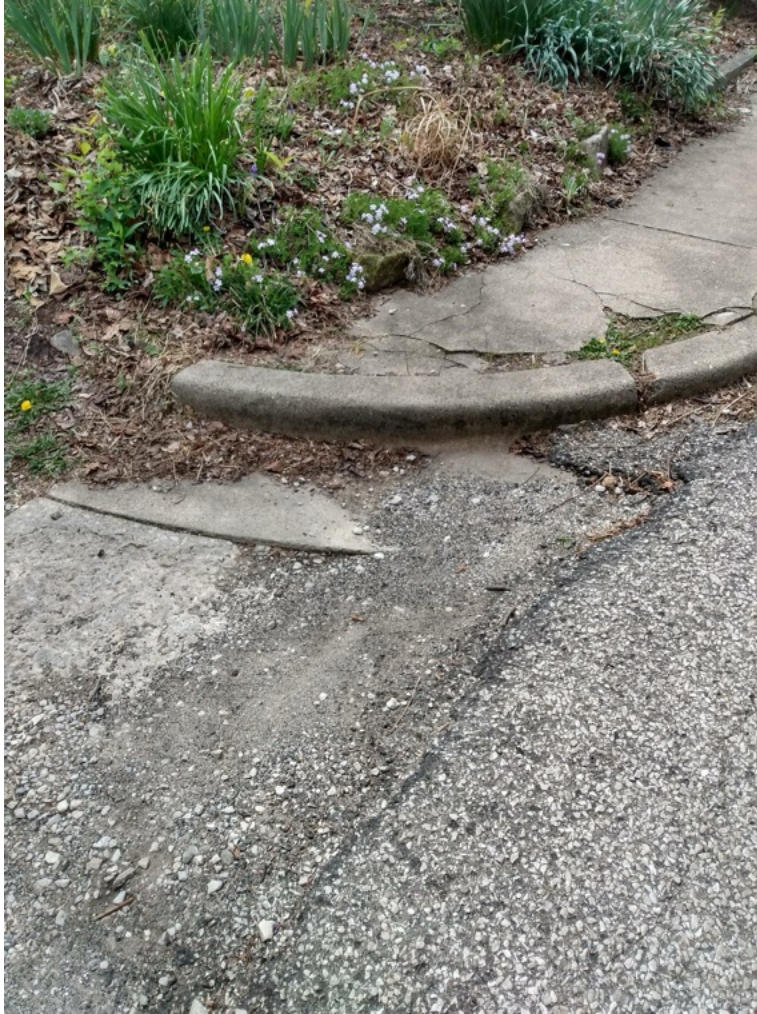
*Fig. 3: Complainant's photograph, April 7, 2026. South side of E University Street at the alley crossing between S Grant Street and S Henderson Street. The sidewalk terminates at a vertical drop of several inches to a loose aggregate alley surface; broken concrete fragment visible at the edge. No ramp, blended transition, or other compliant means of pedestrian traversal exists at this location. This view documents that the south side of E University Street does not provide an accessible alternative route at this alley crossing.*

taken April 7, 2026, documents current conditions. At every documented date, the south-side sidewalk terminates at a loose-aggregate alley surface with no compliant ramp, blended transition, or other means of pedestrian traversal. The April 2026 photograph additionally documents a vertical drop appearing to exceed several inches from a cracked concrete sidewalk panel to the alley surface, with broken concrete at the edge — a drop far in excess of the ½-inch maximum change in level permitted under the 2010 ADA Standards § 303.4 and the corresponding PROWAG provision.

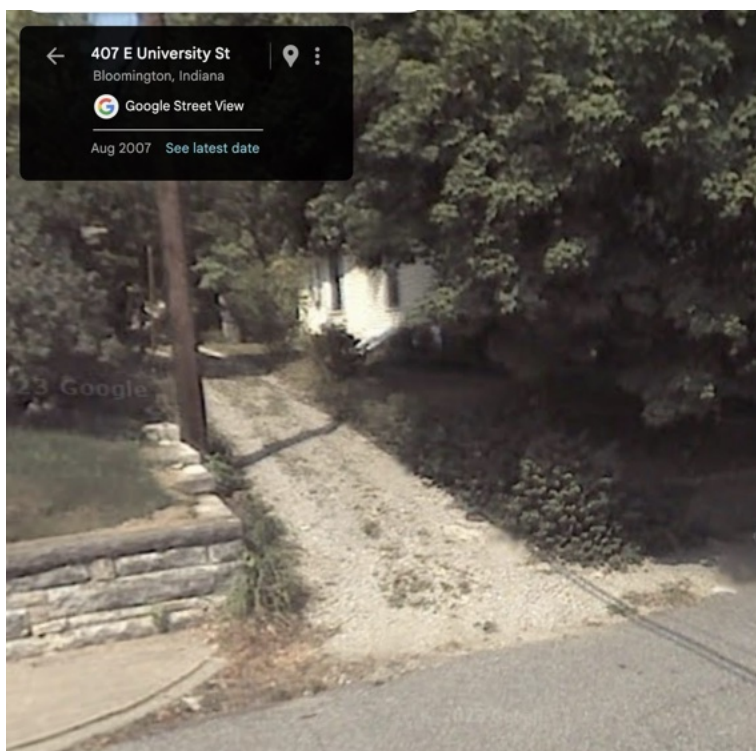
Figure A-1 is a Google Street View image from August 2007 documenting the north-side alley cut on E University Street; Figure A-14 is a complementary view from the same August 2007 imagery pass, looking from the north-side sidewalk into the alley itself, showing that the loose-aggregate surface extends through the alley and not merely at the cut. The alley surface is loose aggregate throughout; no compliant surface exists for pedestrian traversal. Figure A-2 is a Google Street View image from the same 2007 imagery pass documenting the corresponding south-side condition at the same alley. Figure A-3 is a Google Street View image from October 2013 showing the north-side alley cut with the same loose-aggregate condition approximately six years after Fig. A-1. Figure A-4 is a Google Street View image from August 2014 showing the north-side alley cut with the same loose-aggregate condition. Figure A-5 is a Google Street View image from May 2019 showing the north-side alley cut with the same condition nearly twelve years after the 2007 capture. Figures A-6 and A-7 are Google Street View images from July 2023 documenting the loose-aggregate condition on the north and south sides respectively. Figures A-8 through A-10 are the complainant's photographs from April 6, 2026 documenting current north-side conditions, and Fig. A-13 is the complainant's photograph from April 7, 2026 documenting current south-side conditions.

*Fig. A-1 — Aug. 2007. Google Maps Street-level view, north side of E University Street near 407 E University St. View of the alley from the street; the alley surface is unpaved loose aggregate throughout, with stone retaining walls flanking the alley. No compliant pedestrian access route exists at the crossing. This image establishes that the inaccessible condition of the north-side alley crossing has existed for approximately nineteen years as of the date of this complaint.*

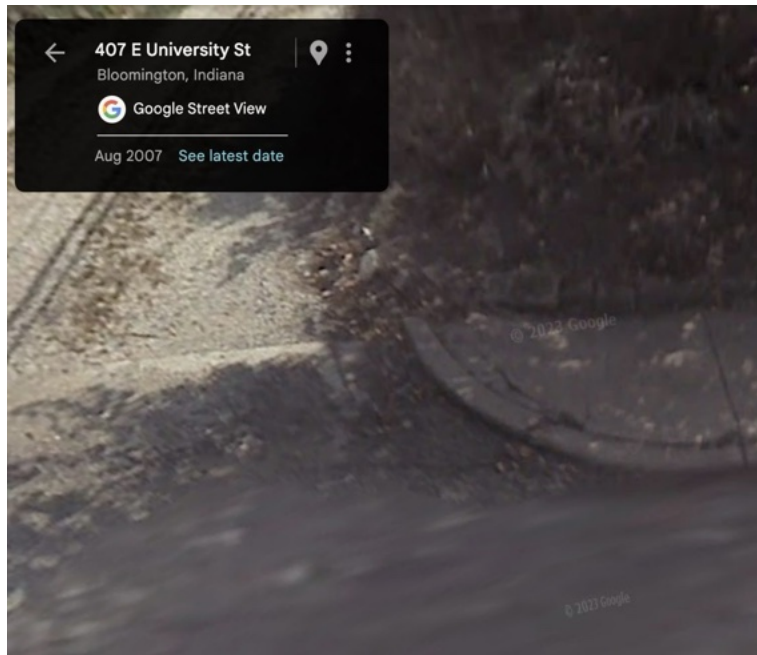
*Fig. A-2 — Aug. 2007. Google Maps Street-level view, ground-level detail at the south-side alley cut on E University Street, from the same 2007 imagery pass as Fig. A-1. The image documents the loose-aggregate condition at the south-side alley crossing as of August 2007. This image establishes that the inaccessible condition of the south-side alley crossing has also existed for approximately nineteen years.*

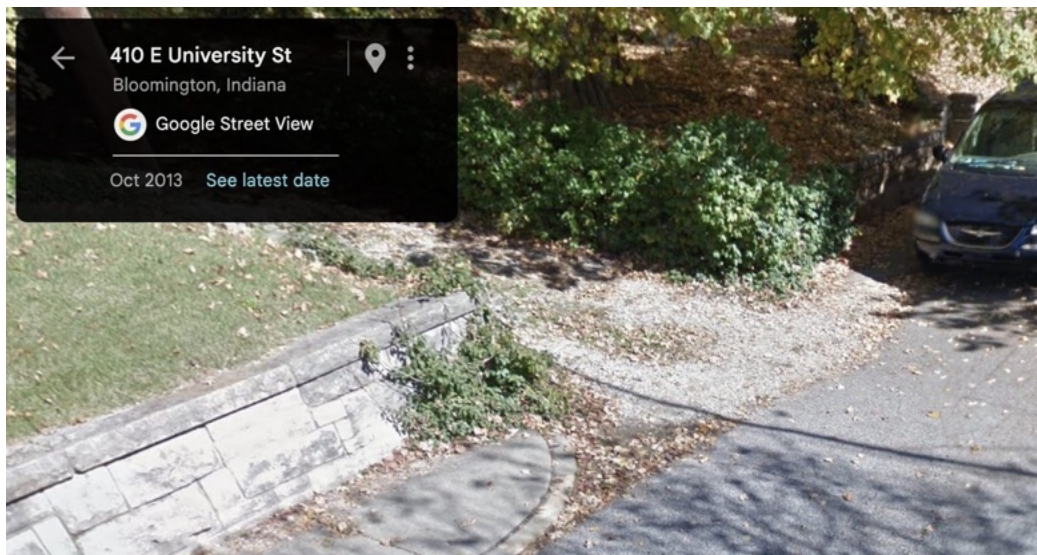
*Fig. A-3 — Oct. 2013. Google Maps Street-level view, north side of E University Street near 410 E University St, at the alley crossing. The sidewalk terminates at a loose-aggregate alley surface; no compliant ramp or transition exists. This image documents the same inaccessible north-side condition approximately six years after Fig. A-1.*

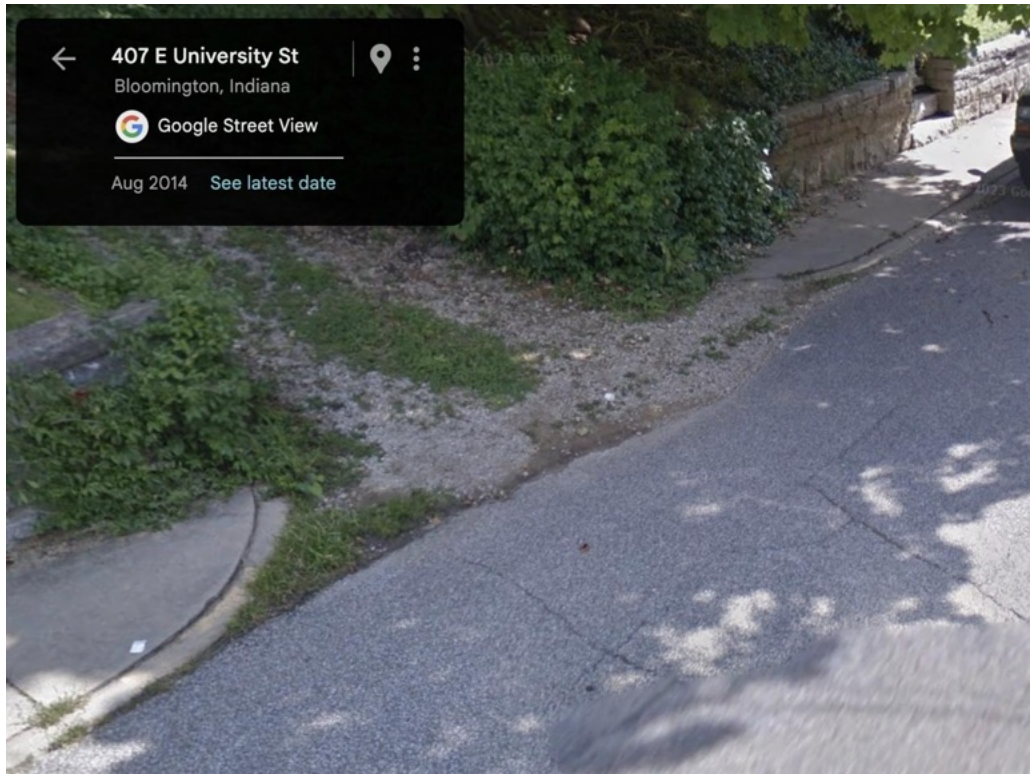
*Fig. A-4 — Aug. 2014. Google Maps Street-level view, north side of E University Street near 407 E University St, at the alley crossing. The sidewalk terminates at a loose-aggregate alley surface with no compliant ramp or transition; yellow-painted curb edge visible at lower left. This image documents the same inaccessible north-side condition approximately seven years after Fig. A-1 and approximately ten months after Fig. A-3.*

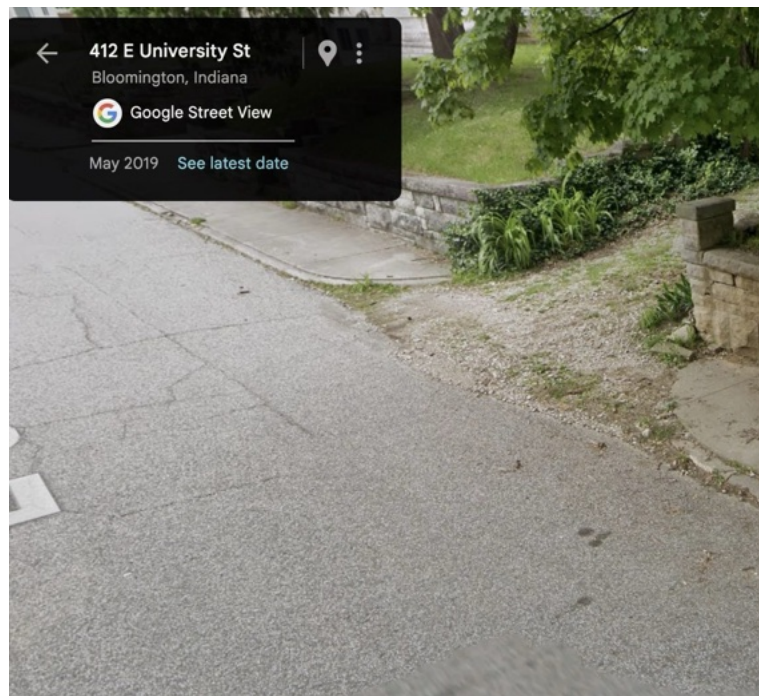
*Fig. A-5 — May 2019. Google Maps Street-level view, north side of E University Street near 412 E University St, at the alley crossing. The sidewalk terminates at a loose-aggregate alley surface; no compliant ramp or transition exists. This image documents the same inaccessible north-side condition nearly twelve years after Fig. A-1.*

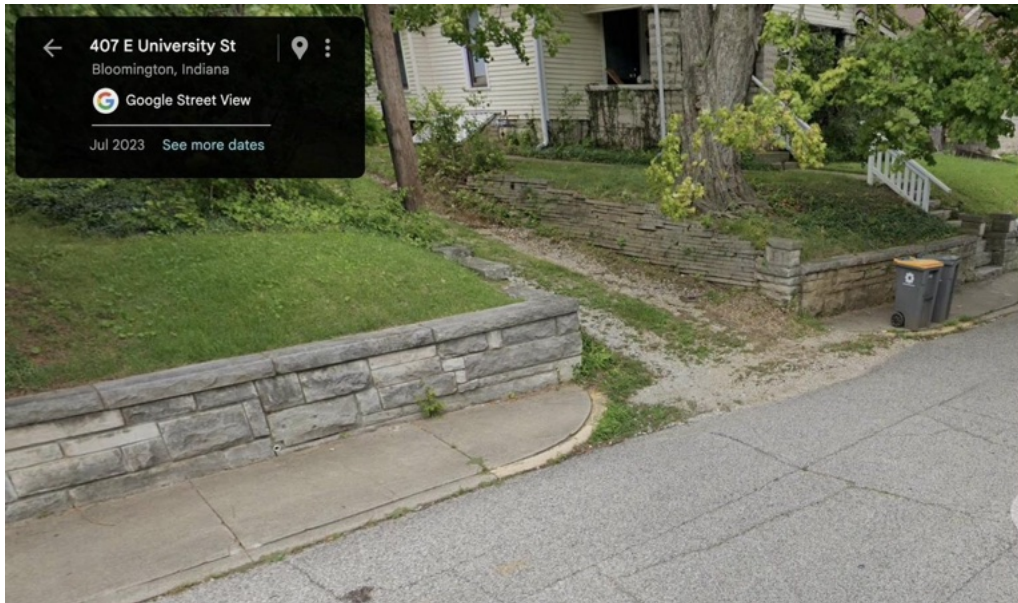
*Fig. A-6 — Jul. 2023. Google Maps Street-level view, north side of E University Street at the alley crossing between S Grant Street and S Henderson Street. Curved sidewalk ramp at center descending to a loose-aggregate alley surface; stone retaining walls flanking the alley; City-marked trash bins at right. The alley extends north into the residential block. This image documents the same inaccessible north-side condition nearly sixteen years after Fig. A-1.*

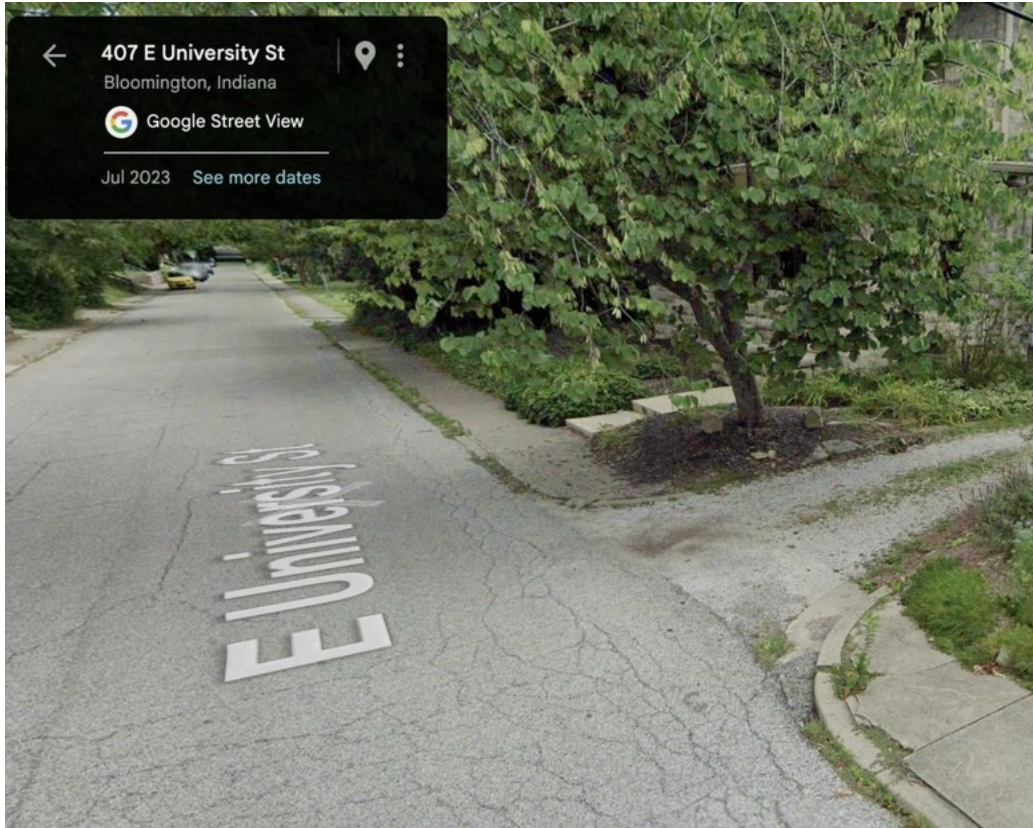
*Fig. A-7 — Jul. 2023. Google Maps Street-level view, south side of E University Street at the same alley crossing. Sidewalk terminating at the alley with no compliant ramp or transition; loose-aggregate alley surface visible at right. This image documents the same inaccessible south-side condition approximately sixteen years after Fig. A-2 and nearly three years before the complainant's April 2026 photograph at Fig. A-13.*

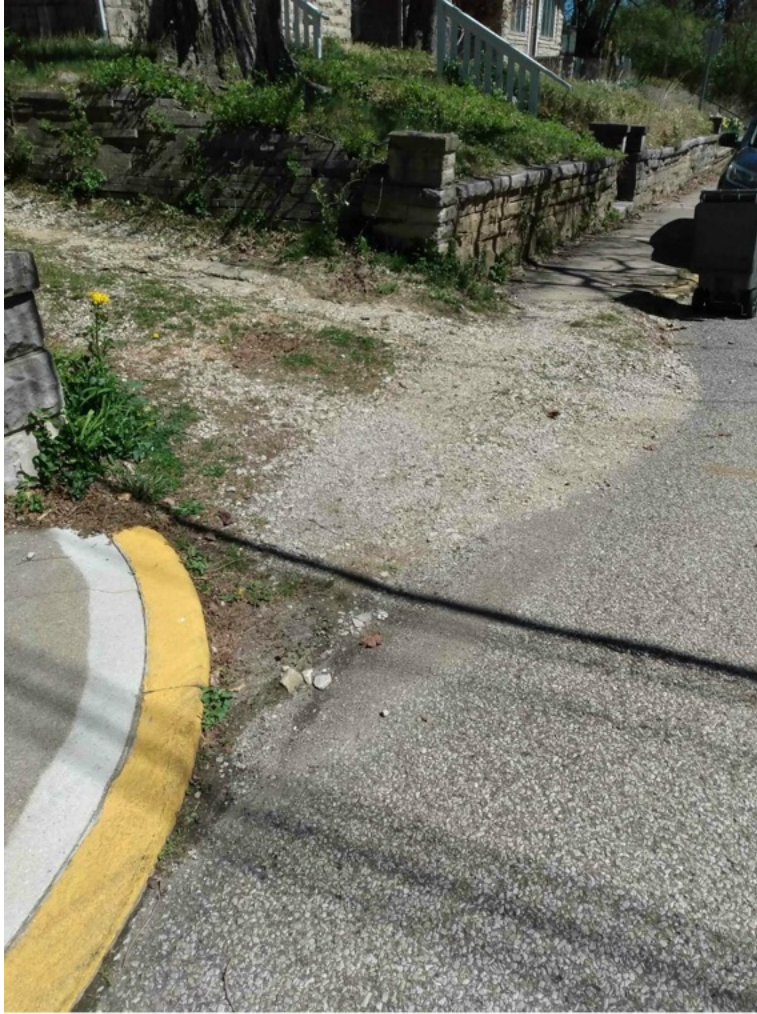
*Fig. A-8 — Apr. 6, 2026. Complainant's photograph. Ramp at the west edge of the north-side alley crossing. Loose gravel on and around the ramp surface; evidence of recent City sidewalk grinding visible at the ramp's leading edge; stone retaining wall at right; City-marked trash bin at upper left. Corresponds to Fig. 1 in body text.*

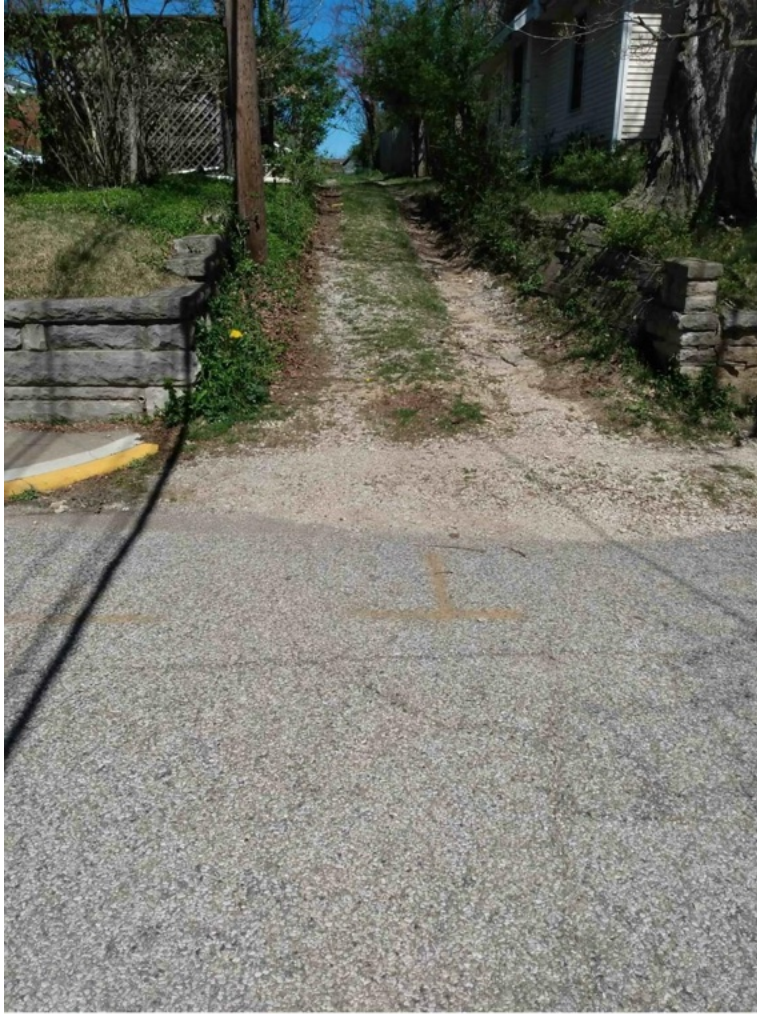
*Fig. A-9 — Apr. 6, 2026. Complainant's photograph. View looking north from the street edge into the alley. Unpaved loose-aggregate surface throughout; no firm, stable, or slip-resistant crossing surface. Stone retaining walls on both sides. Corresponds to Fig. 2 in body text.*

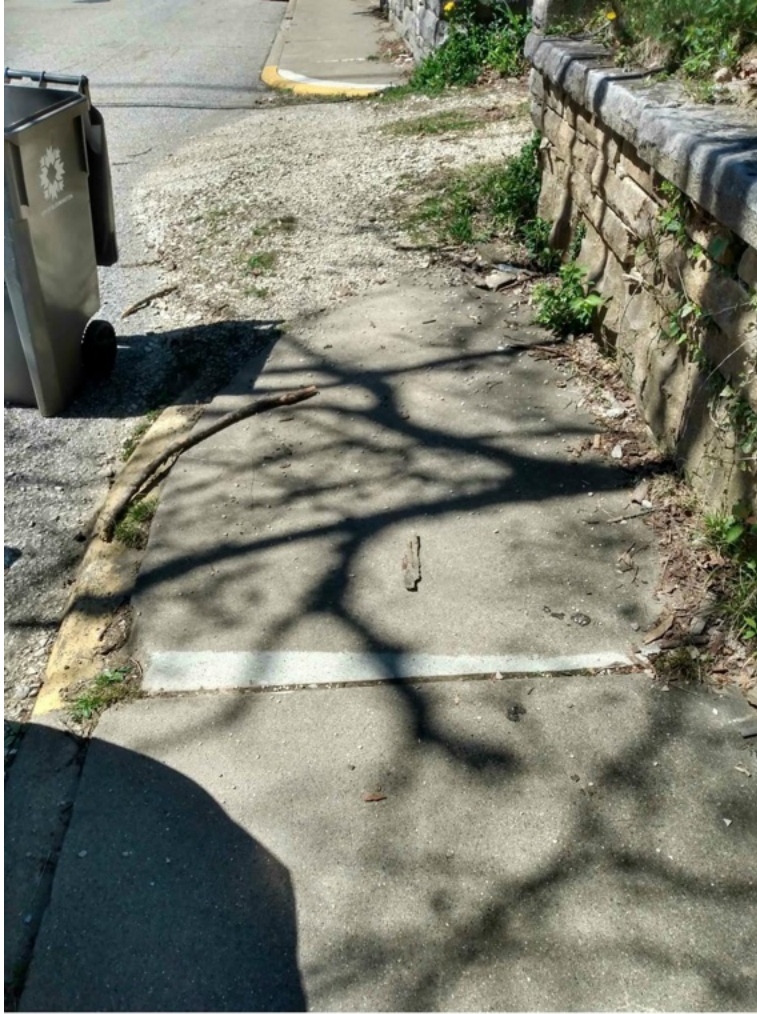
In 2025, the City of Bloomington performed sidewalk grinding work at this alley cut. Based on the complainant's direct observation, the grinding addressed the vertical lip of the cut on the west side of the crossing and in the vicinity of the lip on the east side. Evidence of grinding is visible at the leading edge of the ramp in Fig. 1 (west side) and at the corresponding transition on the east side in Fig. A-9.

*Fig. A-10 — Apr. 6, 2026. Complainant's photograph (HDR). Ground-level view at the alley cut, showing evidence of City sidewalk grinding in the vicinity of the lip on the east side of the alley. Loose gravel on the worked surface and on the surrounding alley surface; stone retaining wall at upper right.*

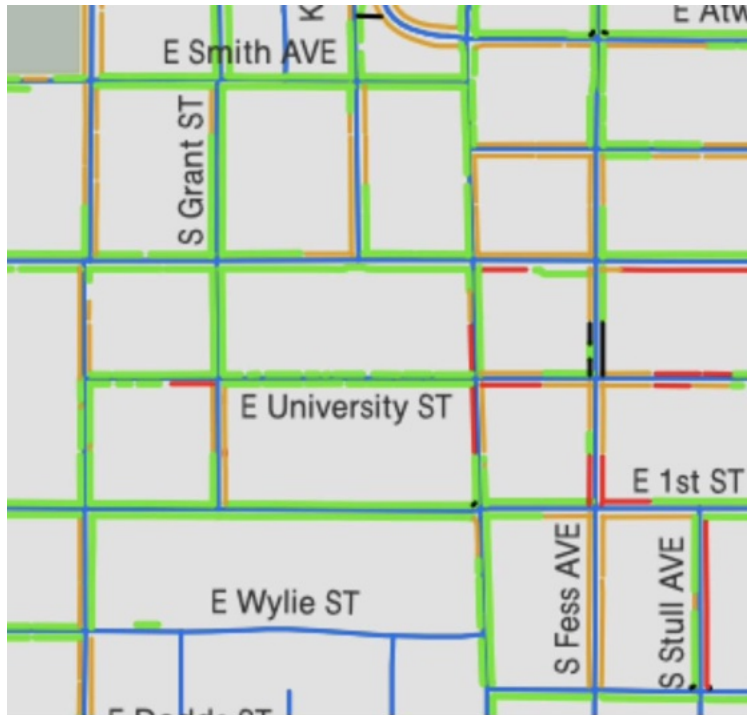
The City's online sidewalk condition map, maintained through the B Clear Open Data platform, rates this sidewalk segment as “Good” (Fig. A-11). That rating does not correspond to conditions on the ground. The City's data either does not capture alley crossing conditions within its rating methodology, or contains inaccurate data for this location. Either circumstance is relevant to the City's ADA self-evaluation and transition plan obligations: a self-evaluation that rates a segment containing an impassable alley crossing as “Good” does not provide an accurate accounting of pedestrian accessibility conditions.

As documented in Section 3.5 and Fig. A-11, the City's B Clear Open Data sidewalk condition map rates this segment as "Good." That rating is incorrect as applied to the pedestrian crossing conditions at this location. An inaccurate self-assessment does not establish compliance; it indicates a record-keeping gap that compounds the underlying accessibility failure and is itself relevant to the City's transition plan obligations.

Fig. A-11 — Apr. 2026. City of Bloomington B Clear Open Data — Sidewalk Condition Map. The segment of E University Street between S Grant Street and S Henderson Street, including this alley crossing, is shown in green (“Good”). This rating does not correspond to conditions on the ground as documented in Figs. A-1 through A-10 and A-13.

The City shall also correct its B Clear Open Data sidewalk condition rating for this segment to reflect actual conditions at the alley crossing.

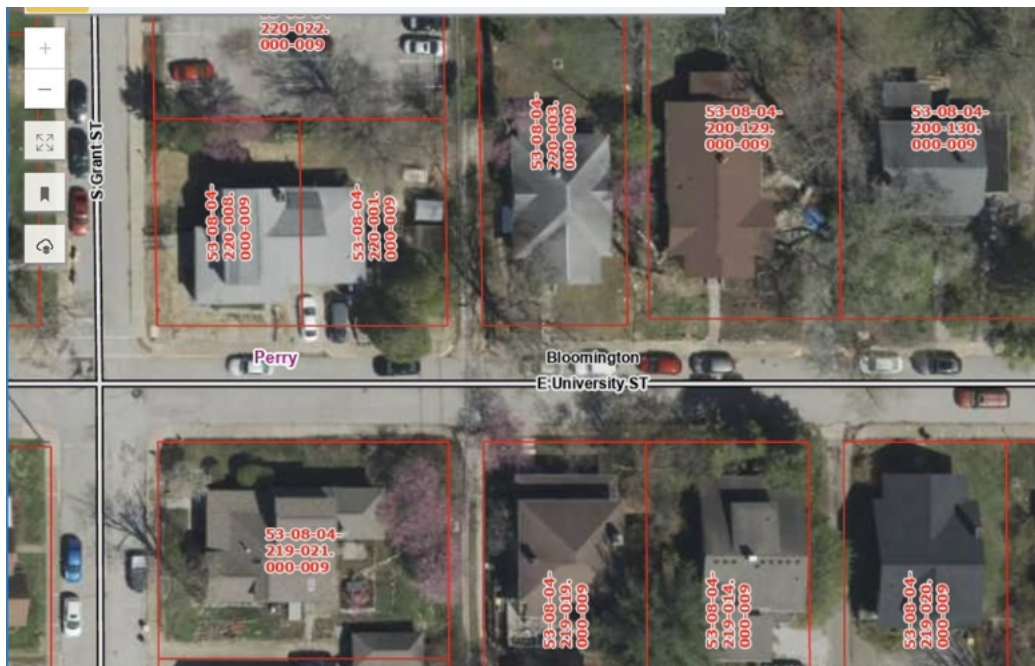
Fig. A-12 — Apr. 2026. Monroe County parcel map, City of Bloomington tax records. E University Street runs horizontally across center; S Grant Street at left. Going east from S Grant Street on the north side of E University Street: parcel 53-08-04-220-008.000-009 (the western house), then parcel 53-08-04-220-001.000-009, then an unenclosed gap, then parcel 53-08-04-220-003.000-009. The unenclosed gap between parcels 001 and 003 is the

*alley. Because the alley space is not incorporated into either abutting parcel, the alley is a separate public right-of-way held by the City.*

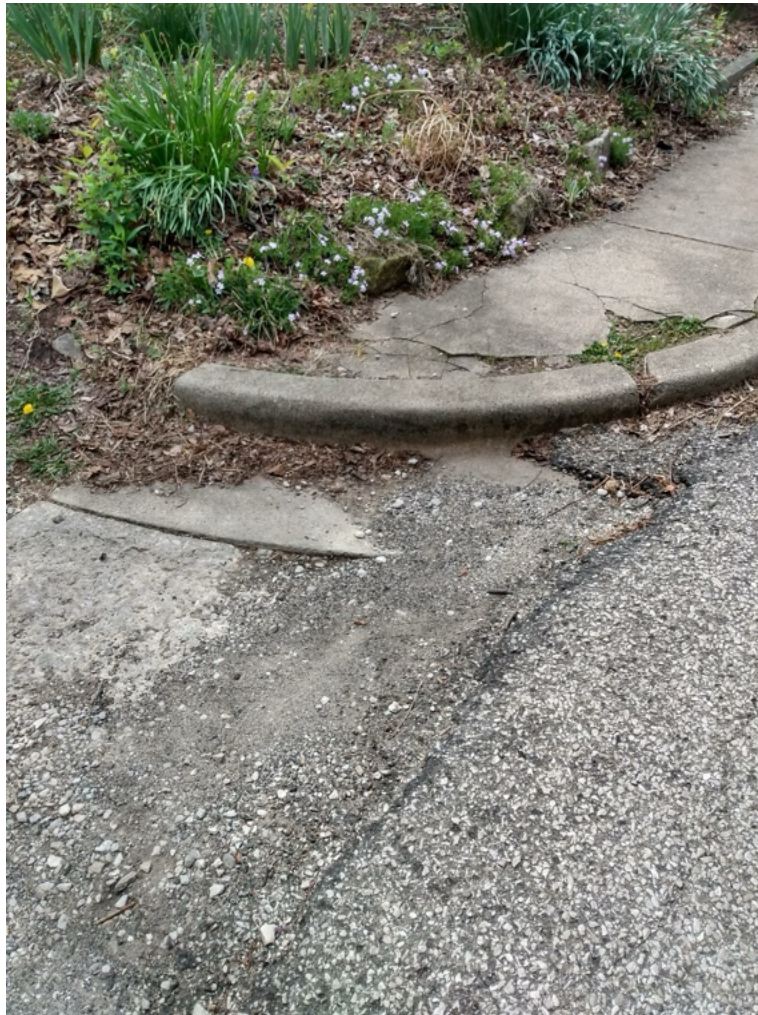
*Fig. A-13 — Apr. 7, 2026. Complainant's photograph. South side of E University Street at the alley crossing between S Grant Street and S Henderson Street. The sidewalk terminates at a vertical drop of several inches to a loose-aggregate alley surface; broken concrete fragment visible at the edge. No ramp, blended transition, or other compliant means of pedestrian traversal exists at this location. Corresponds to Fig. 3 in body text.*

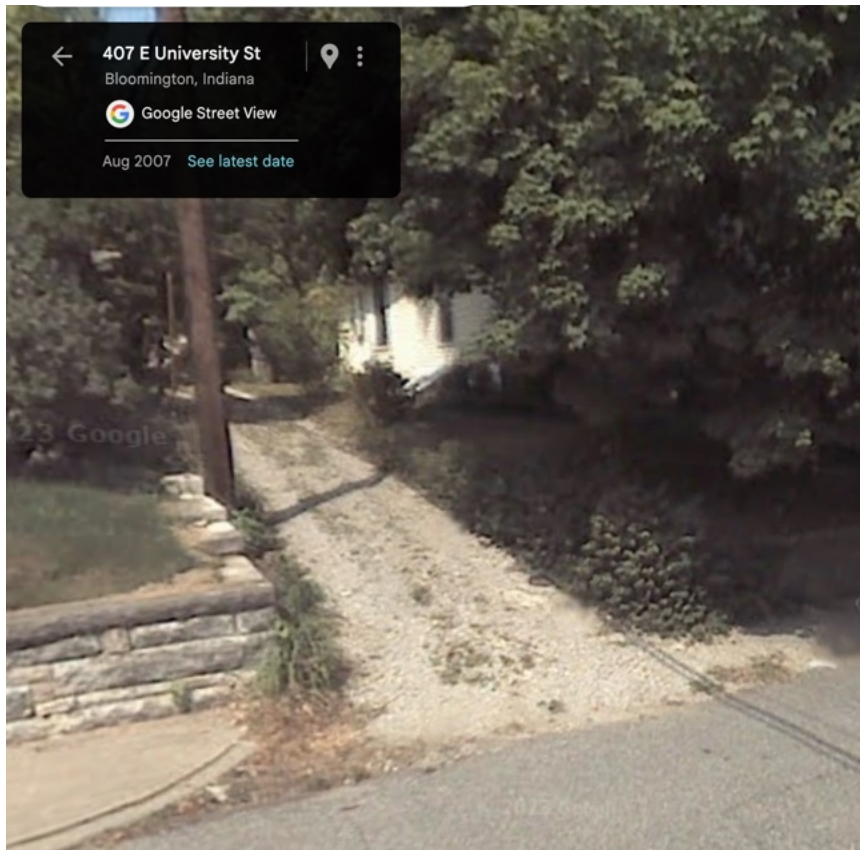
*Fig. A-14 — Aug. 2007. Google Maps Street-level view, north side of E University Street near 407 E University St, looking from the sidewalk into the alley. The unpaved loose-aggregate alley surface extends north into the residential block; stone retaining wall visible at left, telephone pole at the corner. This image is from the same August 2007 imagery pass as Fig. A-1 and provides a complementary view documenting that the loose-aggregate condition extends through the alley itself, not merely at the cut.*
