## Applications of Passive Infrared Thermal Imaging for Detecting Delaminated Areas of Ancient Rock-cut Tunnel

Quang Huy Tran\*, Quoc My Dang, Xuan Tung Pham and Thanh Chung Truong

Department of Civil Engineering, Nha Trang University 57000, Vietnam

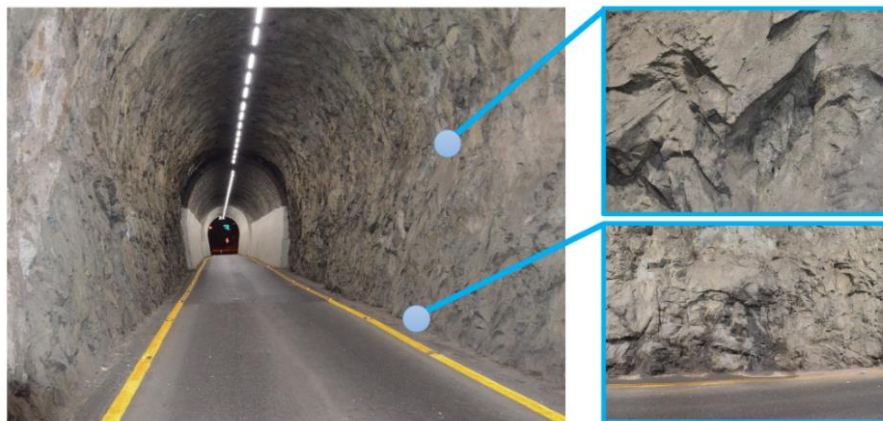
Figure 1. Unlined rock-cut tunnel.
