Date :06/12/2023 Time:6.00pm Pilot:Saathvik

Agenda of the flight: Test the new algorithm for the downward facing camera and the lidar (test1.py).

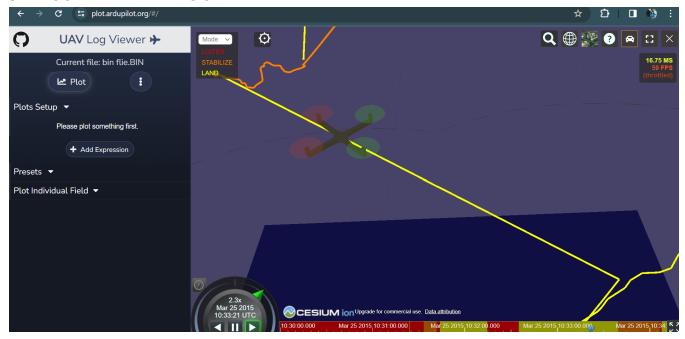
UAV LOG VIEWER ANALYSIS:

Attempted to arm the drone in loiter mode, but encountered arming issues. Eventually took off
in Stabilize mode and switched to loiter. The drone exhibited abnormal behavior in loiter mode,
prompting a switch to land mode.

- Test the code in Gazebo before testing on the drone
- Verify sensor calibration before each and every flight
- Complete one control flight in each mode before testing drone with algorithm
