EMSR703 - AOI02
 Storm in Mexico
 ACAPULCO INLAND

Situation as of 29/10/2023 17:21 UTC

Grading MONIT01 - Detail map 03

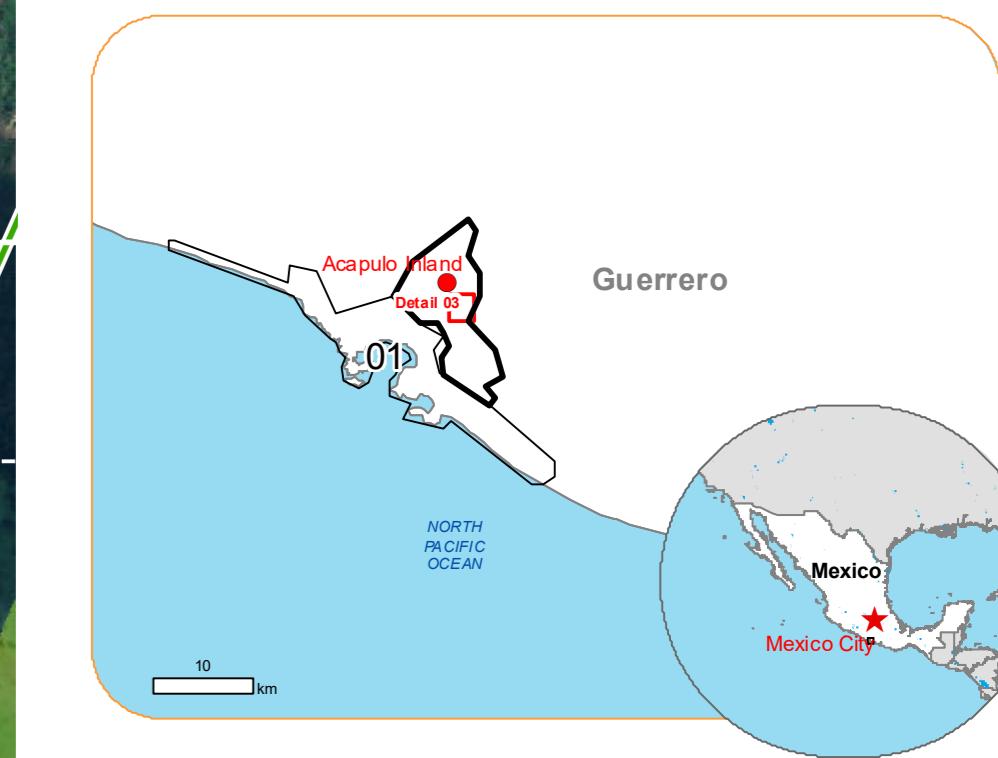
Flooded area 47.9 ha
 (~ 13.5% of total affected)
 Flood trace 174.3 ha
 (~ 20% of total affected)

Potentially affected population
 ~ 15500
 (~ 8% of total affected)

Built-Up
 170.5 ha
 (~ 6% of total affected)

Road
 16 km
 (~ 31% of total affected)
