# Cleaning & Disinfection Certificate

| Job Ref: | GEMW |
|---|---|
| Site Name: | Holiday Inn |

| Clean / Disinfect | Clean & Disinfection |
|---|--|
| Water System | C&D of 1 x 27m3 CWST (split 15m3/12m3) |

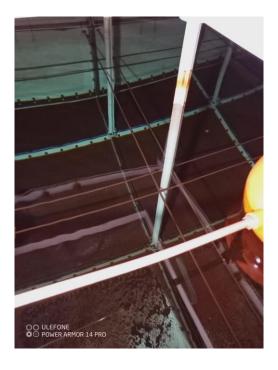
# **Before**

# Tank: 27m3 CWST (Split - Side A: 15m3)

| Tank Lid Condition | Good | Corrosion Presence | None |
| Tank Vent | Yes | Scale Presence | None |
| Over Flow | Yes | Biofilm Presence | None |

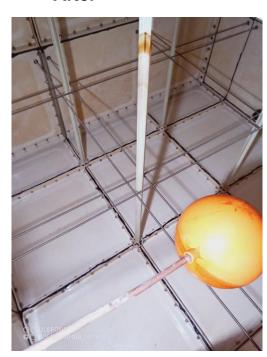
# **After**

This tank has been cleaned and disinfected in accordance with the HPSC standard, National Guidelines for the control of Legionellosis, L8 Standards and Irish Safety, Health at Work regulations.

This system should be cleaned and disinfected annually as per recommended guidelines.

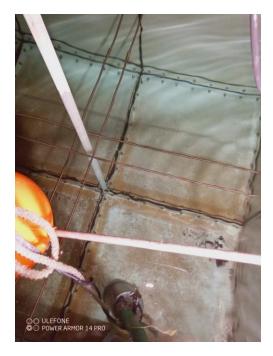
#### **Before**

# Tank: 27m3 CWST (Split - Side B: 12m3)

| Tank Lid Condition | Good | Corrosion Presence | None |
| Tank Vent | Yes | Scale Presence | None |
| Over Flow | Yes | Biofilm Presence | None |
