# Legionella Risk Assessment

28-32 O'Connell Street Upper,

ESI Reference No: J29167

Date: 09/10/2023

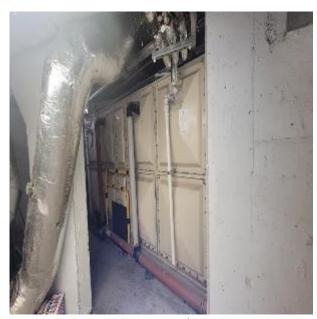
Installation Standards	Yes	No	Comment / Recommendation
Compliant with outlined standards	✓

Image 01: External View

**Recommendations:** Monitored the incoming and stored water temperature on a 6 monthly basis.

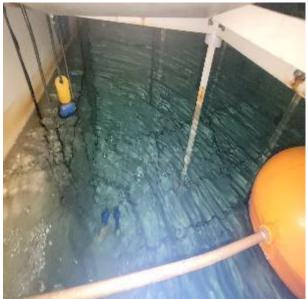
Image 02: CWST Internal View

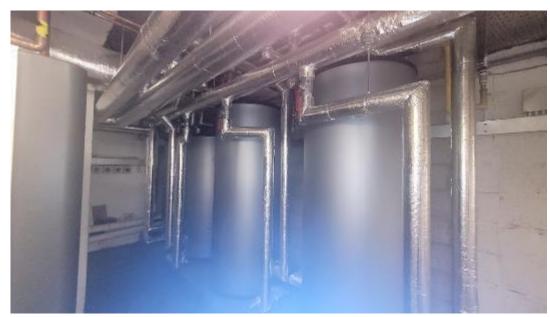
Installation Details				
Capacity	650 LTR EACH			
Operation				
Return Pump Working	ng Yes			
Stored Water	Flow Temperature Return Temperature			
65°C	65°C	55°C

Image 03: Calorifier

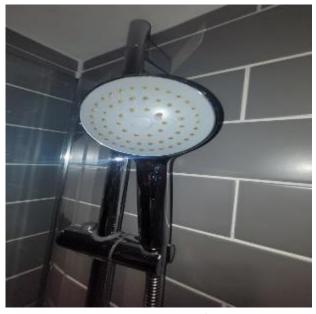
Operation			
Usage	Frequently		
Condition of Shower Heads	Good

Image 05: Condition of Shower Head

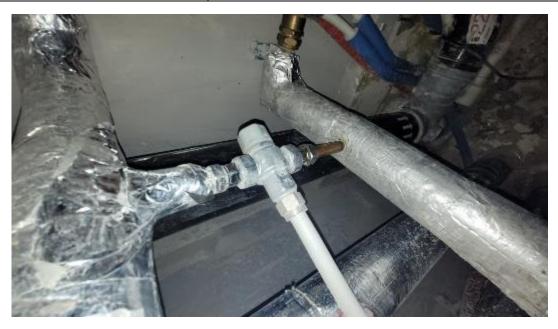
Installation	
Approximate Number	200-250
Accessible for Servicing	No
Isolation Valves Present	Yes
Installed at Each Outlet	Yes
Furthest Outlet < 2m	Yes

Image 08: Thermostatic Mixing Valve

Item	System	System Recommendation	
9	TMV's	The TMVs should be maintained and serviced on an annual basis in accordance with manufacturers' operating instructions and guidelines to ensure they are working safely and correctly (ACOP, L8 Page 42 Par. 170).	3

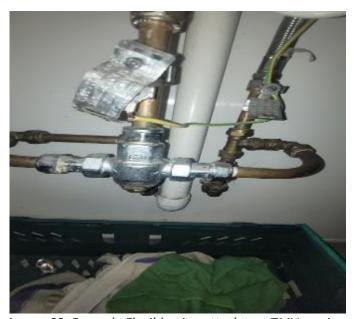
Image 09: Example Flexible pipe attach to a TMV on site.

1. Flexible hoses should be removed as part of any maintenance or upgrade plumbing work to the buildings' water systems; and not used where sinks are replaced, renewed or upgraded.

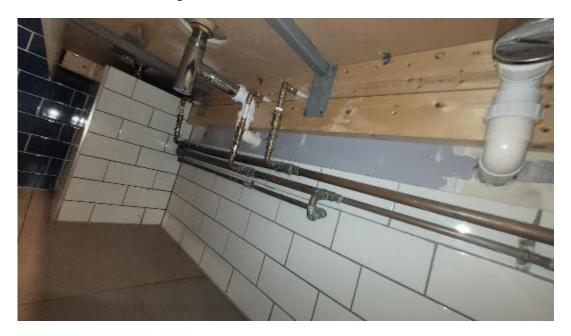
Un-insulated pipework can result in heat loss from the hot water distribution pipework, heat gain within the cold water distribution pipework and heat transfer between pipework. Insulation was not present in a number of areas within the building.

Image 10: Uninsulated pipework on site

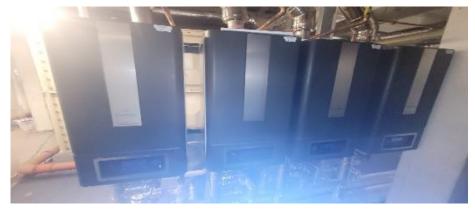
**Image 12:** Heating System

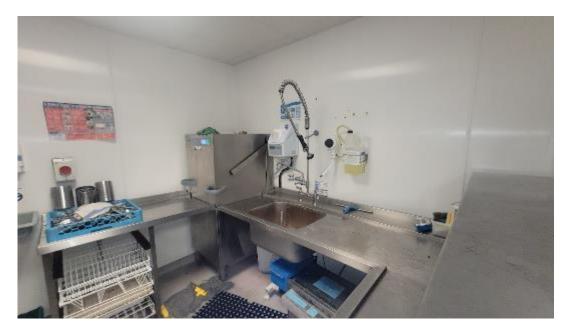
Image 13: Dishwasher

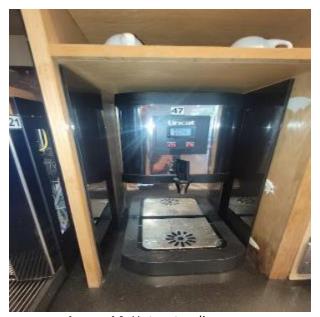
Image 14: Hot water dispenser

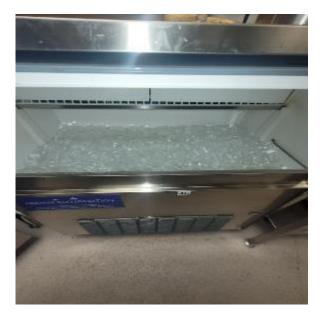
An ice machine is installed on site in the bar areas. These systems are considered to be low risk as they are mains fed and produce no aerosol. The unit is supplied by mains water and in constant use. Ice machines have been associated with the transmission of waterborne bacteria such as *Listeria* and even *Legionella* in an exceptional circumstance so the machine should be kept clean and maintained in accordance with manufacturer's guidelines. It should be noted that where a unit is not frequently used this creates a dead leg in the mains water supply and remedial action should be undertaken.

Image 16: Ice Machine
