Quinn Downes Service & Maintenance Unit H17, Centrepoint Business Park Oak Road, Dublin D12

Job No:	14261	Date:	24/01/2024		
Customer:	Holiday Inn Express Dublin City Centre	Equipment Reference:			
Site / Building:	Holiday Inn Express Dublin City Centre	Equipment Serving:			
Address	Findlater House Ltd	Asset No:			
	28-32 O'Connell Street	Quote Required:	No		
		Repairs Report No:	0		
	D01 T2X2

Job Description

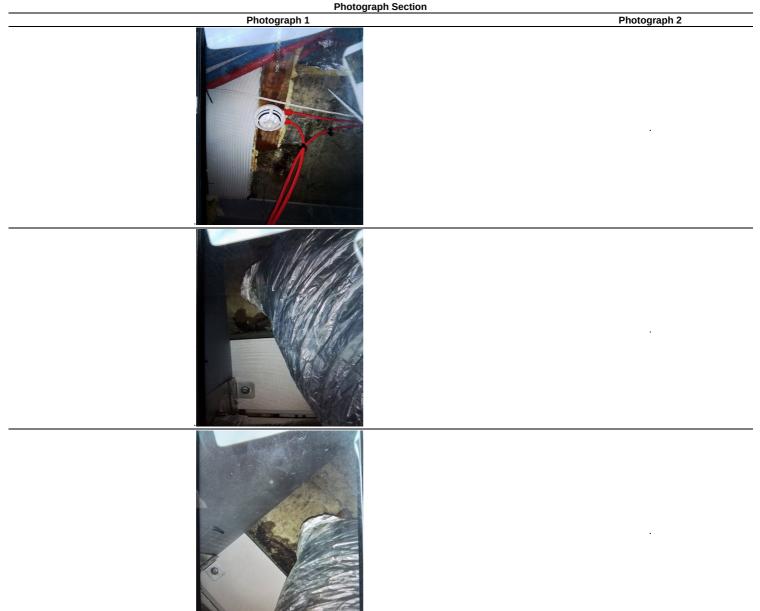
On arrival asses leak in ground floor main toilet area hallway and inside door at gents toilots.

There was water coming down from ceiling.

On further investigation this water appeared to be coming down concrete wall rather than pipework.

With the hotel maintenance staff we poured buckets of water on an area up on the roof off hotel, and this water then came down concrete wall in ceiling into toilet area.

We checked all risers and pipework above this area and could not see any leak.

As this leak only appears during heavy winds and rain.

The hotel is going to get roof company out to investigate possible weatherproof issue up there.
