Property Damage Report

7510 Fairhaven Road, Homer NY 13077
September 10, 2025

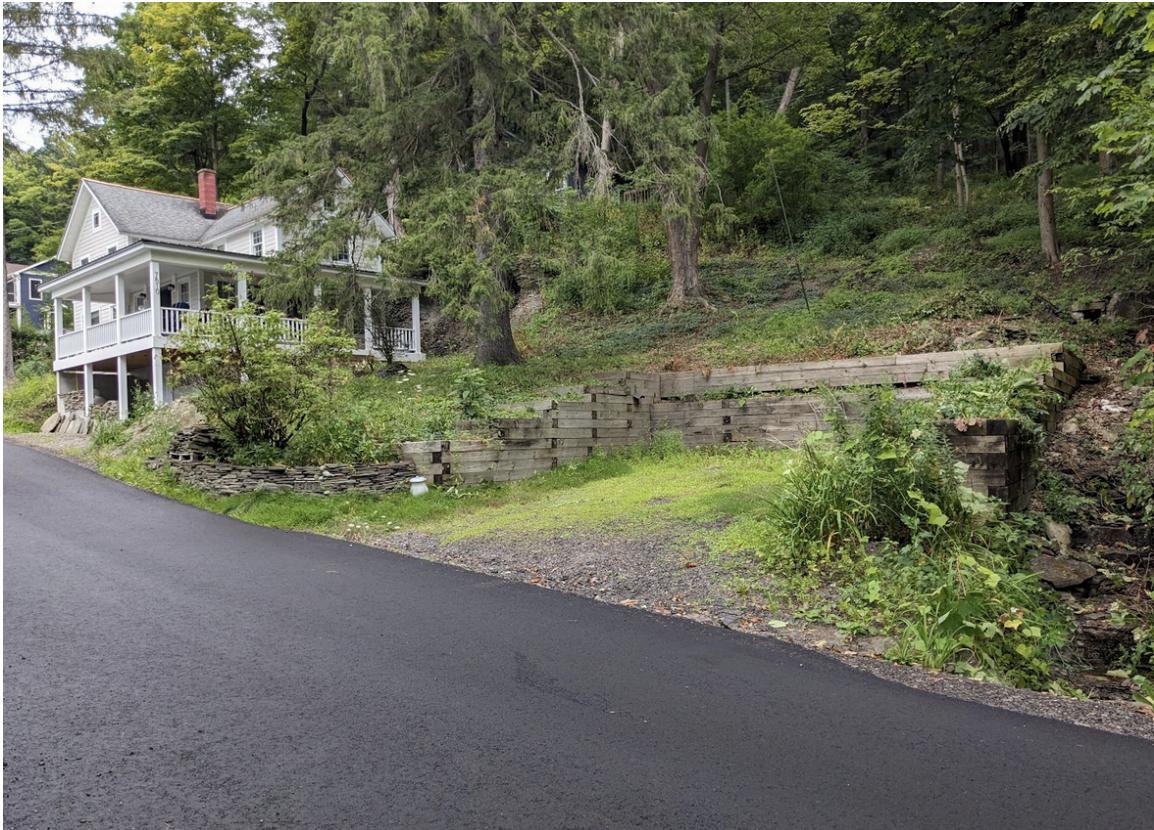
Property at 7510 Fairhaven Road, Homer, NY. Fairhaven Road (County Road 101) is maintained by the Cortland County Department of Highways, who freshly paved the county road with asphalt in June 2025 (photograph above)

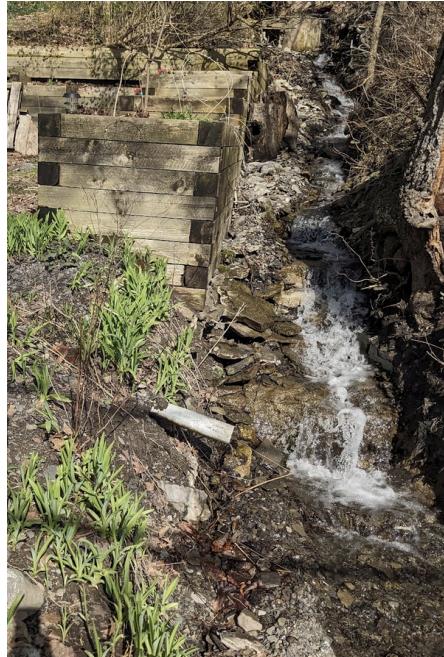
The carport had a drainage system into the creek (white pipe)
to minimize seepage to the base of the carport

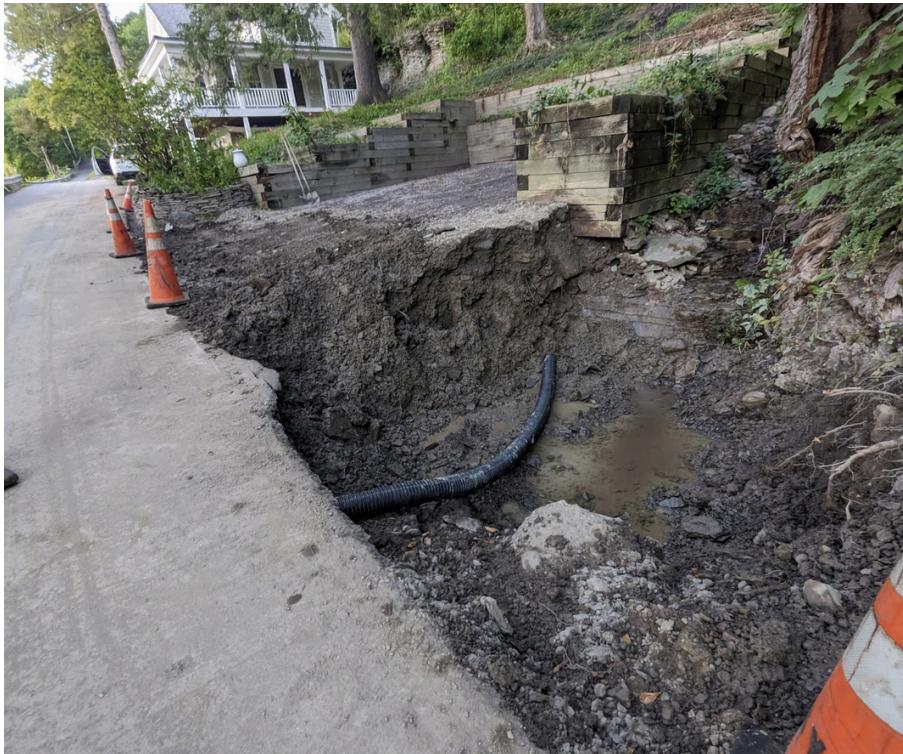
2. The second attempt was with blocks. This involved extensive removal of the carport bank, creek bank, and culvert area, and created an unsafe entry/exit path with a 3+ foot vertical dropoff at the edge of the carport entrance. The blocks did not fix the issue of the length nor the exit point of the carport culvert, which would continue to discharge under the side of the road and undermine the county road. Given the incorrect angle, length, size, and discharge point of the contractor culvert, this was removed.

The second attempt at providing carport drainage resulted in unsafe vertical drop-off at carport entrance, and exposure of the county highway to direct impact of creek runoff.

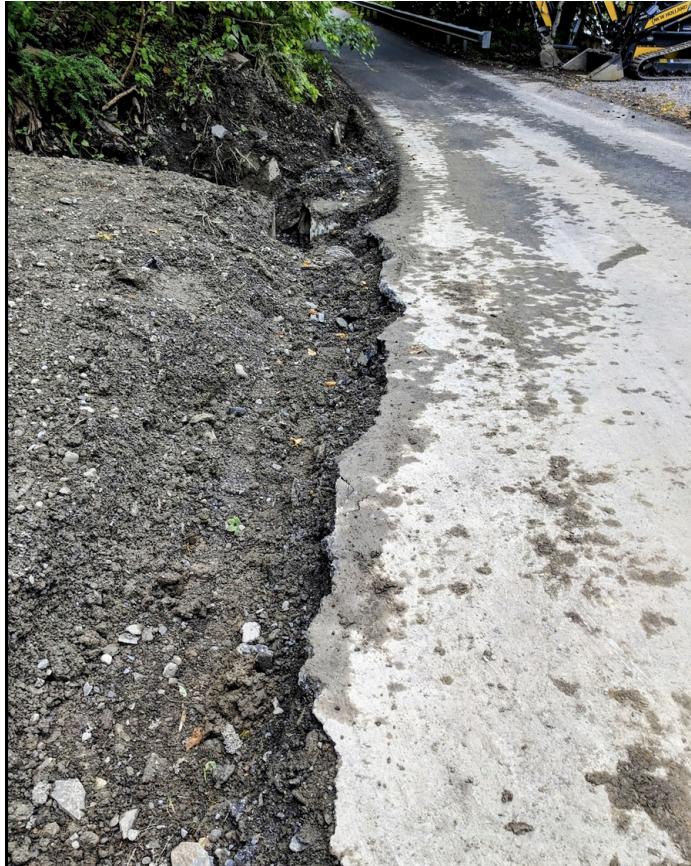
The length (35 ft) of the new county asphalt road into the carport was damaged, broken off, and removed. After one rainfall the carport entrance eroded 6 inches (photograph above). *Any further rainfall and road runoff will continue to erode and undermine the carport and county highway.*

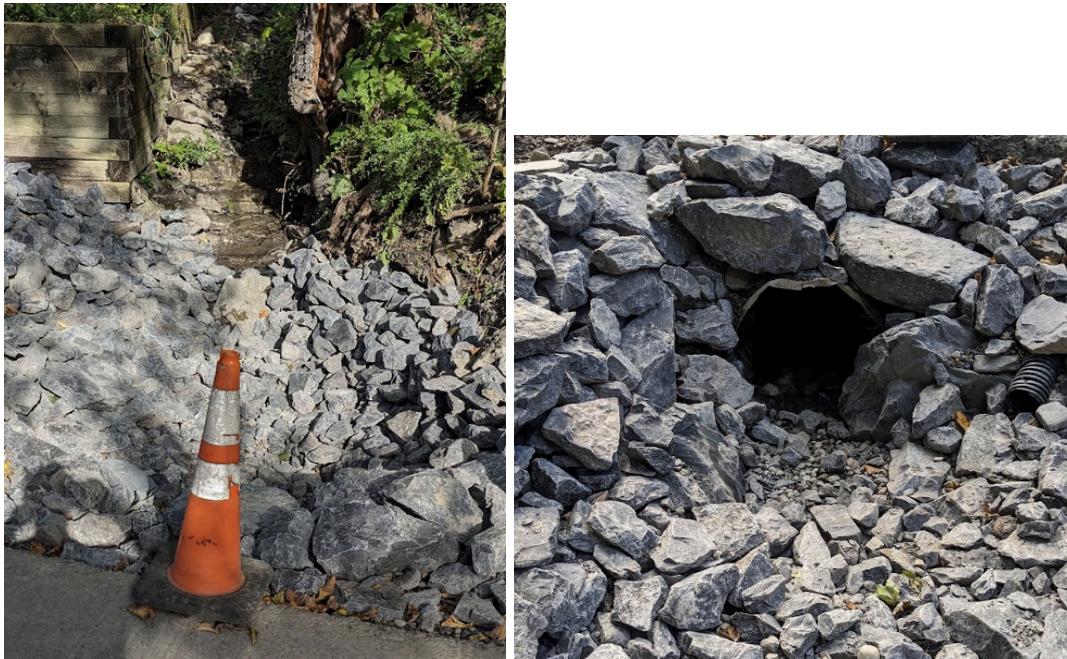
3. The third attempt to remedy the unsafe and incorrect carport and creek drainage into the county culvert was with riprap to support the banks.

The third attempt at culvert and carport drainage.
There was only a single layer of small riprap along creek pathway

The Cortland County Superintendent of Highways and his deputy inspected the contractor's third (and final) version at the carport / culvert drainage on 9/9/2025.

- *The Superintendent stated that the creek bank and culvert would wash out with the first major rainfall.*
- *The Superintendent stated this carport entry, creek bank, culvert area, and asphalt road area and would have to be remediated as soon as possible*
- *This remediation must be with approved permit from the Superintendent of Cortland County Highways prior to any work commencing.*
- *It was discovered at this time that the contractor's work was unauthorized, unpermitted work on county managed highway property.*

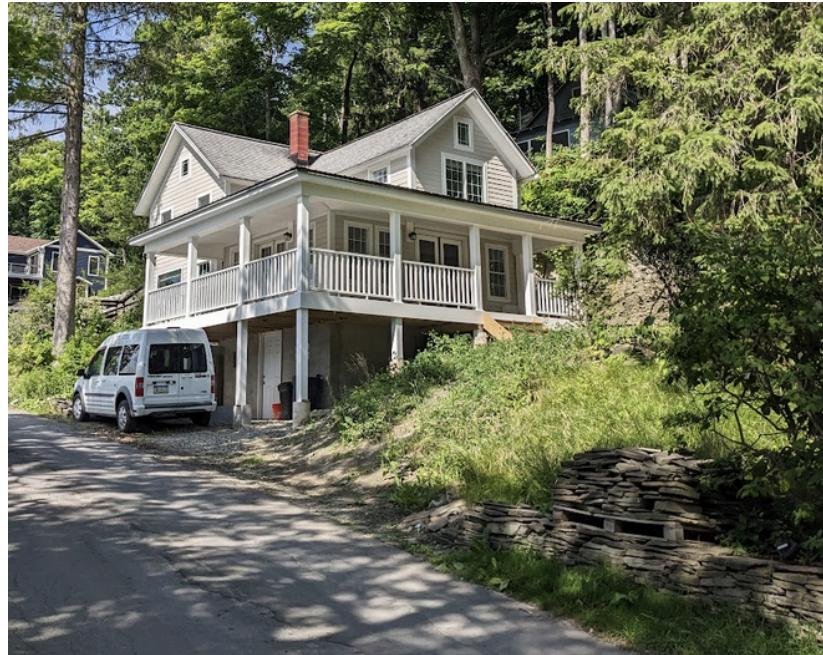
Front bank prior to contractor work

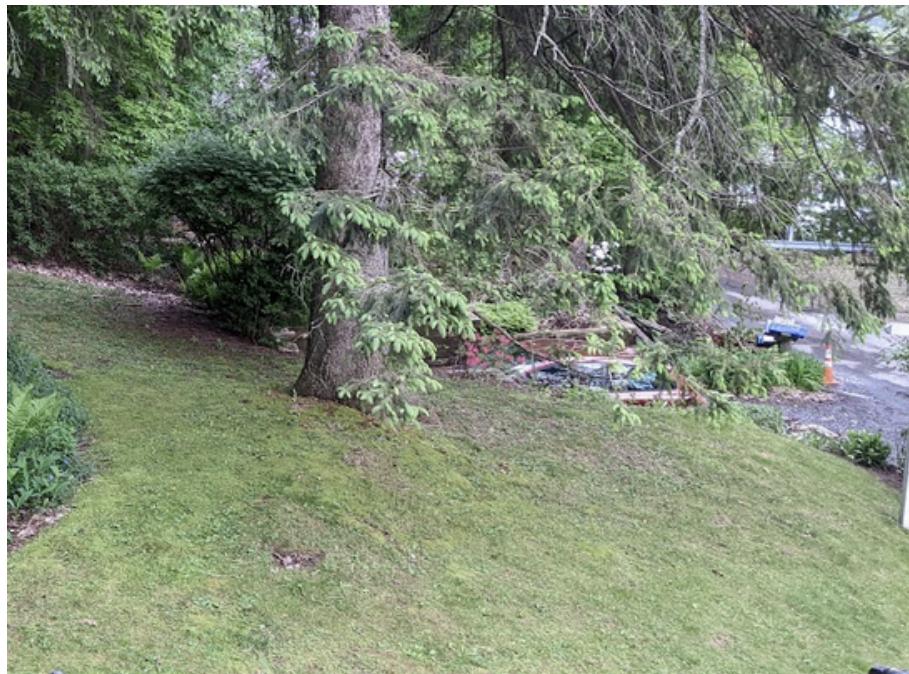
Front yard and tree prior to contracting work

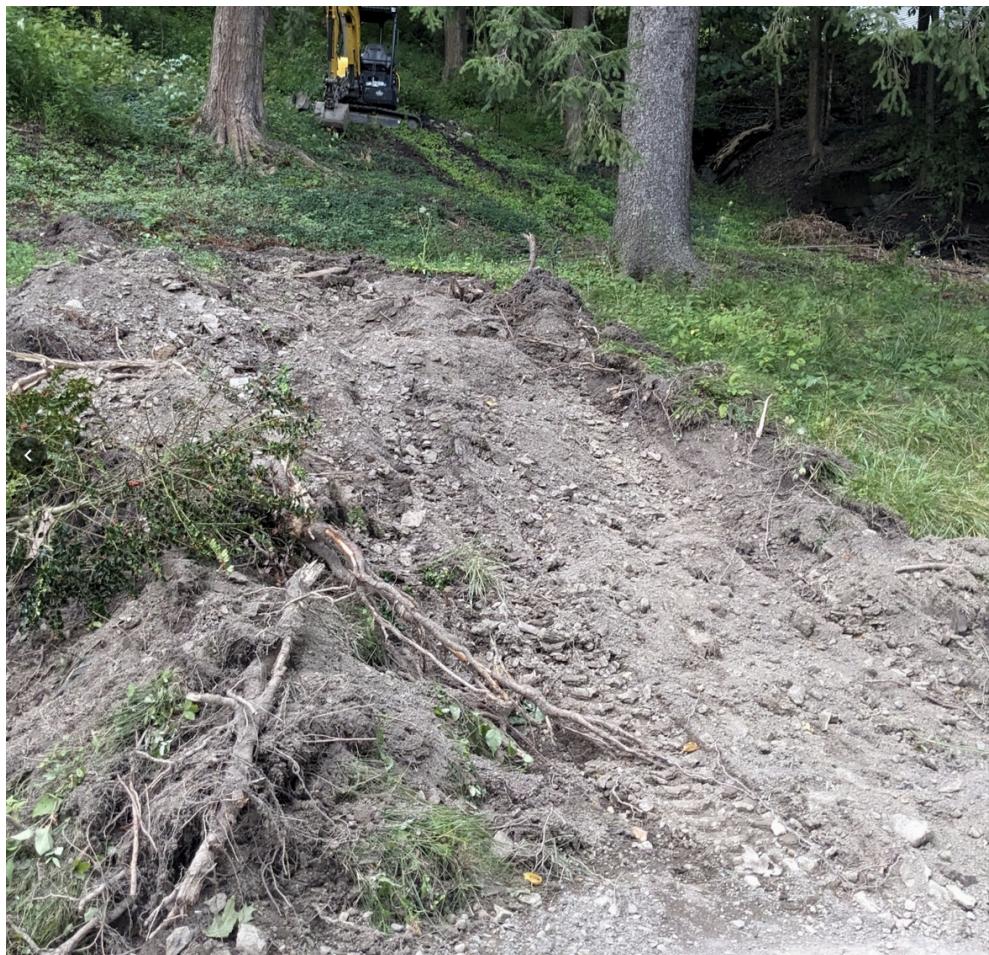
1. Excavation and damage of tree roots of 24-in diameter tree
 - a. A professional arborist inspected the tree root damage and estimated this was 25% of the critical root zone. Given its height (80ft) and exposure to high winds (on the lakefront), and proximity of damage to base of tree (3 ft) it would put the tree at high risk for atrophy and loss.
2. Excavation and removal of yard area 10 ft wide x 25ft long x 1-2 ft deep
 - a. This created a large concave divot in the yard, further damaging the tree roots of the pine tree, which are all in top 2-3 feet of the soil.

Front yard bank with 10ft x 25ft wide excavation damage.
Large tree roots from the base of the large tree were torn up.

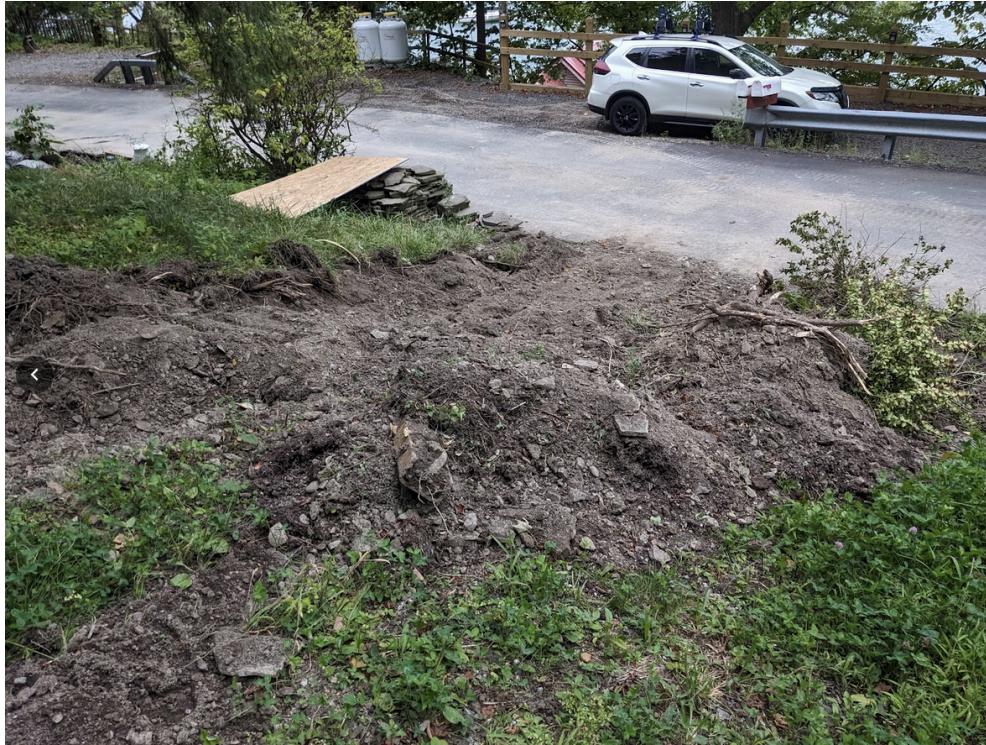
Front yard showing 2 ft deep gouge that exposed and removed tree roots
in the critical root zone of the large tree.

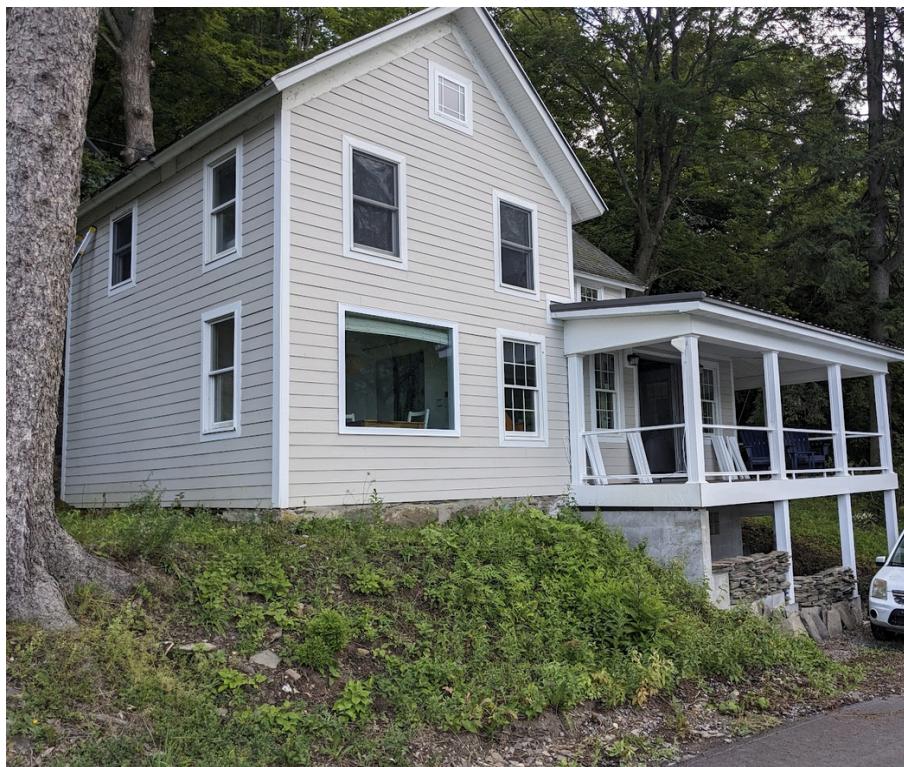
Original road bank was sloped to the road (July 2025)

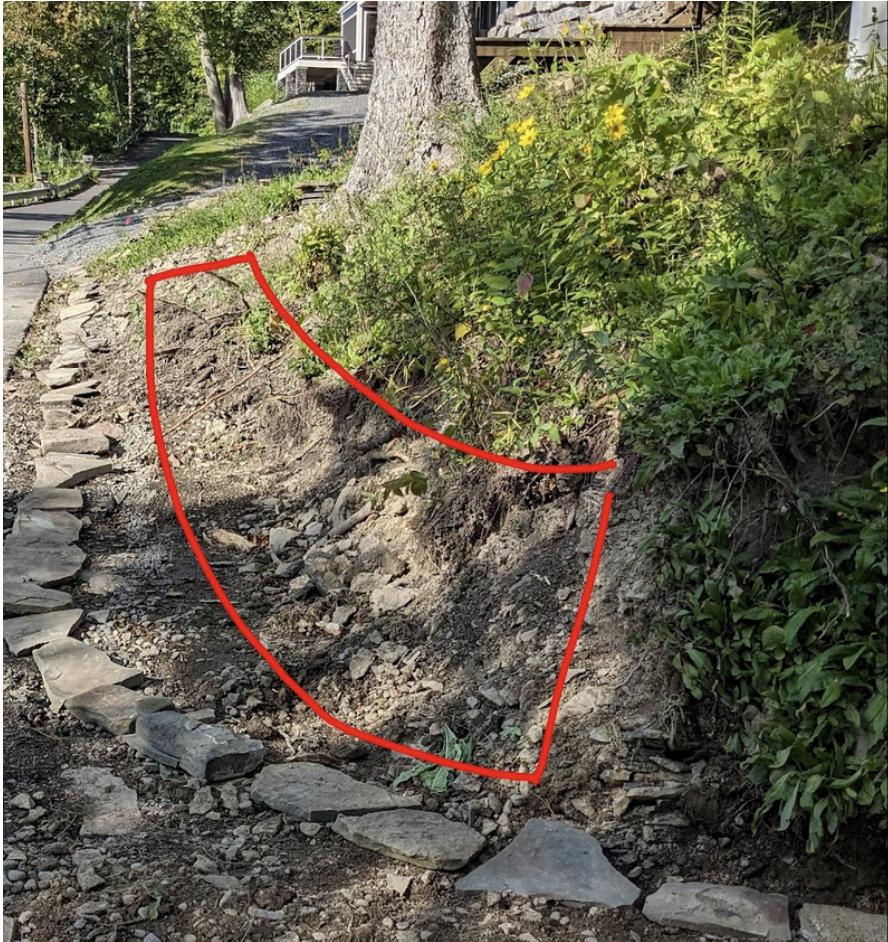
North road bank removal

1. 25ft long x 3 ft high x 3ft wide road bank was removed
2. Tree roots of the upper end of the bank removal were damaged.
