FIRST FULL-SCALE TRIALS OF PEBBLE MATRIX FILTRATION

KATARAGAMA WATER TREATMENT PLANT IN SRI LANKA

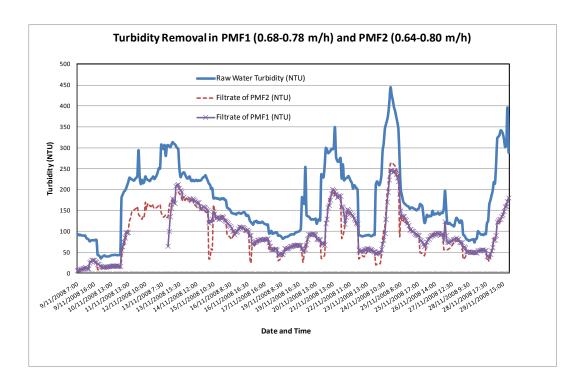
During 9th to 29th of November 2008, the river water turbidity varied from 35-444 NTU with an average value of 173 NTU. The treated water quality of PMF1 varied between 6-246 NTU with an average value of 95 NTU, while filtrate of PMF2 fluctuated between 4-262 NTU with an average value of 95 NTU, similar to PMF1 in the same period. Filtration rates were between 0.68-0.78 m/h for PMF1 and 0.64-0.80 m/h for PMF2. Headloss in the PMF1 was below 10 cm throughout November operating period, while the plant operator has recorded zero headloss in the PMF2 throughout this period. A graph showing the turbidity removal in both PMF1 (d_{10} =0.52 mm) and PMF2 (d_{10} =0.38 mm) during November 2008 is shown in Fig. 10. It is interesting to note that although both filters operated under similar conditions except for the sand size, both filters produced almost identical filtrate graphs,

Undoubtedly, one of the main reasons for poor removal efficiency was the poor cleaning of the filter beds due to use of high turbidity water from the sedimentation tank for backwashing. For example during November 2008 operations when sedimentation tank water had a turbidity of 160 NTU, the initial effluent turbidity of backwashed water in the PMF1 and PMF2 were 934 NTU and 769 NTU respectively, and after 15 minutes of backwashing, the effluent water turbidity was settled around at 300 NTU in each filter, clearly indicating the poor cleaning of the filter media.

Figure 10: Turbidity Removal in PMF1 (RC) and PMF2 (FC) Tanks from 9 to 29 Nov $2008\,$

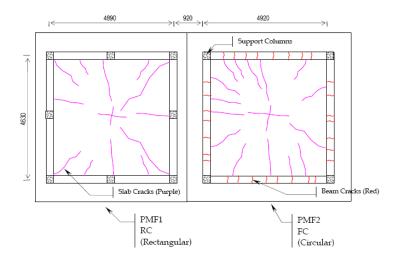
The severe structural damage to the filter slab due to under design may also have led to cracks in the filter bottom creating preferential flow paths of untreated water through the filter bed leading to higher filtrate turbidity. The zero headloss in PMF1 and constantly below 10 cm headloss in PMF2 also indicate such a possibility. During the first two days (9-11 Nov 2008) of operation of PMF1, there has been some 64% - 95% turbidity removal efficiency in the filter; however, the headloss constantly showed a zero reading. One would expect to have some initial headloss in the filter bed and to increase it with time as particles are removed from suspension and accumulated within the filter bed. Although digging the filter bed in two locations did not reveal such damage, to come to a definitive conclusion the whole bed need to be removed and inspected properly in both filters.

Figure 12: Cracks Observed at the Bottom Outer Surface of the Slabs

There were some delays in starting the project due to changes in senior management at the NWSDB. Delay in completion of construction was mainly due to security problems in the area, bad weather and late delivery of materials due to delays in funds transfer. Both tanks were completed by April 2008 and put into operation, however, after several weeks of operation some leaks appeared in both tanks and the operation of the Ferro-cement tank (PMF2) was seized on the 23rd June 2008 due to severity of the leaks until 27 September 2008 when the PMF2 was put back into operation after fixing the leaks. However the operation of Reinforced Concrete tank continued as there was no such serious threat observed by the site staff, although, after an inspection by a senior structural engineer cracks in the bottom of both slabs were observed (Fig. 12) and recommendations were made to provide additional beam and central supports as shown in Fig. 13. These remedial measures to PMF1 were carried out during 27 September and 09 of November 2008 by jacking the centrally supported column under the slab prior to concreting as shown in Fig. 14.

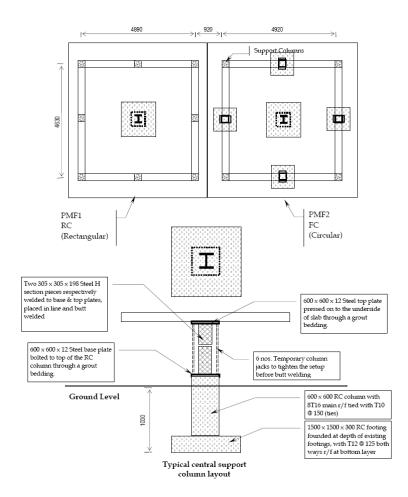
Figure 13: Remedial Measures Carried Out to both PMF Tanks

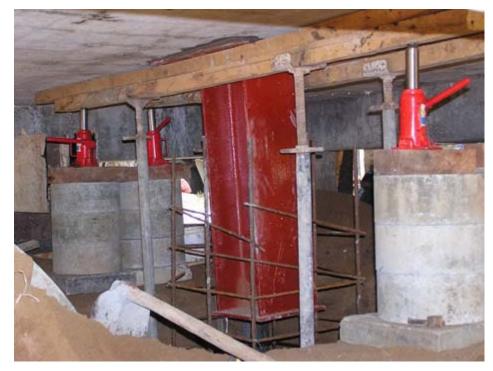
Figure 14: Centre Column H Iron Support Jacked Under the Slab Prior to Concreting.
