# Dell PowerEdge R510

## Legacy Server Hardware Inspection & Component Documentation

Physical inspection, component documentation, POST/BIOS findings, and visual fault assessment

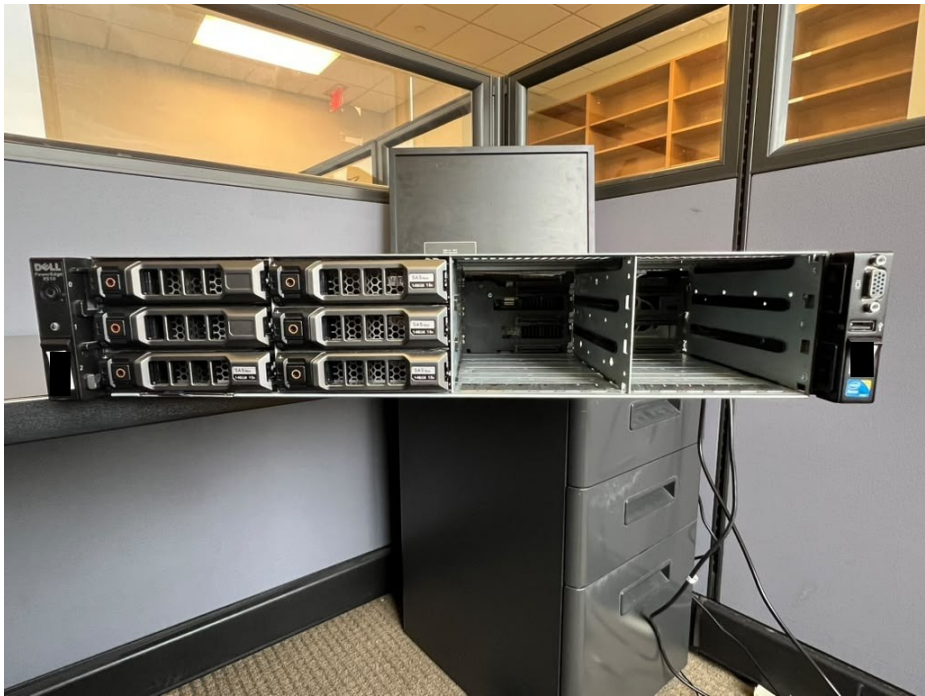
Figure 1. Dell PowerEdge R510 at the start of the inspection.
