# Dell PowerEdge R510

## Hands-On Hardware Inspection

Visual evidence, component identification, startup findings, and next diagnostic steps

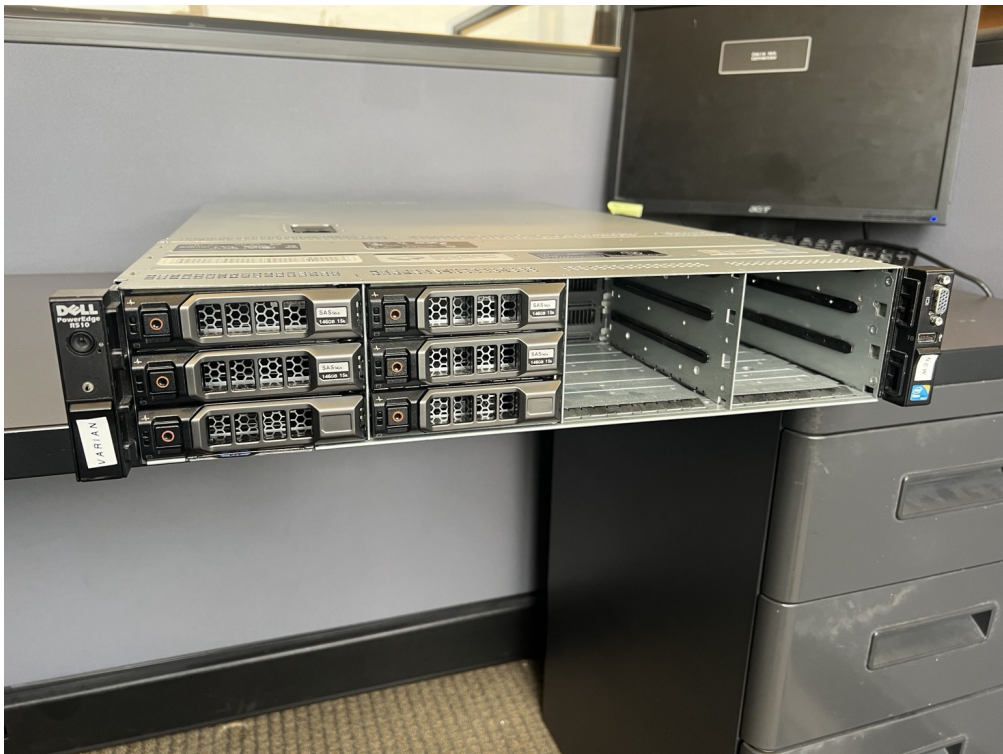
Evidence 01. Server at the beginning of the inspection.

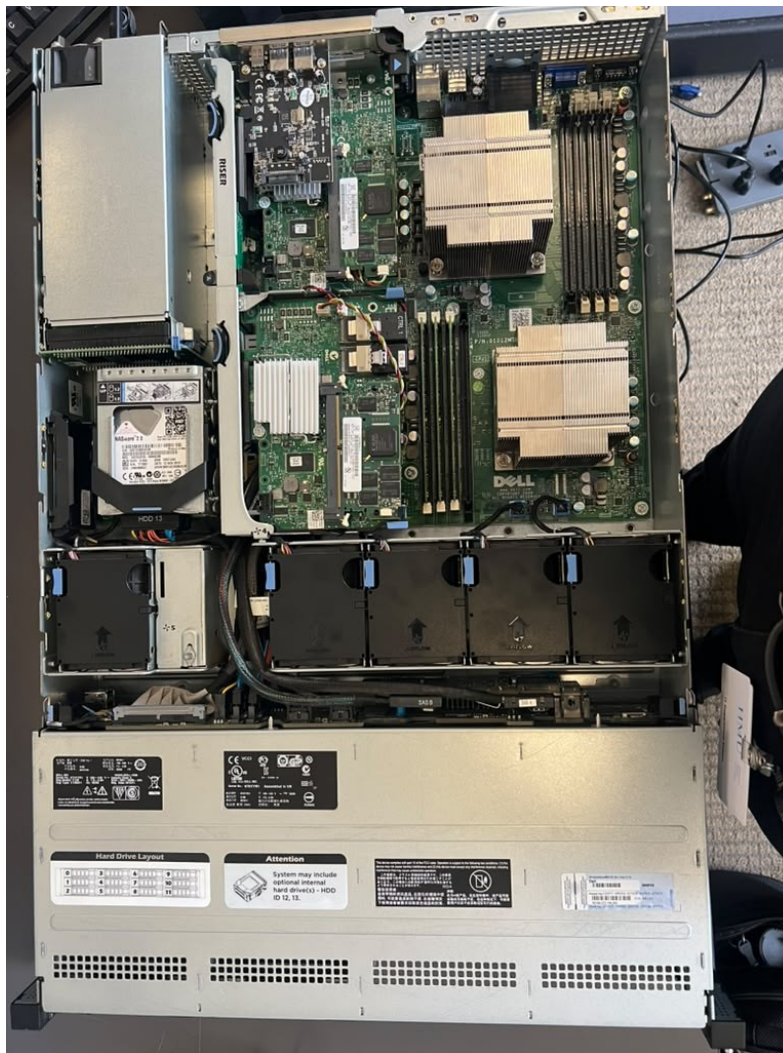
*Evidence 02. Full chassis view after I removed the cover.*

The system showed moderate dust and normal external wear for its age. I did not observe obvious burn damage or visibly swollen motherboard capacitors during this limited inspection. Two redundant 750 W power supplies were installed.

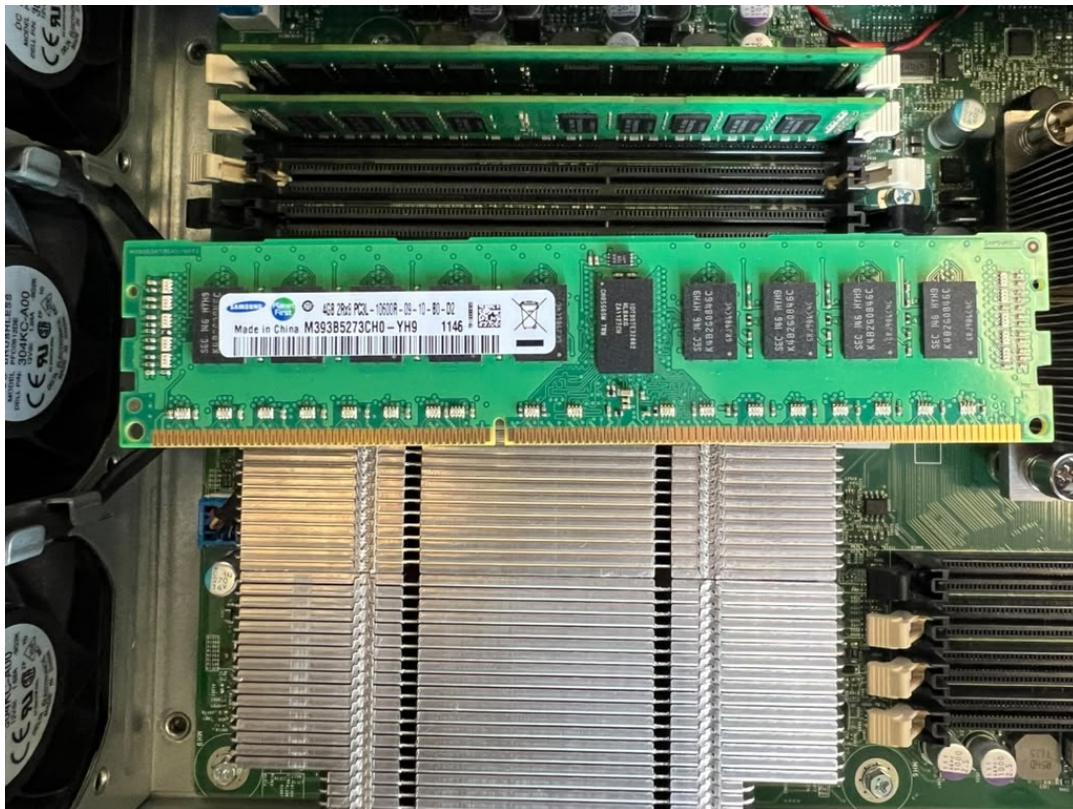
*Evidence 08. Samsung 4 GB registered DDR3 module and populated CPU1 bank.*

I found three 4 GB modules in the CPU1 memory bank and no memory in the CPU2 bank. This physical layout matches the warning shown during POST.

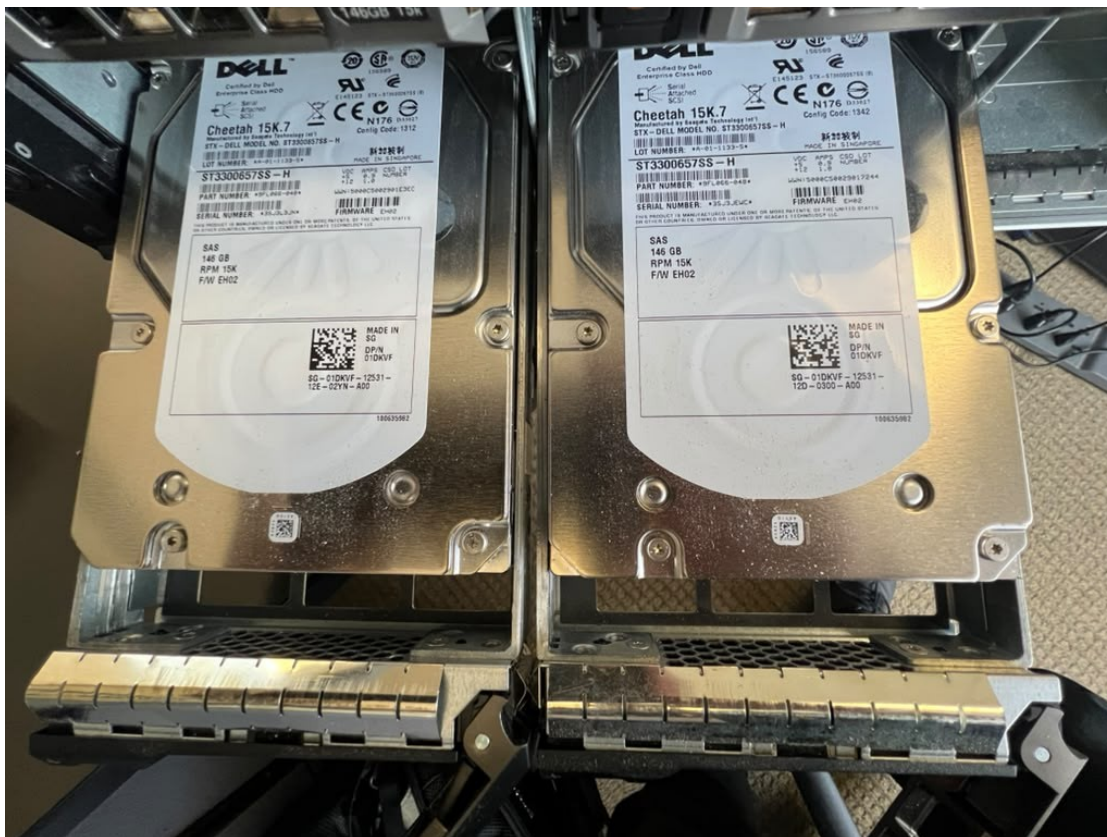
*Evidence 04. I removed the populated carriers and photographed the disk labels.*

Four front disks are Dell-labeled Seagate Cheetah 15K.7 drives marked SAS, 146 GB, and 15K RPM. The visible model string is ST3300657SS-H and the labels show firmware EH02. Two visible front carriers were empty.

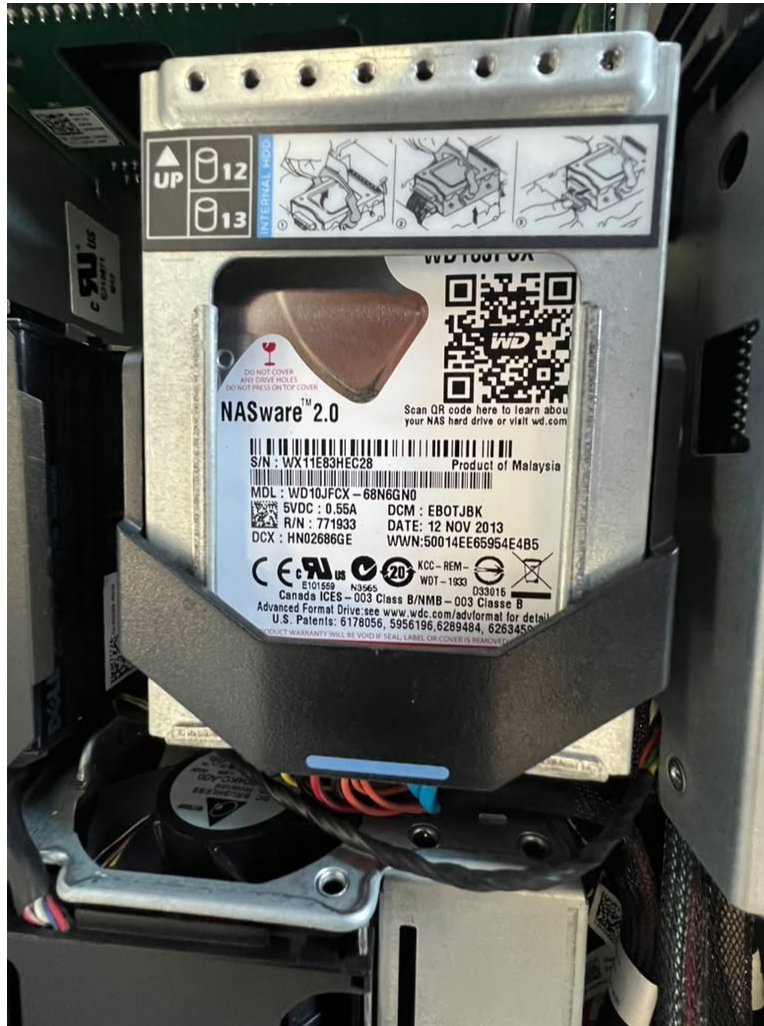
*Evidence 05. One of two fixed WD Red 1 TB SATA drives installed inside the chassis.*

I found two WD Red WD10JFCX 1 TB SATA disks mounted one above the other. The combined label-reported raw capacity is 2 TB. Across all six disks, the raw label total is 2.584 TB decimal. RAID level, usable capacity, health, and data contents remain unverified.

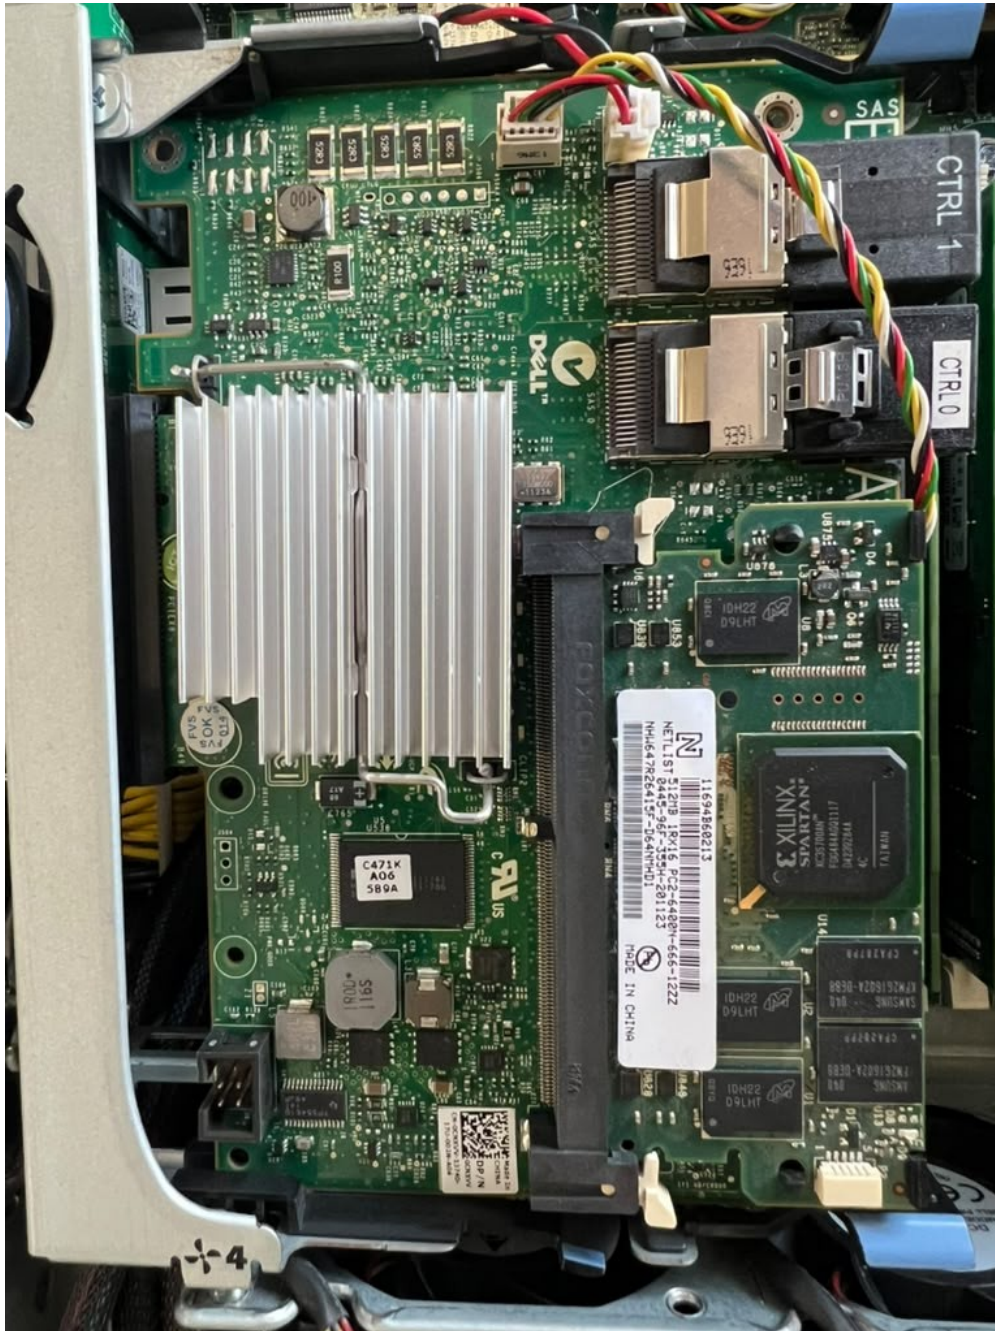
*Evidence 07. RAID controller assembly, cache module, and visible SAS connections.*

During the internal inspection, I noticed that the cache or memory module on the RAID assembly closest to the power-supply area appeared visibly arched or mechanically stressed. I documented the condition but did not remove or reseat the module.

| Priority | Finding | Assessment |
|---|---|---|
| High | Cache or memory module appears arched | Important physical lead; causal link unconfirmed |

The H800 message refers to its SDRAM connection. The physically stressed module appears to belong to the same general type of cache or memory subsystem. That makes the module, its socket, and the controller the first area to inspect. The evidence does not prove that the bent appearance caused the failure, so replacement without further testing would be premature.

1. Disconnect both power supplies and follow ESD precautions.
2. Match each physical RAID adapter to the H700 and H800 names shown during POST.
3. Inspect the arched cache module, socket, retaining clips, and battery cable.
4. Reseat components only after checking for physical damage and recording their original positions.
5. Boot again and record whether the SDRAM and firmware messages change.
6. Enter both PERC utilities without initializing disks or changing the configuration.
7. Capture physical-disk, foreign-configuration, and virtual-disk status.
8. Balance memory across the two processors using a supported R510 layout.
9. Run Dell diagnostics and review the hardware event log.

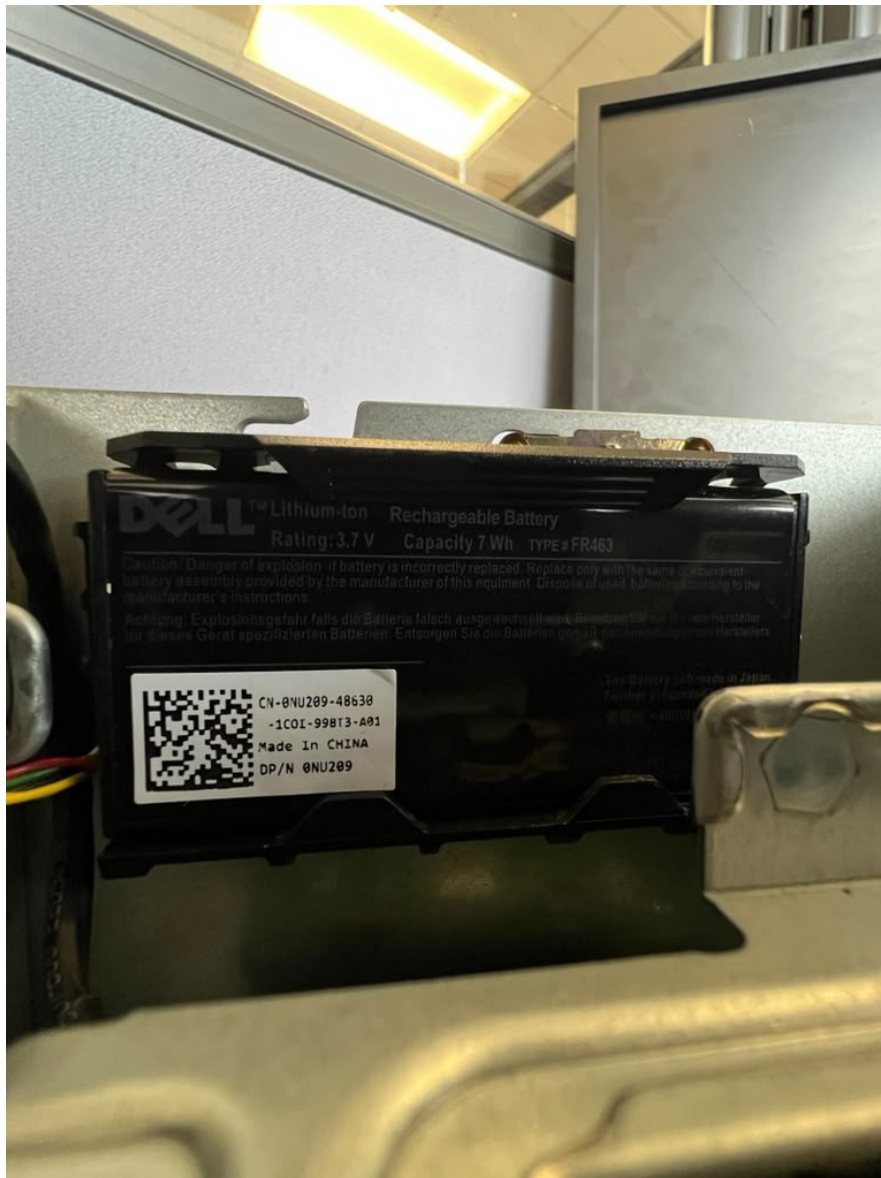
*Evidence 06. Dell FR463 3.7 V, 7 Wh lithium-ion RAID battery.*

The battery was present beside the internal drives. Its physical presence does not establish its charge capacity or health.

| Priority | Finding | Assessment |
|---|---|---|
| Medium | RAID battery health unknown | Needs testing before trusting write-back cache |
