Republic of the Philippines  
City of Cagayan de Oro  
**CITY DISASTER RISK REDUCTION AND  
MANAGEMENT DEPARTMENT  
ORO RESCUE 911**

Re : Survey and Site Assessment of Reported Riverbank Erosion along Purok 3, Brgy.  
Gusa, Cagayan de Oro City

Date August 25, 2026

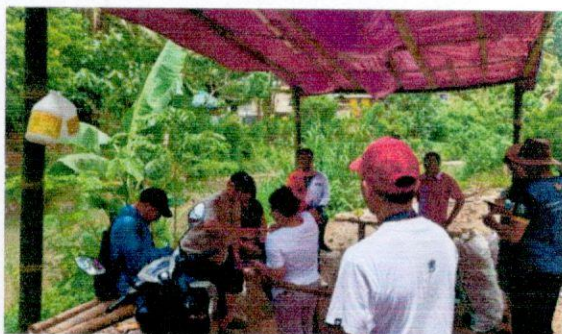
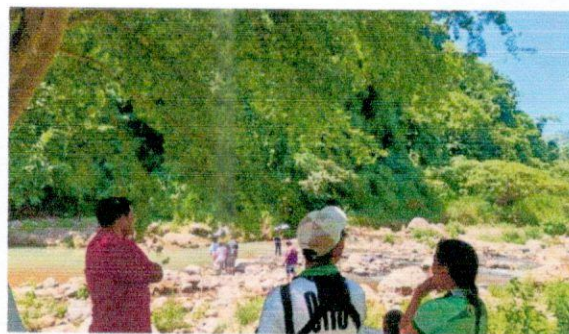
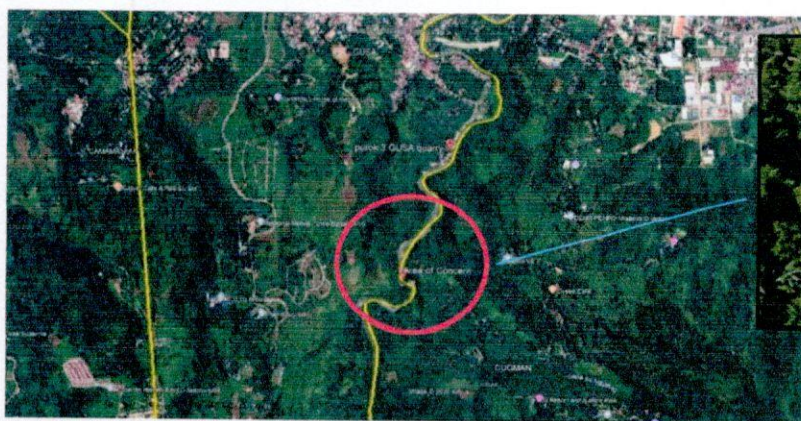
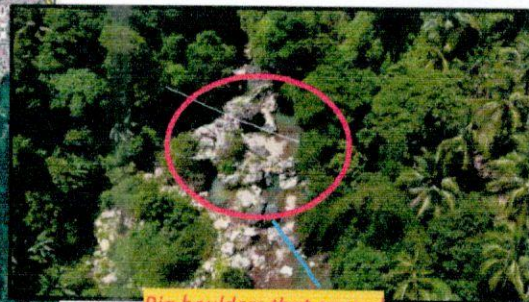
Lat: 8.455882°  
Long: 124.685102°

Based on the ocular inspection, the reported riverbank erosion and changes in the river channel were observed and may contribute to flooding and further erosion of the adjacent properties, especially during heavy rainfall.

Big boulders that caused  
flooding whenever there is heavy  
rainfall in the said area

It is recommended that a more detailed technical assessment be conducted by the appropriate concerned offices to determine the condition of the river channel and the suitability of the proposed dredging, excavation, and riverbank protection measures. Coordination with the City Engineer's Office, CLENRO, DENR, and DPWH is also recommended for proper technical evaluation and appropriate action.

In the meantime, regular monitoring of the affected area is recommended, particularly during periods of heavy rainfall and flooding, to identify any further changes in the riverbank and river flow that may pose a risk to nearby properties and residents.
