# Infrared Report

726 Sunnywood Rd  
York SC 29745

9/18/2025

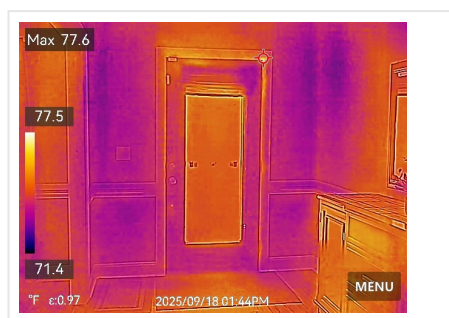
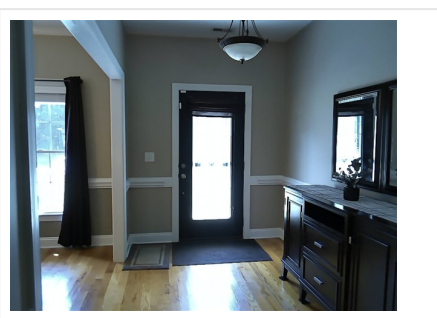
### 1.0 DOORS

Normal or typical conditions viewed at the time of inspection.

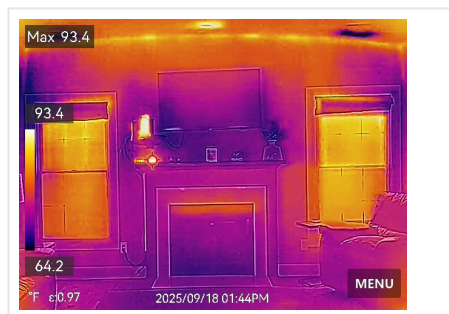
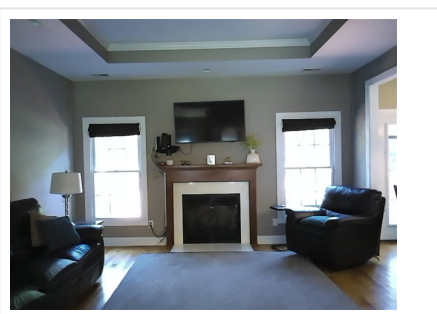
### 1.1 WINDOWS

Normal or typical conditions viewed at the time of inspection.

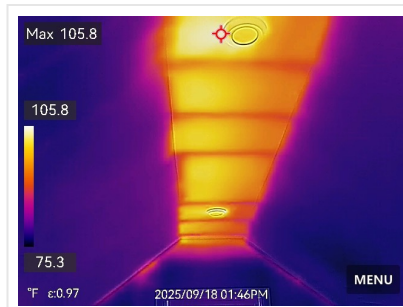
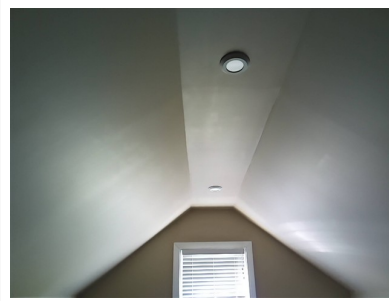
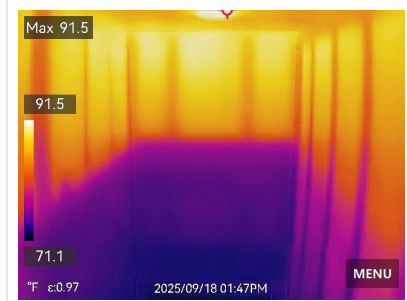
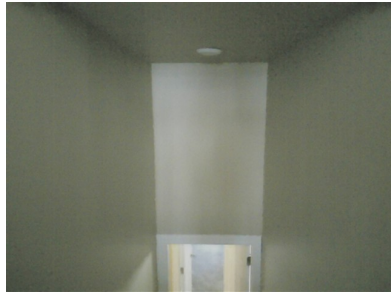
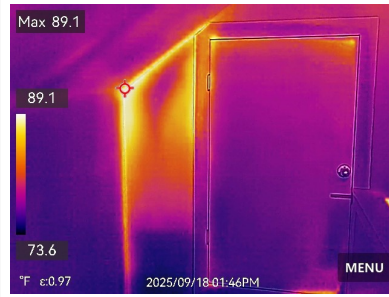
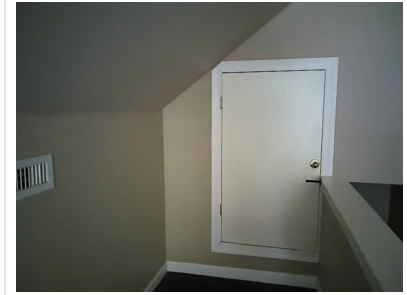
### 1.2 WALLS AND CEILINGS

## Evidence of heating and air loss at the Bonus room

☐ CORRECTION, REPAIR, AND/OR REPLACE IS NEEDED.
