INSPECTION REPORT  
171 Greenbay Rd  
Mooresville NC 28117

INSPECTED BY  
Alex Parr 3692  
Above Parr Home  
Inspections

INSPECTION DATE  
📅 4/25/2023  
🕒 09:00:00 AM

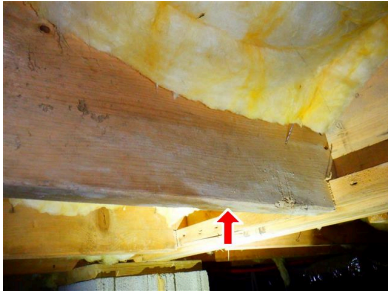
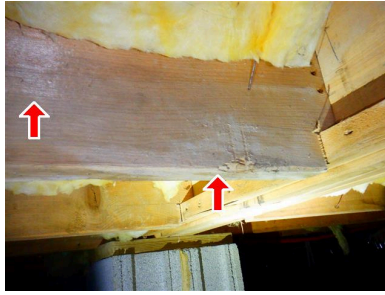
1. Discoloration and some type of mold (Microbial) growth is present in the structure at several areas including but not limited to the crawl space and interior spaces. Evidence suggests that this condition is from a past or present elevated moisture conditions. We did not inspect, test or determine if this type of substance is or is not a health hazard. Further investigation is needed.

We recommend you contact a properly licensed expert for testing, investigation and or correction as deemed appropriate.

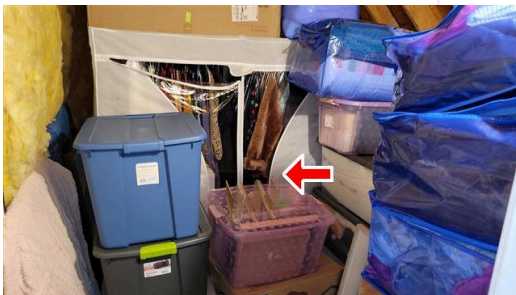
1.1 Item 1 (Picture)

1. Furniture, storage and or personal items in the garage and throughout the house. As a result the areas were not inspected. hidden damage may be present. Further investigation and repairs are needed.

We recommend having all personal items removed and these areas inspected prior to closing.

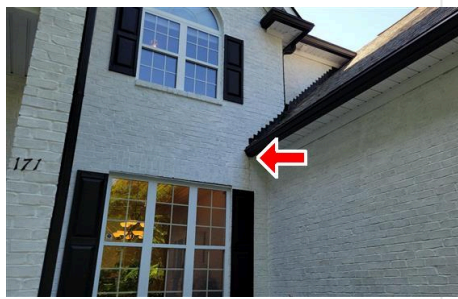
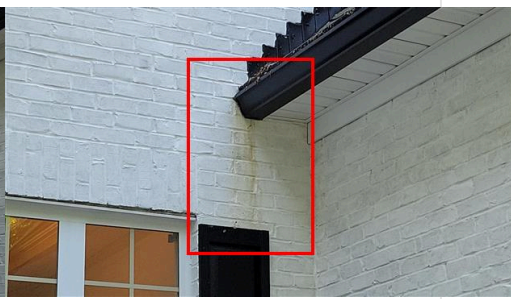
1. The kick-out flashing is missing at the roof to wall intersection at the exterior of the home. This is directing water down the side of the home and can allow for water damage. This is not best practice. Repairs are needed.

A qualified roofing contractor should inspect further and correct as needed.

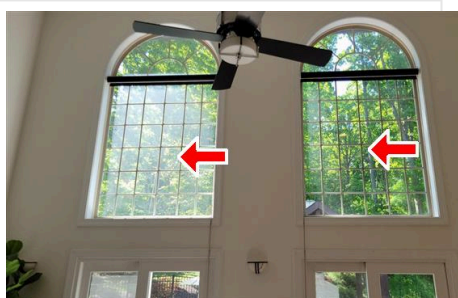
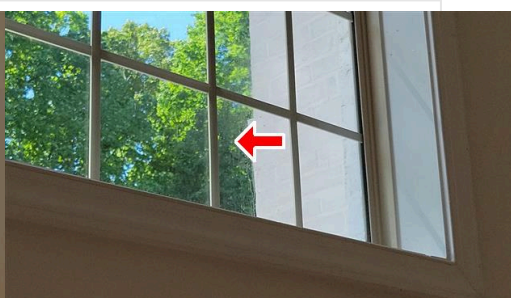
1. Several windows have failed/compromised thermal seals/fogged window panes. This is indicated by the visible moisture, discoloration, calcium deposits and or crystallization visible between the glass window panes. A certified window technician should recheck all the windows throughout the home. Due to weather conditions many times compromised/failed windows cannot be identified at the time of inspection. Further investigation and repairs are needed.

We recommend contacting a properly licensed window technician/contractor regarding these conditions and have repairs made deemed appropriate

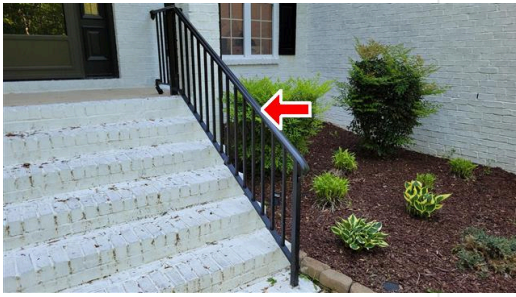
3.4 Item 1 (Picture)

1. The guardrails on steps at the front of home are loose. A fall or injury could occur if not corrected. A repair or replacement is needed.

A qualified contractor should repair or replace as needed.

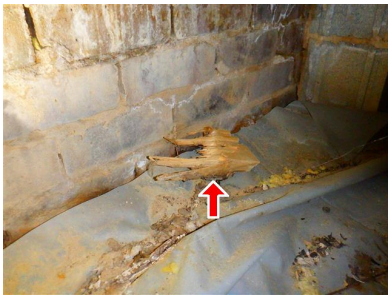
4.5 Item 1 (Picture)

1. Wood debris is in contact with the crawl space floor in numerous areas. This can attract wood destroying organisms. Removal is needed.

A qualified contractor should inspect and repair as needed.

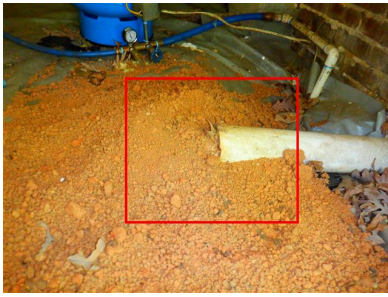
4.6 Item 1 (Picture)

1. The foundation drain in the crawl space is clogged. This can allow for water damage to occur to the home. Further investigation and repairs are needed.

A qualified licensed contractor should inspect further and correct as needed..

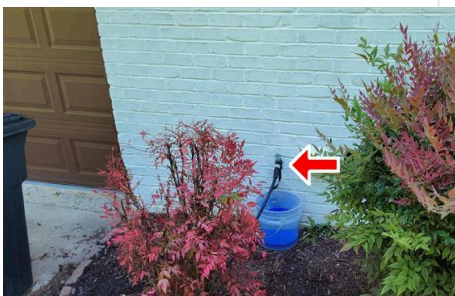
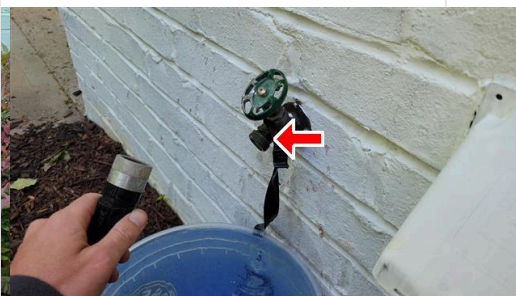
1. The outside water faucet drips when off at the right side (facing front). Repairs are needed to prevent water damage from occurring to the home. Repairs are needed.

A qualified licensed plumber should repair or correct as needed.

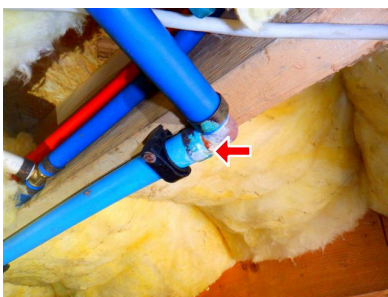
5.2 Item 3 (Picture)

1. The cold supply line is leaking in the crawlspace under the master bath. Repairs are needed to prevent water damage from occurring to the home. Further investigation and repairs are needed..

A qualified licensed plumber should repair or correct as needed.

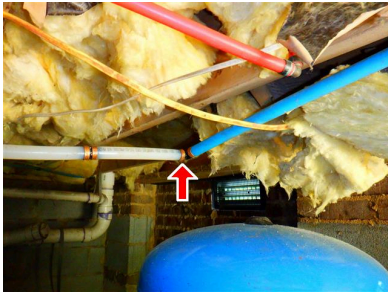
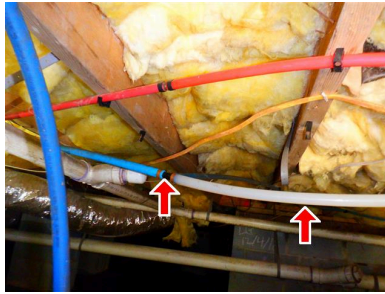
1. The supply lines in the crawlspace are not supported properly. Repairs are needed to prevent water

damage from occurring to the home. Further investigation and repairs are needed..  
A qualified licensed plumber should repair or correct as needed.

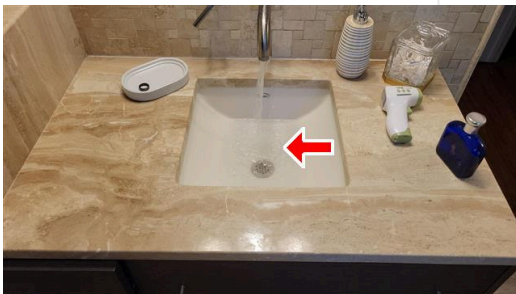
5.3 Item 1 (Picture)

1. The plumbing waste line drains slowly at the master bath sink. A cause of a slow drain can range from a simple cleaning at stop valve or at the trap under sink. Sometimes the drain can be partially clogged down line. I am unable to determine the cause of the slow drain. Repairs are needed.

A qualified licensed plumber should repair or correct as needed.

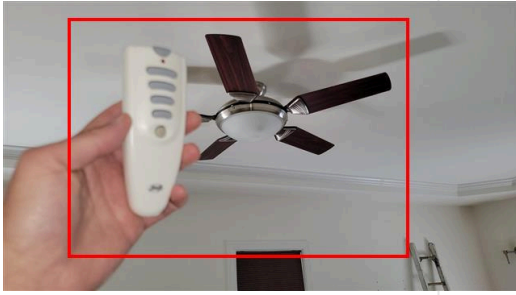
6.4 Item 1 (Picture)

1. The light fixture and fan in the master bedroom did not function at time of inspection. (remote battery probably dead) Further investigation is needed.

A qualified licensed electrical contractor should correct as needed.

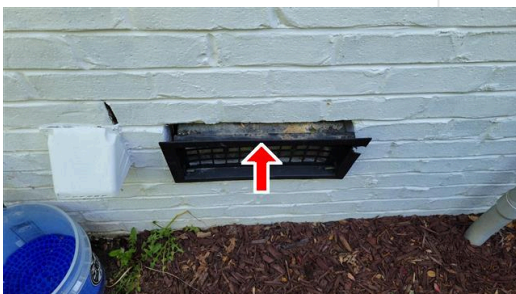
9.1 Item 1 (Picture)

1. One foundation vents is damaged at the right side (facing front). Rodents, reptiles or insects could enter into crawlspace. Repairs are needed.

A qualified person should repair or replace as needed.

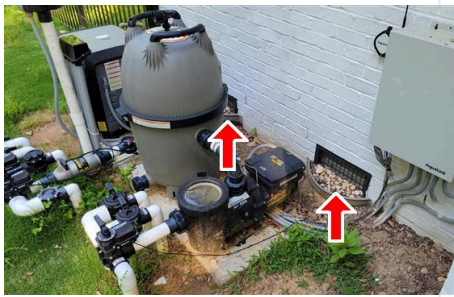
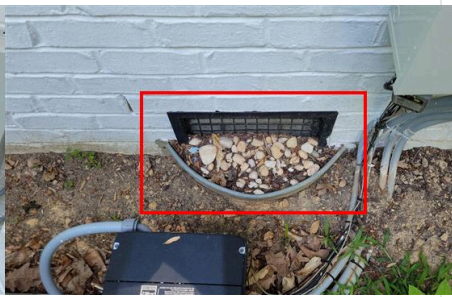
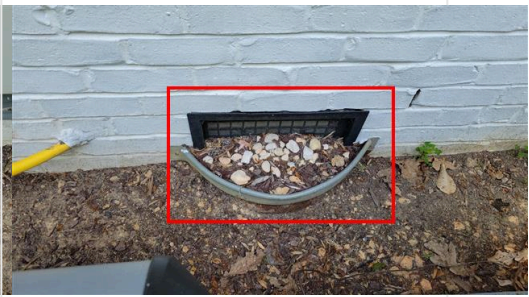
1. The foundation vent wells at the rear of the home have been installed improperly. This may allow water intrusion to occur. Further investigation and repairs are needed.

A qualified person should repair or replace as needed.

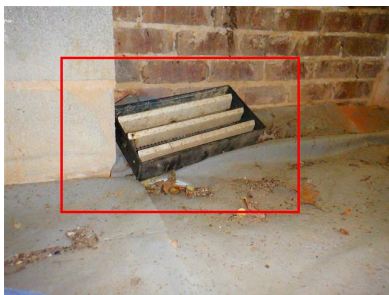
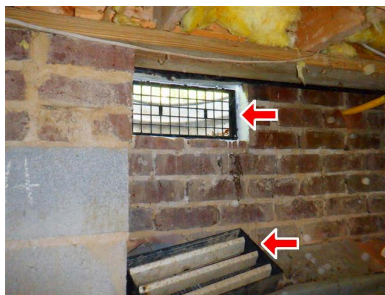
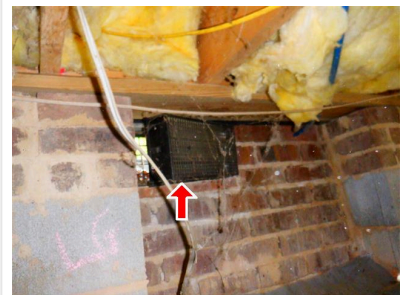
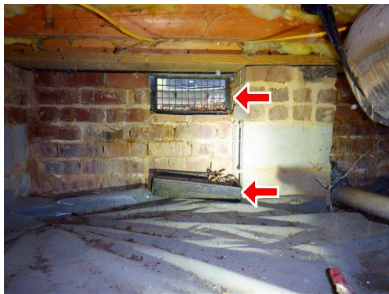
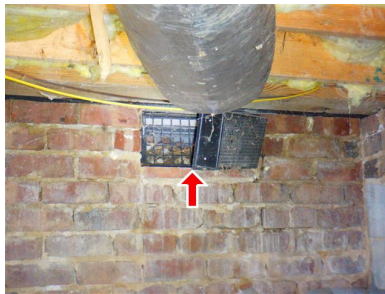
1. The foundation vent flap(s) are damaged in the crawlspace. Opinions vary on whether or not your crawlspace should be ventilated. If you have some moisture entering in then ventilation is usually recommended. Not opening the vents when moisture is present could harm your floor system or contribute to mold. A dry crawlspace that is prepared for no ventilation (other steps required), would not use the vents. Further investigation and repairs are needed.

A qualified person should repair or replace as needed.

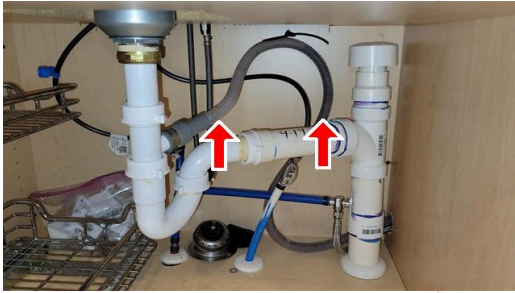
10.0 Item 1 (Picture)

1. The dishwasher drain hose needs to be looped above the level of the kitchen sink drain or an approved air gap installed to prevent back flow of waste water into the water supply. (food safety issue) This can allow waste for the sink to contaminate the dishwasher. This is a small repair.

A qualified licensed plumber should repair or correct as needed.

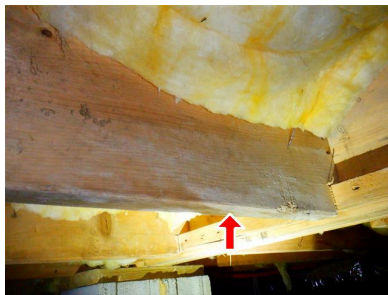
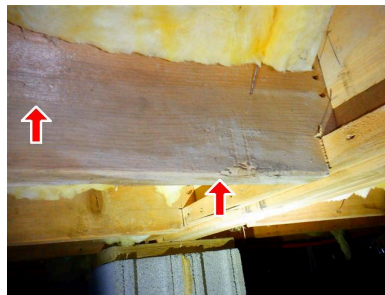
1. Discoloration and some type of mold (Microbial) growth is present in the structure at several areas including but not limited to the crawl space and interior spaces. Evidence suggests that this condition is from a past or present elevated moisture conditions. We did not inspect, test or determine if this type of substance is or is not a health hazard. Further investigation is needed.

We recommend you contact a properly licensed expert for testing, investigation and or correction as deemed appropriate.

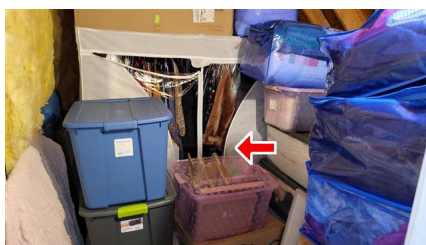
1.1 Item 1 (Picture)

1. Furniture, storage and or personal items in the garage and throughout the house. As a result the areas were not inspected. hidden damage may be present. Further investigation and repairs are needed.

We recommend having all personal items removed and these areas inspected prior to closing.

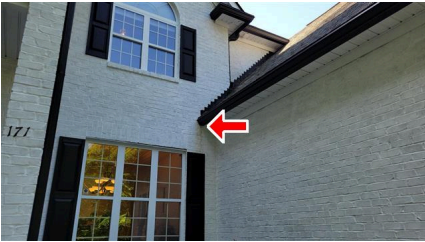
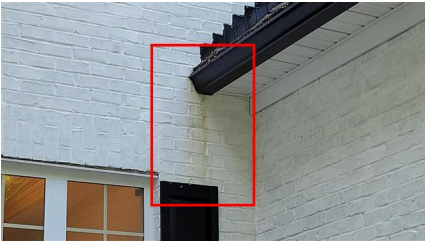
1. The kick-out flashing is missing at the roof to wall intersection at the exterior of the home. This is directing water down the side of the home and can allow for water damage. This is not best practice. Repairs are needed.

A qualified roofing contractor should inspect further and correct as needed.

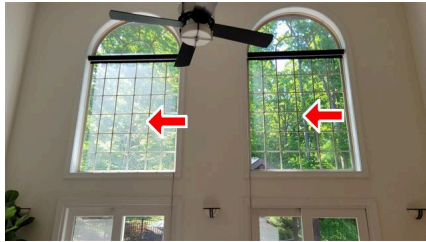
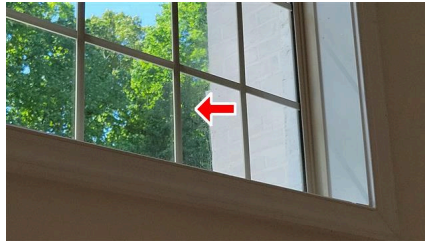
1. Several windows have failed/compromised thermal seals/fogged window panes. This is indicated by the visible moisture, discoloration, calcium deposits and or crystallization visible between the glass window panes. A certified window technician should recheck all the windows throughout the home. Due to weather conditions many times compromised/failed windows cannot be identified at the time of inspection. Further investigation and repairs are needed.

We recommend contacting a properly licensed window technician/contractor regarding these conditions and have repairs made deemed appropriate

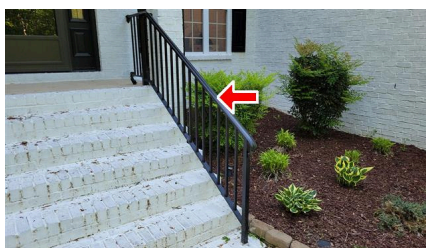
3.4 Item 1 (Picture)

1. The guardrails on steps at the front of home are loose. A fall or injury could occur if not corrected. A repair or replacement is needed.

A qualified contractor should repair or replace as needed.

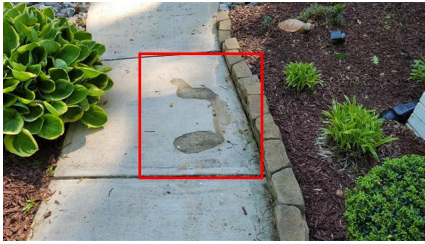
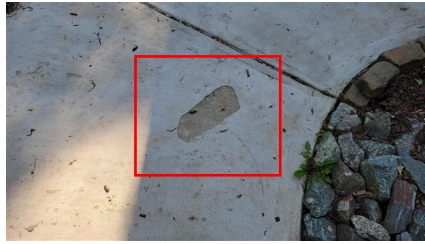
1. The sidewalk at the front of home deteriorated in areas. Further deterioration can occur if not repaired. Repairs are needed.

A qualified person should repair or replace as needed.

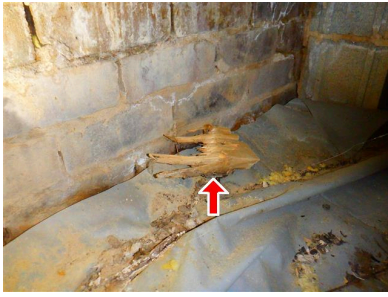
4.5 Item 1 (Picture)

1. Wood debris is in contact with the crawl space floor in numerous areas. This can attract wood destroying organisms. Removal is needed.

A qualified contractor should inspect and repair as needed.

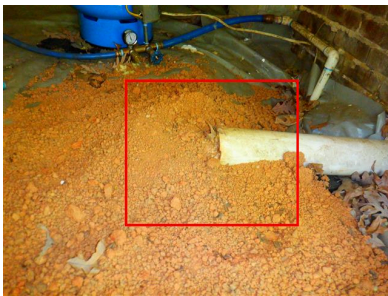
4.6 Item 1 (Picture)

1. The foundation drain in the crawl space is clogged. This can allow for water damage to occur to the home. Further investigation and repairs are needed.

A qualified licensed contractor should inspect further and correct as needed..

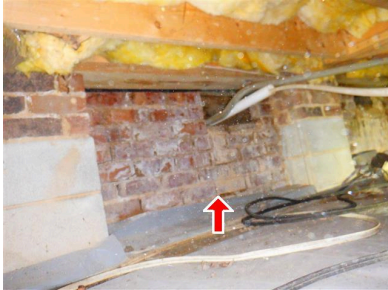
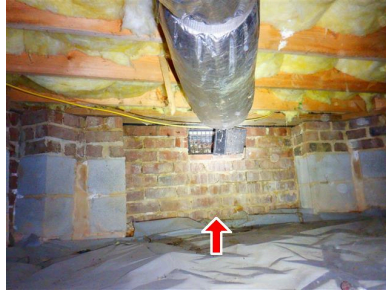
1. White efflorescence (powder substance) on block wall indicates moisture is in contact with the masonry. This does not necessarily indicate that intrusion will occur. I recommend checking the gutters and the downspout drain lines for proper operation. Also, a water proofing paint could be applied to the interior side of the block if necessary. Efflorescence is found on many homes without water intrusion occurring inside the home. But, it should alert you to the possibility that future steps may be needed.

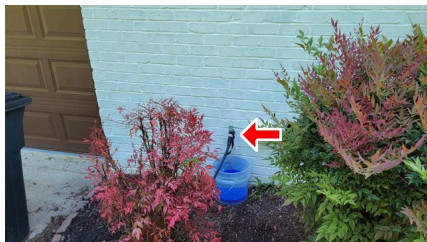
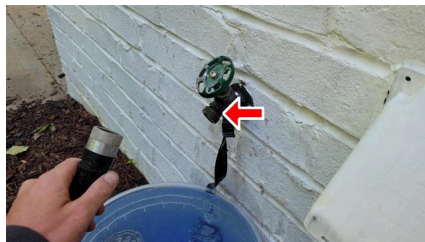
1. The outside water faucet drips when off at the right side (facing front). Repairs are needed to prevent water damage from occurring to the home. Repairs are needed.

A qualified licensed plumber should repair or correct as needed.

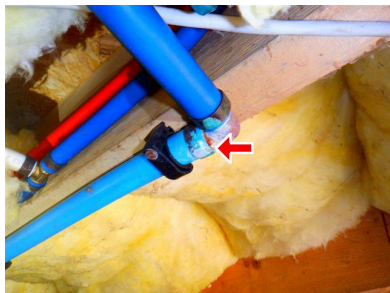
5.2 Item 3 (Picture)

1. The cold supply line is leaking in the crawlspace under the master bath. Repairs are needed to prevent water damage from occurring to the home. Further investigation and repairs are needed..

A qualified licensed plumber should repair or correct as needed.

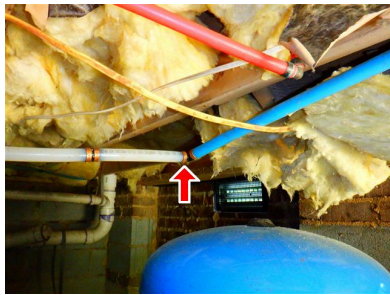
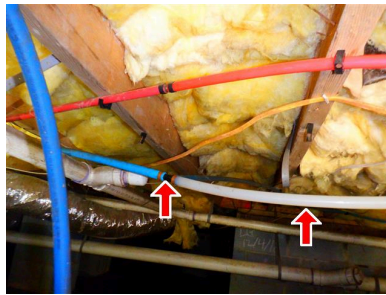
1. The supply lines in the crawlspace are not supported properly. Repairs are needed to prevent water damage from occurring to the home. Further investigation and repairs are needed..

A qualified licensed plumber should repair or correct as needed.

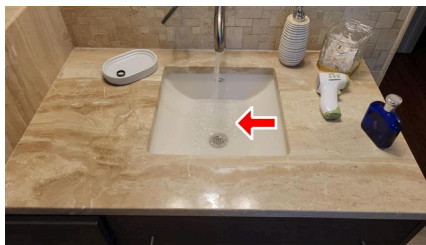
5.3 Item 1 (Picture)

1. The plumbing waste line drains slowly at the master bath sink. A cause of a slow drain can range from a simple cleaning at stop valve or at the trap under sink. Sometimes the drain can be partially clogged down line. I am unable to determine the cause of the slow drain. Repairs are needed.

A qualified licensed plumber should repair or correct as needed.

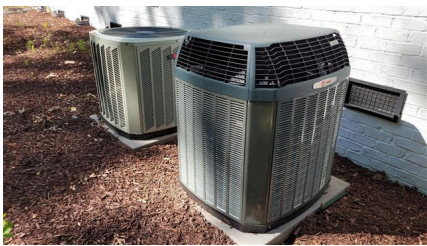
Complimentary photo of the heat pump

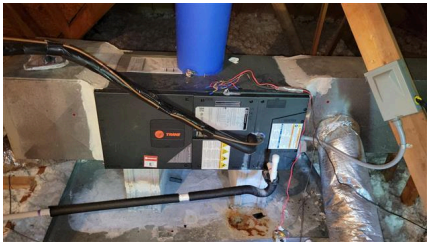
Complimentary photo of the heat pump

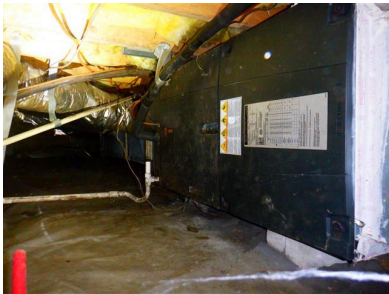
Complimentary photo of the heat pump

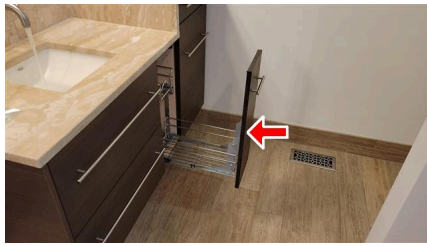
8.4 Item 1 (Picture)

1. Drawer in master bath will not stay closed. Recommend repair or replace as necessary.  
A qualified person should repair or replace as needed

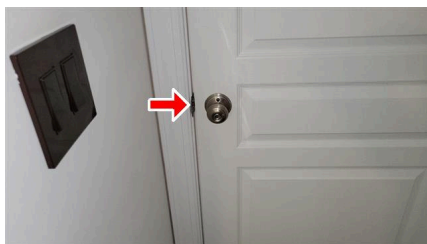
8.5 Item 1 (Picture)

1. The door at guest Bedroom will not latch properly. Evidence suggest that the door needs strike and latch adjustment to shut properly. This is a small repair.

A qualified person should repair or replace as needed.

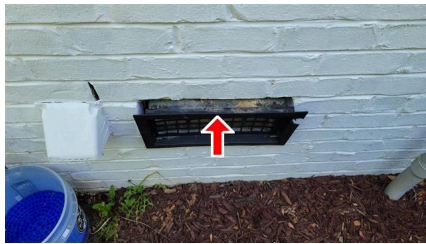
9.1 Item 1 (Picture)

1. One foundation vents is damaged at the right side (facing front). Rodents, reptiles or insects could enter into crawlspace. Repairs are needed.

A qualified person should repair or replace as needed.

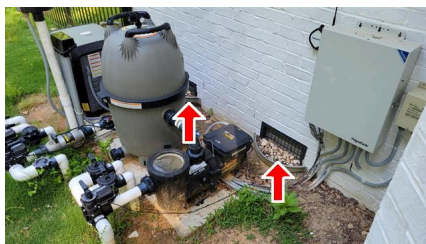
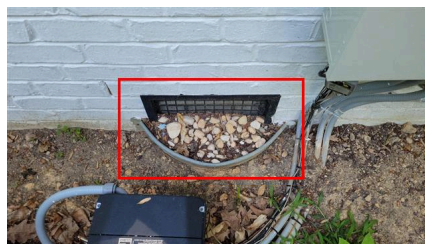
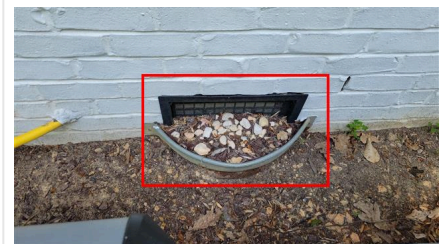
1. The foundation vent wells at the rear of the home have been installed improperly. This may allow water intrusion to occur. Further investigation and repairs are needed.

A qualified person should repair or replace as needed.

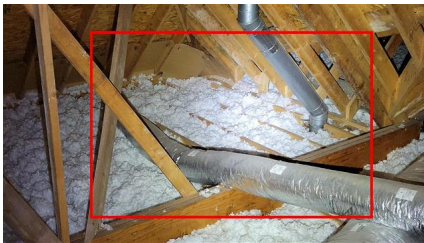
9.2 Item 1 (Picture)

1. Fiberglass (loose-fill) insulation is old and has settled, and less than six inches in thickness remains in attic. Heat loss can occur more on this home than one that is properly insulated. Repairs are needed..

A qualified person should repair or replace as needed.

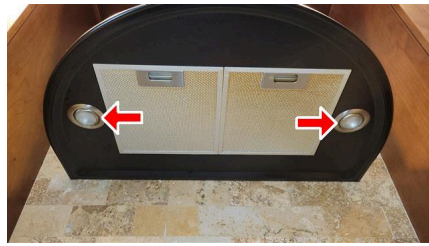
10.2 Item 1 (Picture)

1. The light bulb for fan did not work when tested. I recommend repair or replace as needed. I recommend contacting appliance repair company.
