INSPECTION REPORT  
1060 Glousman Rd  
Winston-Salem NC 27104

INSPECTED BY  
Alex Parr 3692  
Above Parr Home  
Inspections

INSPECTION DATE  
📅 7/22/2025  
🕒 11:00:00 AM

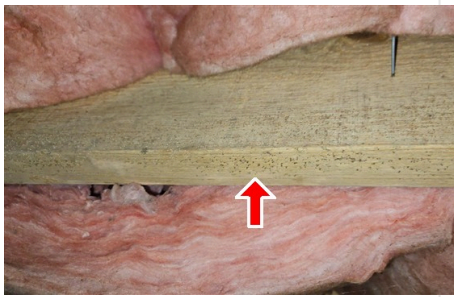
1.0 Item 1 (Picture)

1. Discoloration and some type of mold (Microbial) growth is present in the structure at several areas including but not limited to the crawl space and interior spaces. Evidence suggests that this condition is from a past or present elevated moisture conditions. We did not inspect, test or determine if this type of substance is or is not a health hazard. Further investigation is needed.

We recommend you contact a properly licensed expert for testing, investigation and or correction as deemed appropriate.

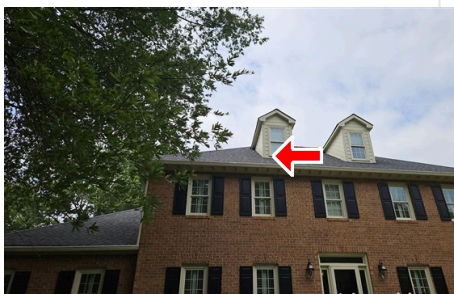
3.0 Item 1 (Picture)

1. The wood trim and siding at the front of home is deteriorated. Further deterioration can occur if not corrected. Further investigation and repairs are needed.

A qualified contractor should inspect and repair as needed.

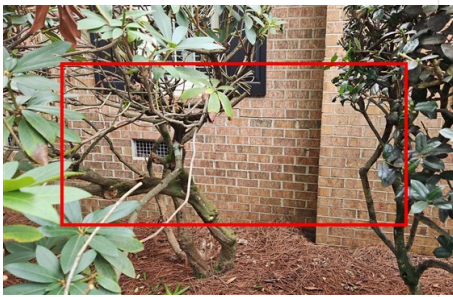
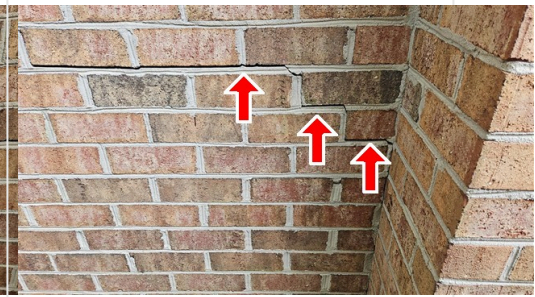
3.0 Item 3 (Picture)

1. I observed small cracks in the brick veneer at the exterior. Although the cracks in the brick veneer are typical, these areas should be re sealed to prevent any water penetration or damage. Further evaluation by a qualified masonry contractor is recommended for this entire condition.

I recommend repair or replace using a qualified contractor.

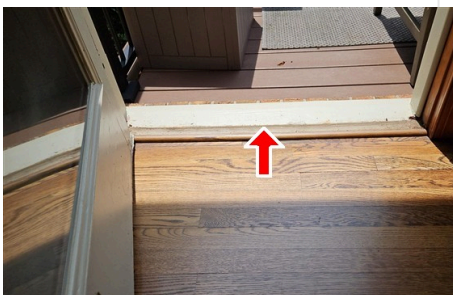
3.3 Item 1 (Picture)

1. The threshold for the rear entry door is sloped back towards the home. This can allow further water damage to occur. Further investigation and repairs are needed.

A qualified contractor should inspect and repair as needed.

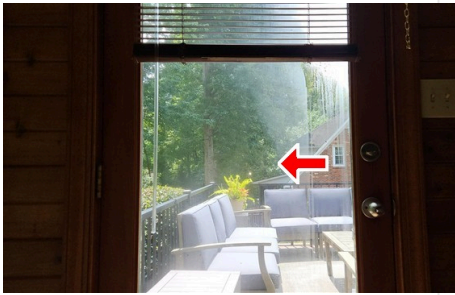
3.3 Item 3 (Picture)

1. The entry door at rear of home cloudy or seal is broken. Glass panes that have lost their seal (cloudy) can usually be replaced without replacing the entire unit. A repair or replacement is needed.

A qualified person should repair or replace as needed.

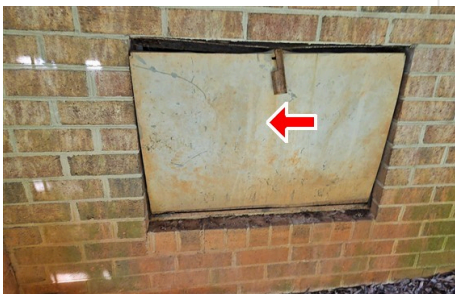
3.3 Item 5 (Picture)

1. The access door to the crawlspace is deteriorated. As a result the door will not close or seal properly. Further investigation and repairs are needed.

A qualified contractor should inspect and repair as needed.

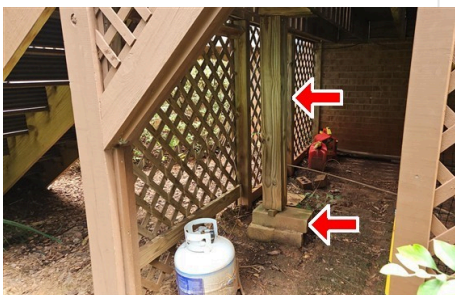
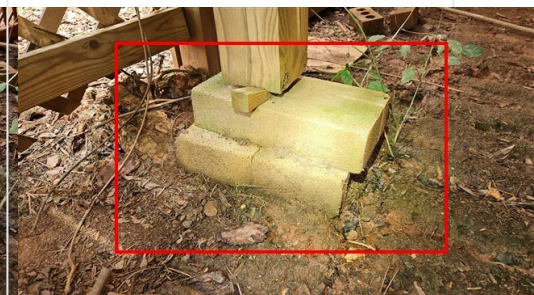
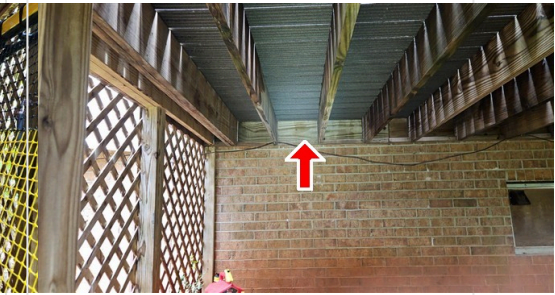
3.4 Item 1 (Picture)

1. The deck at the rear of the home is not supported properly and the bolts appear to be undersized and rusted. This may allow for failure of the deck. Further investigation and repairs are needed.

A qualified contractor should inspect and repair as needed.

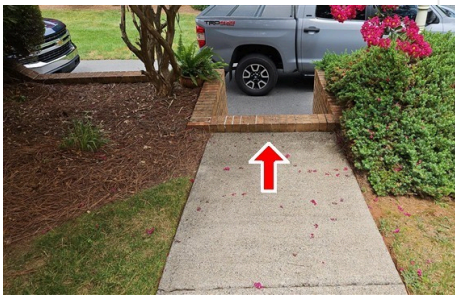
3.4 Item 9 (Picture)

1. The transition between the sidewalk and the steps is uneven. This can be a tripping hazard. Further investigation and repairs are needed.

A qualified contractor should inspect and repair as needed.

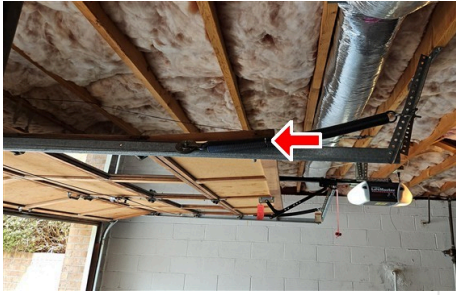
3.6 Item 1 (Picture)

1. The springs for garage door (s) at the right side (facing front) "left" door (from outside), is damaged. This is a safety issue. A repair or replacement is needed.

A qualified contractor should inspect and repair as needed.

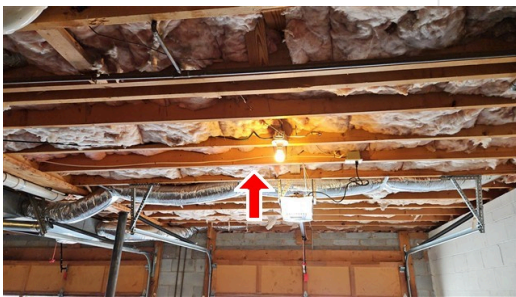
3.8 Item 1 (Picture)

1. I recommend you have a contractor confirm there is proper fire separation between the garage and the rest of the home. This is a fire safety issue. Further investigation and repairs are needed.

A qualified contractor should inspect and repair as needed.

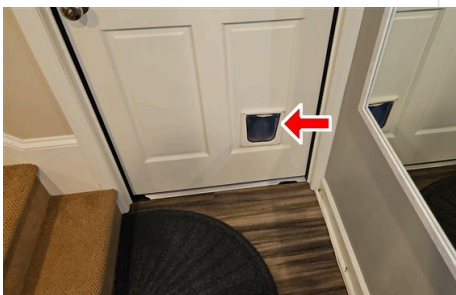
3.9 Item 1 (Picture)

1. The occupant door from inside garage to inside the home is compromise. This means that should a fire occur in garage, the occupant door does not afford protection until fireman arrive. This door should be replaced with a fire rated door. Repairs are needed.

A qualified contractor should inspect and repair as needed.

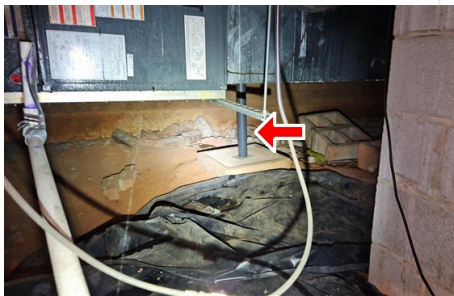
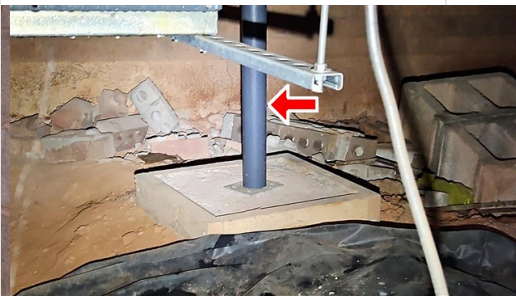
4.1 Item 1 (Picture)

1. Adjustable steel columns are present underneath the home. The hollow steel columns with the one big screw on its end that allows the height of account to be adjusted on site. These are typically used as a temporary repair. Further investigation and repairs are needed.

A qualified licensed general contractor should inspect further and repair as needed.

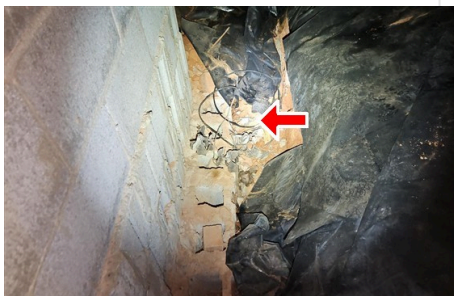
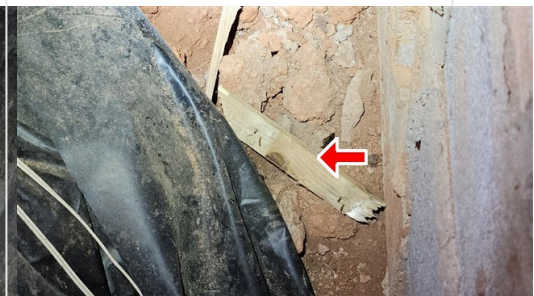
4.5 Item 1 (Picture)

1. Wood debris is in contact with the crawl space floor in numerous areas. This can attract wood destroying organisms. Removal is needed.

A qualified contractor should inspect and repair as needed.

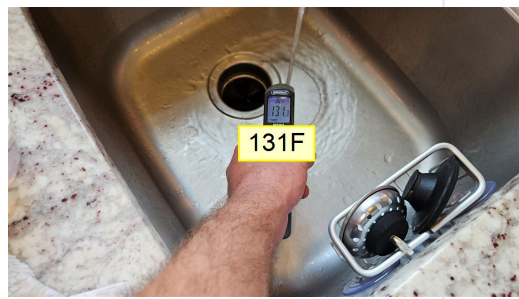
5.1 Item 1 (Picture)

1. The water heater is set over the recommended temperature. (Over 120) The risk is especially acute for infants, children, and the elderly. Water temperatures should never be set higher than 120 degrees. This is a safety issue. Repairs are needed

A qualified contractor should inspect and repair as needed.

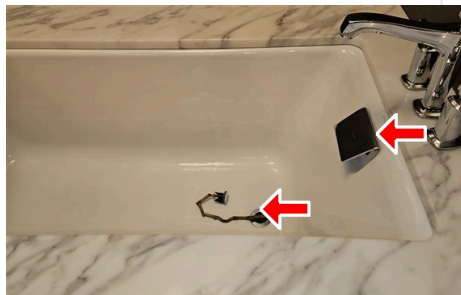
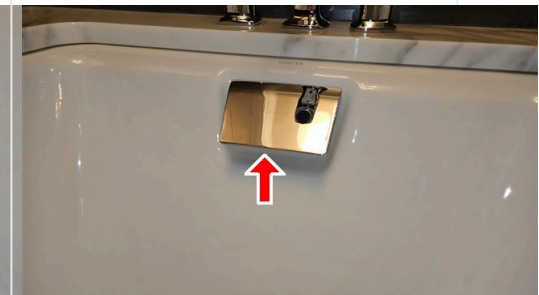
5.3 Item 1 (Picture)

1. The stop-valve linkage is damaged and does not work properly at the master bathroom tub. As a result you cannot fill up the tub. Further investigation and repairs are needed.

A qualified licensed plumber should repair or correct as needed.

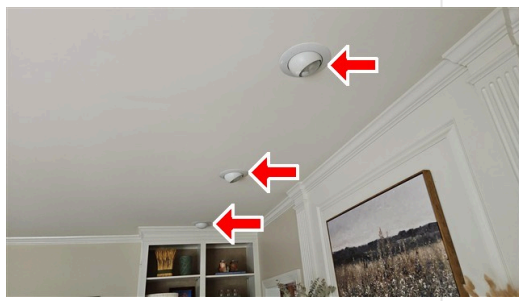
6.4 Item 1 (Picture)

1. The light fixtures do work, but at the living room. Further investigation and repairs are needed..

A qualified licensed electrical contractor should correct as needed.

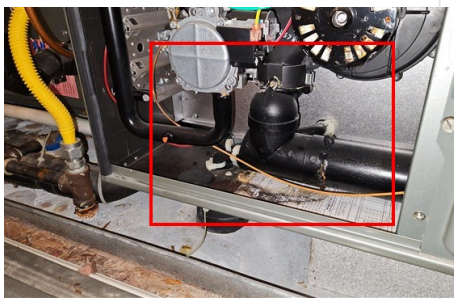
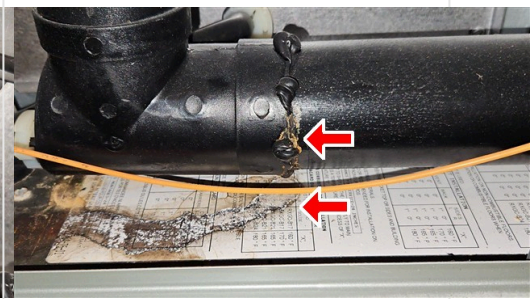
7.0 Item 1 (Picture)

1. The top floor gas furnace is leaking. Leaks can cause damage to unit or home. Further investigation and repairs are needed.

A qualified HVAC person should inspect further and repair or replace as needed.

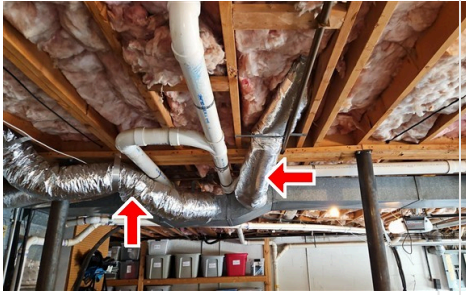
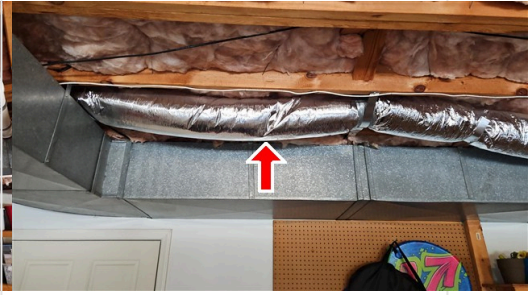
7.3 Item 1 (Picture)

1. The flex supply duct pipe is not allowed for safety reasons. I recommend a complete review of the ductwork. Further investigation and repairs are needed.

A qualified HVAC person should inspect further and repair or replace as needed.

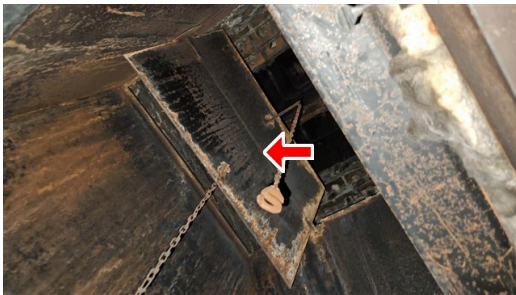
7.7 Item 1 (Picture)

1. The damper for vented fire logs at the Living room is missing a clamp or lock that forces lid to stay open (required for Vented Gas/LP logs). Without a clamp to force open the damper, it could shut and cause unsafe carbon dioxide to enter into living space. Further investigation and repairs are needed. A qualified licensed HVAC (Heat/Ventilation/Air conditioning Contractor) should inspect further and repair as needed.

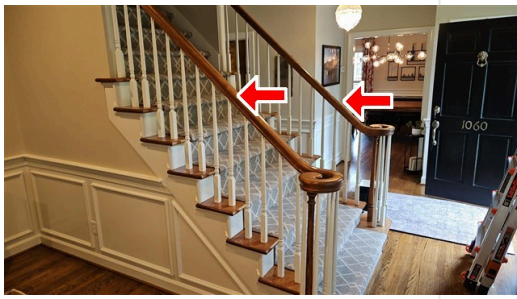
8.3 Item 1 (Picture)

1. The hand/guard rail for the upstairs are loose. A fall or injury could occur if not corrected. Further investigation and repairs are needed.. A qualified contractor should repair or replace as needed.

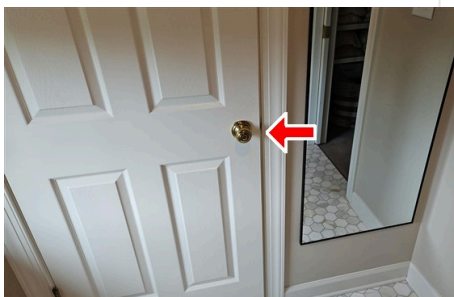
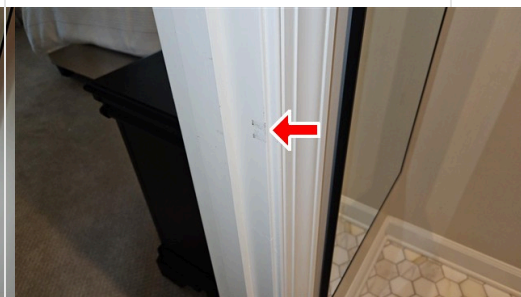
8.5 Item 1 (Picture)

1. The door at master bath will not latch properly. The door needs a latch added to shut properly. Repairs are needed.

A qualified person should repair or replace as needed.

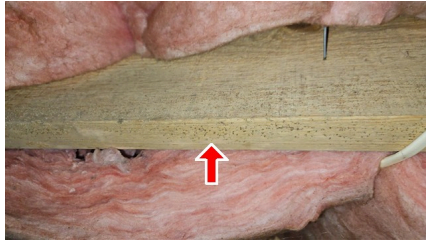
1.0 Item 1 (Picture)

1. Discoloration and some type of mold (Microbial) growth is present in the structure at several areas including but not limited to the crawl space and interior spaces. Evidence suggests that this condition is from a past or present elevated moisture conditions. We did not inspect, test or determine if this type of substance is or is not a health hazard. Further investigation is needed.

We recommend you contact a properly licensed expert for testing, investigation and or correction as deemed appropriate.

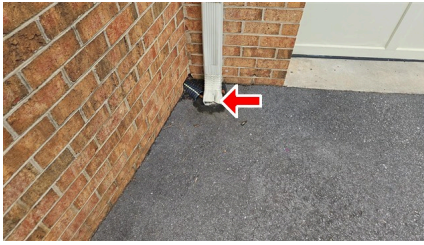
**2.3 Item 1 (Picture)**

1. The downspout dented at the right side of home (facing front). Gutters that drain poorly or clogged can lead to many costly problems such as deterioration of fascia, soffit or roof edge. It can also cause gutters to pull loose and lead to possible water intrusion. Repairs are needed.

A qualified contractor should inspect and repair as needed.

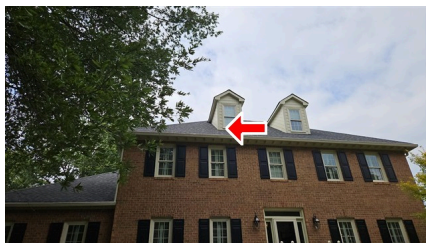
3.0 Item 1 (Picture)

1. The wood trim and siding at the front of home is deteriorated. Further deterioration can occur if not corrected. Further investigation and repairs are needed.

A qualified contractor should inspect and repair as needed.

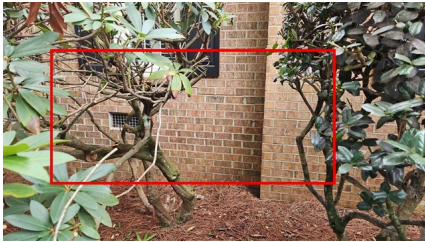
3.0 Item 3 (Picture)

1. I observed small cracks in the brick veneer at the exterior. Although the cracks in the brick veneer are typical, these areas should be re sealed to prevent any water penetration or damage. Further evaluation by a qualified masonry contractor is recommended for this entire condition.

I recommend repair or replace using a qualified contractor.

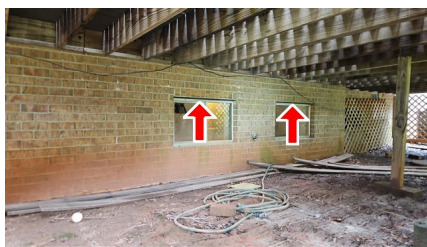
3.2 Item 1 (Picture)

1. The steel lintels around the exterior of the home are beginning to rust or have rust present. A lintel is a horizontal architectural member or steel beam support placed over a wall opening to carry the weight of the masonry placed over it. In most situation, the lintel above you windows and doors will be steel angle iron or I beam. Either due to age or improper rust proofing or weep chord and flashing placement during installation, lintels will begin to rust. Rusting lintels can expand to become mush thicker then their original size. The expansive forces of rusting steel can shift entire multi-story elevations. If your lintels are currently rusting, a telltale sign of expansion is diagonal "step" pattern cracks, which can be found on either end of the window or door opening. Repairs are needed to prevent further damage to the structure. Further deterioration may occur if not repaired.

I recommend a qualified contractor inspect and repair as needed.

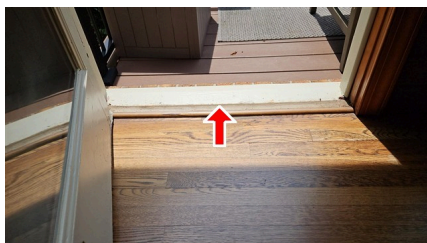
3.3 Item 1 (Picture)

1. The threshold for the rear entry door is sloped back towards the home. This can allow further water damage to occur. Further investigation and repairs are needed.

A qualified contractor should inspect and repair as needed.

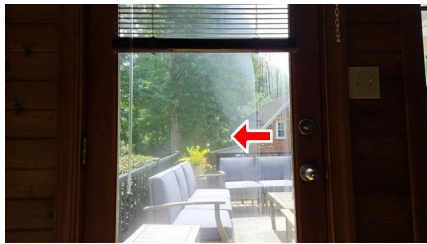
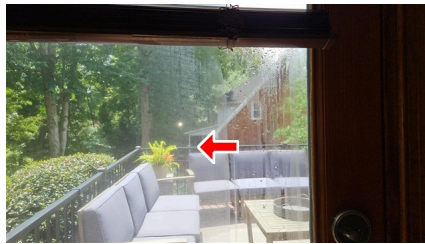
1. The entry door at rear of home cloudy or seal is broken. Glass panes that have lost their seal (cloudy) can usually be replaced without replacing the entire unit. A repair or replacement is needed.

A qualified person should repair or replace as needed.

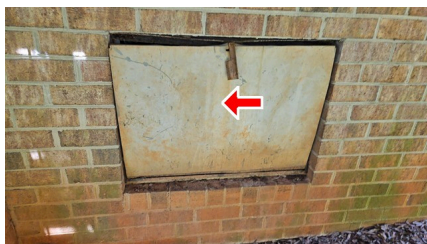
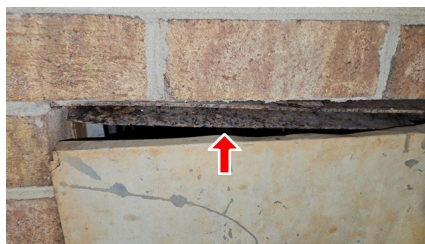
1. The access door to the crawlspace is deteriorated. As a result the door will not close or seal properly. Further investigation and repairs are needed.

A qualified contractor should inspect and repair as needed.

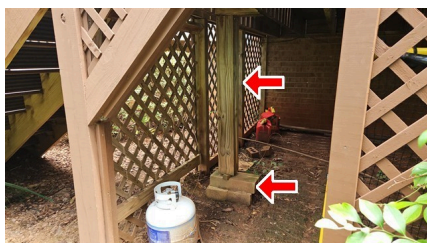
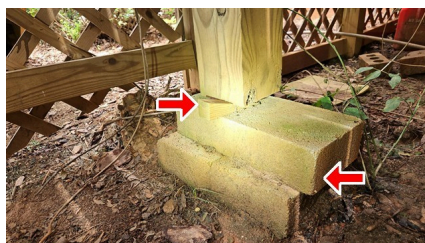
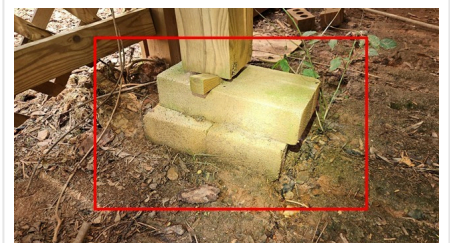
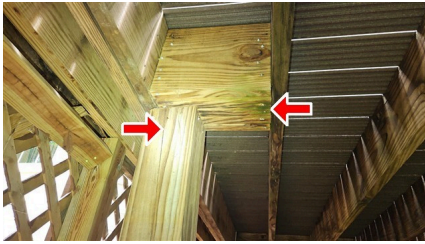
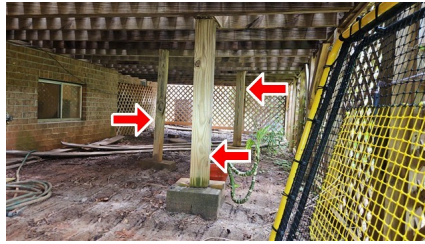
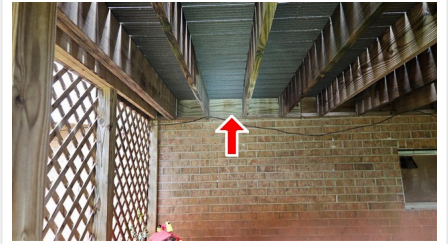
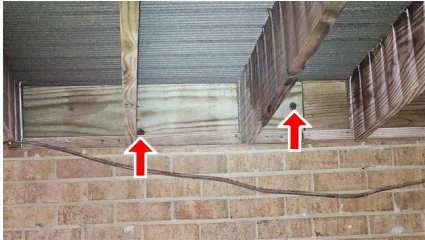
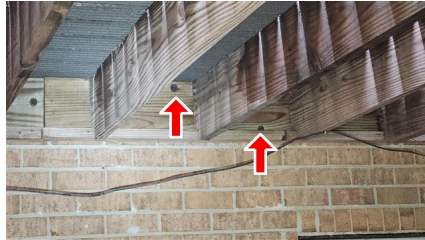
1. The deck at the rear of the home is not supported properly and the bolts appear to be undersized and rusted. This may allow for failure of the deck. Further investigation and repairs are needed.

A qualified contractor should inspect and repair as needed.

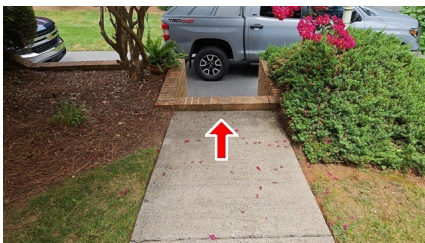
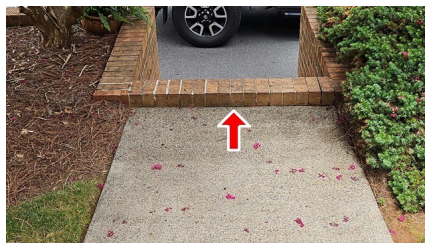
1. The transition between the sidewalk and the steps is uneven. This can be a tripping hazard. Further investigation and repairs are needed.

A qualified contractor should inspect and repair as needed.

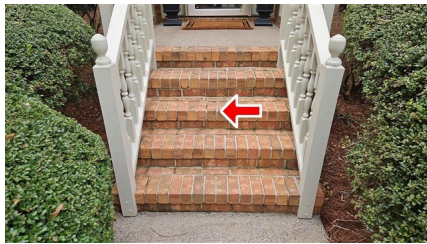
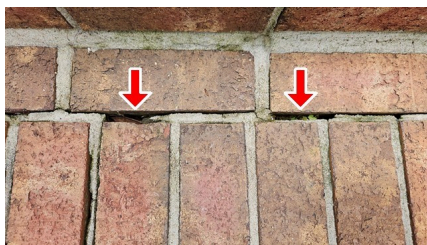
3.4 Item 11 (Picture)

1. The brick steps at the front of home has missing mortar. Further deterioration can occur if not repaired. Repairs are needed.

A qualified person should repair or replace as needed.

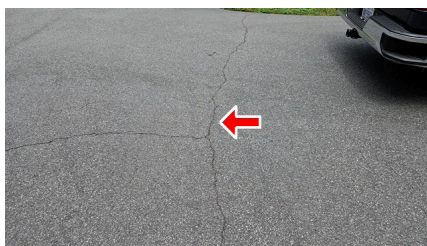
3.5 Item 1 (Picture)

1. The asphalt drive at the right side (facing front) deteriorated in areas. Further deterioration can occur if not repaired. Repairs are needed.

A qualified contractor should inspect and repair as needed.

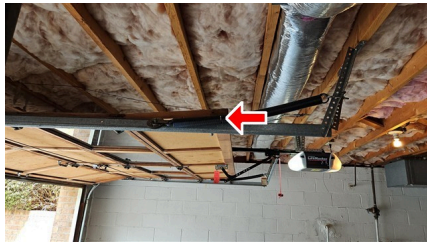
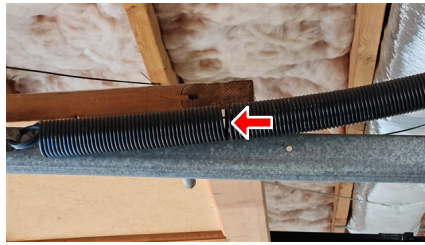
1. The springs for garage door (s) at the right side (facing front) "left" door (from outside), is damaged. This is a safety issue. A repair or replacement is needed.

A qualified contractor should inspect and repair as needed.

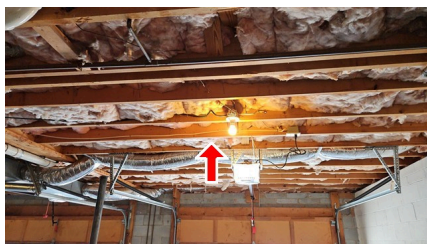
3.8 Item 1 (Picture)

1. I recommend you have a contractor confirm there is proper fire separation between the garage and the rest of the home. This is a fire safety issue. Further investigation and repairs are needed.

A qualified contractor should inspect and repair as needed.

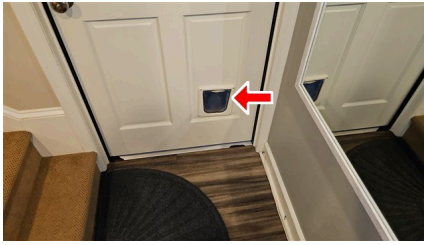
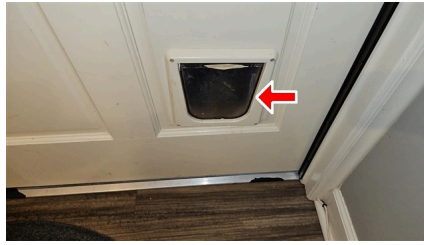
1. The occupant door from inside garage to inside the home is compromise. This means that should a fire occur in garage, the occupant door does not afford protection until fireman arrive. This door should be replaced with a fire rated door. Repairs are needed.

A qualified contractor should inspect and repair as needed.

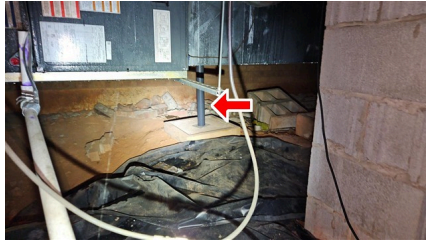
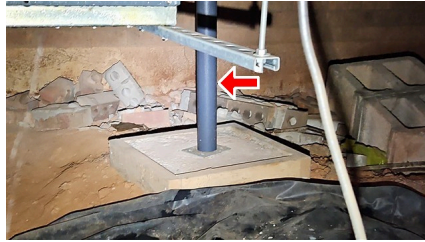
1. Adjustable steel columns are present underneath the home. The hollow steel columns with the one big screw on its end that allows the height of account to be adjusted on site. These are typically used as a temporary repair. Further investigation and repairs are needed.

A qualified licensed general contractor should inspect further and repair as needed.

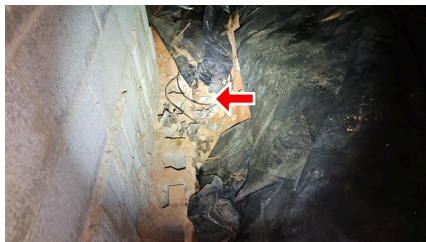
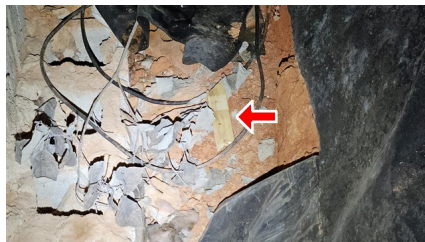
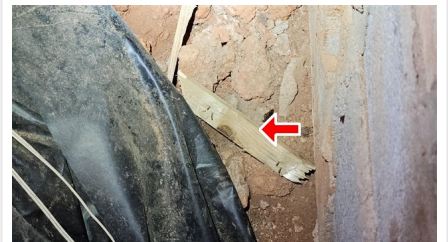
1. Wood debris is in contact with the crawl space floor in numerous areas. This can attract wood destroying organisms. Removal is needed.

A qualified contractor should inspect and repair as needed.

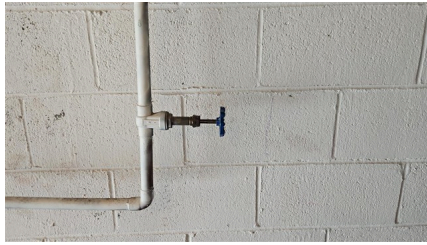
5.0 Item 1 (Picture)

The main shut off is the blue knob located in the garage. This is for your information.

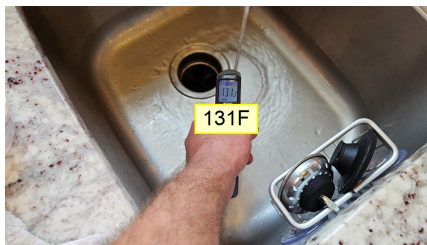
5.1 Item 1 (Picture)

1. The water heater is set over the recommended temperature. (Over 120) The risk is especially acute for infants, children, and the elderly. Water temperatures should never be set higher than 120 degrees. This is a safety issue. Repairs are needed

A qualified contractor should inspect and repair as needed.

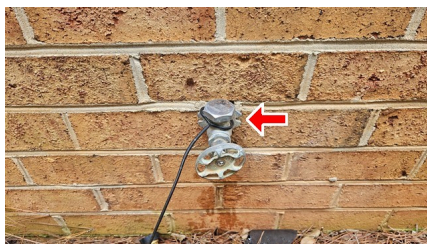
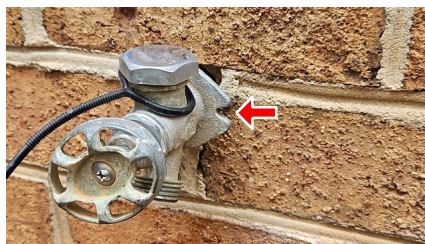
1. The outside water faucet loose, and needs securing to wall at the front of home. This can allow undue stress to occur on supply lines allowing leaks to occur. Repairs are needed..

A qualified licensed plumber should repair or correct as needed.

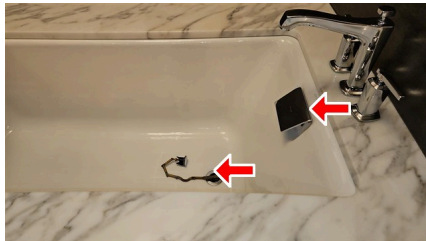
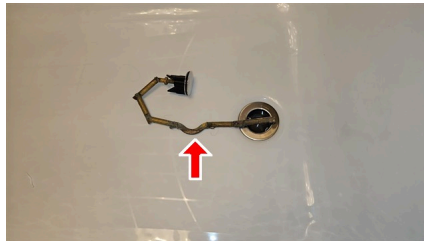
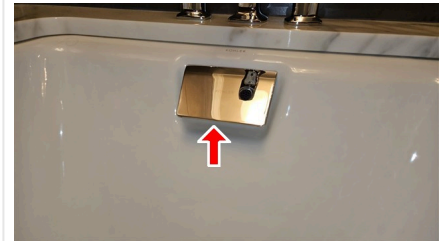
1. The stop-valve linkage is damaged and does not work properly at the master bathroom tub. As a result you cannot fill up the tub. Further investigation and repairs are needed.

A qualified licensed plumber should repair or correct as needed.

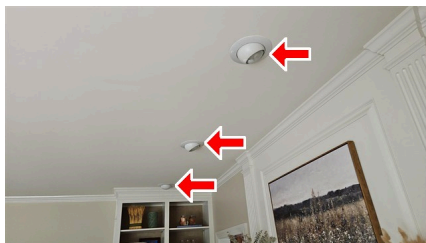
6.4 Item 1 (Picture)

1. The light fixtures do work, but at the living room. Further investigation and repairs are needed.. A qualified licensed electrical contractor should correct as needed.

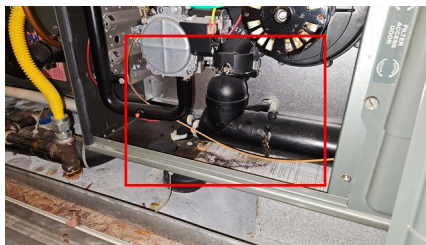
7.0 Item 1 (Picture)

1. The top floor gas furnace is leaking. Leaks can cause damage to unit or home. Further investigation and repairs are needed.

A qualified HVAC person should inspect further and repair or replace as needed.

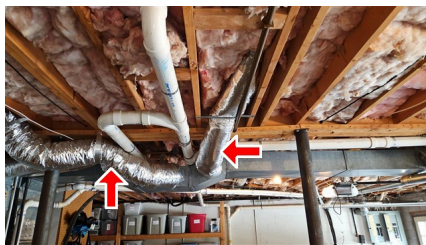
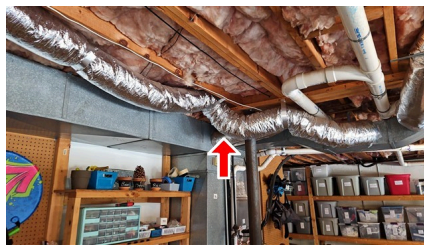
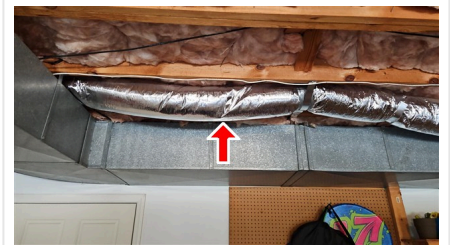
1. The flex supply duct pipe is not allowed for safety reasons. I recommend a complete review of the ductwork. Further investigation and repairs are needed.

A qualified HVAC person should inspect further and repair or replace as needed.

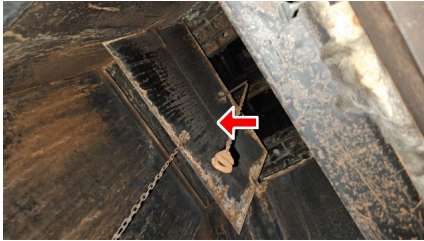
7.7 Item 1 (Picture)

1. The damper for vented fire logs at the Living room is missing a clamp or lock that forces lid to stay open (required for Vented Gas/LP logs). Without a clamp to force open the damper, it could shut and cause unsafe carbon dioxide to enter into living space. Further investigation and repairs are needed.

A qualified licensed HVAC (Heat/Ventilation/Air conditioning Contractor) should inspect further and repair as needed.

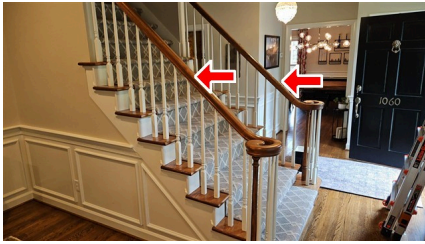
8.3 Item 1 (Picture)

1. The hand/guard rail for the upstairs are loose. A fall or injury could occur if not corrected. Further investigation and repairs are needed..

A qualified contractor should repair or replace as needed.

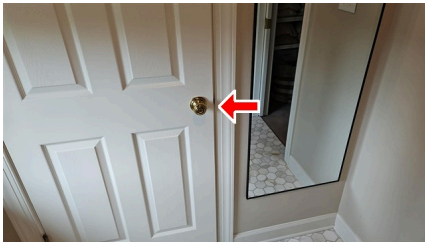
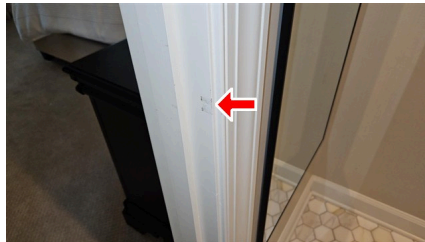
1. The door at master bath will not latch properly. The door needs a latch added to shut properly. Repairs are needed.

A qualified person should repair or replace as needed.

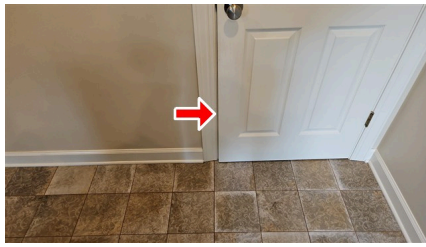
8.5 Item 3 (Picture)

1. The Privacy door rubs at jamb when closing at the Washer/Dryer room. As a result the door will not close properly. Repairs are needed.

A qualified person should repair or replace as needed.

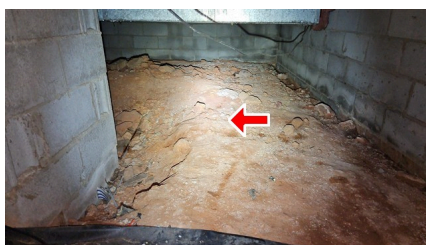
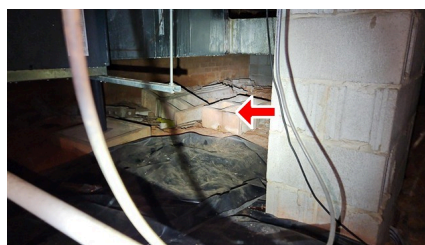
1. The vapor barrier (plastic) on the crawlspace ground is missing in over half of crawlspace. A vapor barrier provides added protection to the floor system from moisture or dampness that can enter from ground. Repairs are needed.

A qualified person should repair or replace as needed.

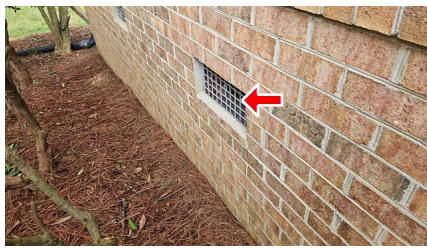
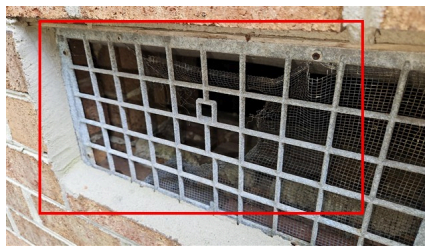
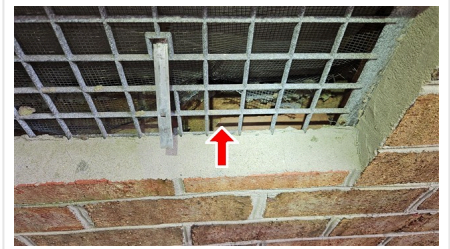
1. The screen for foundation vent(s) damaged at the exterior. Rodents, reptiles or insects could enter into crawlspace. Repairs are needed.

A qualified person should repair or replace as needed.

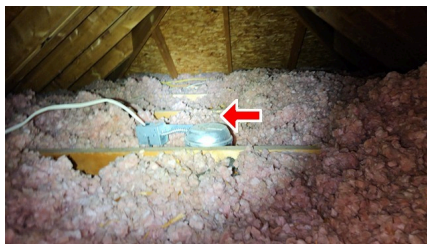
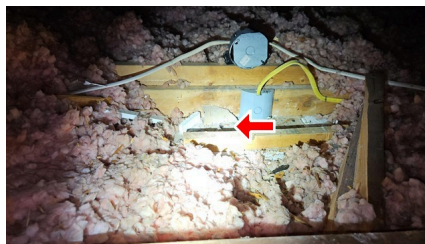
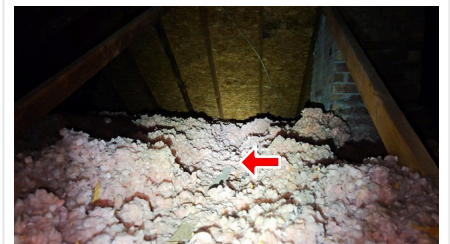
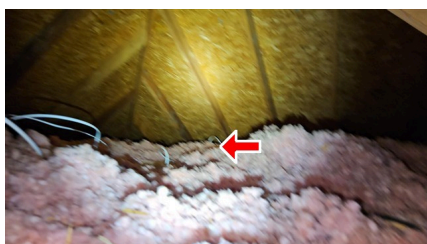
1. Fiberglass (loose-fill) insulation is compressed in areas of the attic due to foot traffic or missing in attic. Heat loss can occur more on this home than one that is properly insulated. Repairs are needed. Repairs are needed.

A qualified person should repair or replace as needed.

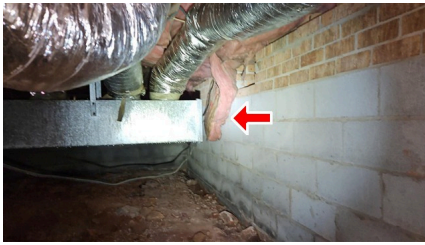
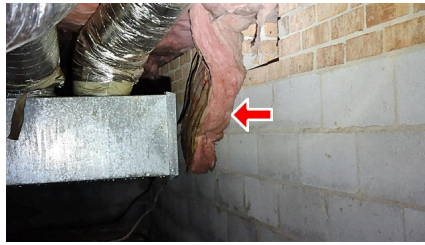
1. The insulation is loose/fallen in the crawlspace. Heat loss can occur more on this home than one that is properly insulated. Repairs are needed..

A qualified person should repair or replace as needed.

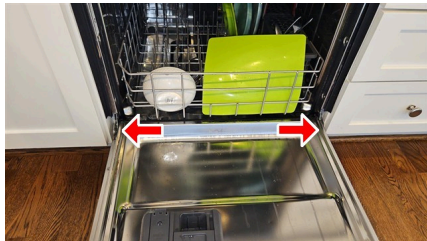
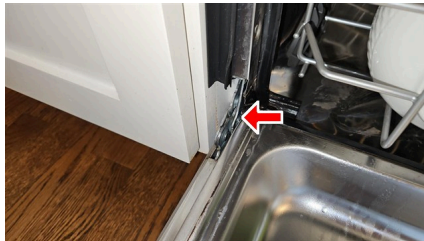
1. The dishwasher door springs are weak. The door springs need replacing if parts are available. I recommend repair as necessary.

A qualified licensed plumber should repair or correct as needed.

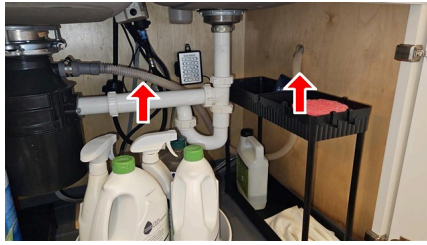
10.0 Item 3 (Picture)

1. The dishwasher drain hose needs to be looped above the level of the kitchen sink drain or an approved air gap installed to prevent back flow of waste water into the water supply. (food safety issue) This can allow waste for the sink to contaminate the dishwasher. This is a small repair.

A qualified licensed plumber should repair or correct as needed.
