INSPECTION REPORT  
113 Ivy Hollow Ln  
Mooreville NC 28117

INSPECTED BY  
Alex Parr 3692  
Above Parr Home  
Inspections

INSPECTION DATE  
📅 11/29/2023  
🕒 02:00:00 PM

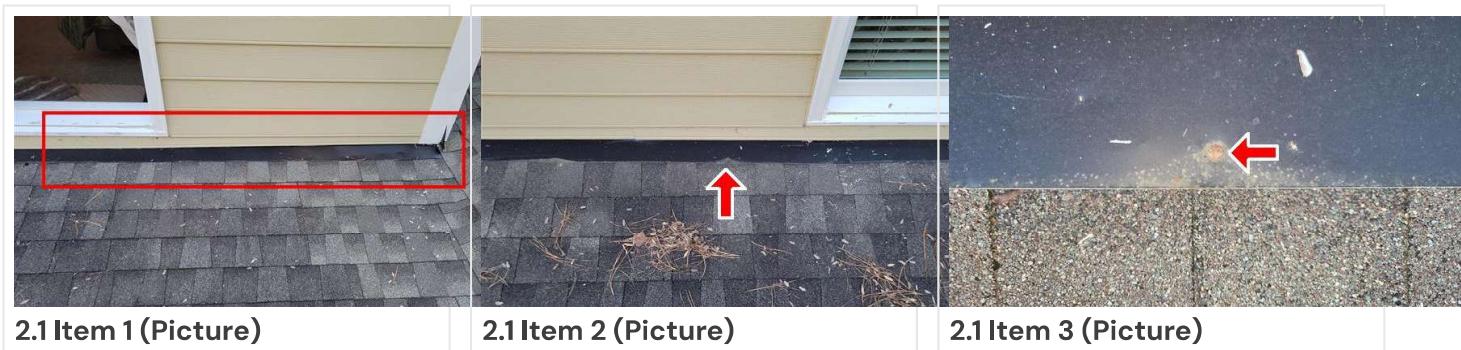
1. The flashing at the rear of the home is not sealed properly. This could allow water damage to occur to the home. Further investigation and repairs are needed

A qualified person should repair or replace as needed.

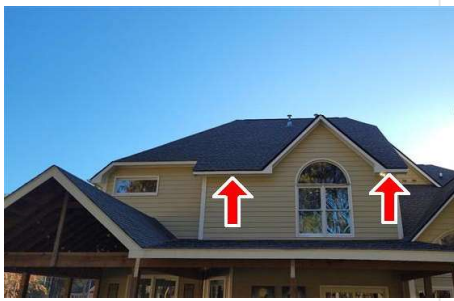
2.3 Item 1 (Picture)

1. The rear of the home made need gutters at the upper roof. If a gutter is not installed it may prematurely deteriorate the roof blow. Further investigation is needed.

A qualified contractor should inspect and repair as needed.

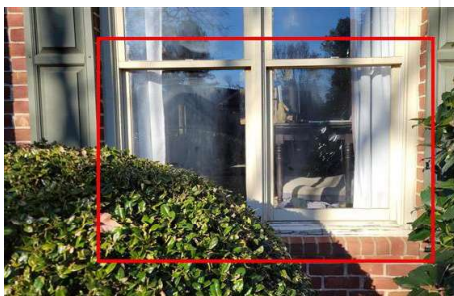
3.2 Item 1 (Picture)

1. The some windows are deteriorated at rear of home. Because of the extent of deterioration it is possible for some framing in wall to be deteriorated. Further investigation and repairs are needed. A qualified contractor should inspect and repair as needed.

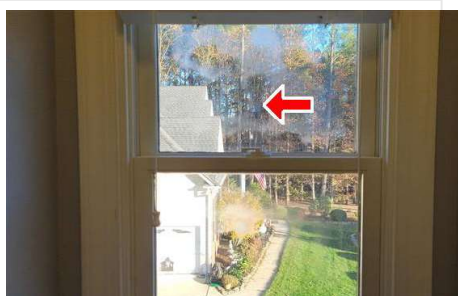
3.2 Item 12 (Picture)

1. Several windows have failed/compromised thermal seals/fogged window panes. This is indicated by the visible moisture, discoloration, calcium deposits and or crystallization visible between the glass window panes. A certified window technician should recheck all the windows throughout the home. Due to weather conditions many times compromised/failed windows cannot be identified at the time of inspection. Further investigation and repairs are needed.

We recommend contacting a properly licensed window technician/contractor regarding these conditions and have repairs made deemed appropriate

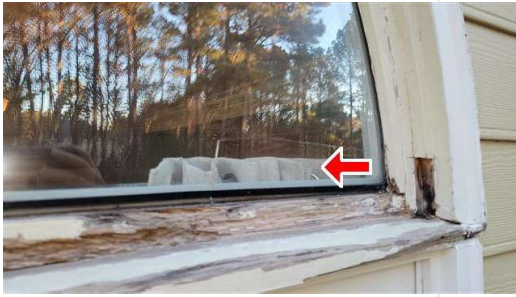
3.2 Item 15 (Picture)

1. The master bedroom window is cracked. Cracked glass should be replaced to prevent an injury from occurring. Repairs are needed

I recommend a qualified contractor inspect and repair as needed.

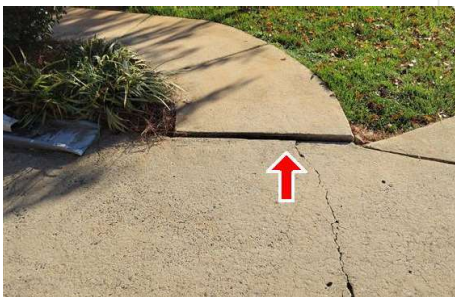
3.5 Item 1 (Picture)

1. The concrete drive at the left side (facing front) has dropped or settled causing a steep or uneven step. A fall or injury can occur if not corrected. Repairs are needed.

A qualified person should repair or replace as needed.

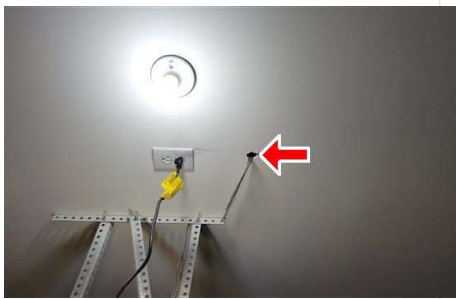
3.8 Item 1 (Picture)

1. The fire protection wall that separates garage from heated space is compromised. This is considered unsafe until corrected. Repairs are needed.

A qualified person should correct for safety.

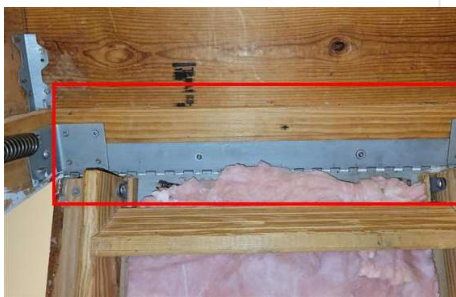
4.4 Item 1 (Picture)

1. The pull down stairs for the attic is installed with deck screws. The only approved means of securing attic stairs is a 16 penny nail per manufacture. An injury could occur if not corrected. Repairs are needed.

A qualified person should repair or replace as needed.

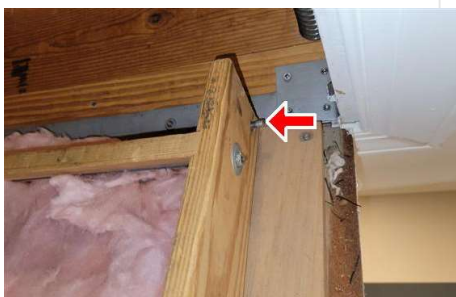
4.4 Item 4 (Picture)

1. The attic stairs is missing hardware. Injury could result if not repaired. Repairs are needed.

A qualified person should repair or replace as needed.

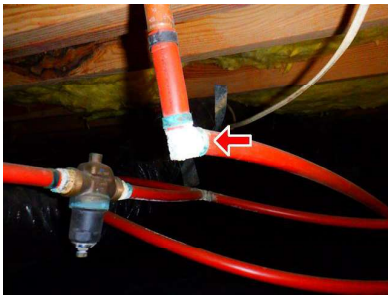
5.2 Item 1 (Picture)

1. The PEX fitting has a corroded joints at connection in the crawlspace. Repairs are needed to prevent water damage from occurring to the home. Further investigation and repairs are needed.

I recommend having all the plumbing supply lines for the home evaluated.

A qualified licensed plumber should repair or correct as needed.

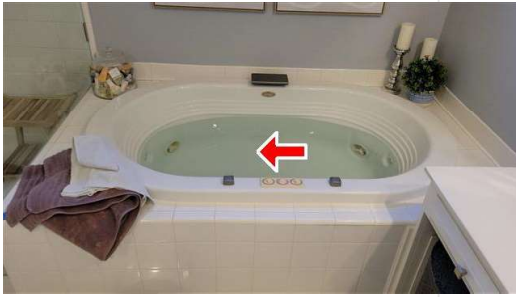
5.4 Item 1 (Picture)

1. The jacuzzi tub in the master bath did not function at the time of inspection. Further investigation and repairs are needed.

I recommend a qualified licensed plumber repair or correct as needed.

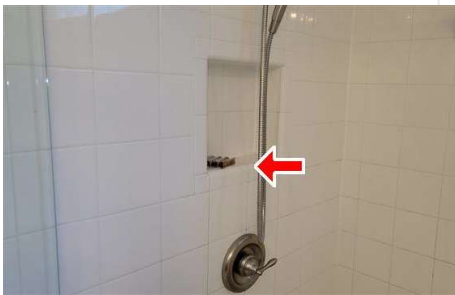
5.5 Item 1 (Picture)

1. The tile shelf in the master bath is sloped improperly. This can cause water damage to occur to the home. Further investigation and repairs are needed.

I recommend a qualified contractor inspect and repair as needed.

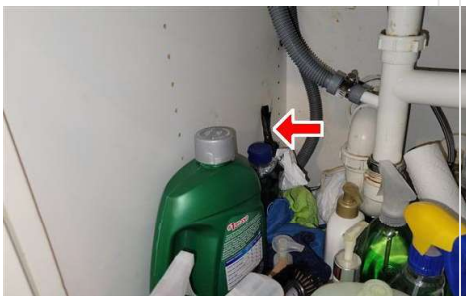
**6.4 Item 2 (Picture)**

1. The wire underneath the kitchen sink was improperly terminated. This is a safety issue that needs to be corrected. Repairs are needed.

A qualified licensed electrical contractor should correct as needed.

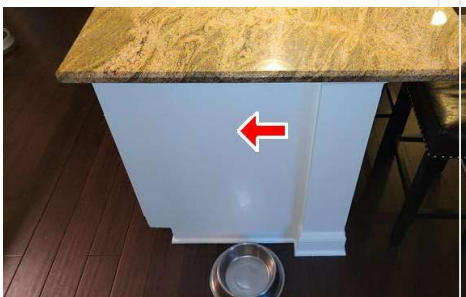
**6.4 Item 4 (Picture)**

1. The outlet or outlets are missing at the kitchen island. Further investigation and repairs are needed..

A qualified licensed electrical contractor should correct as needed.

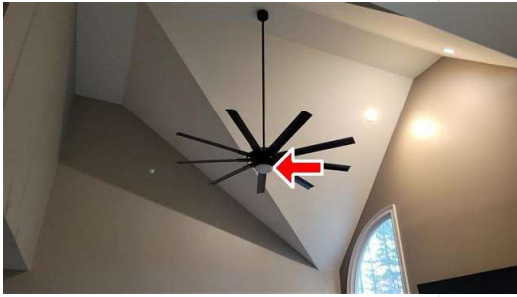
6.4 Item 6 (Picture)

1. The remote for the fan in the living room was missing at the time of inspection. Therefore I was unable to test or inspect the operation of the fan. This is an inspection limitation and for your information. Further investigation is needed

A qualified licensed electrical contractor should correct as needed.

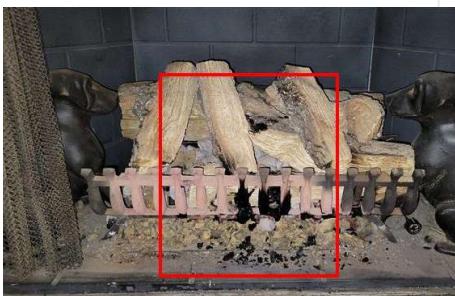
7.7 Item 1 (Picture)

1. The black soot build-up indicates that Gas Fire logs do not appear to be arranged or positioned according to manufacturer's specs. If logs are not positioned correctly, carbon monoxide can be produced. Further investigation and repairs are needed.

A qualified contractor should inspect and repair as needed.

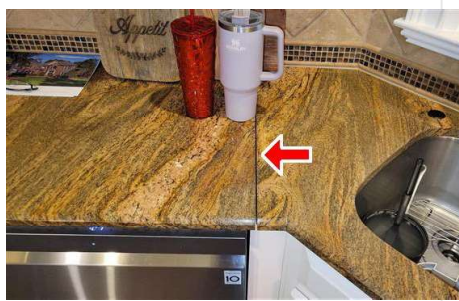
8.4 Item 1 (Picture)

1. Countertop (left of sink) is not sealed. This may allow for water damage to occur. Further investigation and repairs are needed.

A qualified person should repair or replace as needed.

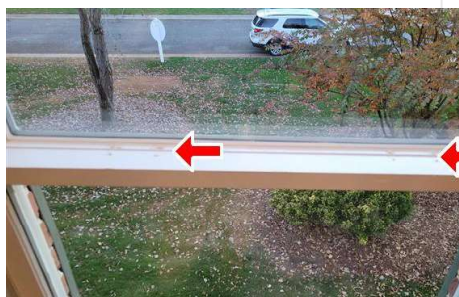
8.6 Item 1 (Picture)

1. Numerous windows is damaged at lock hardware at the throughout the home. As a result you can not lock the window. Repairs are needed.

A qualified person should repair or replace as needed.

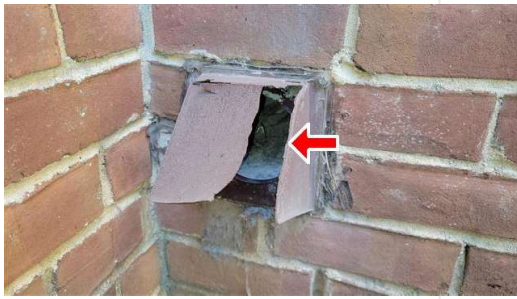
9.5 Item 1 (Picture)

1. The dryer vent piping has a damaged vent hood outside. this could allow pest or rodents into the home. I recommend repair as needed.

A qualified person should repair or replace as needed.

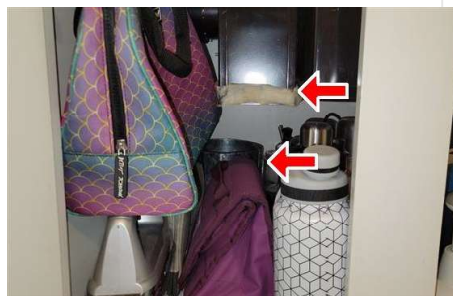
10.2 Item 1 (Picture)

1. The downdraft fan vents into the cabinet and should vent to the outside. This is a fire hazard. I recommend repair or replace as needed.

I recommend contacting appliance repair company.

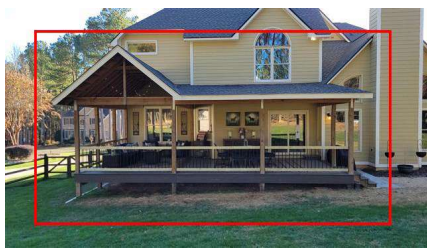
1.1 Item 1 (Picture)

1. The deck and covered porch at the rear of the home are still under construction. As a result the areas were not inspected. Hidden damage may be present. Further investigation and repairs are needed.

We recommend having all personal items removed and these areas inspected prior to closing.

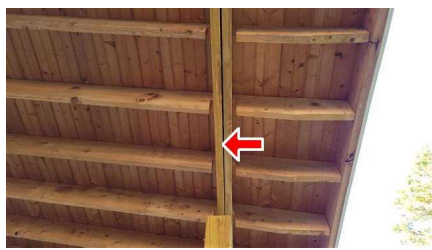
1.1 Item 2 (Picture)

1. The deck and covered porch at the rear of the home are still under construction. As a result the areas were not inspected. Hidden damage may be present. Further investigation and repairs are needed.

We recommend having all personal items removed and these areas inspected prior to closing.

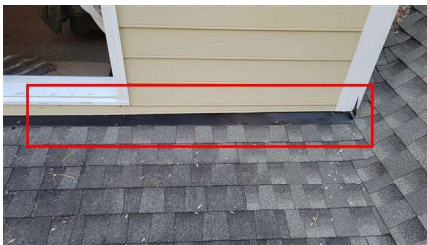
2.1 Item 1 (Picture)

1. The flashing at the rear of the home is not sealed properly. This could allow water damage to occur to the home. Further investigation and repairs are needed

A qualified person should repair or replace as needed.

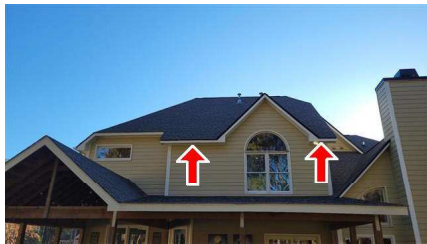
2.3 Item 1 (Picture)

1. The rear of the home made need gutters at the upper roof. If a gutter is not installed it may prematurely deteriorate the roof blow. Further investigation is needed.

A qualified contractor should inspect and repair as needed.

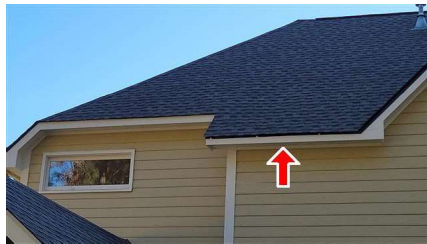
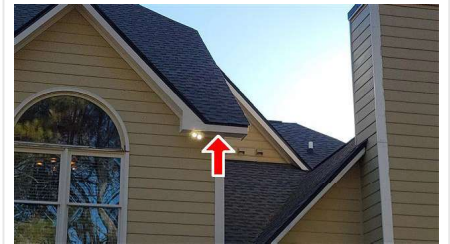
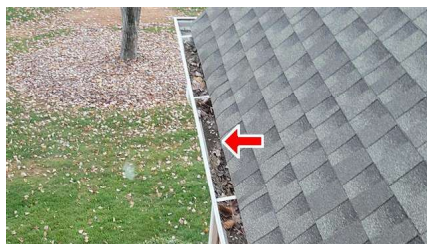
1. The gutter is clogged at the virtually all areas where gutters are installed. Gutters that drain poorly or clogged can lead to many costly problems such as deterioration of fascia, soffit or roof edge. It can also cause gutters to pull loose and lead to possible water intrusion.

A qualified person should repair or replace as needed.

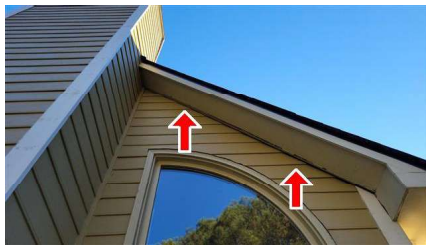
3.0 Item 1 (Picture)

1. The Wood trim at the rear of home is missing. Deterioration can eventually occur if not corrected. Repairs are needed.

A qualified person should repair or replace as needed.

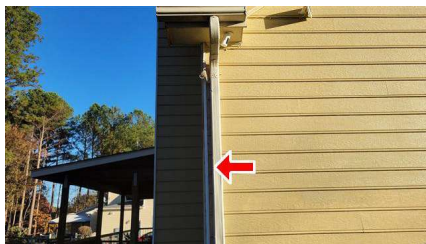
3.0 Item 4 (Picture)

1. The wood trim at the left side (facing front) installed improperly or not according to standard workmanlike practices. Deterioration can eventually occur if not corrected. Repairs are needed.

A qualified person should repair or replace as needed.

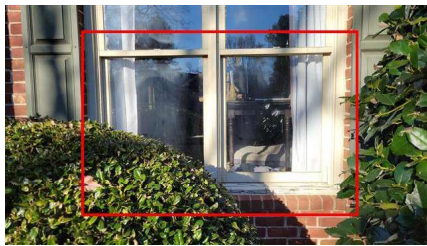
3.2 Item 1 (Picture)

1. The some windows are deteriorated at rear of home. Because of the extent of deterioration it is possible for some framing in wall to be deteriorated. Further investigation and repairs are needed. A qualified contractor should inspect and repair as needed.

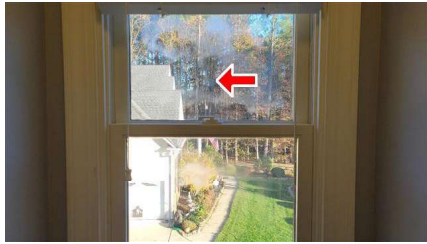
3.2 Item 12 (Picture)

1. Several windows have failed/compromised thermal seals/fogged window panes. This is indicated by the visible moisture, discoloration, calcium deposits and or crystallization visible between the glass window panes. A certified window technician should recheck all the windows throughout the home. Due to weather conditions many times compromised/failed windows cannot be identified at the time of inspection. Further investigation and repairs are needed.

We recommend contacting a properly licensed window technician/contractor regarding these conditions and have repairs made deemed appropriate

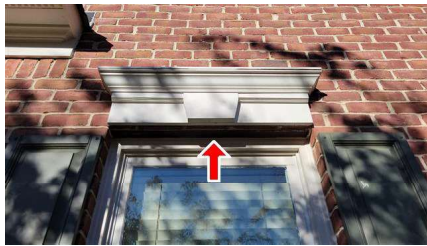
3.2 Item 16 (Picture)

1. The steel lintels around the exterior of the home are beginning to rust or have rust present. A lintel is a horizontal architectural member or steel beam support placed over a wall opening to carry the weight of the masonry placed over it. In most situation, the lintel above you windows and doors will be steel angle iron or I beam. Either due to age or improper rust proofing or weep chord and flashing placement during installation, lintels will begin to rust. Rusting lintels can expand to become much thicker then their original size. The expansive forces of rusting steel can shift entire multi-story elevations. If your lintels are currently rusting, a telltale sign of expansion is diagonal "step" pattern cracks, which can be found on either end of the window or door opening. Repairs are needed to prevent further damage to the structure. Further deterioration may occur if not repaired.

I recommend a qualified contractor inspect and repair as needed.

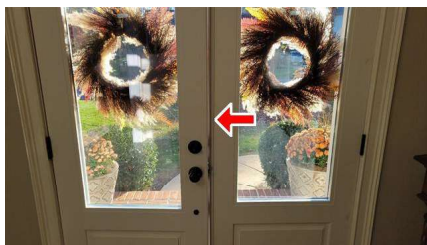
3.3 Item 1 (Picture)

1. The main entry door rubs the other door when closing. As a result the door will not close properly. Further investigation and repairs are needed.

A qualified person should repair or replace as needed.

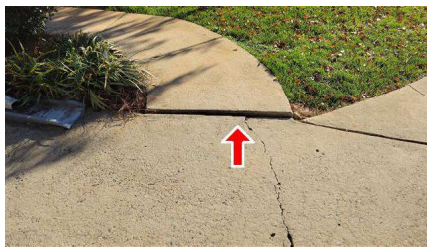
3.5 Item 1 (Picture)

1. The concrete drive at the left side (facing front) has dropped or settled causing a steep or uneven step. A fall or injury can occur if not corrected. Repairs are needed.

A qualified person should repair or replace as needed.

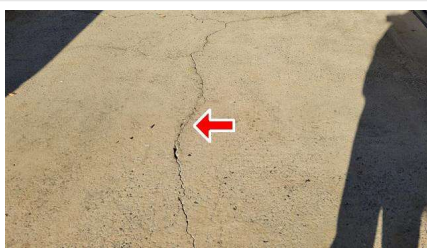
3.5 Item 5 (Picture)

1. The concrete driveway has cracks that should be sealed to prevent further damage, which is part of ongoing maintenance of a concrete driveway that will need to be performed on a regular basis. Repairs are recommended.

A qualified contractor should inspect and repair as needed.

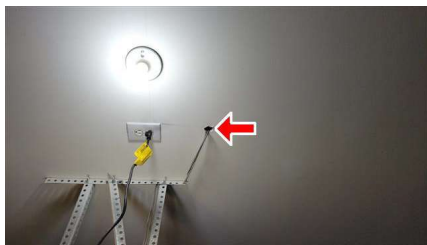
3.8 Item 1 (Picture)

1. The fire protection wall that separates garage from heated space is compromised. This is considered unsafe until corrected. Repairs are needed.

A qualified person should correct for safety.

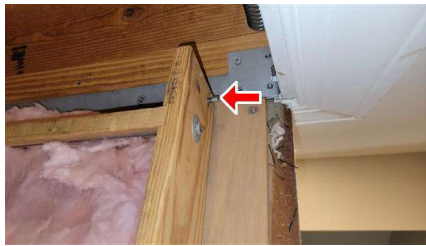
4.4 Item 4 (Picture)

1. The attic stairs is missing hardware. Injury could result if not repaired. Repairs are needed.

A qualified person should repair or replace as needed.

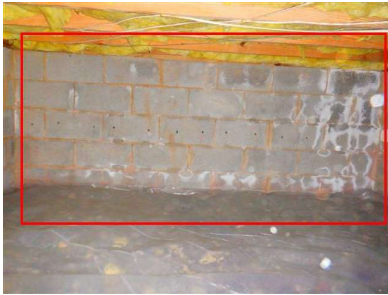
**4.6 Item 1 (Picture)**

1. White efflorescence (powder substance) on block wall indicates moisture is in contact with the masonry. This does not necessarily indicate that intrusion will occur. I recommend checking the gutters and the downspout drain lines for proper operation. Also, a water proofing paint could be applied to the interior side of the block if necessary. Efflorescence is found on many homes without water intrusion occurring inside the home. But, it should alert you to the possibility that future steps may be needed.

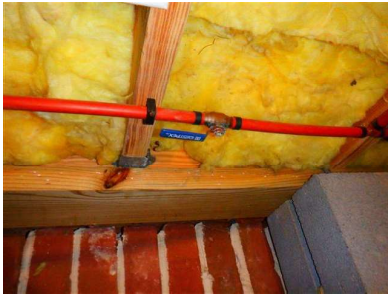
5.0 Item 1 (Picture)

The main shut off is the blue lever located underneath in the crawlspace. This is for your information.

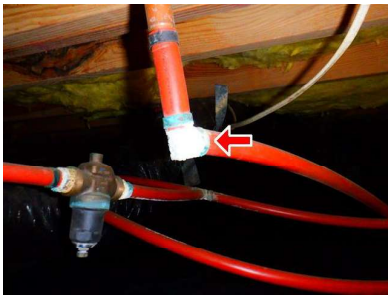
5.2 Item 1 (Picture)

1. The PEX fitting has a corroded joints at connection in the crawlspace. Repairs are needed to prevent water damage from occurring to the home. Further investigation and repairs are needed.

I recommend having all the plumbing supply lines for the home evaluated.

A qualified licensed plumber should repair or correct as needed.

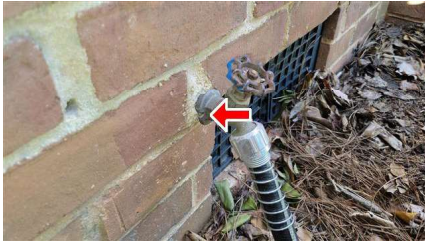
5.2 Item 5 (Picture)

1. The outside water faucet loose, and needs securing to wall at the front of home. This can allow

undue stress to occur on supply lines allowing leaks to occur. Repairs are needed..  
A qualified licensed plumber should repair or correct as needed.

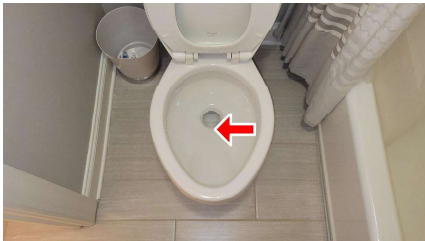
5.3 Item 1 (Picture)

1. The toilet is loose at floor at the bath. Repairs may involve re-setting the toilet on a new wax seal.  
Repairs are needed.

I recommend a qualified licensed plumber repair or correct as needed.

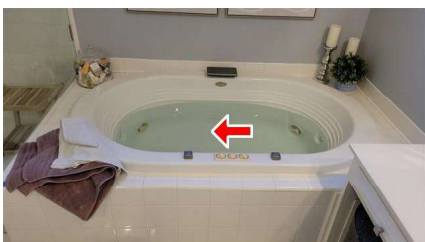
5.4 Item 1 (Picture)

1. The jacuzzi tub in the master bath did not function at the time of inspection. Further investigation and repairs are needed.

I recommend a qualified licensed plumber repair or correct as needed.

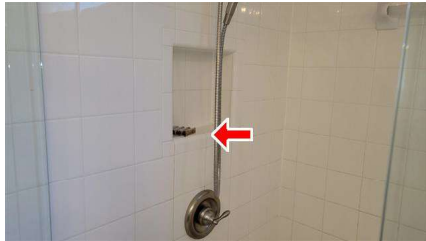
5.5 Item 1 (Picture)

1. The tile shelf in the master bath is sloped improperly. This can cause water damage to occur to the home. Further investigation and repairs are needed.

I recommend a qualified contractor inspect and repair as needed.

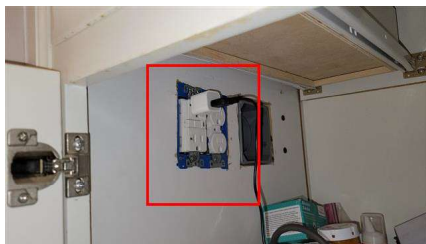
**6.4 Item 1 (Picture)**

1. At least one is cover-plate in the guest bath. This is a safety issue that needs to be corrected.  
Repairs are needed.

A qualified licensed electrical contractor should correct as needed.

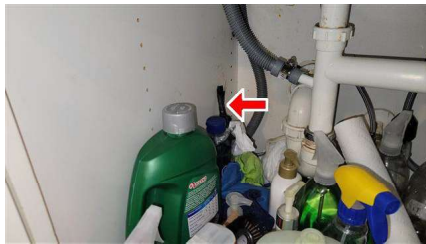
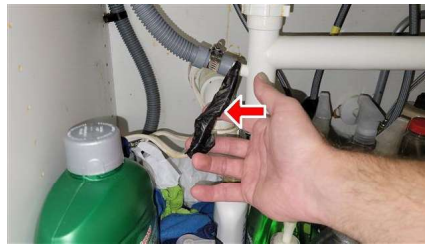
1. The wire underneath the kitchen sink was improperly terminated. This is a safety issue that needs to be corrected. Repairs are needed.

A qualified licensed electrical contractor should correct as needed.

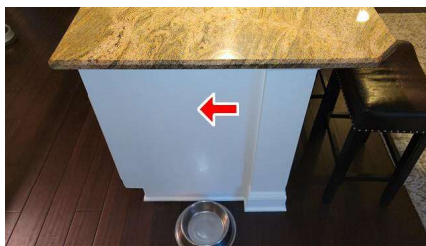
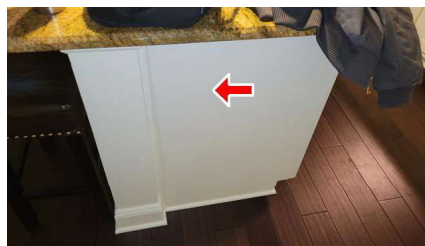
1. The outlet or outlets are missing at the kitchen island. Further investigation and repairs are needed..

A qualified licensed electrical contractor should correct as needed.

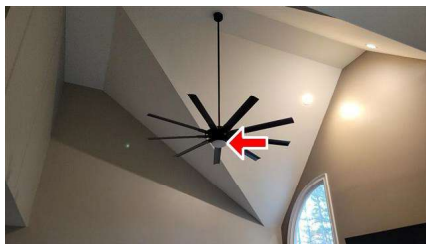
6.4 Item 6 (Picture)

1. The remote for the fan in the living room was missing at the time of inspection. Therefore I was unable to test or inspect the operation of the fan. This is an inspection limitation and for your information. Further investigation is needed

A qualified licensed electrical contractor should correct as needed.

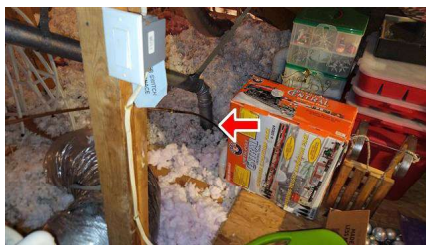
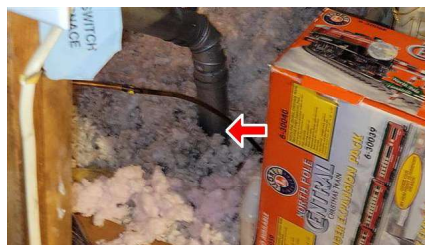
1. The vent pipe for gas water hear needs a 1 inch clearance from combustibles. This is a safety issue and should be repaired. Repairs are needed.

I recommend a qualified licensed heat contractor inspect further and repair as needed.

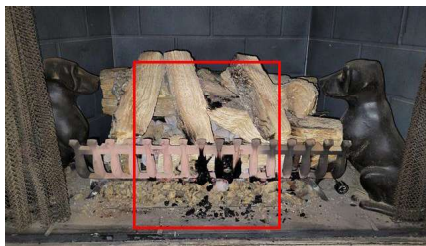
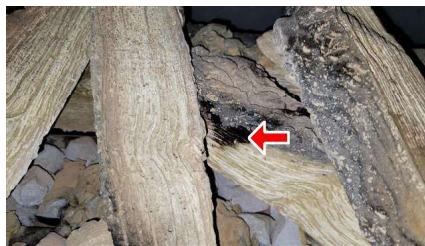
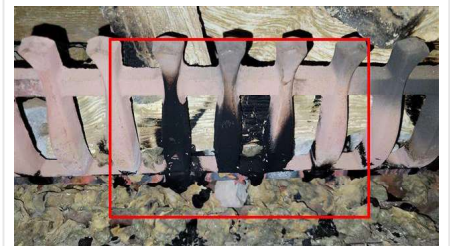
1. The black soot build-up indicates that Gas Fire logs do not appear to be arranged or positioned according to manufacturer's specs. If logs are not positioned correctly, carbon monoxide can be produced. Further investigation and repairs are needed.

A qualified contractor should inspect and repair as needed.

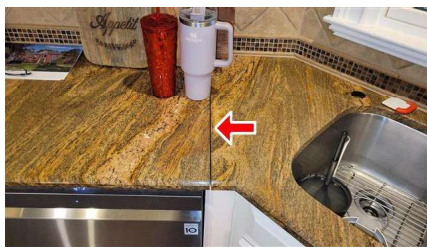
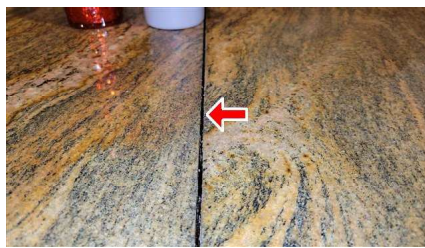
1. Countertop (left of sink) is not sealed. This may allow for water damage to occur. Further investigation and repairs are needed.

A qualified person should repair or replace as needed.

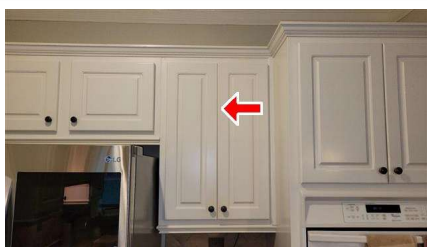
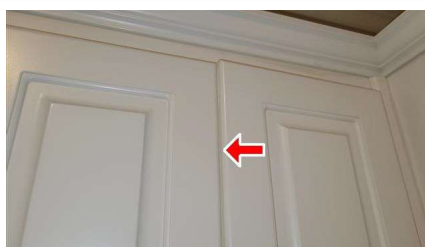
1. Cabinet door rubs the other cabinet door (right of refrigerator). Recommend repair or replace as necessary.

A qualified person should repair or replace as needed.

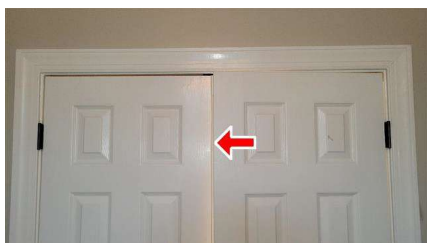
8.5 Item 1 (Picture)

1. The double doors needs adjustment at the master bedroom. As a result the door will not close properly. Repairs are needed.

A qualified person should repair or replace as needed.

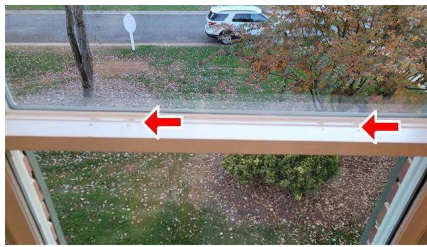
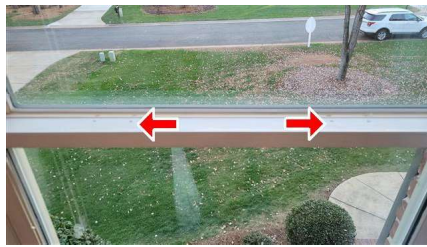
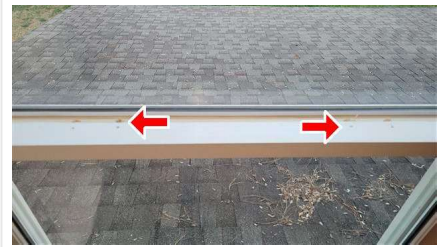
1. Numerous windows is damaged at lock hardware at the throughout the home. As a result you can not lock the window. Repairs are needed.

A qualified person should repair or replace as needed.

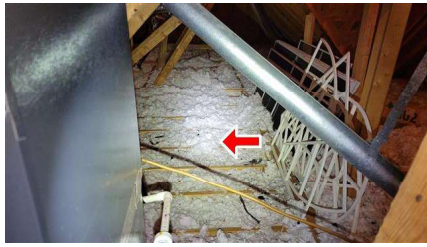
9.2 Item 1 (Picture)

1. Fiberglass (loose-fill) insulation is old and has settled, and less than six inches in thickness remains. in attic. Heat loss can occur more on this home than one that is properly insulated. Repairs are needed..

A qualified person should repair or replace as needed.

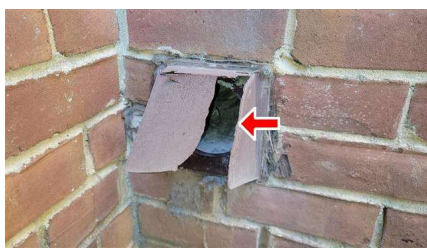
9.5 Item 1 (Picture)

1. The dryer vent piping has a damaged vent hood outside. this could allow pest or rodents into the home. I recommend repair as needed.

A qualified person should repair or replace as needed.

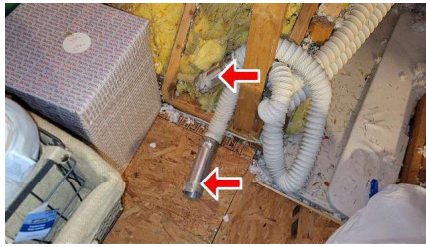
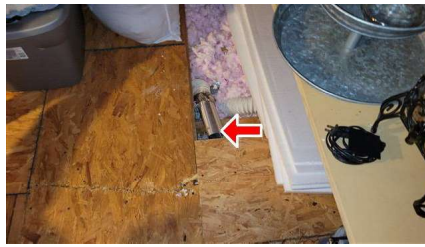
1. The exhaust fans does not vent to outside at the guest baths and master bath. Vent pipes that terminate in attic space can sometimes cause moisture that can lead to mold or cause condensation. Repairs are needed.

A qualified person should repair or replace as needed.

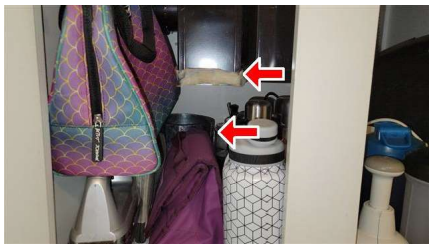
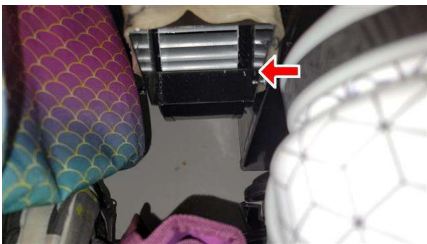
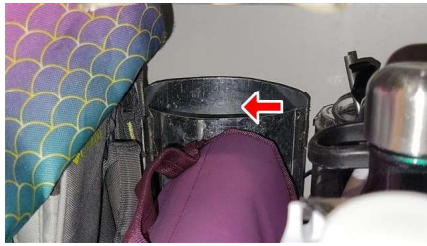
1. The downdraft fan vents into the cabinet and should vent to the outside. This is a fire hazard. I recommend repair or replace as needed.

I recommend contacting appliance repair company.
