INSPECTION REPORT  
1135 Brook Path Trail  
Denver NC 28037

INSPECTED BY  
Alex Parr 3692  
Above Parr Home  
Inspections

INSPECTION DATE  
📅 5/21/2025  
🕒 09:00:00 AM

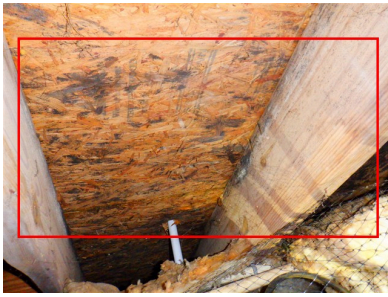
1.0 Item 1 (Picture)

1. Discoloration and some type of mold (Microbial) growth is present in the structure at several areas including but not limited to the crawl space and interior spaces. Evidence suggests that this condition is from a past or present elevated moisture conditions. We did not inspect, test or determine if this type of substance is or is not a health hazard. Further investigation is needed.

We recommend you contact a properly licensed expert for testing, investigation and or correction as deemed appropriate.

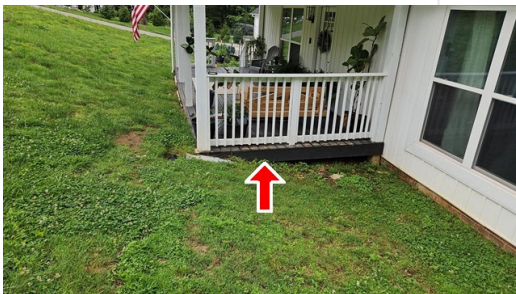
1.1 Item 1 (Picture)

1. The framing and foundation of the deck were not inspected as the deck was too low to the ground for inspector to enter below. Hidden damage may be present.

I recommend contacting a licensed contractor for further evaluation.

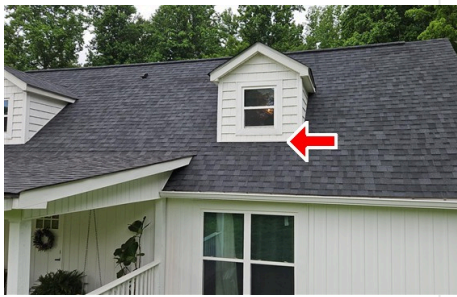
2.0 Item 1 (Picture)

1. The roof shingle at the front of home has an exposed nail. This may allow water intrusion to occur. Further investigation and repairs are needed.

A qualified person should repair or replace as needed.

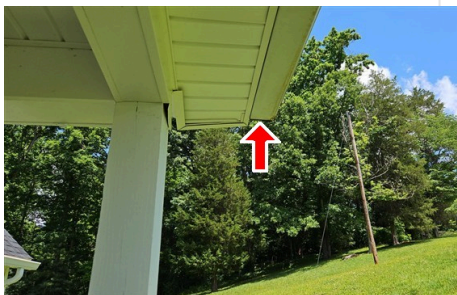
2.3 Item 1 (Picture)

1. The gutter leaks at seam (s) at the front (right of main entry). Gutters that drain poorly or clogged can lead to many costly problems such as deterioration of fascia, soffit or roof edge. It can also cause gutters to pull loose and lead to possible water intrusion. Repairs are needed.

A qualified person should repair or replace as needed.

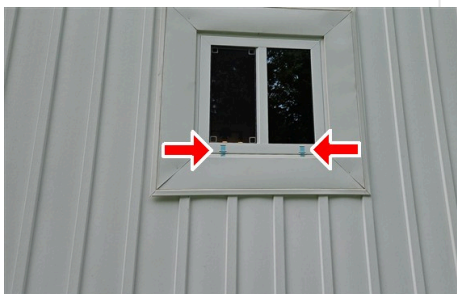
3.2 Item 1 (Picture)

1. The window drain is taped shut at the right side of the home. Deterioration may occur if not repaired. Repairs are needed.

I recommend a qualified contractor inspect and repair as needed.

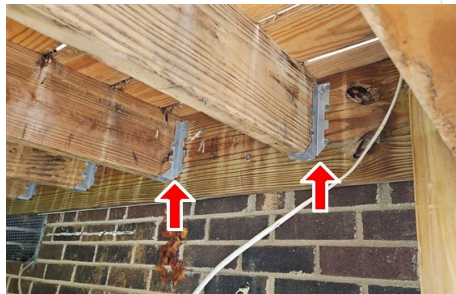
3.4 Item 1 (Picture)

1. The floor joist hangers for the deck at the rear of home are fastened improperly. A more proper repair is needed to ensure stability or an injury might occur. Further investigation and repairs are needed. I recommend having the entire deck evaluated for structural stability.

A qualified contractor should repair or replace as needed.

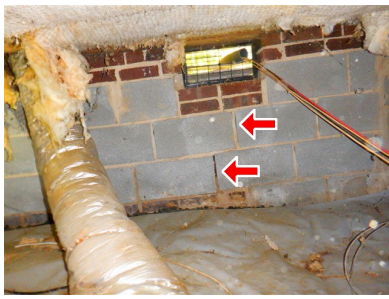
4.0 Item 1 (Picture)

1. The foundation wall in the crawlspace has cracks present. The wall(s) may need reinforcement. Further investigation and repairs are needed. A qualified licensed general contractor should inspect further and repair as needed.

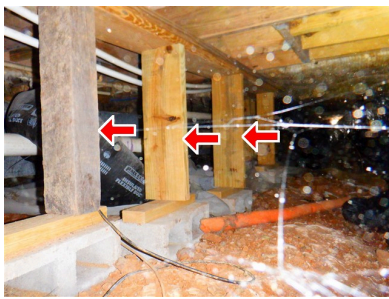
4.1 Item 1 (Picture)

1. Temporary wood support posts have been added in the crawlspace. All piers should be masonry. All piers should be examined for signs of settlement condition and their adequacy in accepting bearing loads. Those that are deficient should be repaired or replaced to prevent further foundation issues and movement. Not addressing these issues could result in further floor system movement and other foundation issues. Further investigation and repairs are needed.

A qualified licensed general contractor should inspect further and repair as needed.

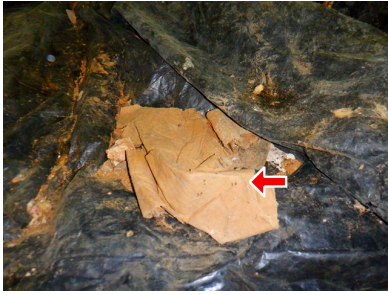
4.5 Item 1 (Picture)

1. Wood debris is in contact with the crawlspace floor in numerous areas. This can attract wood destroying organisms. Removal is needed.

A qualified contractor should inspect and repair as needed.

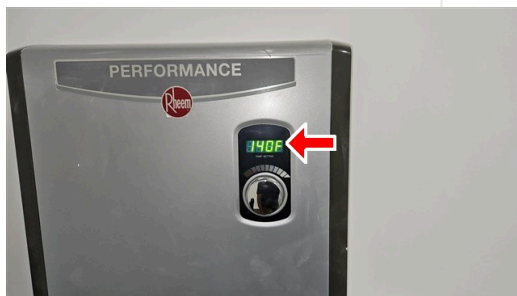
5.1 Item 1 (Picture)

1. The water heater is set over the recommended temperature. (Over 120) The risk is especially acute for infants, children, and the elderly. Water temperatures should never be set higher than 120 degrees.

This is a safety issue. Repairs are needed

A qualified contractor should inspect and repair as needed.

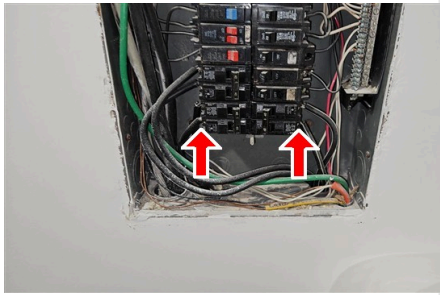
6.2 Item 1 (Picture)

1. Wires were observed to be cut down to fit circuit breakers in the sub panel. This often leads to wires that can overheat. Electrical issues are considered a hazard until repaired. Further investigation and repairs are needed.

A qualified licensed electrical contractor should correct as needed.

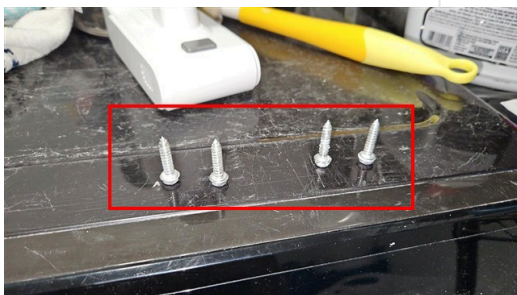
6.2 Item 4 (Picture)

1. The electrical panel cover sub panel has been secured with sheet metal screws. This is considered unsafe as sheet metal screws are not rated for electrical panel use. The use of sheet metal screws with panel cover has been known to short hot wires, as they can pierce the branch wiring protective coverings. (Safety Issue) Repairs are needed.

A qualified licensed electrical contractor should correct as needed.

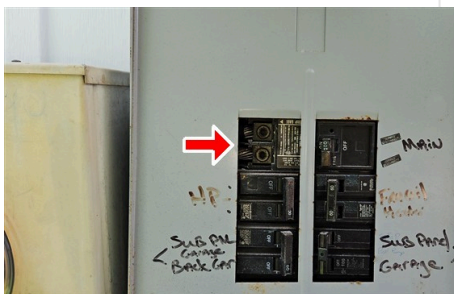
6.2 Item 5 (Picture)

1. The main panel has missing knockouts. (safety issue) Unused openings in panel equipment need to be closed. Covering these openings helps to prevent accidental shocks (think of kids), helps to prevent pests from entering. Repairs are needed.

A qualified licensed electrical contractor should correct as needed.

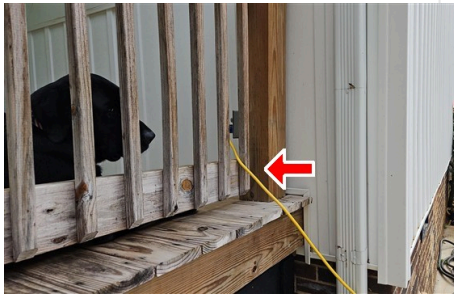
6.4 Item 1 (Picture)

1. The septic pump an extension cord as permanent wiring at the exterior. Electrical issues are considered a hazard until repaired. Further investigation and repairs are needed.

A qualified licensed electrical contractor should correct as needed.

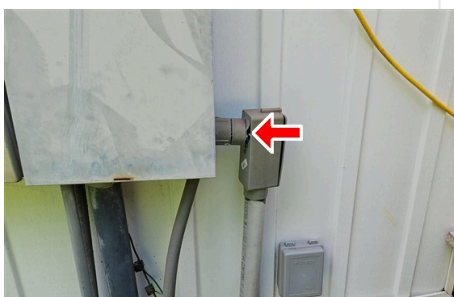
6.4 Item 5 (Picture)

1. The electrical conduit at the rear of the home is damaged. This may allow for water intrusion to occur. Further investigation and repairs are needed..

I recommend a qualified licensed electrical contractor correct.

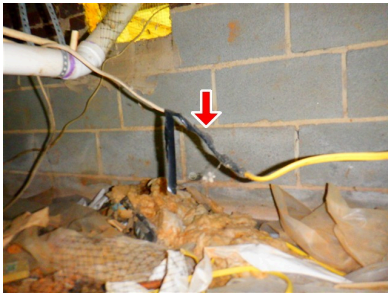
6.4 Item 8 (Picture)

1. Several open splices needs electrical splice placed inside access panel, or install inside a box with cover-plate in the crawlspace. Electrical wires laying on the ground. Electrical issues are considered a hazard until repaired. Further investigation and repairs are needed.

A qualified licensed electrical contractor should correct as needed.

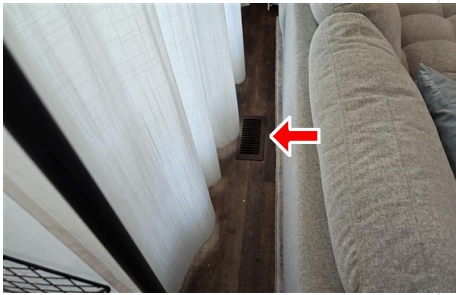
7.3 Item 1 (Picture)

1. The supply register in floor is weak (not intended for floor) throughout the home. This is a safety issue and should be repaired. A replacement is needed.

A qualified HVAC person should inspect further and repair or replace as needed.

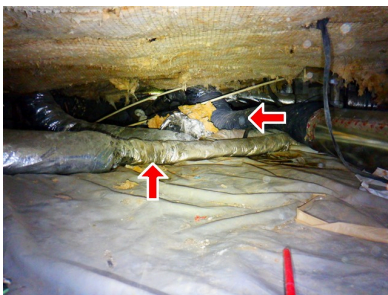
7.3 Item 5 (Picture)

1. The supply and return duct pipe are damaged and is in contact with ground and may deteriorate if not corrected in the crawlspace. Energy loss is occurring in crawlspace and immediate correction is needed. A minimum of four inches of clearance from the ground is needed to prevent deterioration to ductwork. Further investigation and repairs are needed.

I recommend having the homes entire ductwork system evaluated.

A qualified HVAC person should inspect further and repair or replace as needed.

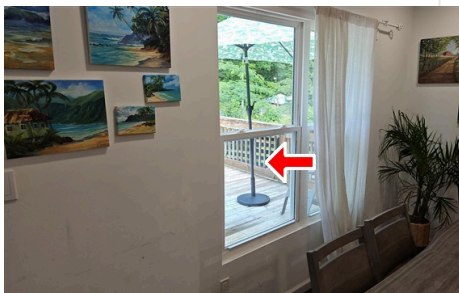
8.6 Item 1 (Picture)

1. One window does not lock properly at the dining room. As a result you can not lock the window. Further investigation and repairs are needed.

A qualified contractor should inspect and repair as needed.

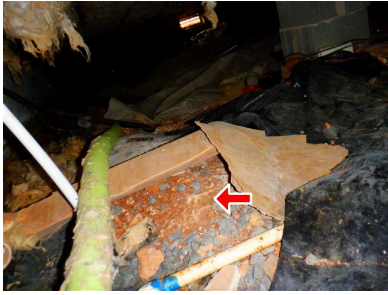
9.0 Item 1 (Picture)

1. The vapor barrier (plastic) on the crawlspace ground is missing in areas. A vapor barrier provides added protection to the floor system from moisture or dampness that can enter from ground. Repairs are needed.

A qualified person should repair or replace as needed.

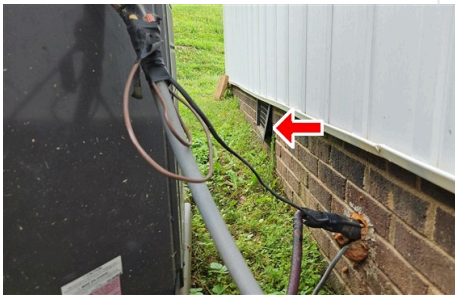
9.1 Item 1 (Picture)

1. The foundation vents are missing screens and or loose at the exterior. Rodents, reptiles or insects could enter into crawlspace. Repairs are needed.

A qualified person should repair or replace as needed.

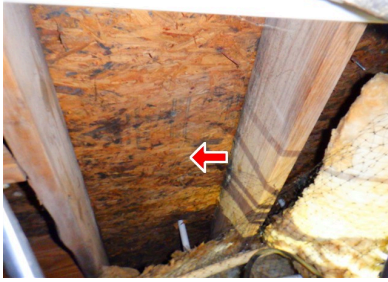
9.3 Item 1 (Picture)

1. The insulation is missing is deteriorated in areas in the crawlspace. Heat loss can occur more on this home than one that is properly insulated. Repairs are needed.

A qualified contractor should inspect and repair as needed.

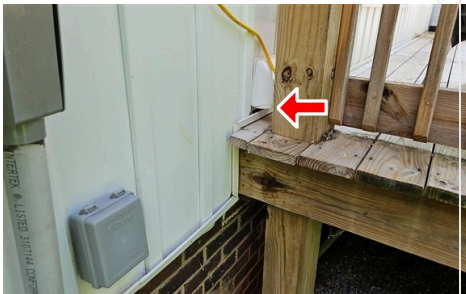
9.5 Item 1 (Picture)

1. The dryer vent hood at the rear of home does not have the proper clearance from the grade/ground to function as intended. Dryer vent exhaust shall terminate not less than 12 inches above finish grade to prevent blockages. Current conditions should be considered a fire hazard until repaired. Repairs are needed.

A qualified person should repair or replace as needed.

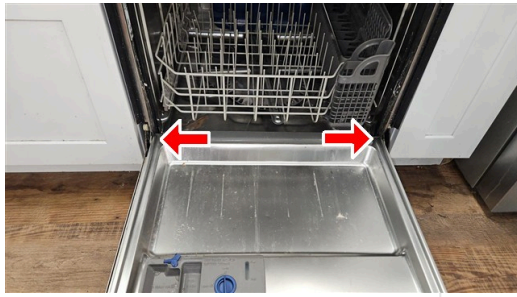
10.0 Item 1 (Picture)

1. The dishwasher door springs are damaged. The door springs need replacing if parts are available is damaged. I recommend repair as necessary.

I recommend contacting appliance repair company.

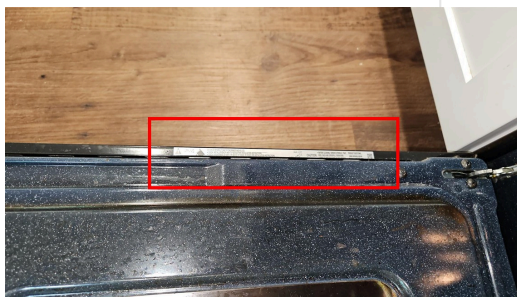
10.1 Item 1 (Picture)

1. The range/oven needs to be properly attached/anchored to the structure as to keep it from tipping over when the oven door is opened and/or oven racks are pulled out during use. This is a safety issue. Repairs are needed.

I recommend contacting appliance repair company.

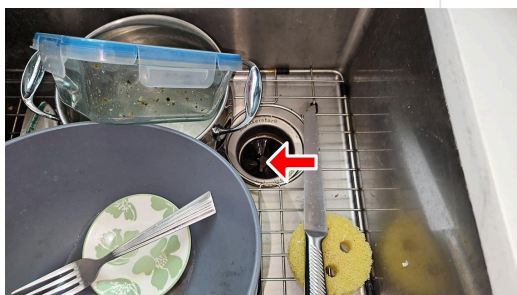
10.3 Item 1 (Picture)

1. The food disposer has an obstruction inside. I recommend repair as needed.

I recommend contacting a plumber to make repairs.

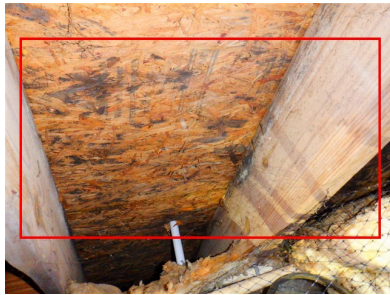
1.0 Item 1 (Picture)

1. Discoloration and some type of mold (Microbial) growth is present in the structure at several areas including but not limited to the crawl space and interior spaces. Evidence suggests that this condition is from a past or present elevated moisture conditions. We did not inspect, test or determine if this type of substance is or is not a health hazard. Further investigation is needed.

We recommend you contact a properly licensed expert for testing, investigation and or correction as deemed appropriate.

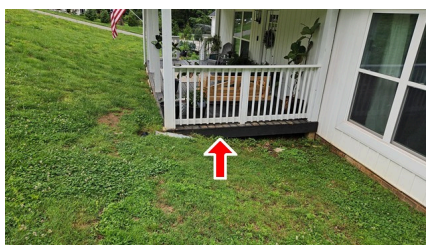
1.1 Item 1 (Picture)

1. The framing and foundation of the deck were not inspected as the deck was too low to the ground for inspector to enter below. Hidden damage may be present.

I recommend contacting a licensed contractor for further evaluation.

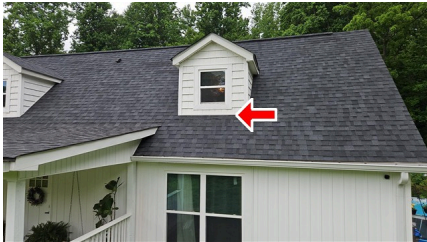
2.0 Item 1 (Picture)

1. The roof shingle at the front of home has an exposed nail. This may allow water intrusion to occur. Further investigation and repairs are needed.

A qualified person should repair or replace as needed.

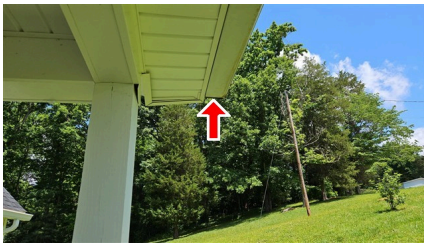
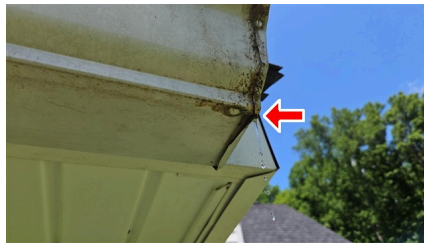
1. The gutter leaks at seam (s) at the front (right of main entry). Gutters that drain poorly or clogged can lead to many costly problems such as deterioration of fascia, soffit or roof edge. It can also cause gutters to pull loose and lead to possible water intrusion. Repairs are needed.

A qualified person should repair or replace as needed.

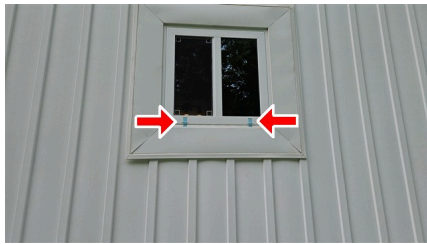
3.2 Item 1 (Picture)

1. The window drain is taped shut at the right side of the home. Deterioration may occur if not repaired. Repairs are needed.

I recommend a qualified contractor inspect and repair as needed.

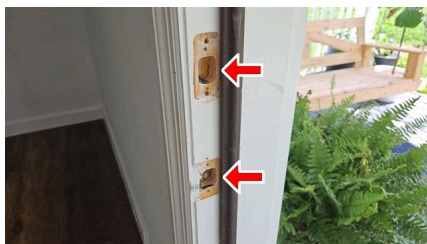
3.3 Item 1 (Picture)

1. The strike plates for the main entry door are missing. Repairs are needed.

I recommend a qualified contractor inspect and repair as needed.

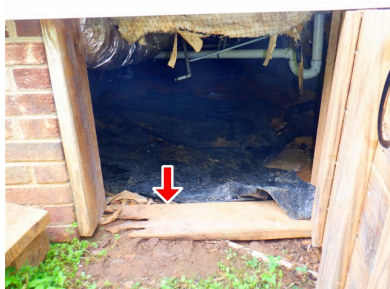
3.3 Item 2 (Picture)

1. The access door to the crawlspace deteriorated at bottom frame. Further deterioration will occur. I recommend repair as needed.

I recommend a qualified contractor inspect and repair as needed.

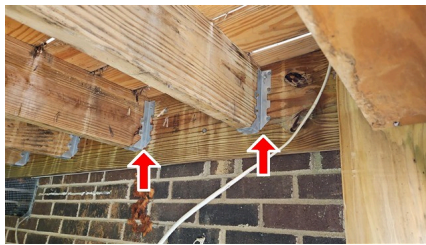
3.4 Item 1 (Picture)

1. The floor joist hangers for the deck at the rear of home are fastened improperly. A more proper repair is needed to ensure stability or an injury might occur. Further investigation and repairs are needed.

I recommend having the entire deck evaluated for structural stability.

A qualified contractor should repair or replace as needed.

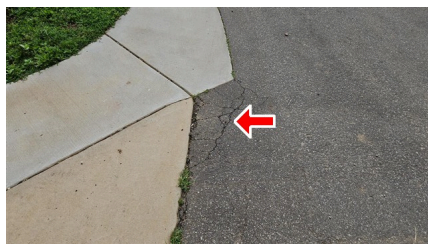
3.5 Item 1 (Picture)

1. The asphalt drive at the front of home deteriorated in areas. Further deterioration can occur if not repaired. Repairs are needed.

A qualified person should repair or replace as needed.

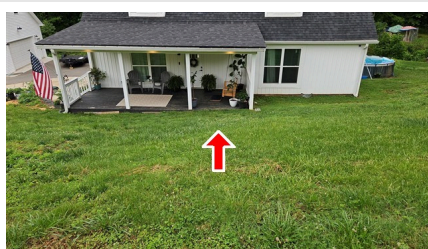
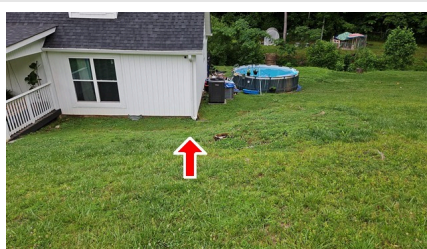
1. There is a negative slope at the exterior and can cause or contribute to water intrusion or deterioration. I recommend correcting landscape to drain water away from home.

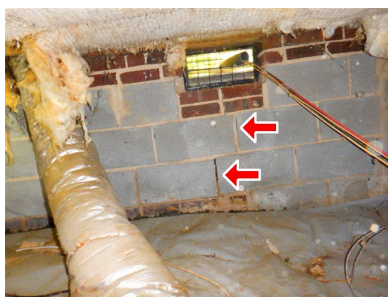
4.0 Item 1 (Picture)

1. The foundation wall in the crawlspace has cracks present. The wall(s) may need reinforcement. Further investigation and repairs are needed.

A qualified licensed general contractor should inspect further and repair as needed.

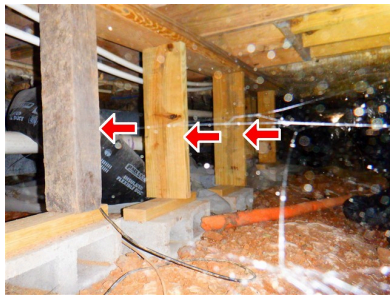
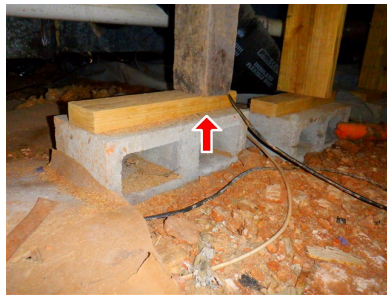
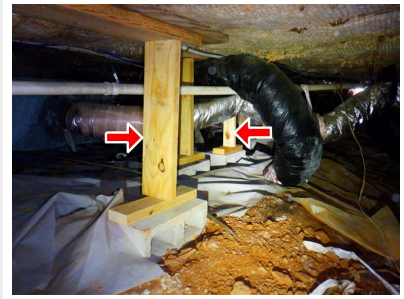
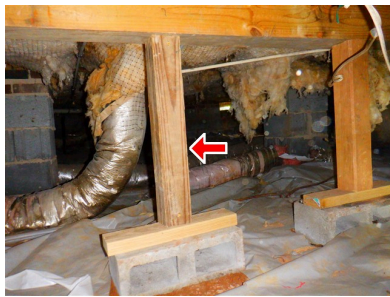
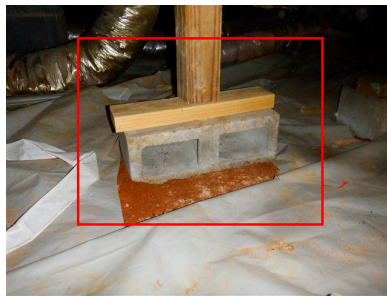
1. Temporary wood support posts have been added in the crawl space. All piers should be masonry. All piers should be examined for signs of settlement condition and their adequacy in accepting bearing loads. Those that are deficient should be repaired or replaced to prevent further foundation issues and movement. Not addressing these issues could result in further floor system movement and other foundation issues. Further investigation and repairs are needed.

A qualified licensed general contractor should inspect further and repair as needed.

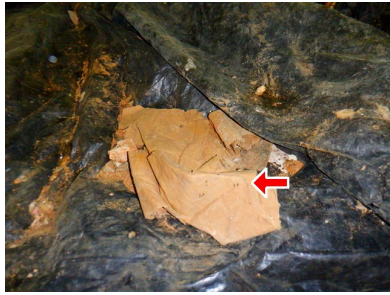
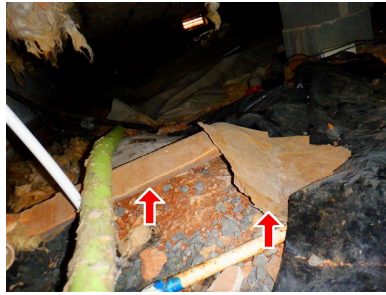
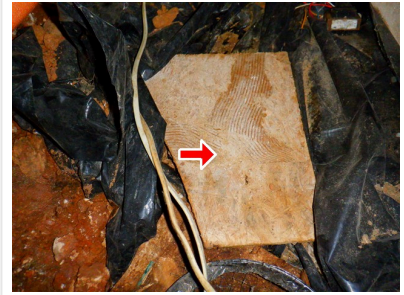
1. Wood debris is in contact with the crawl space floor in numerous areas. This can attract wood destroying organisms. Removal is needed.

A qualified contractor should inspect and repair as needed.

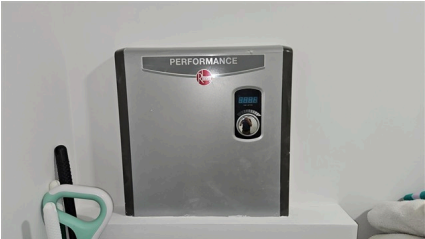
Complimentary photo of the water heater

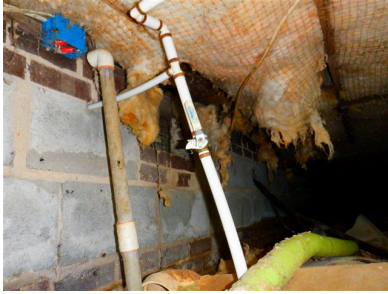
5.0 Item 1 (Picture)

The main shut off is the white lever located underneath in the crawlspace. This is for your information.

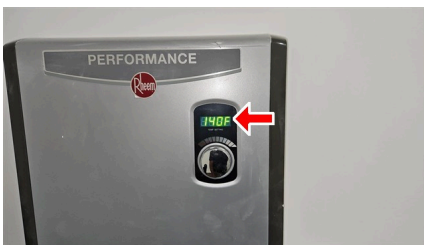
5.1 Item 1 (Picture)

1. The water heater is set over the recommended temperature. (Over 120) The risk is especially acute for infants, children, and the elderly. Water temperatures should never be set higher than 120 degrees. This is a safety issue. Repairs are needed

A qualified contractor should inspect and repair as needed.

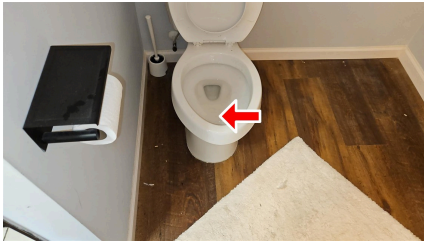
5.3 Item 1 (Picture)

1. The toilet is loose at floor at the bath. Repairs may involve re-setting the toilet on a new wax seal. Repairs are needed.

I recommend a qualified licensed plumber repair or correct as needed.

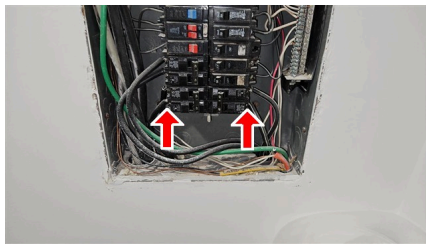
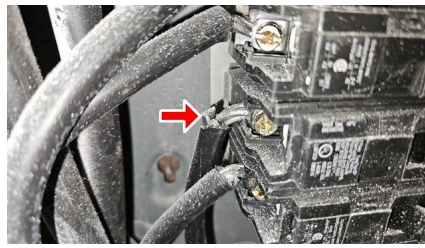
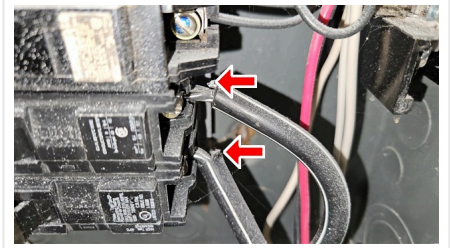
1. Wires were observed to be cut down to fit circuit breakers in the sub panel. This often leads to wires that can overheat. Electrical issues are considered a hazard until repaired. Further investigation and repairs are needed.

A qualified licensed electrical contractor should correct as needed.

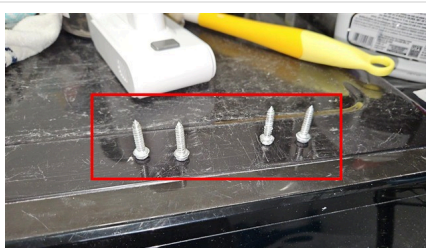
6.2 Item 4 (Picture)

1. The electrical panel cover sub panel has been secure with sheet metal screw. This is considered unsafe as sheet metal screws are not rated for electrical panel use. The use of sheet metal screws with panel cover have been known to short hot wires, as the can pearce the branch wiring protective coverings. (Safety Issue) Repairs are needed.

A qualified licensed electrical contractor should correct as needed.

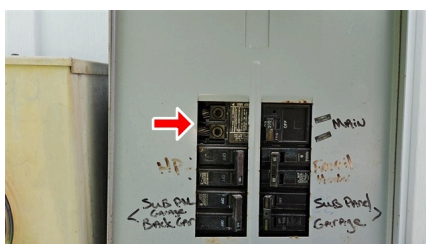
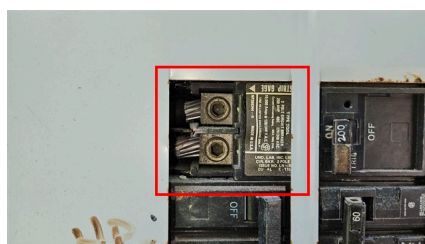
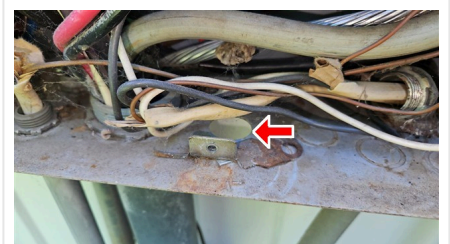
1. The main panel has missing knockouts. (safety issue) Unused openings in panel equipment need to be closed. Covering these openings helps to prevent accidental shocks (think of kids), helps to prevent pests from entering. Repairs are needed.

A qualified licensed electrical contractor should correct as needed.

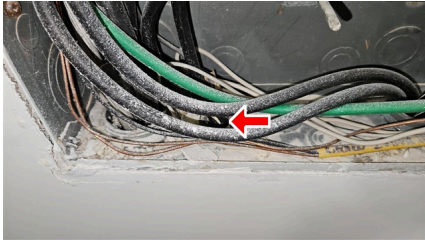
6.2 Item 8 (Picture)

1. The wire protection grommets are missing where the branch wiring enters the panel. Electrical issues are considered a hazard until repaired. Repairs are recommended.

A qualified licensed electrical contractor should correct as needed.

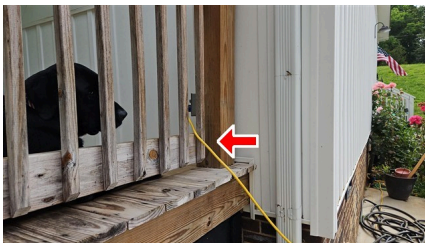
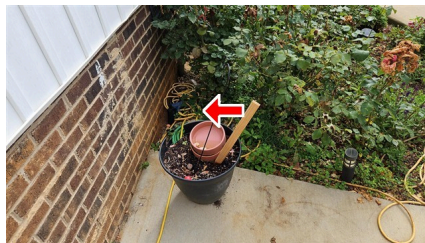
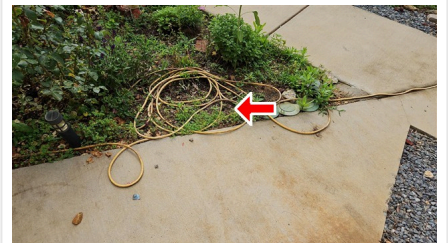
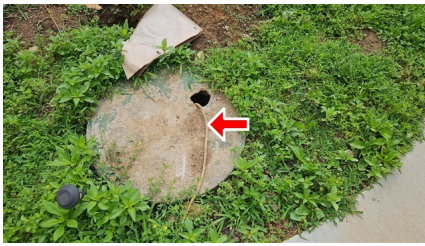
1. The septic pump an extension cord as permanent wiring at the exterior. Electrical issues are considered a hazard until repaired. Further investigation and repairs are needed.

A qualified licensed electrical contractor should correct as needed.

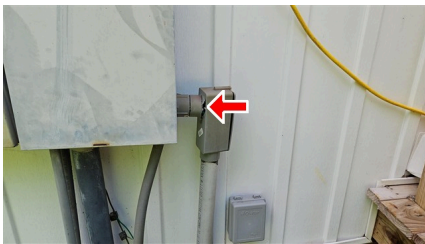
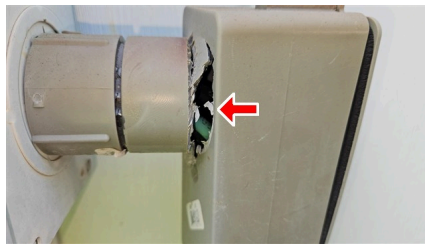
1. The electrical conduit at the rear of the home is damaged. This may allow for water intrusion to occur. Further investigation and repairs are needed..

I recommend a qualified licensed electrical contractor correct.

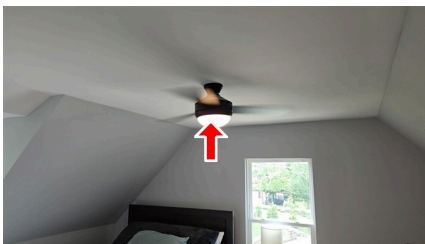
**6.4 Item 7 (Picture)**

1. The ceiling fan does work, but "wobbles" in the Guest bedroom. Some fans that wobble cannot be corrected without replacement. Repairs are needed.

A qualified licensed electrical contractor should correct as needed.

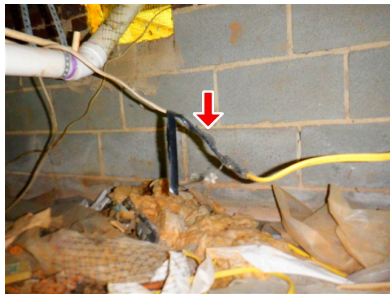
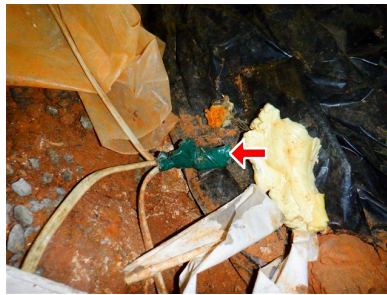
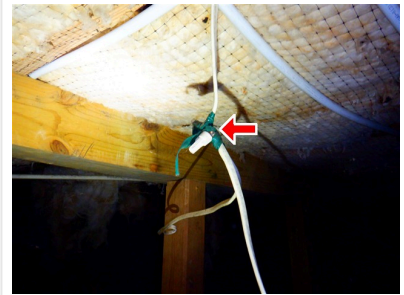
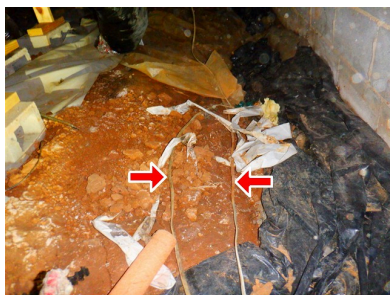
1. Several open splices needs electrical splice placed inside access panel, or install inside a box with cover-plate in the crawlspace. Electrical wires laying on the ground. Electrical issues are considered a hazard until repaired. Further investigation and repairs are needed.

A qualified licensed electrical contractor should correct as needed.

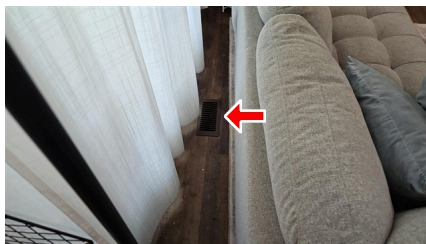
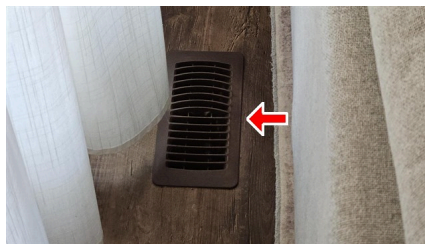
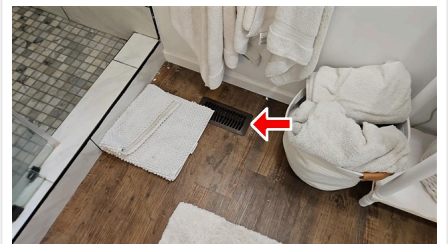
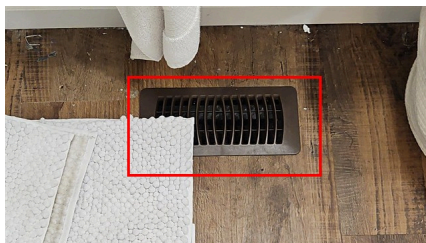
1. The supply register in floor is weak (not intended for floor) throughout the home. This is a safety issue and should be repaired. A replacement is needed.

A qualified HVAC person should inspect further and repair or replace as needed.

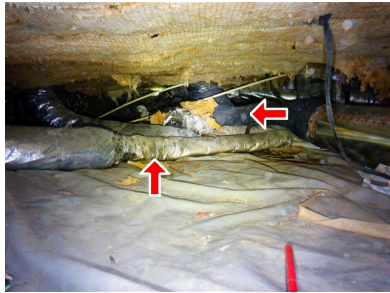
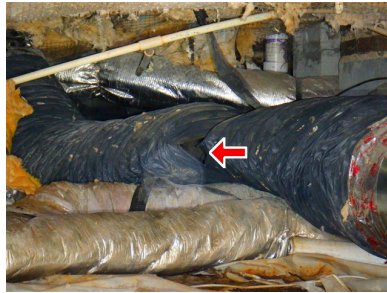
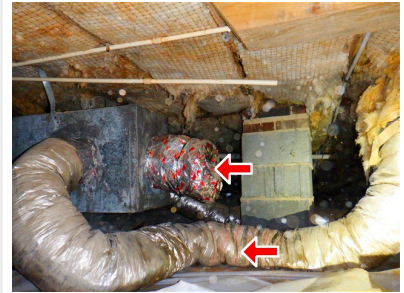
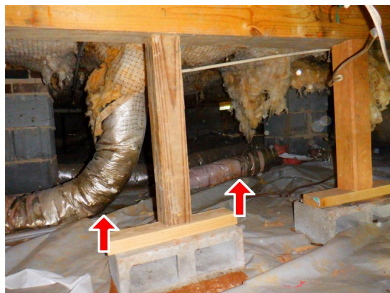
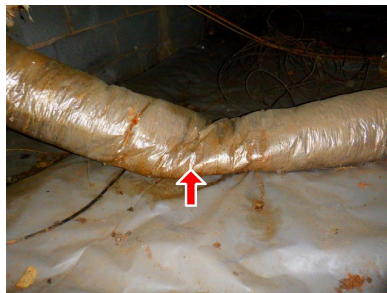
1. The supply and return duct pipe are damaged and is in contact with ground and may deteriorate if not corrected in the crawlspace. Energy loss is occurring in crawlspace and immediate correction is needed. A minimum of four inches of clearance from the ground is needed to prevent deterioration to ductwork. Further investigation and repairs are needed.

I recommend having the homes entire ductwork system evaluated.

A qualified HVAC person should inspect further and repair or replace as needed.

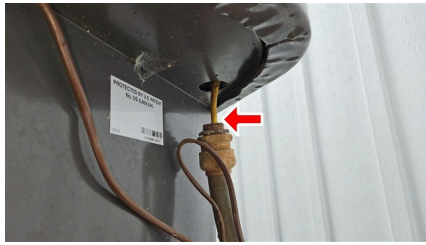
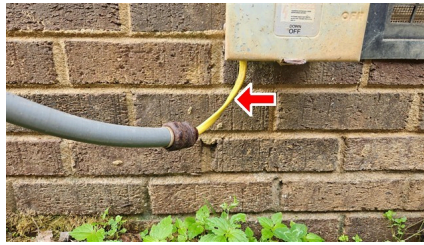
1. The electrical conduit is not long enough and then at outside unit. This is a safety issue and should be repaired. Repairs are needed.

A licensed HVAC contractor should service or repair unit.

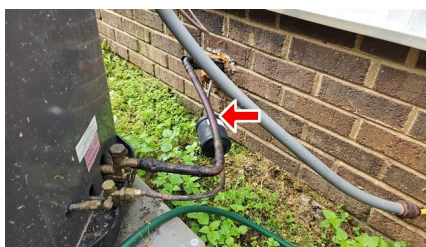
7.8 Item 3 (Picture)

1. The foam sleeve on suction line is missing foam sleeve in area(s) at outside unit. Missing foam on suction line can cause energy loss and condensation. I recommend service or repair as needed.

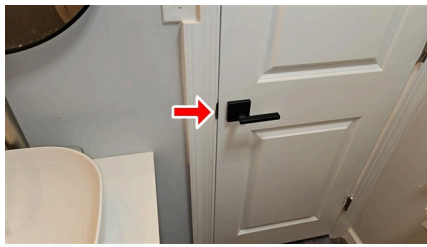
8.5 Item 1 (Picture)

1. The door at private bath will not latch properly. Evidence suggest that the door needs strike and latch adjustment to shut properly. This is a small repair.

A qualified person should repair or replace as needed.

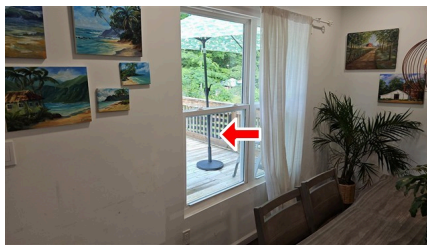
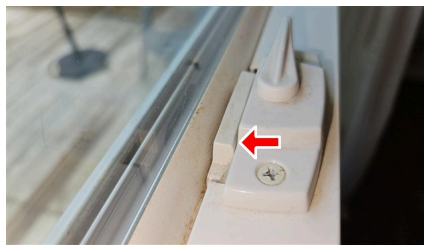
1. One window does not lock properly at the dining room. As a result you can not lock the window.  
Further investigation and repairs are needed.

A qualified contractor should inspect and repair as needed.

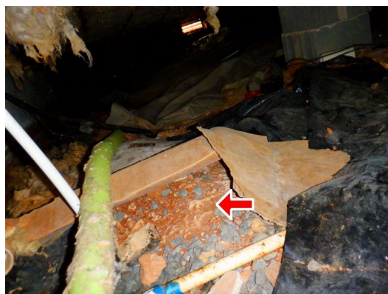
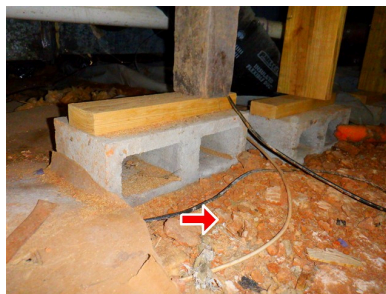
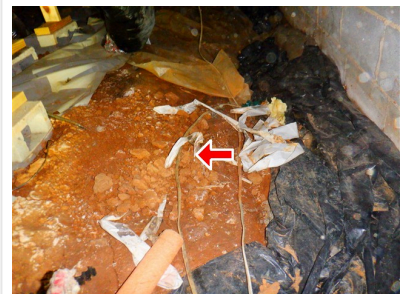
1. The vapor barrier (plastic) on the crawlspace ground is missing in areas. A vapor barrier provides added protection to the floor system from moisture or dampness that can enter from ground. Repairs are needed.

A qualified person should repair or replace as needed.

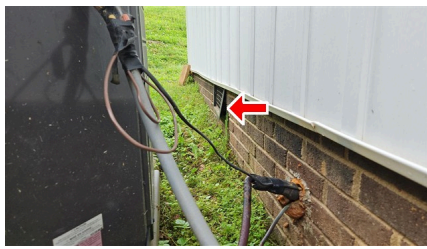
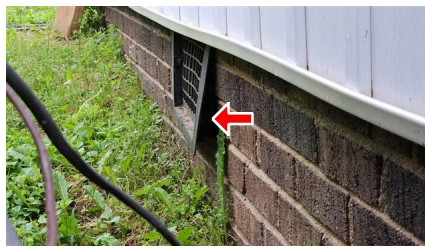
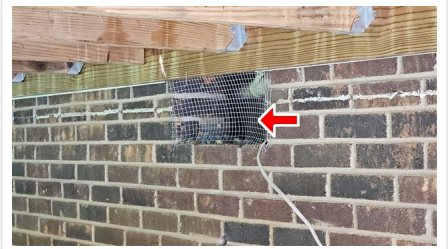
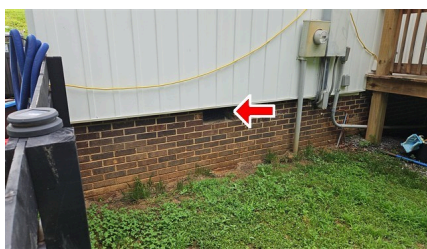
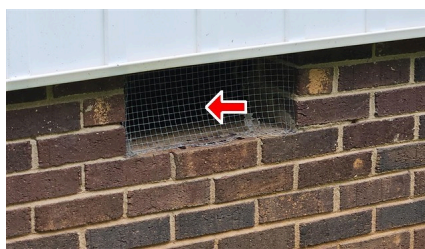
1. The foundation vents are missing screens and or loose at the exterior. Rodents, reptiles or insects could enter into crawlspace. Repairs are needed.

A qualified person should repair or replace as needed.

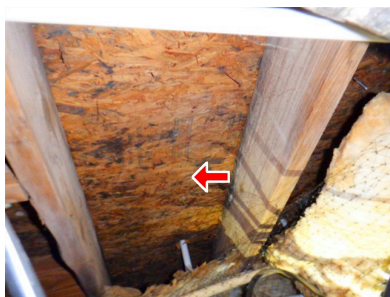
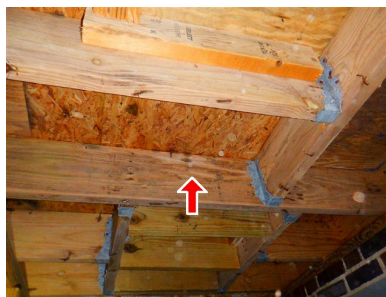
1. The insulation is missing is deteriorated in areas in the crawlspace. Heat loss can occur more on this home than one that is properly insulated. Repairs are needed.

A qualified contractor should inspect and repair as needed.

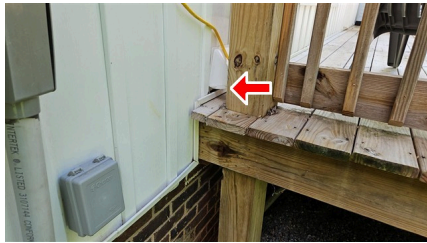
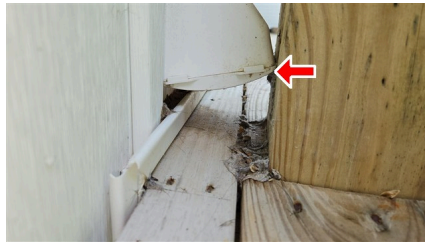
1. The dryer vent hood at the rear of home does not have the proper clearance from the grade/ground to function as intended. Dryer vent exhaust shall terminate not less than 12 inches above finish grade to prevent blockages. Current conditions should be considered a fire hazard until repaired. Repairs are needed.

A qualified person should repair or replace as needed.

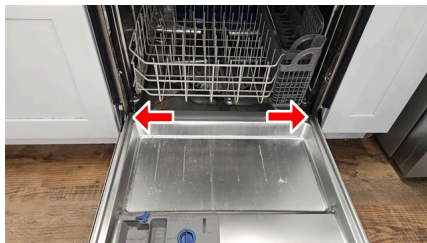
10.0 Item 1 (Picture)

1. The dishwasher door springs are damaged. The door springs need replacing if parts are available is damaged. I recommend repair as necessary.

I recommend contacting appliance repair company.

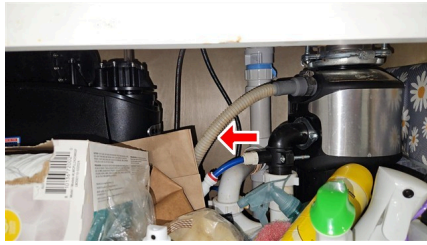
10.0 Item 2 (Picture)

1. The dishwasher drain hose needs to be looped above the level of the kitchen sink drain or an approved air gap installed to prevent back flow of waste water into the water supply. (food safety issue) This can allow waste for the sink to contaminate the dishwasher. This is a small repair.

A qualified licensed plumber should repair or correct as needed.

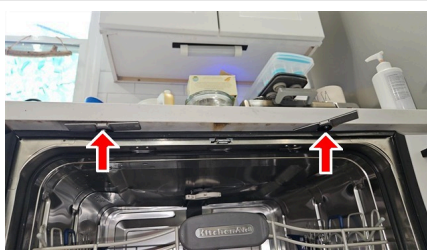
10.0 Item 3 (Picture)

1. The dishwasher is loose and needs securing to underside of countertop (using a proper length screw). I recommend repair as necessary.

I recommend contacting appliance repair company.

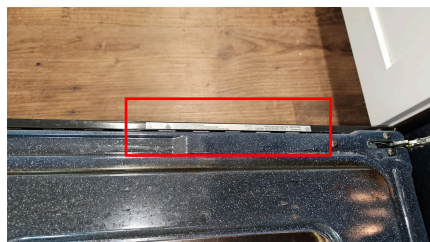
10.1 Item 1 (Picture)

1. The range/oven needs to be properly attached/anchored to the structure as to keep it from tipping over when the oven door is opened and/or oven racks are pulled out during use. This is a safety issue. Repairs are needed.

I recommend contacting appliance repair company.

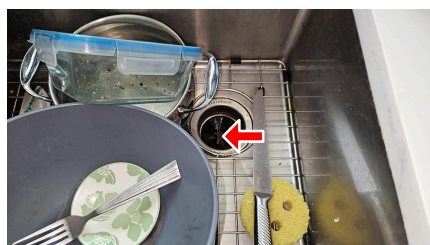
10.3 Item 1 (Picture)

1. The food disposer has an obstruction inside. I recommend repair as needed.  
I recommend contacting a plumber to make repairs.
