INSPECTION REPORT  
122 Dobbin Ln  
 Mooresville NC 28117

INSPECTED BY  
Alex Parr 3692  
Above Parr Home  
Inspections

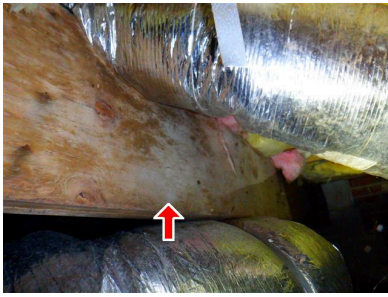
1.0 Item 1 (Picture)

1. Discoloration and some type of mold (Microbial) growth is present in the structure at several areas including but not limited to the crawl space and interior spaces. Evidence suggests that this condition is from a past or present elevated moisture conditions. We did not inspect, test or determine if this type of substance is or is not a health hazard. Further investigation is needed.

We recommend you contact a properly licensed expert for testing, investigation and or correction as deemed appropriate.

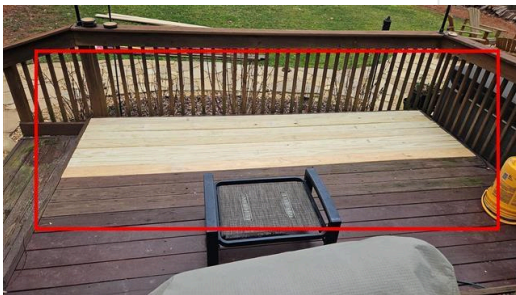
1.1 Item 1 (Picture)

1. The deck was currently under repairs at the time of inspection. Therefore I did not inspect deck. Further investigation and repairs are needed.

We recommend having all personal items removed and these areas inspected prior to closing.

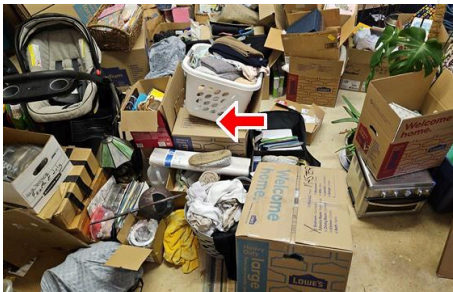
1.1 Item 2 (Picture)

1. Furniture, storage and or personal items in the garage and throughout the house. As a result the areas were not inspected. Hidden damage may be present. Further investigation and repairs are needed.

We recommend having all personal items removed and these areas inspected prior to closing.

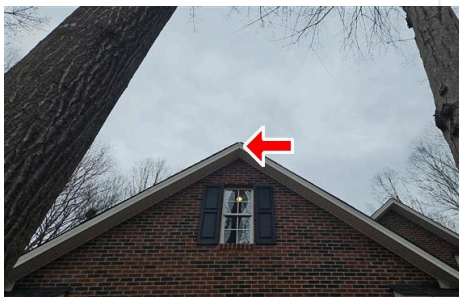
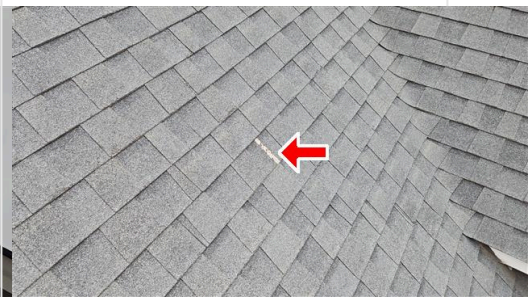
2.0 Item 1 (Picture)

1. The roof shingles are damaged at the front of home. This damage should be repaired or replaced.  
Further investigation and repairs are needed.

A qualified person should repair or replace as needed.

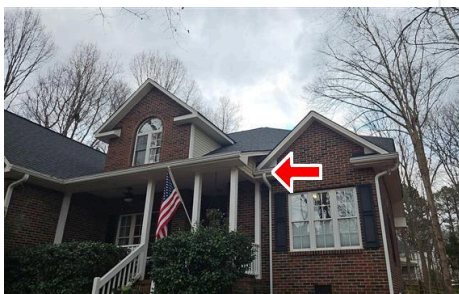
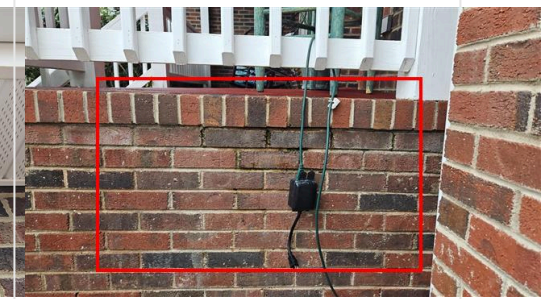
3.1 Item 1 (Picture)

1. Evidence of water damage at the front of the home. Further deterioration can occur if not corrected.  
Further investigation and repairs are needed.

A qualified contractor should inspect and repair as needed.

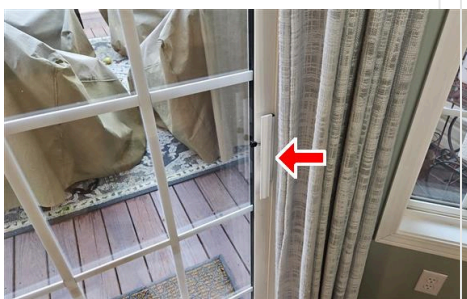
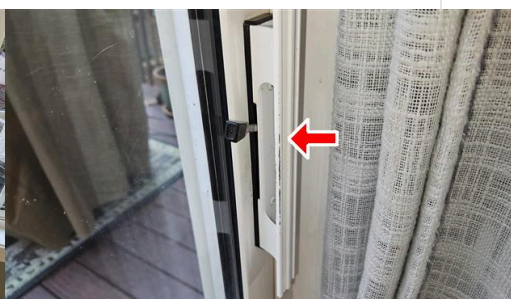
3.3 Item 1 (Picture)

1. The sliding glass door lock at the rear of home does not work. Therefore you cannot lock the door. Repairs are needed.

A qualified person should repair or replace as needed.

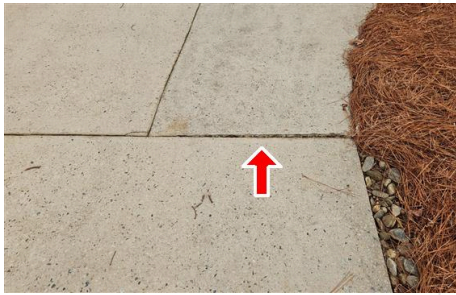
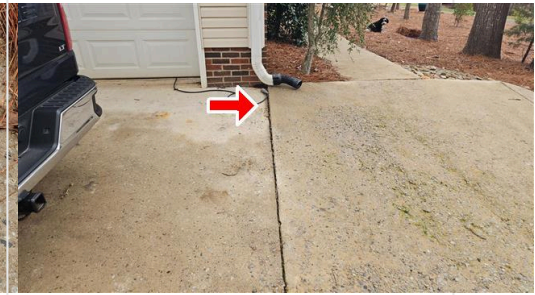
3.5 Item 1 (Picture)

1. The concrete drive at the left side (facing front) uneven, and can be a tripping hazard. Water can cause further deterioration if not repaired and sealed properly. A fall or injury can occur if not corrected. Further investigation and repair are needed.

A qualified contractor should inspect and repair as needed.

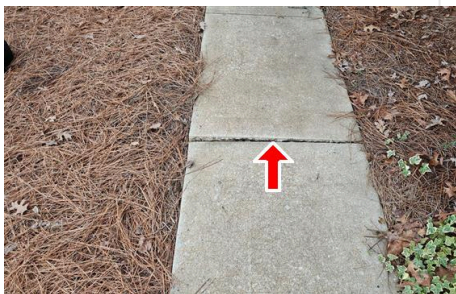
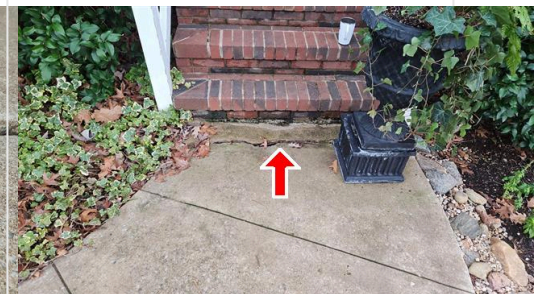
3.5 Item 6 (Picture)

1. The concrete sidewalk at the front of the home uneven, and can be a tripping hazard. Water can cause further deterioration if not repaired and sealed properly. A fall or injury can occur if not corrected. Further investigation and repair are needed.

A qualified contractor should inspect and repair as needed.

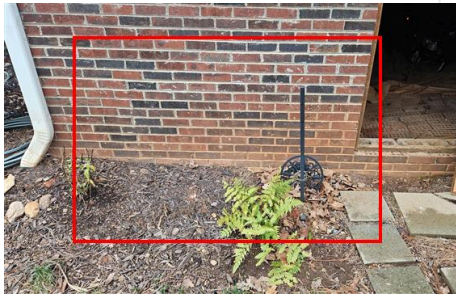
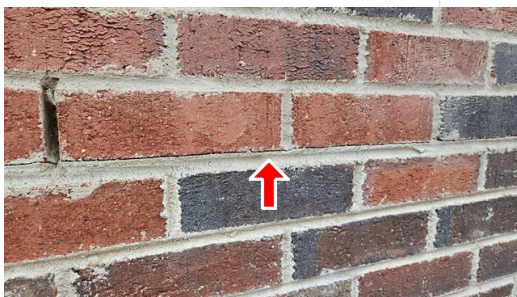
4.0 Item 1 (Picture)

1. The foundation wall at the right side (facing front) has cracks present. The wall(s) may need reinforcement. Further investigation and repairs are needed.

A qualified licensed general contractor should inspect further and repair as needed.

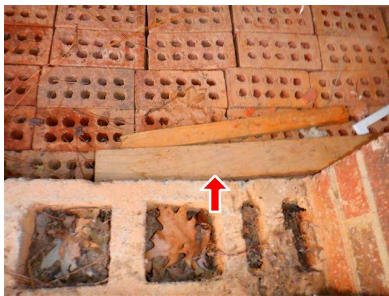
4.5 Item 1 (Picture)

1. Wood debris is in contact with the crawl space floor in numerous areas. This can attract wood destroying organisms. Removal is needed.

A qualified contractor should inspect and repair as needed.

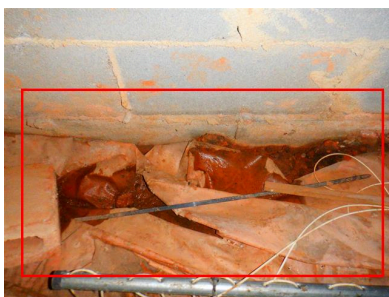
4.6 Item 1 (Picture)

1. Visible signs of water intrusion in the crawlspace (right side of home facing rear) are present from standing water on plastic vapor barrier. Water intrusion can lead to more costly repairs and increase damage if not corrected. Further investigation and repairs are needed.

I recommend further investigation or correction by a qualified licensed contractor or water infiltration specialist.

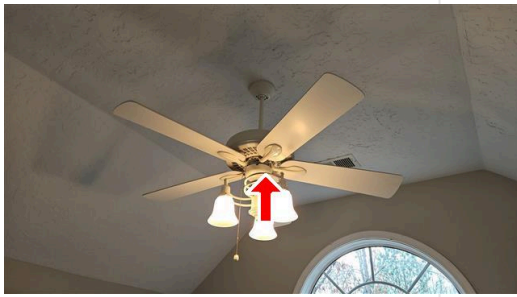
6.4 Item 1 (Picture)

1. The ceiling fan does not work and in the guest bedroom. Electrical issues are considered a hazard until repaired. Repairs are needed.

A qualified licensed electrical contractor should correct as needed.

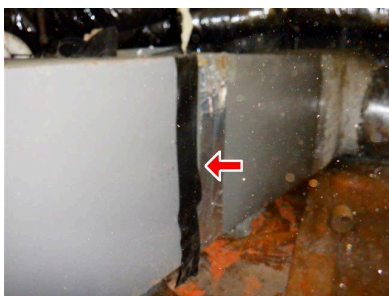
7.3 Item 1 (Picture)

1. The ducts have been repaired improperly with duct tape in the crawlspace. Energy loss is occurring where duct tape has failed. Further investigation and repairs are needed..

I recommend further inspection by a licensed HVAC contractor.

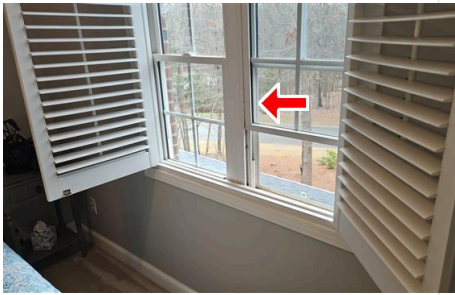
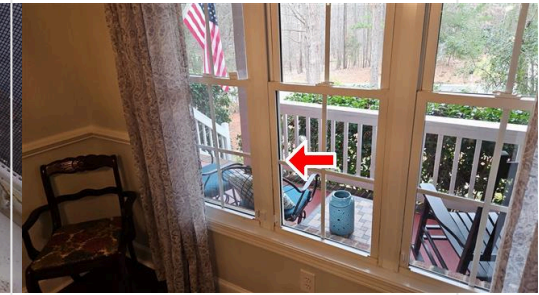
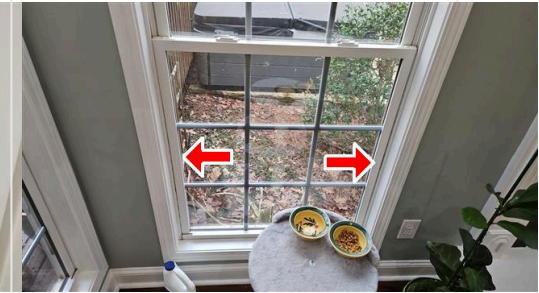
8.6 Item 1 (Picture)

1. The windows at the throughout the home have damaged sash springs. This can allow the window to come down suddenly causing glass breakage and or injury. (Safety Issue) Repairs are needed.

A qualified person should repair or replace as needed.

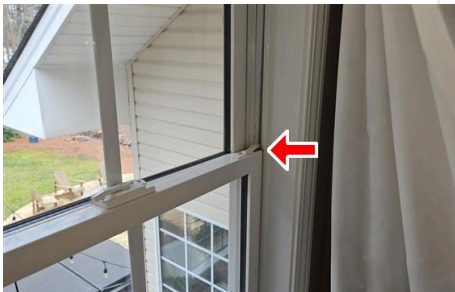
8.6 Item 7 (Picture)

1. One window at the guest bedroom has a damaged tilt clip. This can allow the window to come down suddenly causing glass breakage and or injury. (Safety issue). Repairs are needed.

A qualified person should repair or replace as needed.

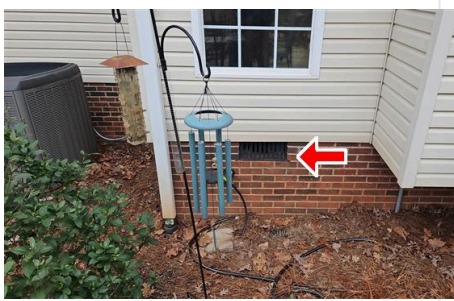
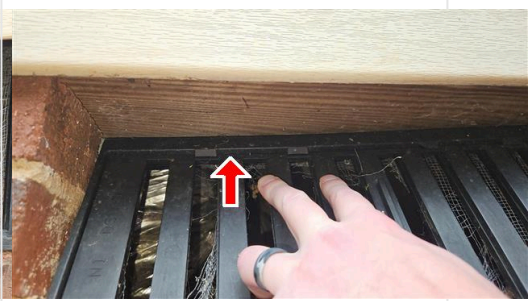
9.1 Item 1 (Picture)

1. Several foundation vents are loose and missing screens at the exterior. Rodents, reptiles or insects could enter into crawlspace. Repairs are needed.

A qualified person should repair or replace as needed.

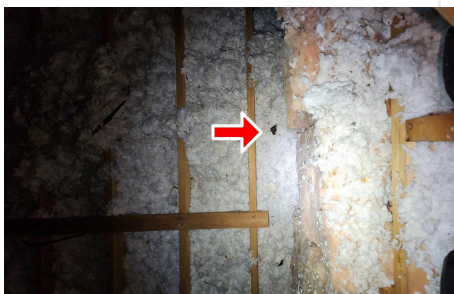
9.2 Item 1 (Picture)

1. Evidence of animal feces in the attic (above Living room). I was unable to determine if this was an active infestation. Sometimes pests can cause damage to home or components. Further investigation is needed.

A pest control company should inspect further and correct as needed.

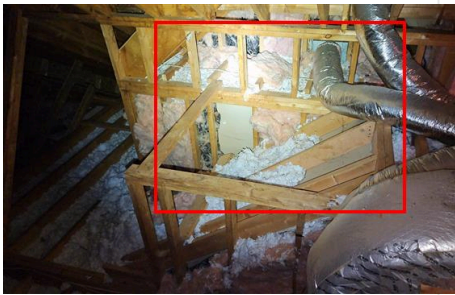
9.2 Item 5 (Picture)

1. Fiberglass (Batts) insulation in attic is missing in areas. Heat loss can occur more on this home than one that is properly insulated. Repairs are needed..

A qualified person should repair or replace as needed.

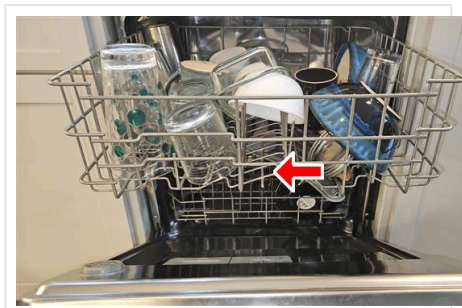
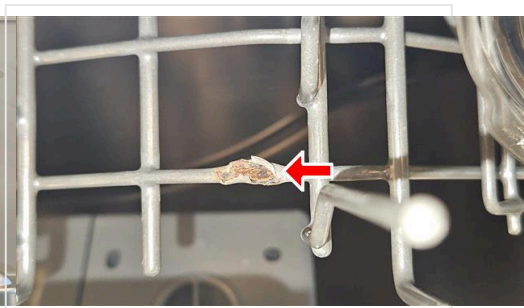
10.0 Item 1 (Picture)

1. The dishwasher rack is rusted in areas. Further deterioration will occur. I recommend repair as necessary.

I recommend contacting appliance repair company.

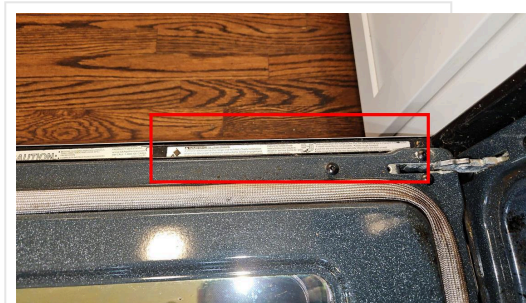
10.1 Item 1 (Picture)

1. The range/oven needs to be properly attached/anchored to the structure as to keep it from tipping over when the oven door is opened and/or oven racks are pulled out during use. This is a safety issue. Repairs are needed.

I recommend contacting appliance repair company.

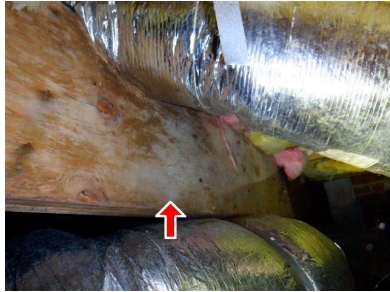
1.0 Item 1 (Picture)

1. Discoloration and some type of mold (Microbial) growth is present in the structure at several areas including but not limited to the crawl space and interior spaces. Evidence suggests that this condition is from a past or present elevated moisture conditions. We did not inspect, test or determine if this type of substance is or is not a health hazard. Further investigation is needed.

We recommend you contact a properly licensed expert for testing, investigation and or correction as deemed appropriate.

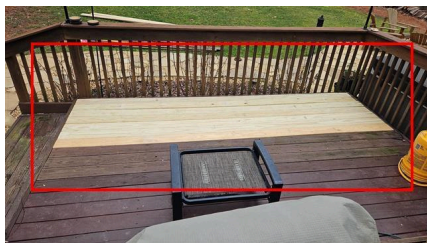
1.1 Item 1 (Picture)

1. The deck was currently under repairs at the time of inspection. Therefore I did not inspect deck. Further investigation and repairs are needed.

We recommend having all personal items removed and these areas inspected prior to closing.

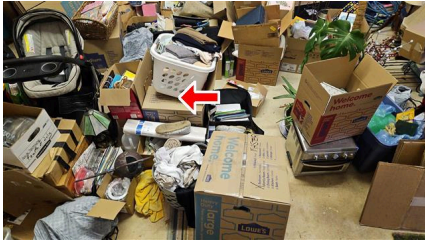
1.1 Item 2 (Picture)

1. Furniture, storage and or personal items in the garage and throughout the house. As a result the areas were not inspected. Hidden damage may be present. Further investigation and repairs are needed.

We recommend having all personal items removed and these areas inspected prior to closing.

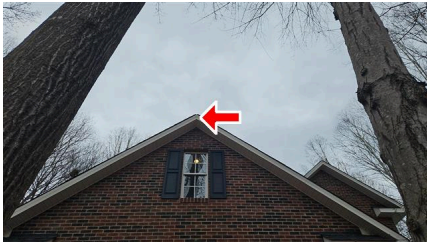
2.0 Item 1 (Picture)

1. The roof shingles are damaged at the front of home. This damage should be repaired or replaced.  
Further investigation and repairs are needed.

A qualified person should repair or replace as needed.

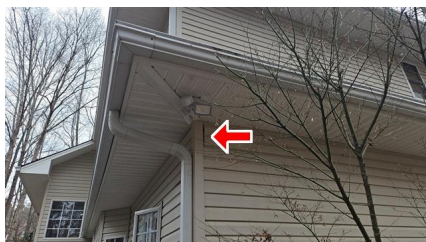
3.0 Item 1 (Picture)

1. The vinyl siding at the left side (facing front) is loose or not sealed properly. Deterioration can eventually occur if not corrected. Repairs are needed.

A qualified person should repair or replace as needed.

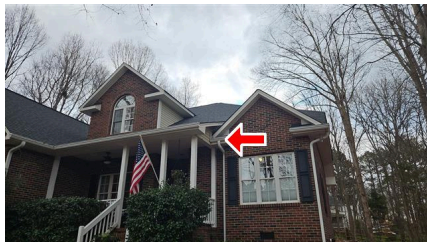
3.1 Item 1 (Picture)

1. Evidence of water damage at the front of the home. Further deterioration can occur if not corrected. Further investigation and repairs are needed.

A qualified contractor should inspect and repair as needed.

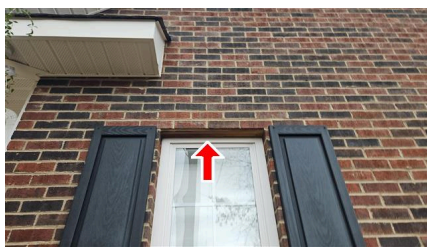
3.2 Item 1 (Picture)

1. The steel lintels around the exterior of the home are beginning to rust or have rust present. A lintel is a horizontal architectural member or steel beam support placed over a wall opening to carry the weight of the masonry placed over it. In most situation, the lintel above you windows and doors will be steel angle iron or I beam. Either due to age or improper rust proofing or weep chord and flashing placement during installation, lintels will begin to rust. Rusting lintels can expand to become mush thicker then their original size. The expansive forces of rusting steel can shift entire multi-story elevations. If your lintels are currently rusting, a telltale sign of expansion is diagonal "step" pattern cracks, which can be found on either end of the window or door opening. Repairs are needed to prevent further damage to the structure. Further deterioration may occur if not repaired.

I recommend a qualified contractor inspect and repair as needed.

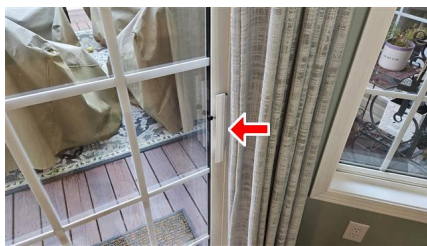
3.3 Item 1 (Picture)

1. The sliding glass door lock at the rear of home does not work. Therefore you cannot lock the door. Repairs are needed.

A qualified person should repair or replace as needed.

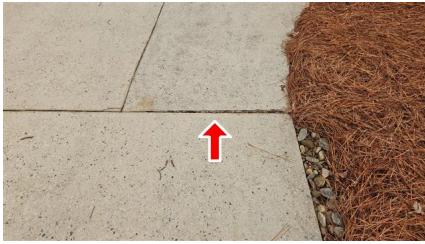
3.5 Item 1 (Picture)

1. The concrete drive at the left side (facing front) uneven, and can be a tripping hazard. Water can

cause further deterioration if not repaired and sealed properly. A fall or injury can occur if not corrected. Further investigation and repair are needed.

A qualified contractor should inspect and repair as needed.

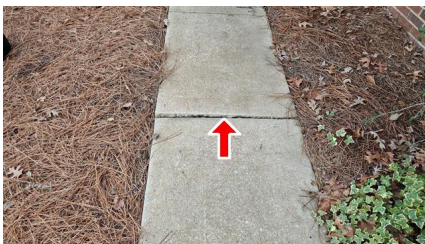
3.5 Item 6 (Picture)

1. The concrete sidewalk at the front of the home uneven, and can be a tripping hazard. Water can cause further deterioration if not repaired and sealed properly. A fall or injury can occur if not corrected. Further investigation and repair are needed.

A qualified contractor should inspect and repair as needed.

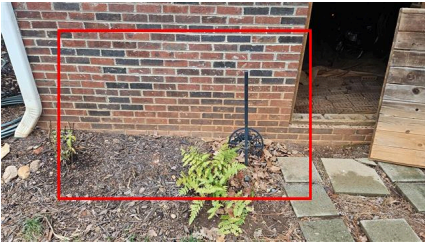
4.0 Item 1 (Picture)

1. The foundation wall at the right side (facing front) has cracks present. The wall(s) may need reinforcement. Further investigation and repairs are needed.

A qualified licensed general contractor should inspect further and repair as needed.

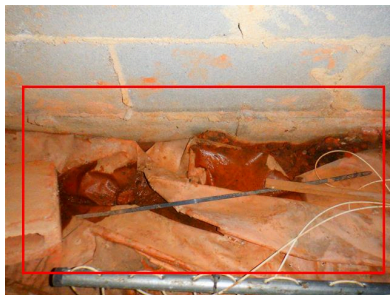
4.6 Item 1 (Picture)

1. Visible signs of water intrusion in the crawlspace (right side of home facing rear) are present from standing water on plastic vapor barrier. Water intrusion can lead to more costly repairs and increase damage if not corrected. Further investigation and repairs are needed.

I recommend further investigation or correction by a qualified licensed contractor or water infiltration specialist.

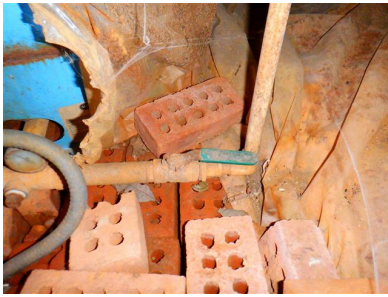
5.0 Item 1 (Picture)

The main shut off is the green lever located underneath in the crawlspace. This is for your information.

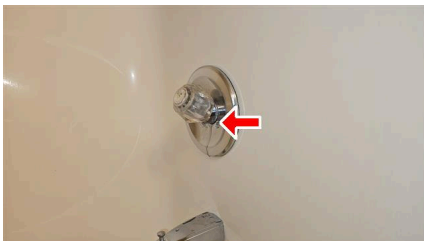
5.2 Item 1 (Picture)

1. The control knob leaks at the guest bath tub. Repairs are needed to prevent water damage from occurring to the home. Repairs are needed.

A qualified licensed plumber should repair or correct as needed.

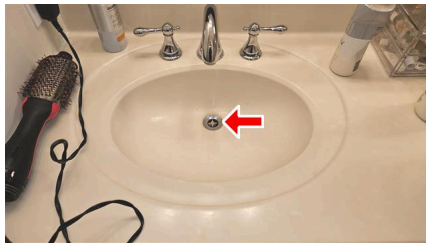
5.2 Item 3 (Picture)

1. The stop-valve is damaged at the master bath sinks. As a result you cannot fill up the tub. Repairs are needed.

A qualified licensed plumber should repair or correct as needed.

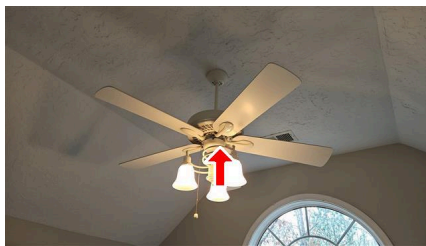
6.4 Item 1 (Picture)

1. The ceiling fan does not work and in the guest bedroom. Electrical issues are considered a hazard until repaired. Repairs are needed.

A qualified licensed electrical contractor should correct as needed.

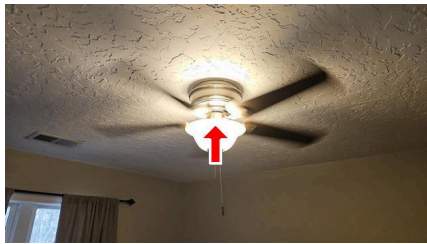
6.4 Item 2 (Picture)

1. The ceiling fan is noisy in the guest bedroom and the bonus room. Some fans that wobble can not be corrected without replacement. Repairs are needed.

A qualified licensed electrical contractor should correct as needed.

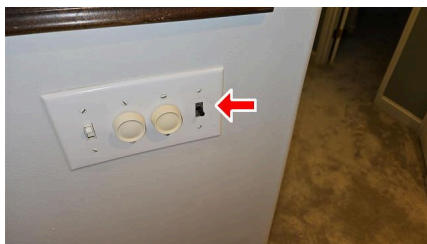
6.4 Item 4 (Picture)

1. The control knob dimmer switch is missing at the bonus room. Repairs are needed..

A qualified licensed electrical contractor should correct as needed.

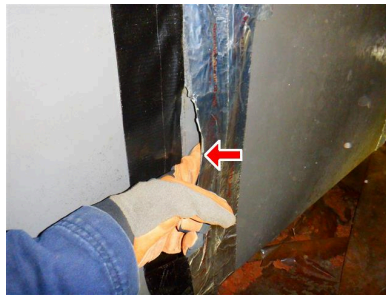
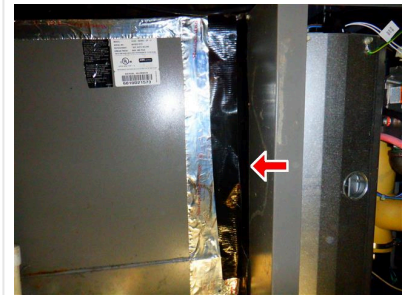
1. The ducts have been repaired improperly with duct tape in the crawlspace. Energy loss is occurring where duct tape has failed. Further investigation and repairs are needed..

I recommend further inspection by a licensed HVAC contractor.

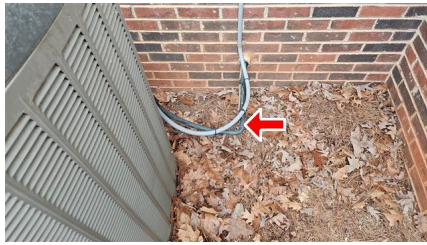
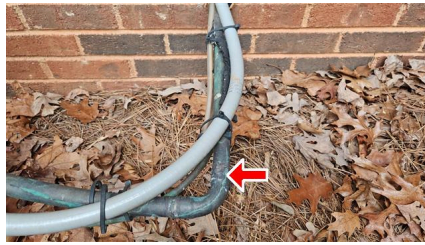
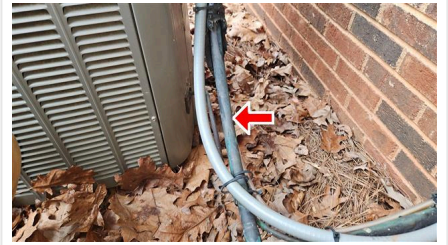
1. The foam sleeve on suction line is missing foam sleeve in area(s) at outside unit. Missing foam on suction line can cause energy loss and condensation. I recommend service or repair as needed.

A licensed HVAC contractor should service or repair unit.

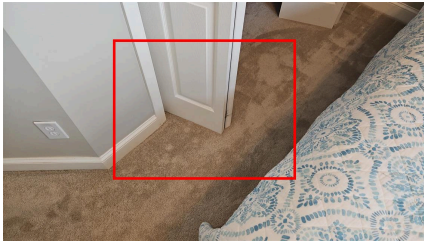
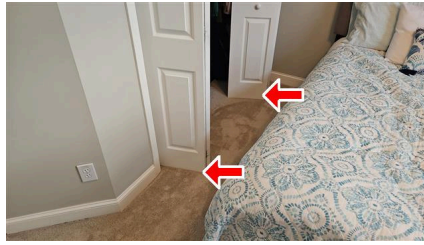
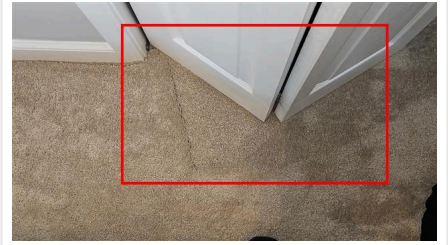
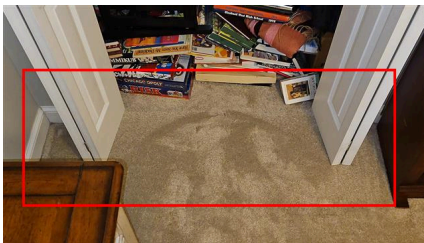
1. The bifold doors rub the floor when opened. The door needs to be trimmed at the bottom by a skilled craftsman at the guest bedrooms. As a result, the door will not close properly. Repairs are needed.

A qualified person should repair or replace as needed.

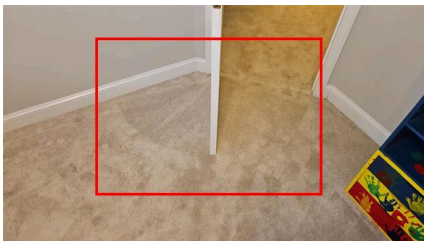
8.5 Item 5 (Picture)

1. The privacy door rubs floor when opened at the office. Door needs to be trimmed at bottom by a skilled craftsman at the office. As a result the door will not close properly. A repair or replacement is needed.

A qualified person should repair or replace as needed.

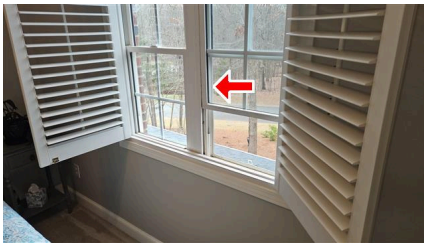
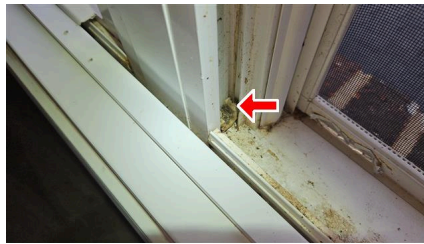
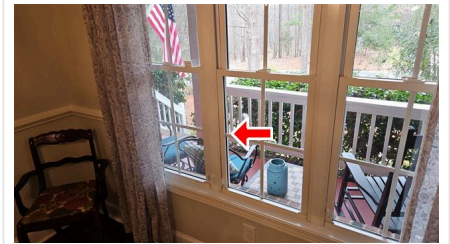
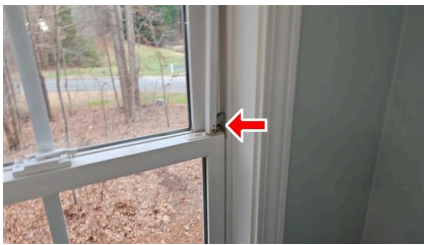
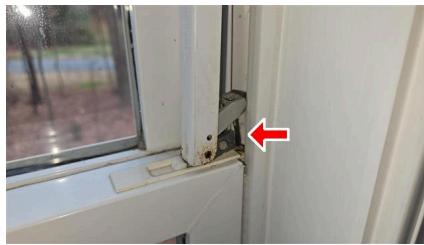
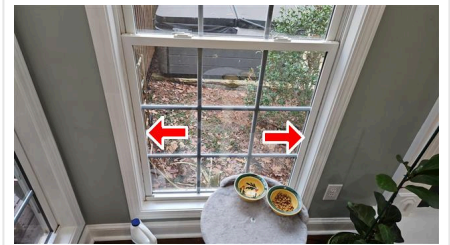
1. The windows at the throughout the home have damaged sash springs. This can allow the window to come down suddenly causing glass breakage and or injury. (Safety Issue) Repairs are needed.

A qualified person should repair or replace as needed.

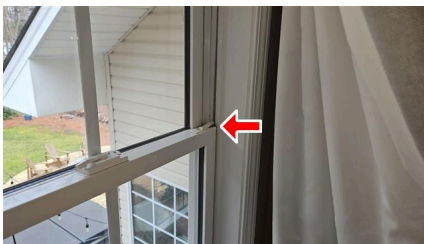
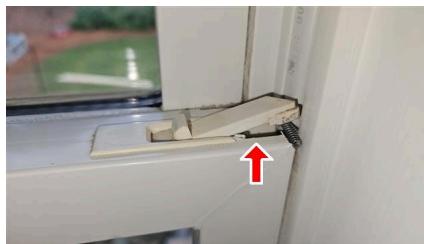
1. One window at the guest bedroom has a damaged tilt clip. This can allow the window to come down suddenly causing glass breakage and or injury. (Safety issue). Repairs are needed.

A qualified person should repair or replace as needed.

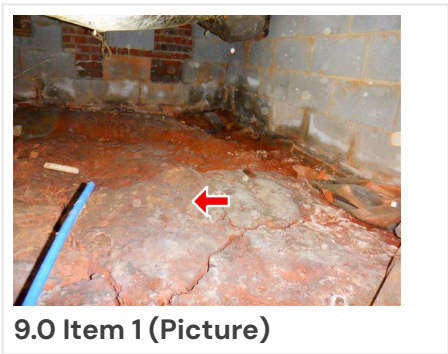
1. The vapor barrier (plastic) on the crawlspace ground is missing in areas. A vapor barrier provides added protection to the floor system from moisture or dampness that can enter from ground.  
Repairs are needed.

A qualified person should repair or replace as needed.

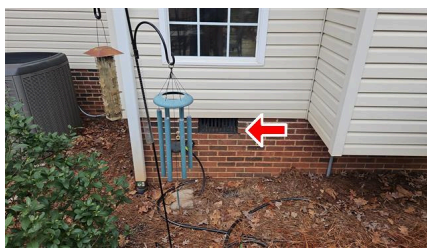
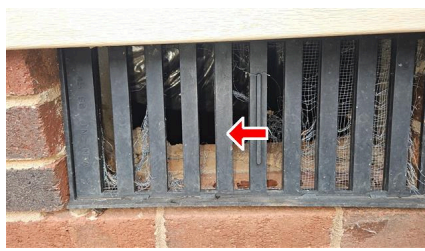
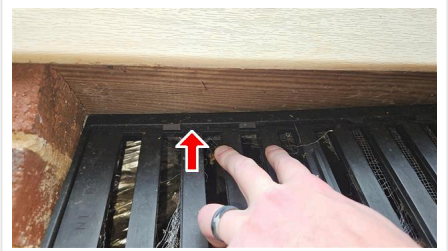
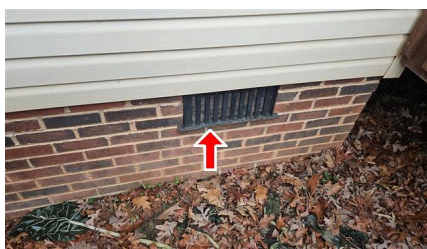
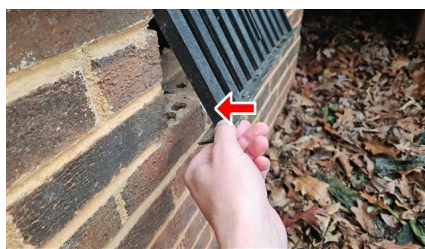
1. Several foundation vents are loose and missing screens at the exterior. Rodents, reptiles or insects could enter into crawlspace. Repairs are needed.

A qualified person should repair or replace as needed.

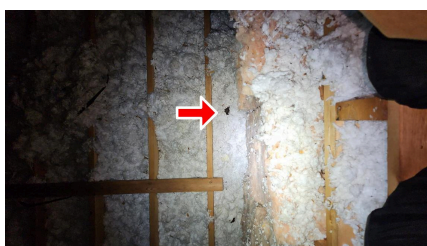
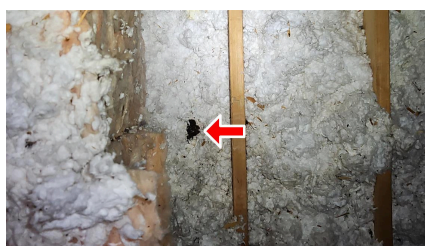
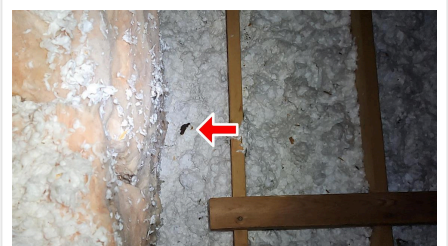
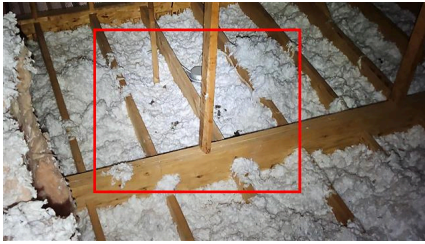
1. Evidence of animal feces in the attic (above Living room). I was unable to determine if this was an active infestation. Sometimes pests can cause damage to home or components. Further investigation is needed.

A pest control company should inspect further and correct as needed.

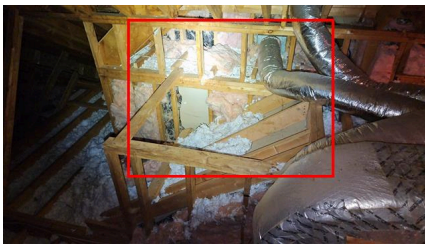
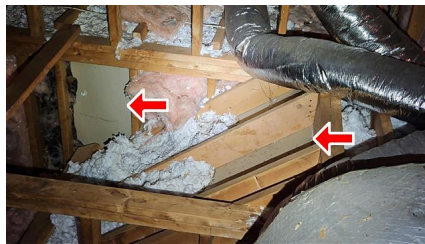
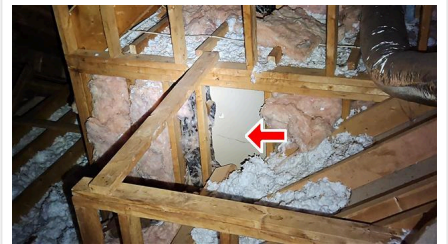
1. Fiberglass (Batts) insulation in attic is missing in areas. Heat loss can occur more on this home than one that is properly insulated. Repairs are needed..

A qualified person should repair or replace as needed.

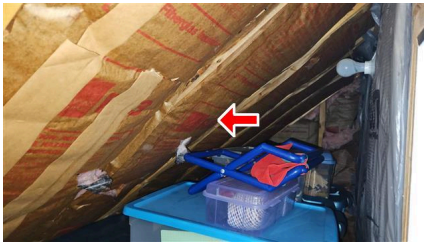
9.2 Item 9 (Picture)

1. Fiberglass (Batts) insulation in attic is installed improperly under a roof line. This can Prematurely the shingles. Repairs are needed..

A qualified person should repair or replace as needed.

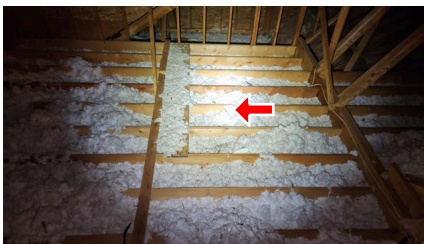
9.2 Item 11 (Picture)

1. Fiberglass (loose-fill) insulation is is old and has settled, and less than six inches in thickness remains. in attic. Heat loss can occur more on this home than one that is properly insulated. Repairs are needed..

A qualified person should repair or replace as needed.

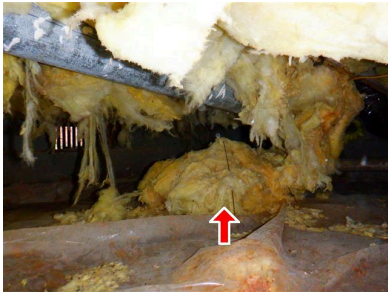
9.3 Item 1 (Picture)

1. The insulation is loose/fallen in the crawlspace. Heat loss can occur more on this home than one that is properly insulated. Repairs are needed..

A qualified person should repair or replace as needed.

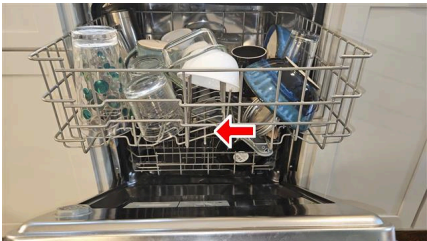
10.0 Item 1 (Picture)

- (1)
1. The dishwasher rack is rusted in areas. Further deterioration will occur. I recommend repair as necessary.

I recommend contacting appliance repair company.

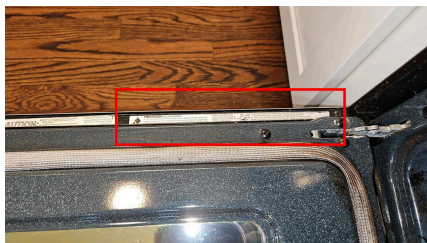
10.1 Item 1 (Picture)

1. The range/oven needs to be properly attached/anchored to the structure as to keep it from tipping over when the oven door is opened and/or oven racks are pulled out during use. This is a safety issue. Repairs are needed.

I recommend contacting appliance repair company.

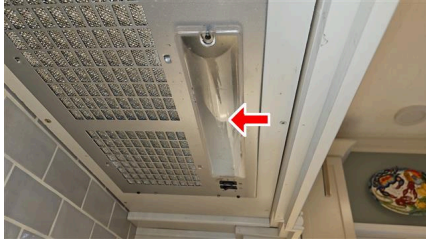
10.2 Item 1 (Picture)

1. The light bulb for fan did not work when tested. I recommend repair or replace as needed.  
I recommend contacting appliance repair company.
