INSPECTION REPORT  
14023 Timbergreen Dr  
Huntersville NC 28078

INSPECTED BY  
Alex Parr 3692  
Above Parr Home  
Inspections

INSPECTION DATE  
📅 3/28/2023  
🕒 02:00:00 PM

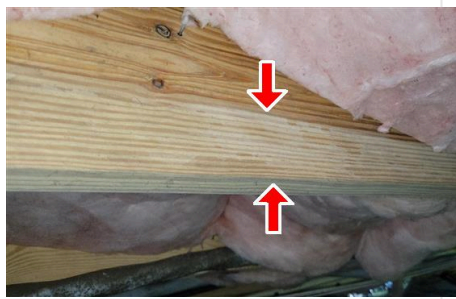
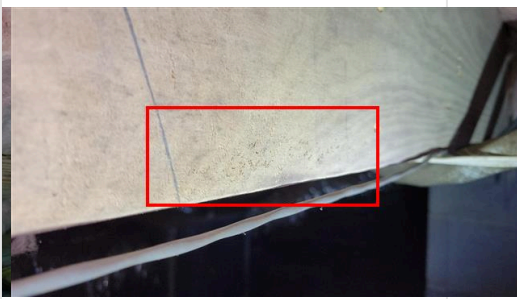
1. Discoloration and some type of mold (Microbial) growth is present in the structure at several areas including but not limited to the crawl space and interior spaces. Evidence suggests that this condition is from a past or present elevated moisture conditions. We did not inspect, test or determine if this type of substance is or is not a health hazard. Further investigation is needed.

We recommend you contact a properly licensed expert for testing, investigation and or correction as deemed appropriate.

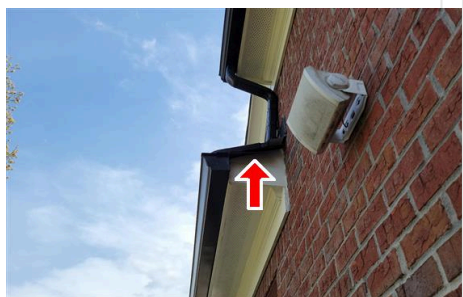
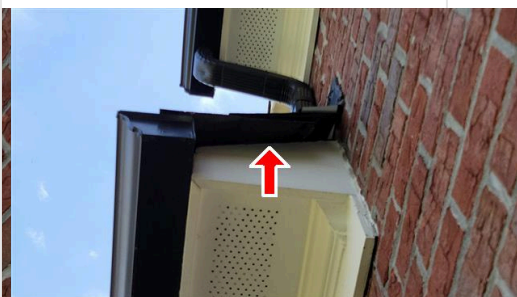
1. The roof shingles was installed improperly at the rear of home. (Improper overhang) this condition can allow damage to the shingle to occur. Further investigation and repairs are needed.

A qualified person should repair or replace as needed.

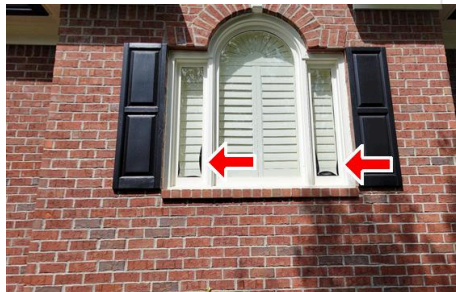
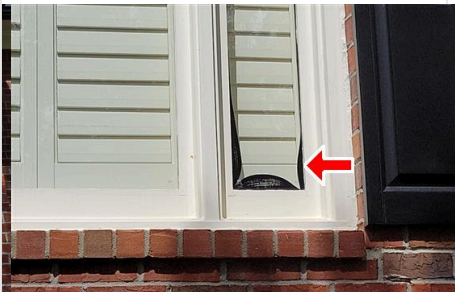
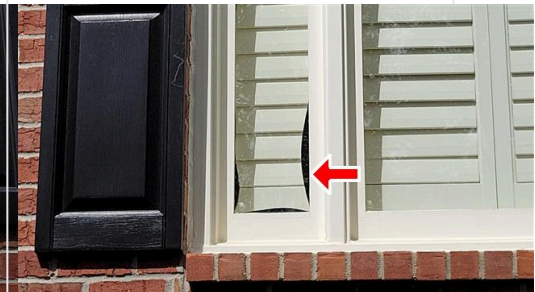
1. Several windows have failed/compromised thermal seals/fogged window panes. This is indicated by the visible moisture, discoloration, calcium deposits and or crystallization visible between the glass

window panes. A certified window technician should recheck all the windows throughout the home. Due to weather conditions many times compromised/failed windows cannot be identified at the time of inspection. Further investigation and repairs are needed.

We recommend contacting a properly licensed window technician/contractor regarding these conditions and have repairs made deemed appropriate

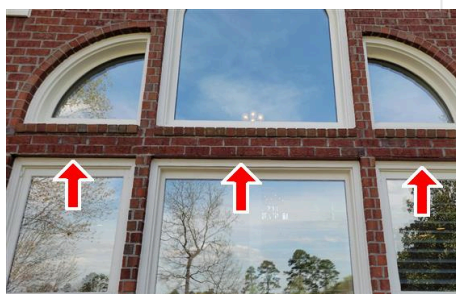
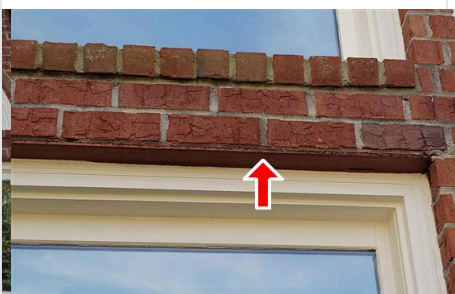
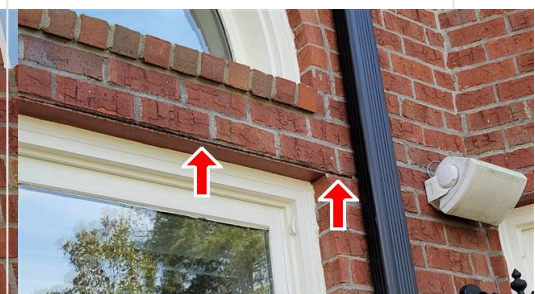
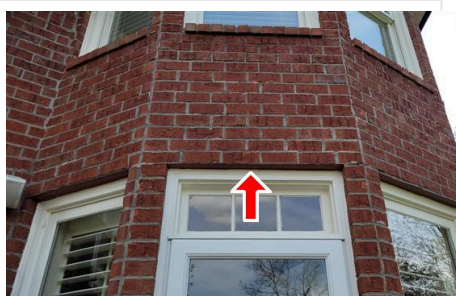
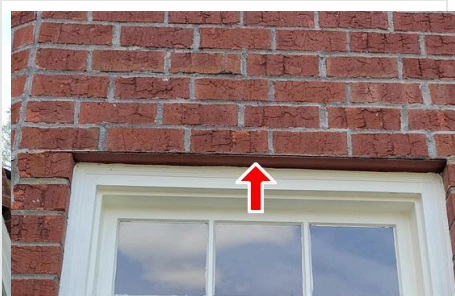
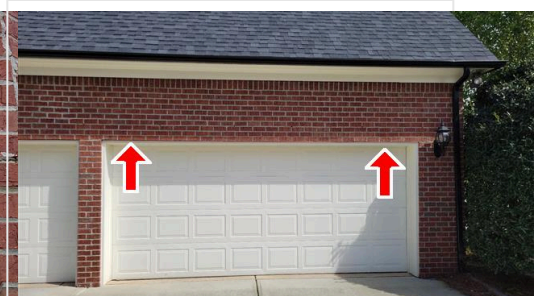
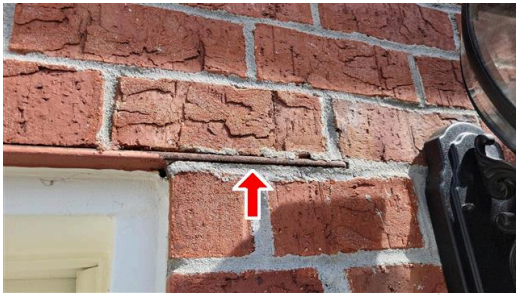
1. The steel lintels around the exterior of the home are beginning to rust or have rust present. A lintel is a horizontal architectural member or steel beam support placed over a wall opening to carry the weight of the masonry placed over it. In most situation, the lintel above you windows and doors will be steel angle iron or I beam. Either due to age or improper rust proofing or weep chord and flashing placement during installation, lintels will begin to rust. Rusting lintels can expand to become much thicker than their original size. The expansive forces of rusting steel can shift entire multi-story elevations. If your lintels are currently rusting, a telltale sign of expansion is diagonal "step" pattern cracks, which can be found on either end of the window or door opening. Repairs are needed to prevent further damage to the structure. Further deterioration may occur if not repaired.

I recommend a qualified contractor inspect and repair as needed.

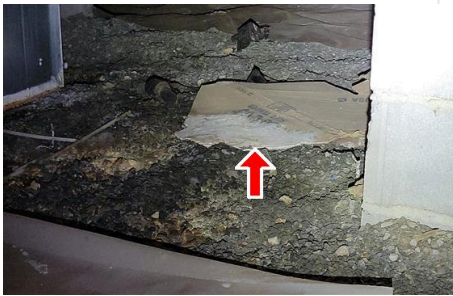
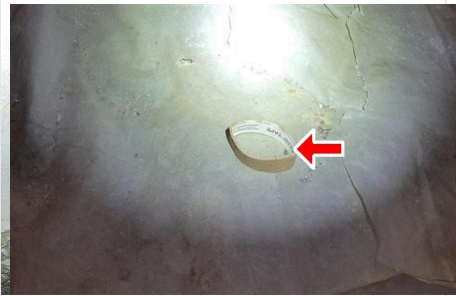
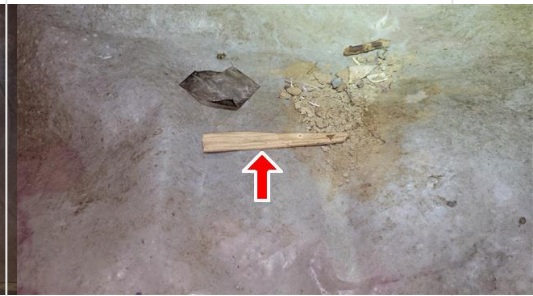
1. Wood debris is in contact with the crawl space floor in numerous areas. This can attract wood destroying organisms. Removal is needed.

A qualified contractor should inspect and repair as needed.

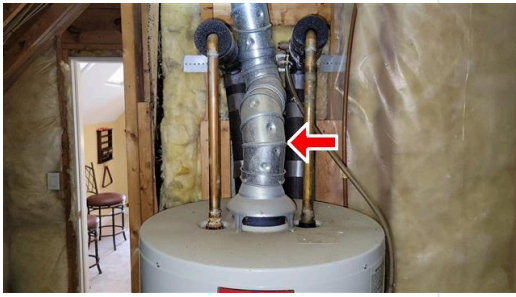
5.1 Item 1 (Picture)

1. The draft hood connection to flue vent connector: provide at least 12" vertical inches of the flue vent between the draft hood outlet and the first elbow. This is a safety issue and should be repaired. Further investigation and repairs are needed.

A qualified licensed plumber should repair or correct as needed.

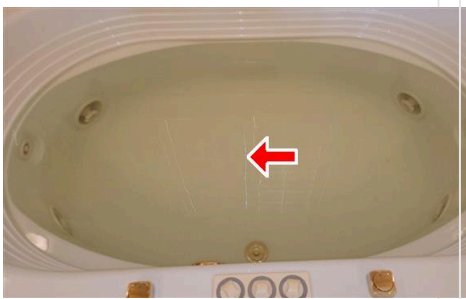
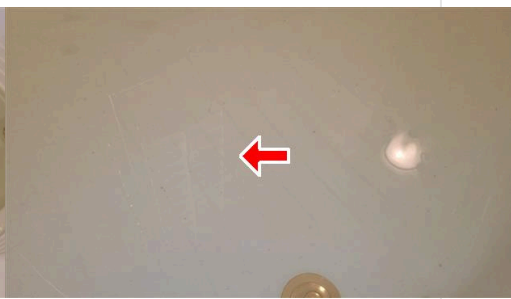
1. The jacuzzi shows signs of improper cleaning and maintenance, as a result black residue is present (likely bacteria) when the tub was operated. (Health Safety Issue) Repairs are needed.

I recommend contacting a licensed plumber.

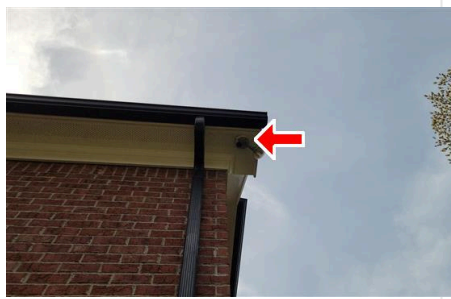
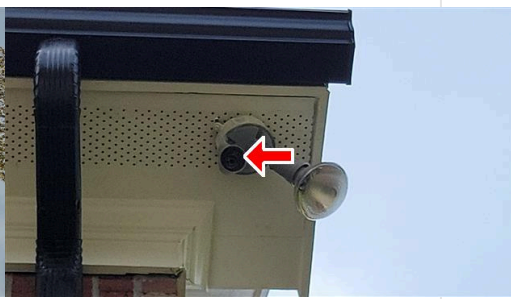
1. The light fixture at the rear of the home appears to have part of a light bulb broken off. Further investigation and repairs are needed..

A qualified licensed electrical contractor should correct as needed.

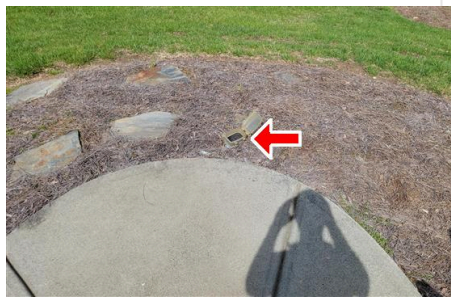
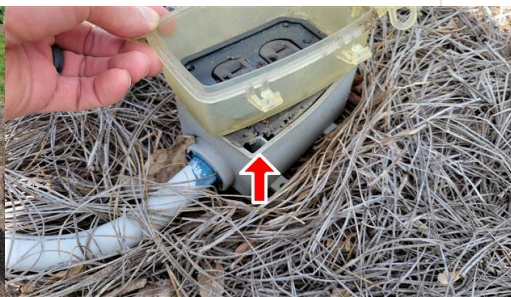
1. The GFCI (Ground Fault Circuit Interrupter) outlet at the exterior has loose cover. This may allow for water intrusion to occur. Repairs are needed..

A qualified licensed electrical contractor should correct as needed.

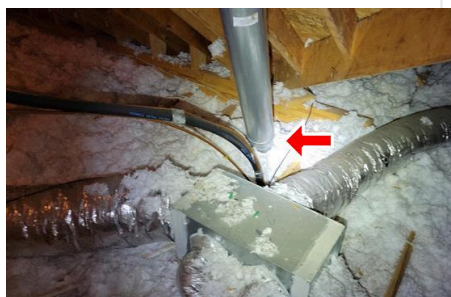
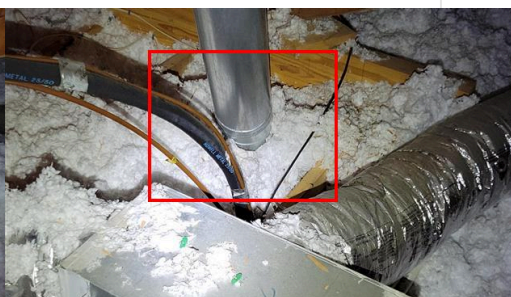
1. The vent pipe for gas furnace needs a 1 inch clearance from combustibles. This is a safety issue and should be repaired. Repairs are needed.

I recommend a qualified licensed heat contractor inspect further and repair as needed.

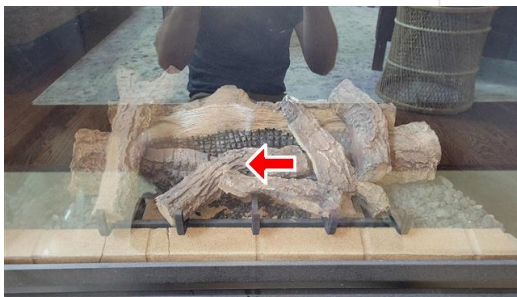
7.7 Item 1 (Picture)

1. The vented fire logs (natural gas) in the Living room is not operable (pilot would not ignite). Repairs should be made so unit works properly. Repairs are needed.

A qualified person should repair or replace as needed.

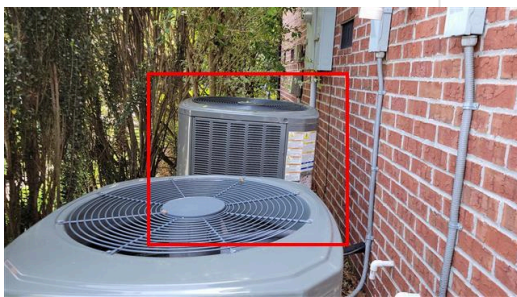
7.8 Item 1 (Picture)

1. The condenser is not level. This can cause damage to the unit or shorten its life span. Repairs are needed.

A qualified HVAC person should inspect further and repair or replace as needed.

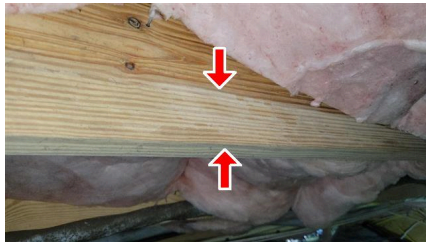
1.0 Item 1 (Picture)

1. Discoloration and some type of mold (Microbial) growth is present in the structure at several areas including but not limited to the crawl space and interior spaces. Evidence suggests that this condition is from a past or present elevated moisture conditions. We did not inspect, test or determine if this type of substance is or is not a health hazard. Further investigation is needed.

We recommend you contact a properly licensed expert for testing, investigation and or correction as deemed appropriate.

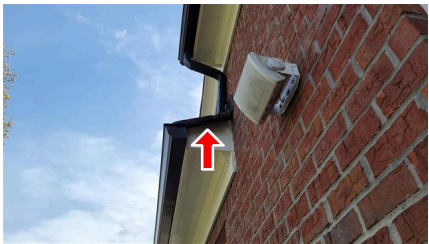
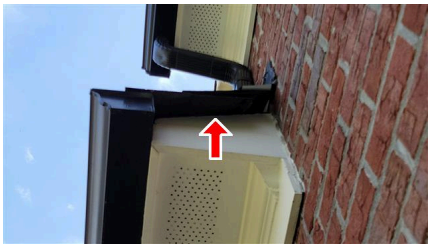
1. The roof shingles was installed improperly at the rear of home. (Improper overhang) this condition can allow damage to the shingle to occur. Further investigation and repairs are needed.

A qualified person should repair or replace as needed.

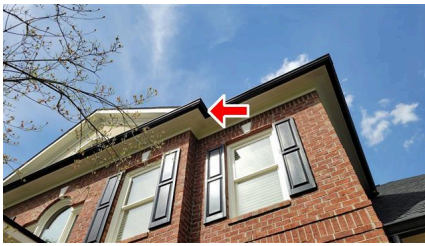
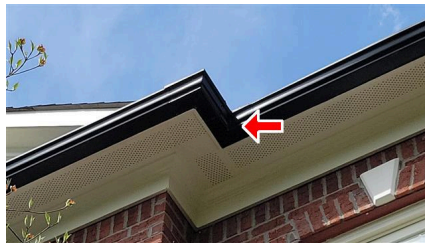
1. The gutter leaks at seam (s) virtually all areas where gutters are installed. Erosion can continue or become worse if not corrected possibly leading to water intrusion. Repairs are needed.

A qualified person should repair or replace as needed.

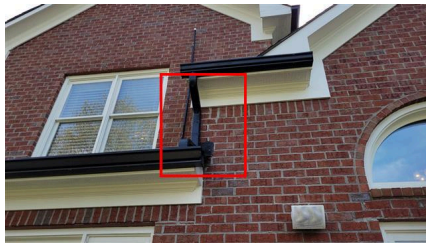
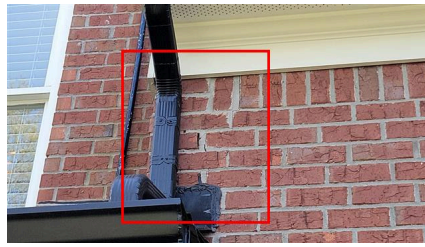
1. I observed small cracks in the brick veneer at the exterior. These are typical in nature due to age and normal masonry shrinkage. Although the cracks in the brick veneer are typical, these areas should be re sealed to prevent any water penetration or damage. Further evaluation by a qualified masonry contractor is recommended for this entire condition.

I recommend repair or replace using a qualified contractor.

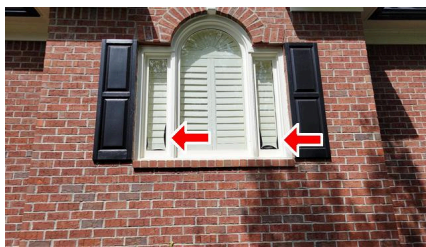
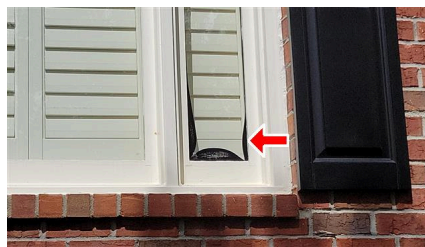
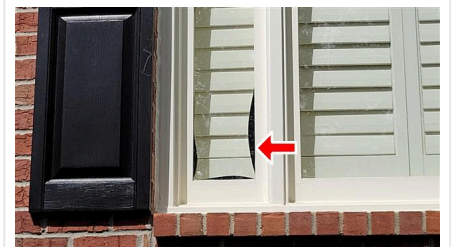
1. Several windows have failed/compromised thermal seals/fogged window panes. This is indicated by the visible moisture, discoloration, calcium deposits and or crystallization visible between the glass window panes. A certified window technician should recheck all the windows throughout the home. Due to weather conditions many times compromised/failed windows cannot be identified at the time of inspection. Further investigation and repairs are needed.

We recommend contacting a properly licensed window technician/contractor regarding these conditions and have repairs made deemed appropriate

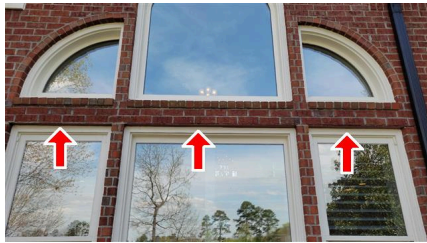
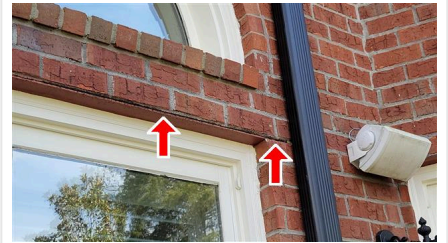
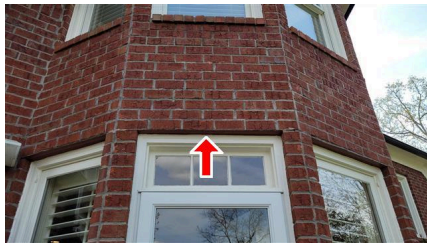
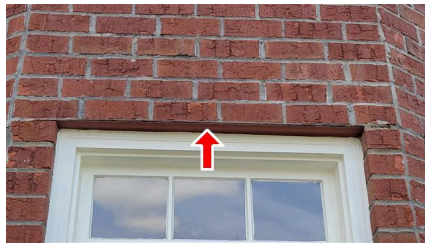
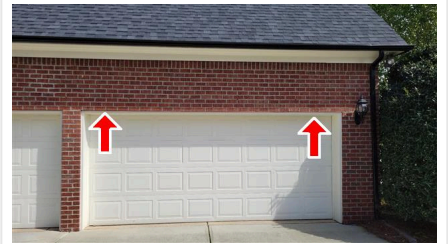
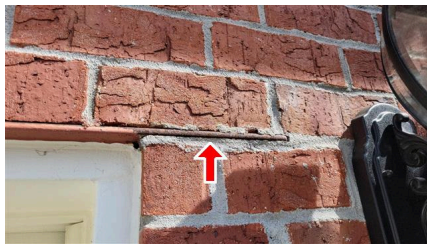
1. The steel lintels around the exterior of the home are beginning to rust or have rust present. A lintel is a horizontal architectural member or steel beam support placed over a wall opening to carry the weight of the masonry placed over it. In most situation, the lintel above you windows and doors will be steel angle iron or I beam. Either due to age or improper rust proofing or weep chord and flashing

placement during installation, lintels will begin to rust. Rusting lintels can expand to become much thicker than their original size. The expansive forces of rusting steel can shift entire multi-story elevations. If your lintels are currently rusting, a telltale sign of expansion is diagonal "step" pattern cracks, which can be found on either end of the window or door opening. Repairs are needed to prevent further damage to the structure. Further deterioration may occur if not repaired.

I recommend a qualified contractor inspect and repair as needed.

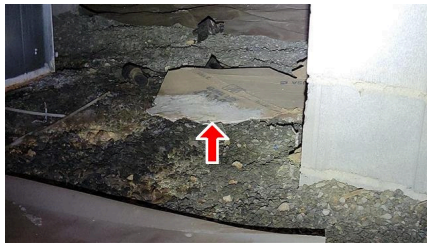
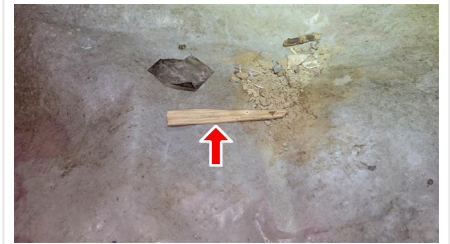
1. Wood debris is in contact with the crawl space floor in numerous areas. This can attract wood destroying organisms. Removal is needed.

A qualified contractor should inspect and repair as needed.

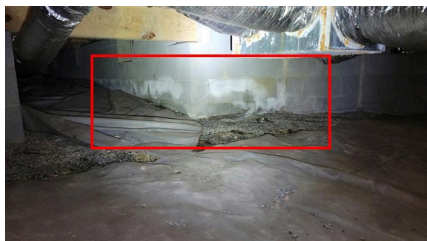
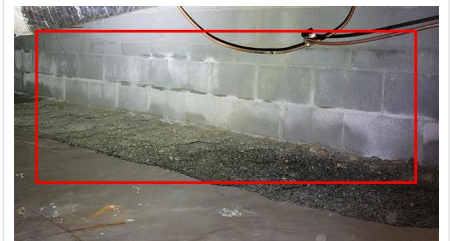
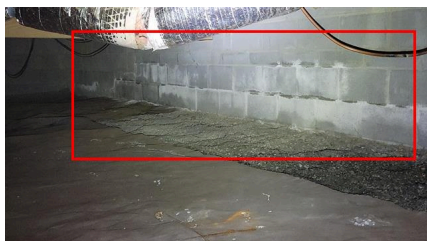
1. White efflorescence (powder substance) on block wall indicates moisture is in contact with the masonry. This does not necessarily indicate that intrusion will occur. I recommend checking the gutters and the downspout drain lines for proper operation. Also, a water proofing paint could be applied to the interior side of the block if necessary. Efflorescence is found on many homes without water intrusion occurring inside the home. But, it should alert you to the possibility that future steps may be needed.

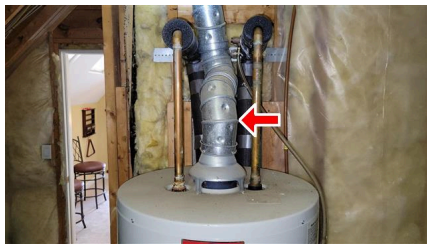
5.1 Item 1 (Picture)

1. The draft hood connection to flue vent connector: provide at least 12" vertical inches of the flue vent between the draft hood outlet and the first elbow. This is a safety issue and should be repaired. Further investigation and repairs are needed.

A qualified licensed plumber should repair or correct as needed.

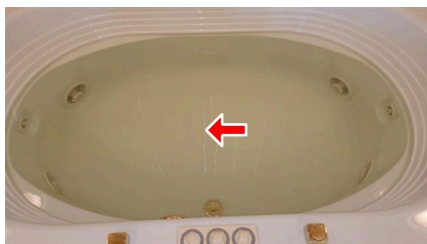
5.2 Item 1 (Picture)

1. The jacuzzi shows signs of improper cleaning and maintenance, as a result black residue is present (likely bacteria) when the tub was operated. (Health Safety Issue) Repairs are needed.

I recommend contacting a licensed plumber.

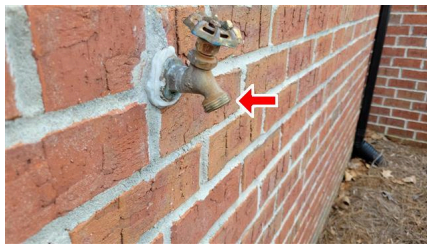
5.2 Item 3 (Picture)

1. The hose bibs (outside water faucets) are missing anti-siphon device. An anti-siphon faucet prevents contaminated water from being back-washed into the main water supply. Cross contamination could occur if not corrected. This is a small repair.
-

I recommend contacting a licensed plumber.

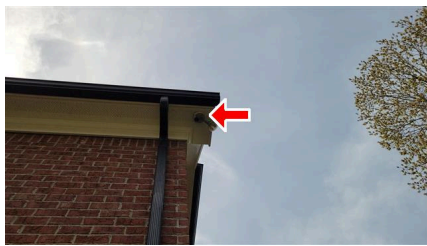
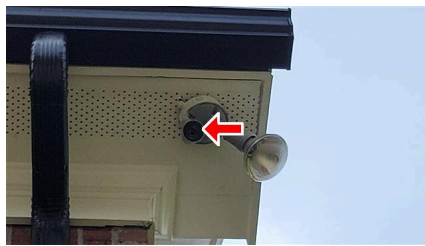
1. The light fixture at the rear of the home appears to have part of a light bulb broken off. Further investigation and repairs are needed..

A qualified licensed electrical contractor should correct as needed.

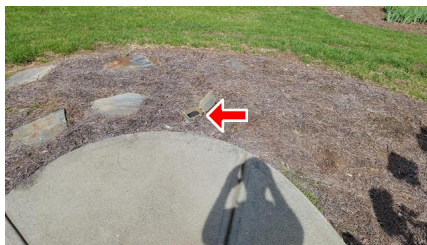
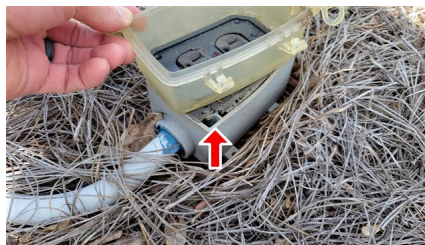
1. The GFCI (Ground Fault Circuit Interrupter) outlet at the exterior has loose cover. This may allow for water intrusion to occur. Repairs are needed..

A qualified licensed electrical contractor should correct as needed.

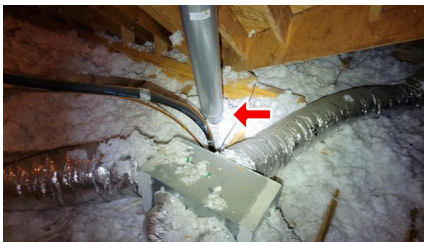
7.5 Item 1 (Picture)

1. The vent pipe for gas furnace needs a 1 inch clearance from combustibles. This is a safety issue and should be repaired. Repairs are needed.

I recommend a qualified licensed heat contractor inspect further and repair as needed.

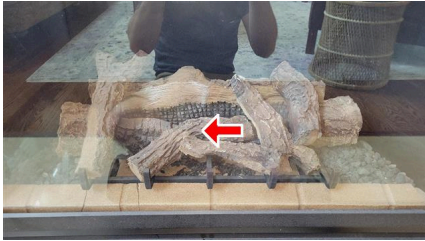
7.7 Item 1 (Picture)

1. The vented fire logs (natural gas) in the Living room is not operable (pilot would not ignite). Repairs should be made so unit works properly. Repairs are needed.

A qualified person should repair or replace as needed.

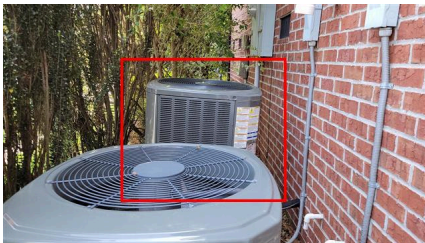
7.8 Item 1 (Picture)

1. The condenser is not level. This can cause damage to the unit or shorten its life span. Repairs are needed.

A qualified HVAC person should inspect further and repair or replace as needed.

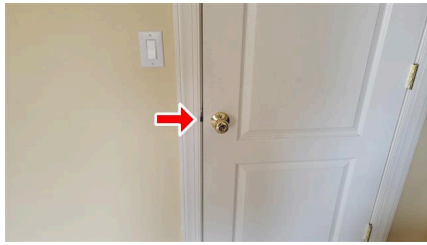
8.5 Item 1 (Picture)

1. The door at guest Bedroom will not latch properly. Evidence suggest that the door needs strike and latch adjustment to shut properly. This is a small repair.

A qualified person should repair or replace as needed.

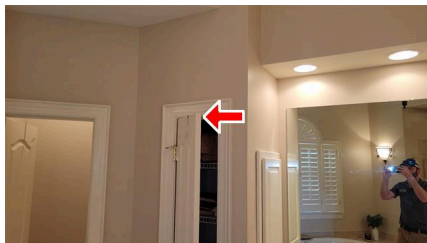
8.5 Item 2 (Picture)

1. The closet door has damage or missing roller ball catch at the master bath. As a result the door will not close properly. Repairs are needed.

A qualified person should repair or replace as needed.

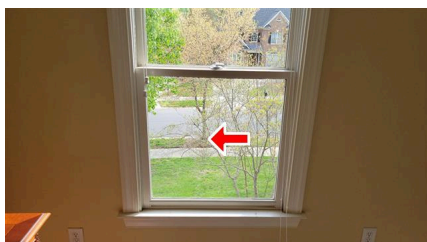
8.6 Item 1 (Picture)

1. Several windows stuck or painted shut at the throughout the home. This is a maintenance issue and is for your information.

A qualified person should repair or replace as needed.

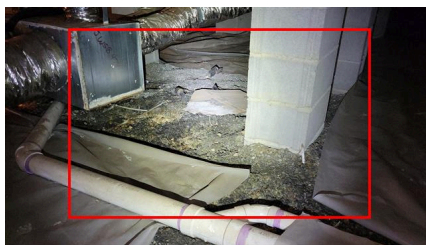
9.0 Item 1 (Picture)

1. The vapor barrier (plastic) on the crawlspace ground is missing in areas. A vapor barrier provides added protection to the floor system from moisture or dampness that can enter from ground. Repairs are needed.

A qualified person should repair or replace as needed.

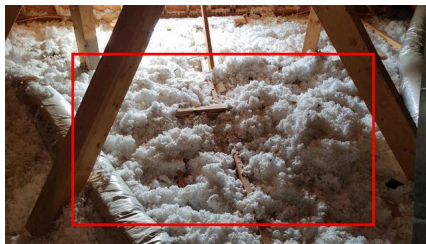
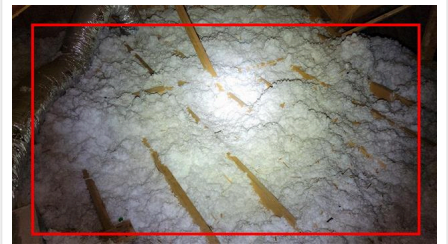
1. Fiberglass (loose-fill) insulation is is compressed in areas of the attic due to foot traffic or storage in attic. Heat loss can occur more on this home than one that is properly insulated. Repairs are recommended .

A qualified person should repair or replace as needed.
