INSPECTION REPORT  
151 Alder Springs Ln  
 Mooresville NC 28117

INSPECTED BY  
Alex Parr 3692  
Above Parr Home  
Inspections

INSPECTION DATE  
📅 4/30/2024  
🕒 02:00:00 PM

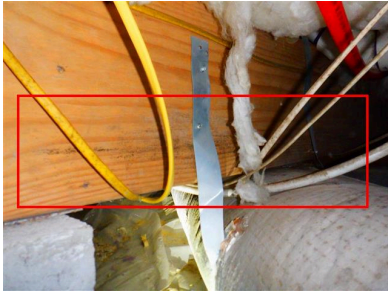
1.0 Item 1 (Picture)

1. Discoloration and some type of mold (Microbial) growth is present in the structure at several areas including but not limited to the crawl space and interior spaces. Evidence suggests that this condition is from a past or present elevated moisture conditions. We did not inspect, test or determine if this type of substance is or is not a health hazard. Further investigation is needed.

We recommend you contact a properly licensed expert for testing, investigation and or correction as deemed appropriate.

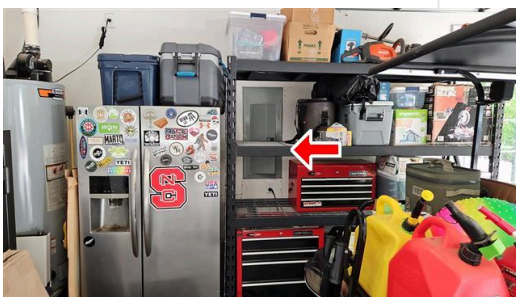
1.1 Item 1 (Picture)

1. Furniture, storage and or personal items in the garage and throughout the house. As a result the areas were not inspected. Hidden damage may be present. Further investigation and repairs are needed.

We recommend having all personal items removed and these areas inspected prior to closing.

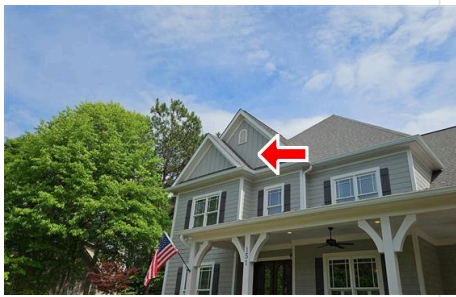
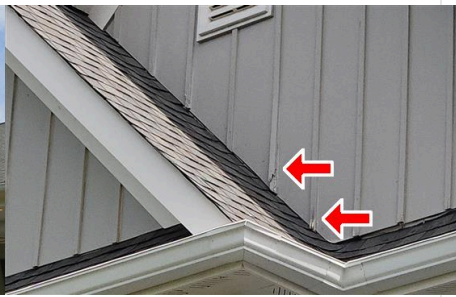
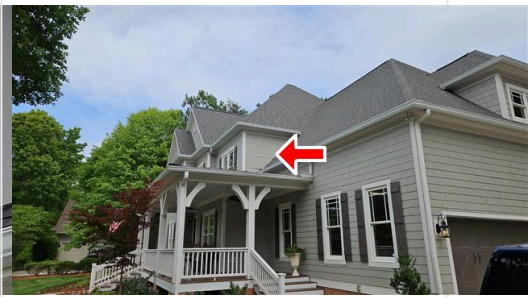
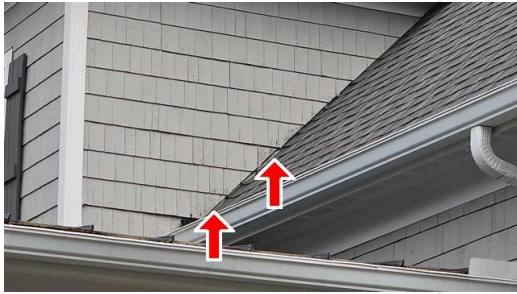
3.0 Item 1 (Picture)

1. The wood siding at the exterior is deteriorated. Further deterioration can occur if not corrected. Further investigation and repairs are needed.

A qualified contractor should inspect and repair as needed.

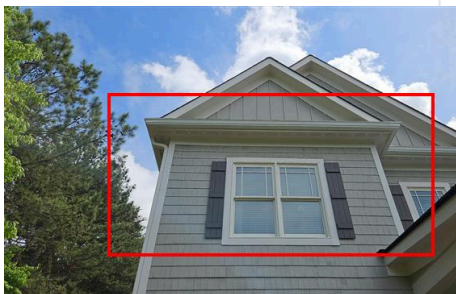
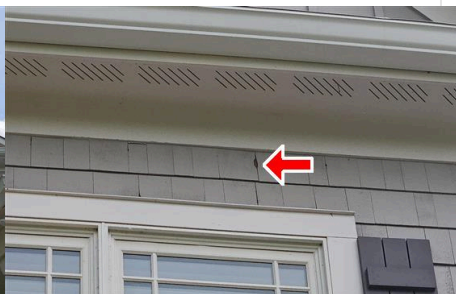
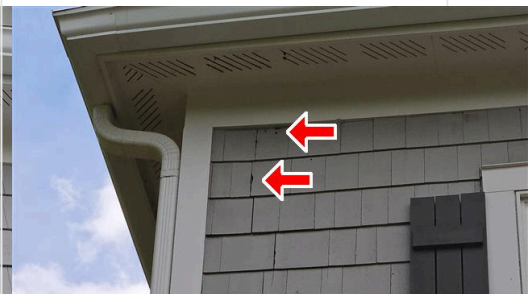
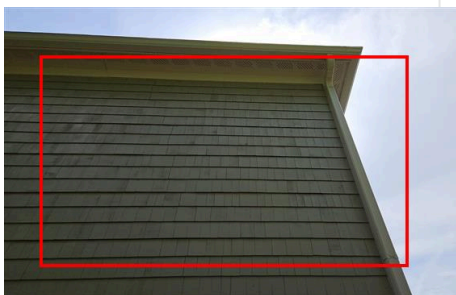
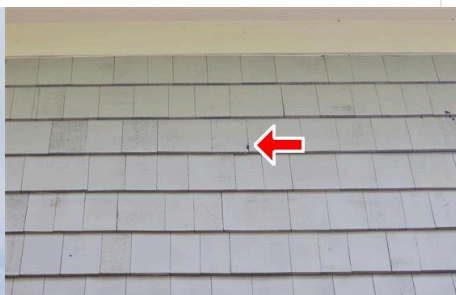
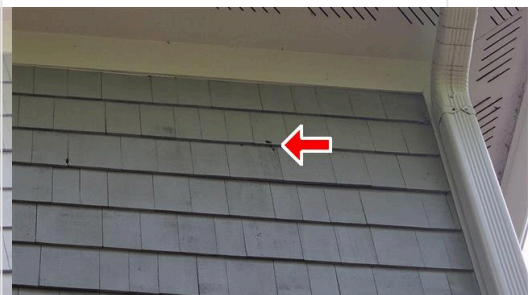
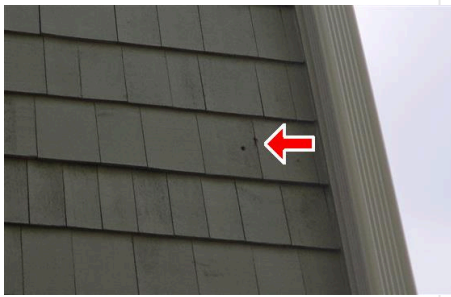
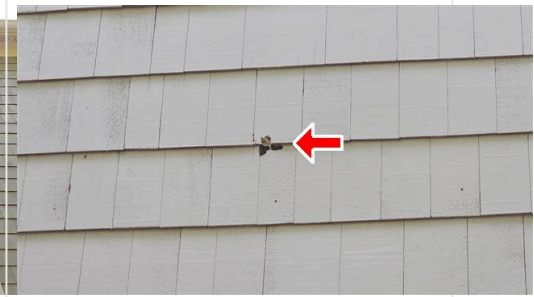
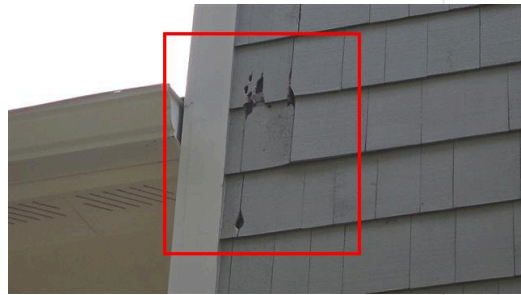
3.0 Item 5 (Picture)

1. The wood siding at the exterior is damaged from what appears to be a woodpecker. Further deterioration can occur if not corrected. Further investigation and repairs are needed.

A qualified person should repair or replace as needed.

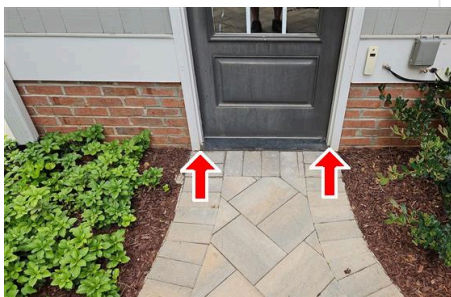
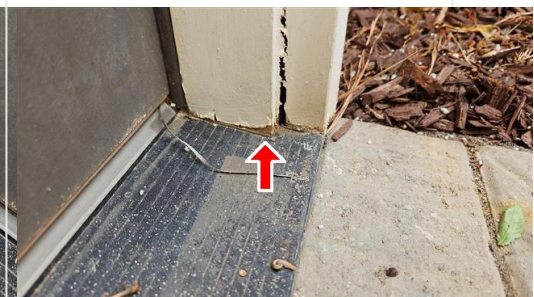
3.3 Item 1 (Picture)

1. The entry door at rear of home deteriorated at bottom of jamb (s). Further deterioration may occur if not repaired. Repairs are needed.

A qualified person should repair or replace as needed.

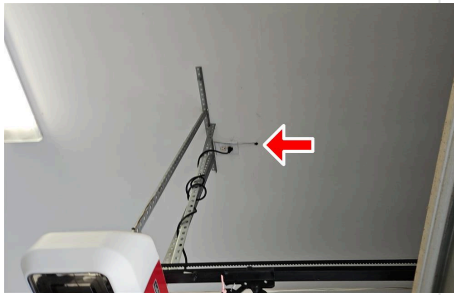
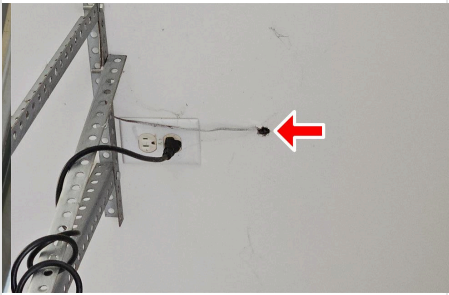
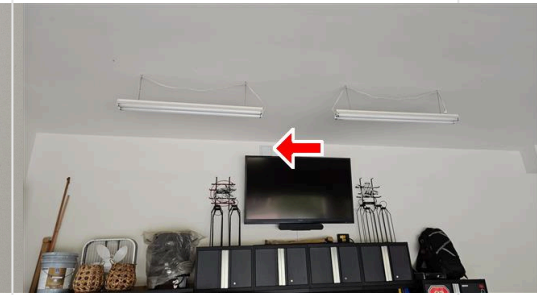
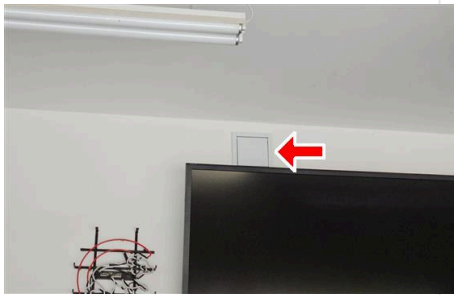
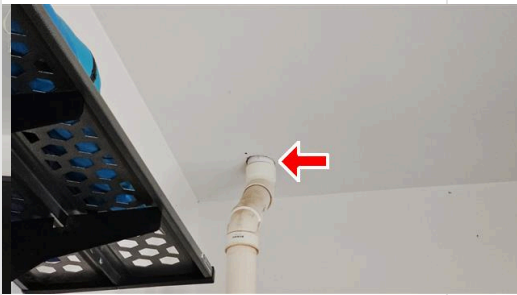
3.8 Item 1 (Picture)

1. The fire resistance sheathing that separates garage from heated space that separates garage from heated space is compromised. This is considered unsafe until corrected. Repairs are needed.

A qualified person should correct for safety.

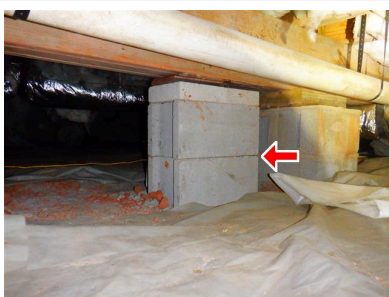
4.1 Item 1 (Picture)

1. Several added CMU (concrete masonry unit) piers are installed incorrectly in the crawl space. As the piers have been installed with no concrete footing and with their cores horizontal with no mortar between the blocks. All masonry block piers should be installed on a concrete footing with the cores vertical and with joints mortared. All piers should be examined for signs of settlement condition and their adequacy in accepting bearing loads. Those that are deficient should be repaired or replaced to prevent foundation issues and movement. Further investigation and repairs are needed.

A qualified licensed general contractor should inspect further and repair as needed.

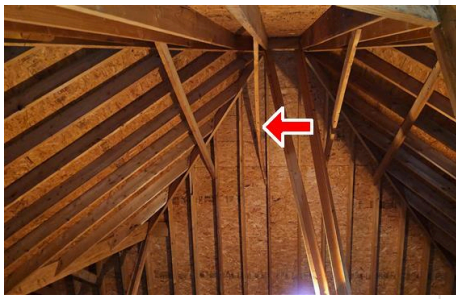
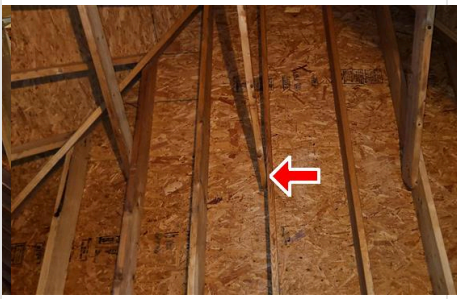
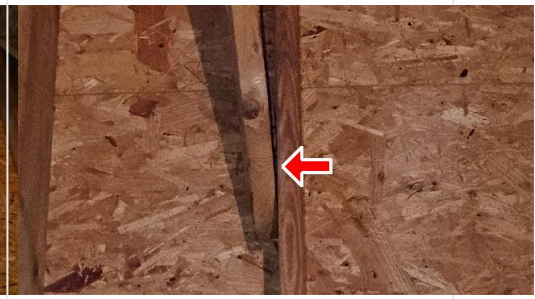
4.4 Item 1 (Picture)

1. The collar ties is loose in the attic. Repairs are needed to maintain the stability of roof. Further investigation and repairs are needed.

I recommend a qualified contractor perform the work.

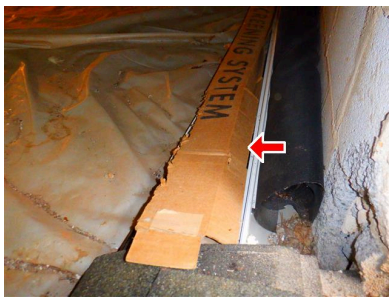
4.5 Item 1 (Picture)

1. Wood debris is in contact with the crawl space floor in numerous areas. This can attract wood destroying organisms. Removal is needed.

A qualified contractor should inspect and repair as needed.

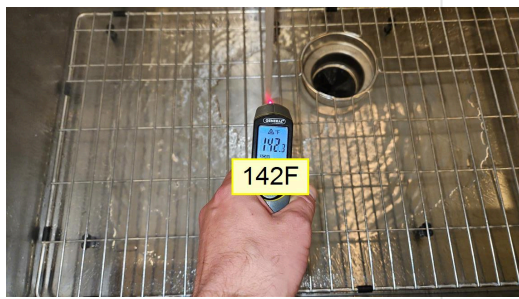
5.1 Item 1 (Picture)

1. The water heater is set over the recommended temperature. (Over 120) The risk is especially acute for infants, children, and the elderly. Water temperatures should never be set higher than 120 degrees.

This is a safety issue. Repairs are needed

A qualified contractor should inspect and repair as needed.

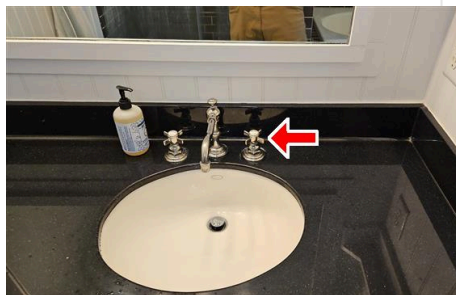
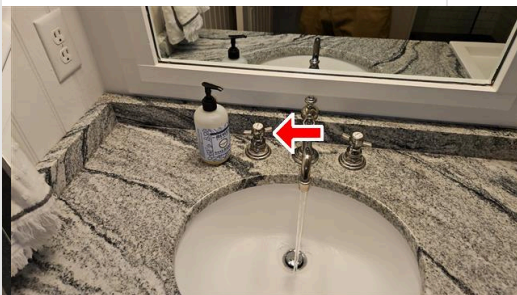
5.2 Item 1 (Picture)

1. The sink controls are difficult to operate possibly hard water throughout the home. Therefore they do not function as intended. Further investigation and repairs are needed..

A qualified licensed plumber should repair or correct as needed.

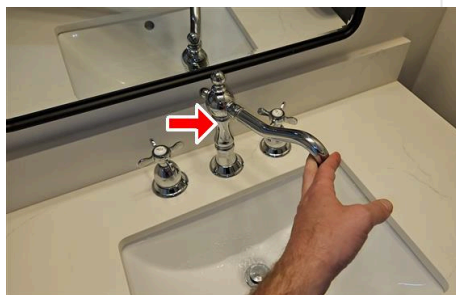
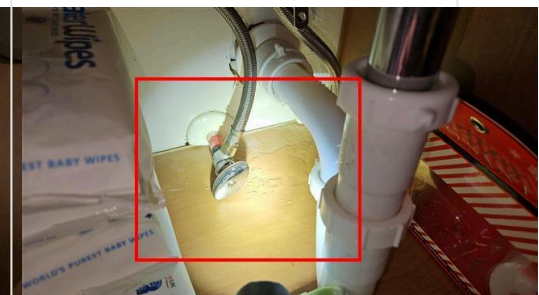
5.2 Item 3 (Picture)

1. The sink faucets is loose at the guest bath. This is allow undue stress to occur on supply lines allowing leaks to occur. Repairs are needed..

A qualified licensed plumber should repair or correct as needed.

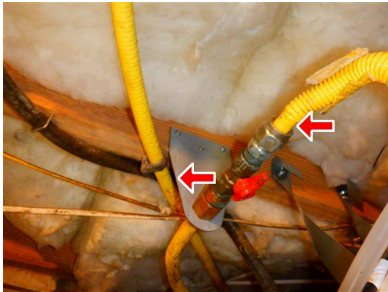
5.6 Item 1 (Picture)

1. The gas piping in the house includes corrugated stainless steel tubing (CSST). There is no electrical bonding connection between the gas piping system and the electrical system, other than the connection at the gas appliance that utilizes the grounding conductors for the appliance. The lack of a strong electrical bonding may increase the potential for lightning strikes to cause arcing of the CSST gas piping that may result in perforation of the piping, gas leaks, and fires. For safety, it is recommended that this installation be further investigated by a licensed electrical contractor.

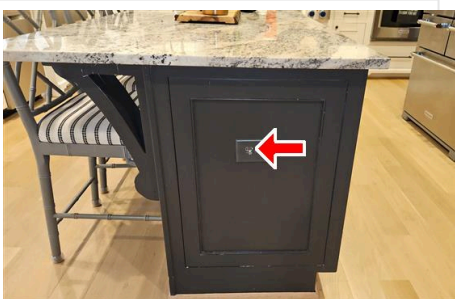
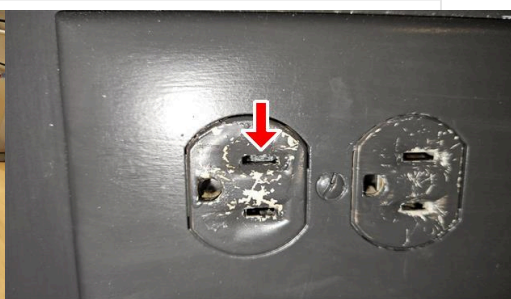
6.4 Item 1 (Picture)

1. One "three-prong" outlet is damaged (foreign object blocking prong holes) in the kitchen. Electrical issues are considered a hazard until repaired. Further investigation and repairs are needed.

A qualified licensed electrical contractor should correct as needed.

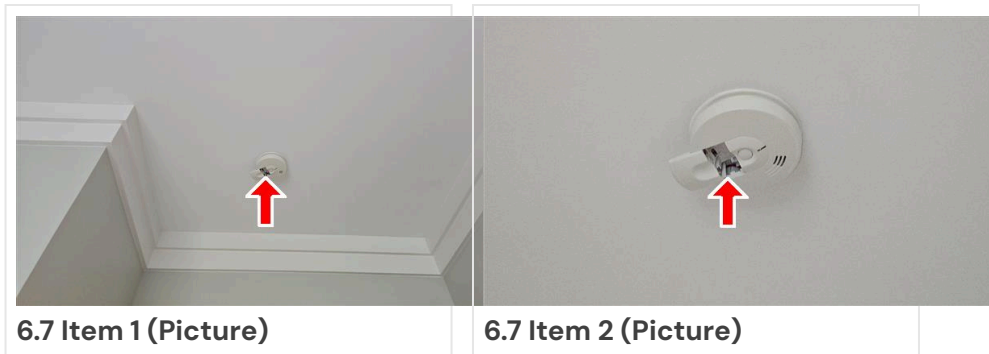
1. The smoke detector is missing battery at the bedroom. Without a working smoke detector in your home you have no first alert to a possible fire. Repairs are needed.

A qualified person should repair or replace as needed.

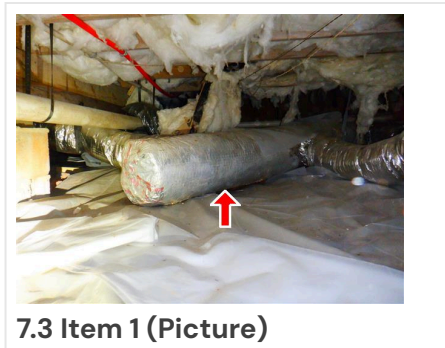
1. The supply plenum is in contact with ground and may deteriorate if not corrected in the crawlspace. A minimum of four inches of clearance from the ground is needed to prevent deterioration to ductwork. Further investigation and repairs are needed..

A qualified HVAC person should inspect further and repair or replace as needed.

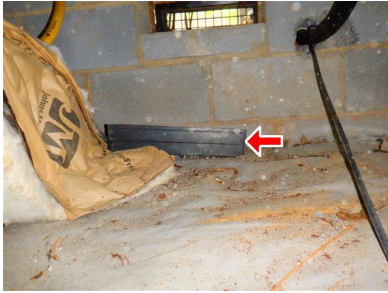
9.1 Item 1 (Picture)

1. Several foundation vent are damaged at the crawlspace entry. Opinions vary on whether or not your crawlspace should be ventilated. If you have some moisture entering in then ventilation is usually recommended. Not opening the vents when moisture is present could harm your floor system or contribute to mold. A dry crawlspace that is prepared for no ventilation (other steps required), would not use the vents. Further investigation and repairs are needed.

A qualified person should repair or replace as needed.

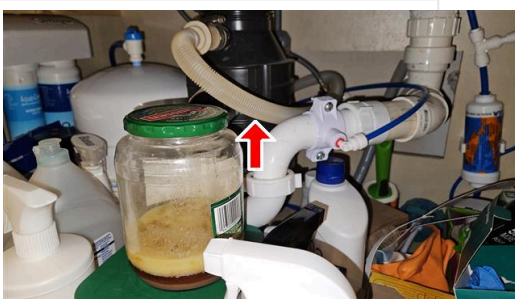
10.0 Item 1 (Picture)

1. The dishwasher drain hose needs to be looped above the level of the kitchen sink drain or an approved air gap installed to prevent back flow of waste water into the water supply. (food safety issue) This can allow waste for the sink to contaminate the dishwasher. This is a small repair.

A qualified licensed plumber should repair or correct as needed.

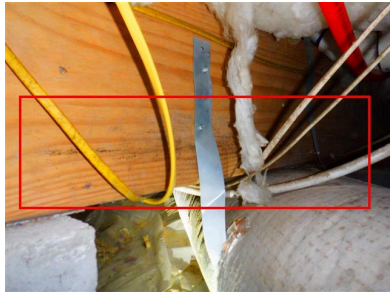
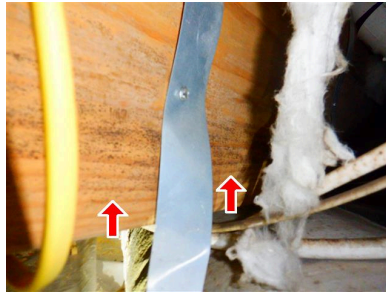
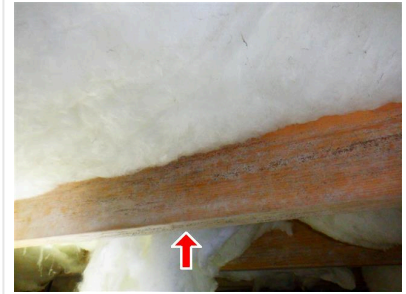
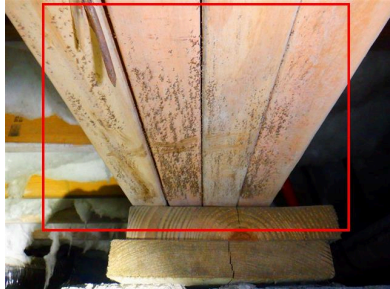
1. Discoloration and some type of mold (Microbial) growth is present in the structure at several areas including but not limited to the crawl space and interior spaces. Evidence suggests that this condition is from a past or present elevated moisture conditions. We did not inspect, test or determine if this type of substance is or is not a health hazard. Further investigation is needed.

We recommend you contact a properly licensed expert for testing, investigation and or correction as deemed appropriate.

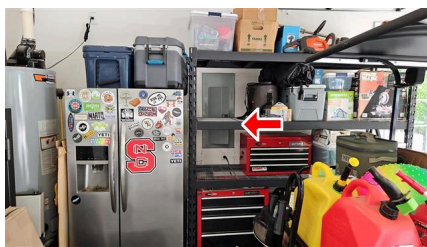
1.1 Item 1 (Picture)

1. Furniture, storage and or personal items in the garage and throughout the house. As a result the areas were not inspected. Hidden damage may be present. Further investigation and repairs are needed.

We recommend having all personal items removed and these areas inspected prior to closing.

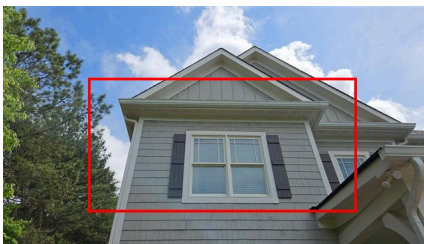
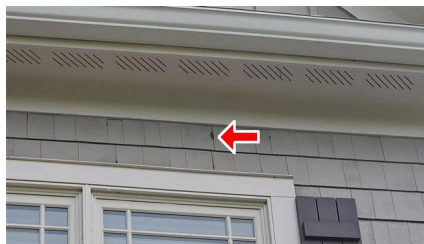
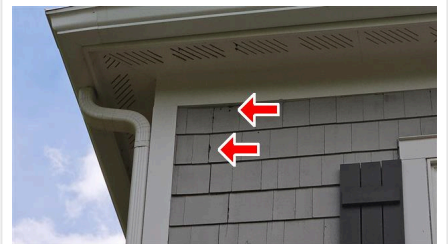
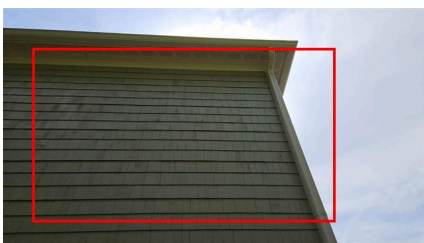
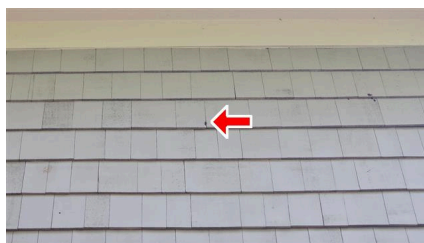
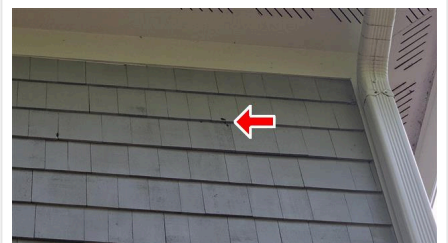
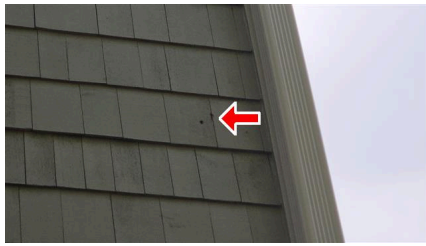
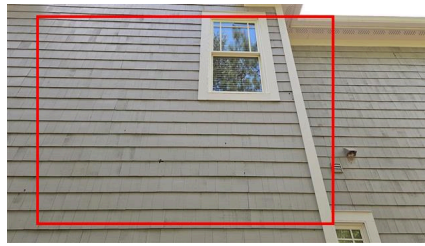
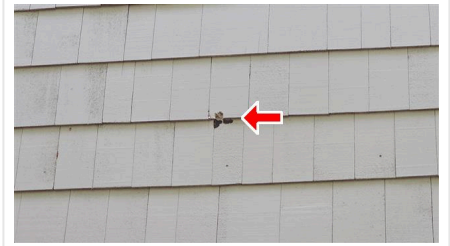
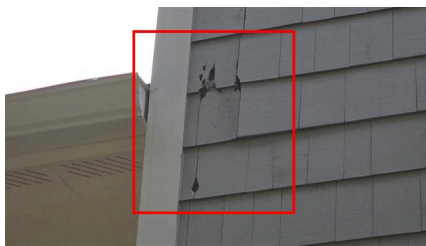
1. The wood siding at the exterior is damaged from what appears to be a woodpecker. Further deterioration can occur if not corrected. Further investigation and repairs are needed.

A qualified person should repair or replace as needed.

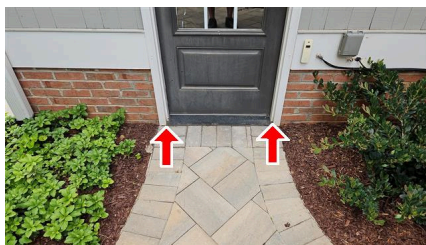
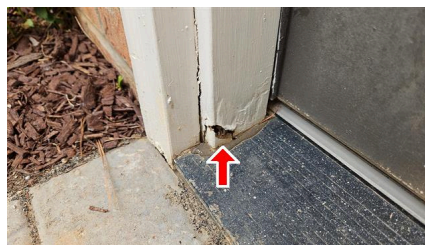
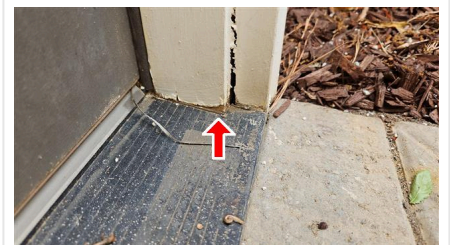
1. The entry door at rear of home deteriorated at bottom of jamb (s). Further deterioration may occur if not repaired. Repairs are needed.

A qualified person should repair or replace as needed.

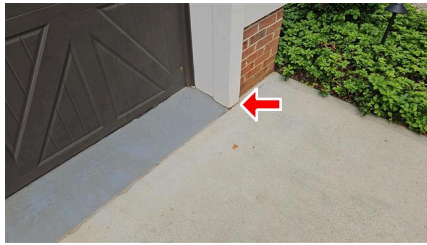
3.6 Item 1 (Picture)

1. The garage door at the right side (facing front) shows deterioration on bottom of side jambs.

Further deterioration may occur if not repaired. Repairs are needed.

A qualified person should repair or replace as needed.

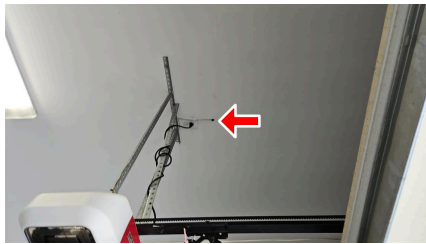
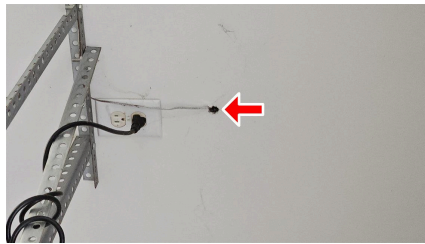
1. The fire resistance sheathing that separates garage from heated space that separates garage from heated space is compromised. This is considered unsafe until corrected. Repairs are needed. A qualified person should correct for safety.

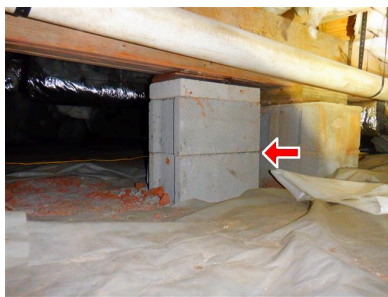
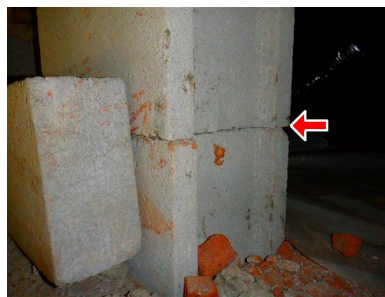
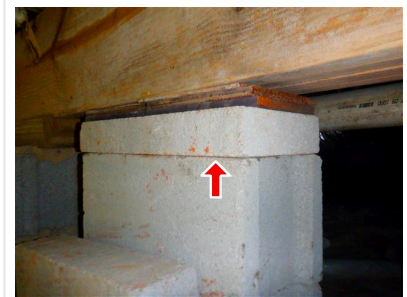
1. Several added CMU (concrete masonry unit) piers are installed incorrectly in the crawl space. As the piers have been installed with no concrete footing and with their cores horizontal with no mortar between the blocks. All masonry block piers should be installed on a concrete footing with the cores vertical and with joints mortared. All piers should be examined for signs of settlement condition and their adequacy in accepting bearing loads. Those that are deficient should be repaired or replaced to prevent foundation issues and movement. Further investigation and repairs are needed.

A qualified licensed general contractor should inspect further and repair as needed.

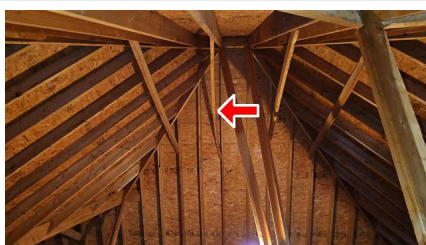
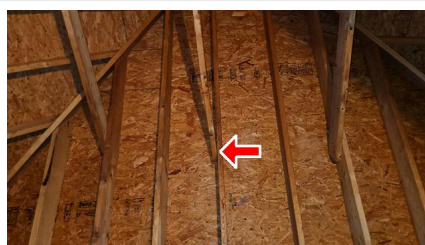
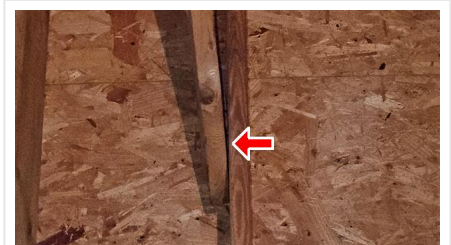
1. The collar ties is loose in the attic. Repairs are needed to maintain the stability of roof. Further investigation and repairs are needed.

I recommend a qualified contractor perform the work.

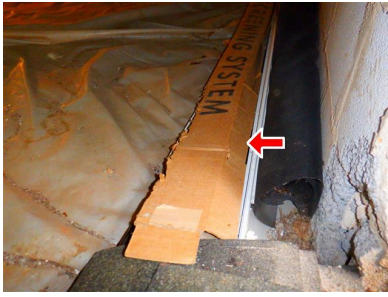
4.5 Item 1 (Picture)

1. Wood debris is in contact with the crawl space floor in numerous areas. This can attract wood destroying organisms. Removal is needed.

A qualified contractor should inspect and repair as needed.

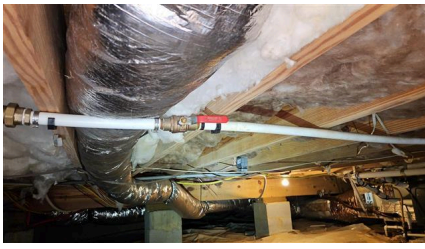
5.0 Item 1 (Picture)

The main shut off is the red lever located underneath in the crawlspace. This is for your information.

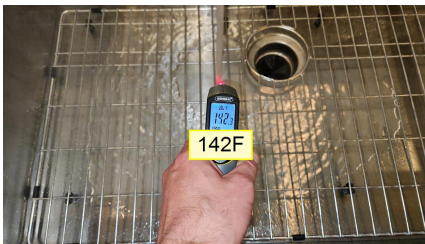
5.1 Item 1 (Picture)

1. The water heater is set over the recommended temperature. (Over 120) The risk is especially acute for infants, children, and the elderly. Water temperatures should never be set higher than 120 degrees. This is a safety issue. Repairs are needed

A qualified contractor should inspect and repair as needed.

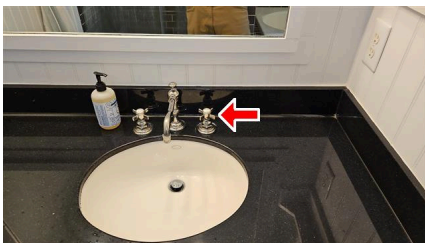
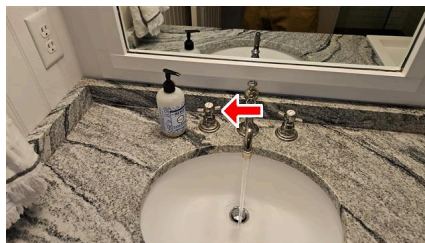
1. The sink controls are difficult to operate possibly hard water throughout the home. Therefore they do not function as intended. Further investigation and repairs are needed..

A qualified licensed plumber should repair or correct as needed.

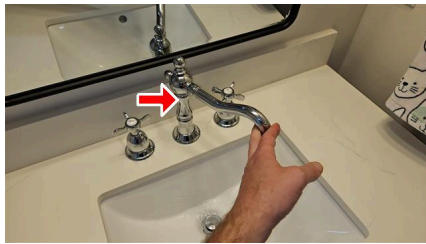
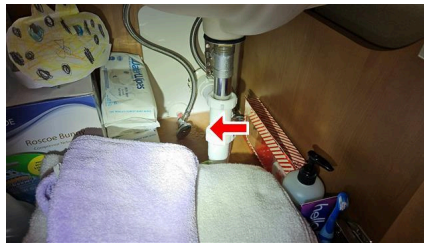
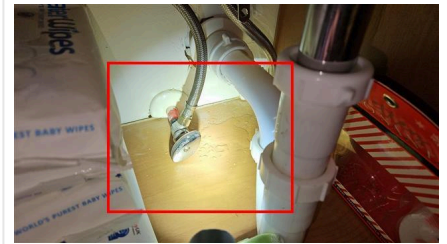
1. The sink faucets is loose at the guest bath. This is allow undue stress to occur on supply lines allowing leaks to occur. Repairs are needed..

A qualified licensed plumber should repair or correct as needed.

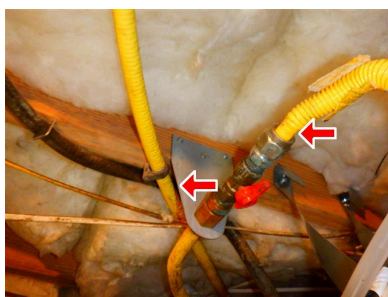
5.6 Item 1 (Picture)

1. The gas piping in the house includes corrugated stainless steel tubing (CSST). There is no electrical bonding connection between the gas piping system and the electrical system, other than the connection at the gas appliance that utilizes the grounding conductors for the appliance. The lack of a strong electrical bonding may increase the potential for lightning strikes to cause arcing of the CSST gas piping that may result in perforation of the piping, gas leaks, and fires. For safety, it is recommended that this installation be further investigated by a licensed electrical contractor.

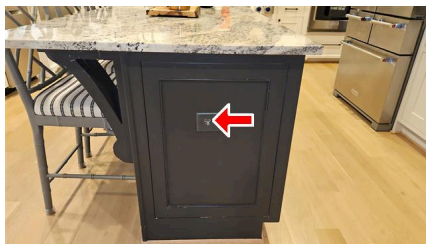
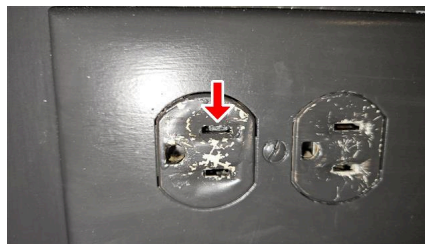
1. One "three-prong" outlet is damaged (foreign object blocking prong holes) in the kitchen. Electrical issues are considered a hazard until repaired. Further investigation and repairs are needed.

A qualified licensed electrical contractor should correct as needed.

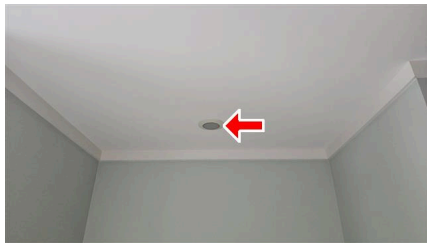
6.4 Item 3 (Picture)

1. The light fixture does not work (try bulb first) at the throughout the home. Further investigation and repairs are needed..

A qualified licensed electrical contractor should correct as needed.

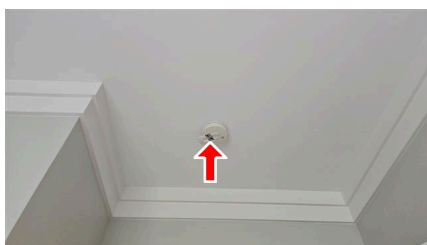
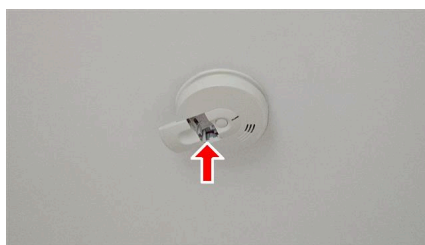
1. The smoke detector is missing battery at the bedroom. Without a working smoke detector in your home you have no first alert to a possible fire. Repairs are needed.

A qualified person should repair or replace as needed.

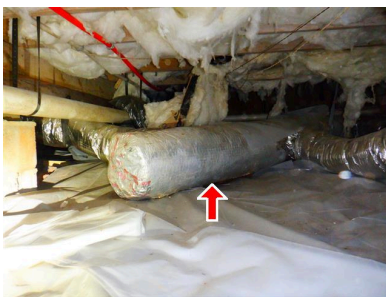
**7.3 Item 1 (Picture)**

1. The supply plenum is in contact with ground and may deteriorate if not corrected in the crawlspace. A minimum of four inches of clearance from the ground is needed to prevent deterioration to ductwork. Further investigation and repairs are needed..

A qualified HVAC person should inspect further and repair or replace as needed.

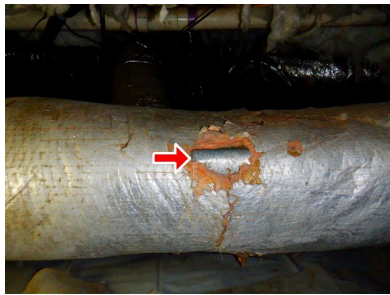
7.3 Item 2 (Picture)

1. The supply plenum and duct pipe is damaged in the crawlspace. Energy loss is occurring in crawlspace and immediate correction is needed. Repairs are needed..

I recommend further inspection by a licensed HVAC contractor.

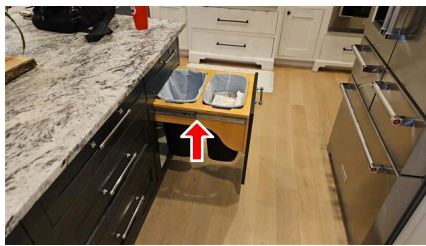
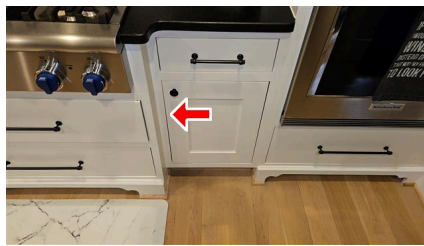
1. Drawer faces and Cabinet door (s) rubs against cabinets. Further investigation and repairs are needed.

A qualified person should repair or replace as needed

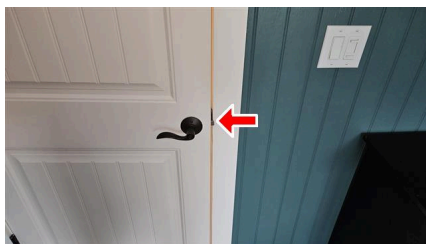
8.5 Item 1 (Picture)

1. The door at guest Bedroom will not latch properly. Evidence suggest that the door needs strike and latch adjustment to shut properly. This is a small repair.

A qualified person should repair or replace as needed.

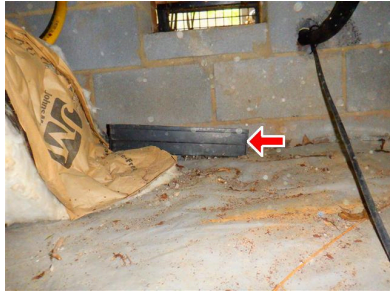
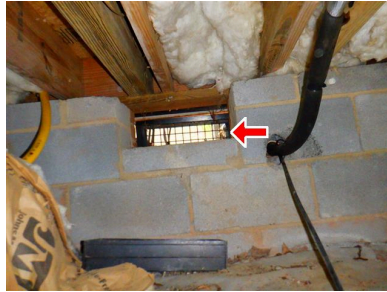
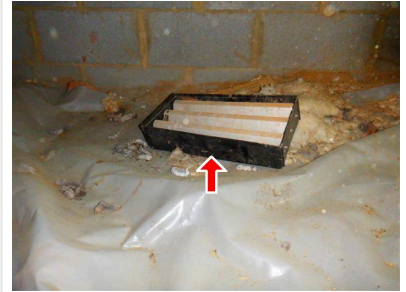
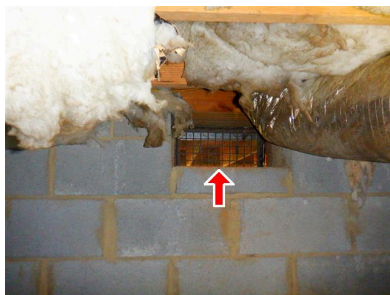
1. Several foundation vent are damaged at the crawlspace entry. Opinions vary on whether or not your crawlspace should be ventilated. If you have some moisture entering in then ventilation is usually recommended. Not opening the vents when moisture is present could harm your floor system or contribute to mold. A dry crawlspace that is prepared for no ventilation (other steps required), would not use the vents. Further investigation and repairs are needed.

A qualified person should repair or replace as needed.

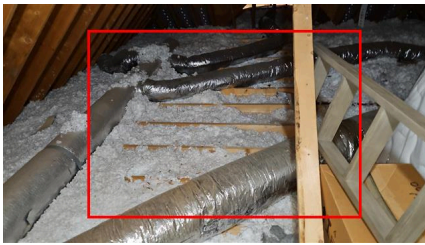
9.2 Item 1 (Picture)

1. Fiberglass (loose-fill) insulation is is compressed in areas of the attic due to foot traffic or storage in attic. Heat loss can occur more on this home than one that is properly insulated. Repairs are recommended .

A qualified person should repair or replace as needed.

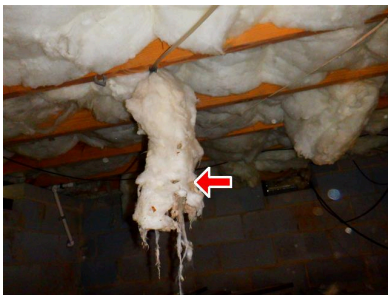
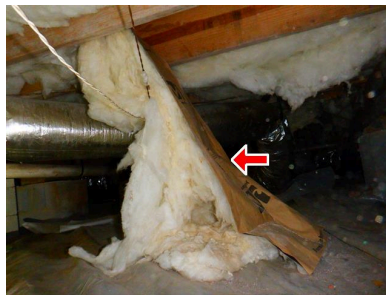
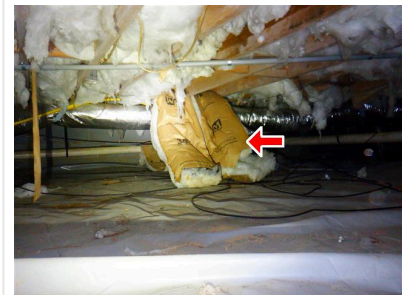
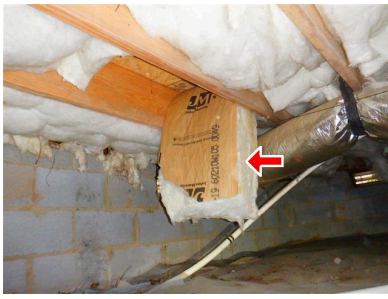
1. The insulation is loose/fallen in the crawlspace. Heat loss can occur more on this home than one that is properly insulated. Repairs are needed..

A qualified person should repair or replace as needed.

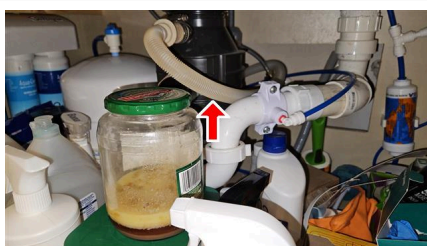
10.0 Item 1 (Picture)

1. The dishwasher drain hose needs to be looped above the level of the kitchen sink drain or an approved air gap installed to prevent back flow of waste water into the water supply. (food safety issue) This can allow waste for the sink to contaminate the dishwasher. This is a small repair.

A qualified licensed plumber should repair or correct as needed.
