INSPECTION REPORT  
16215 Sasanoa Dr  
Cornelius NC 28031

INSPECTED BY  
Alex Parr 3692  
Above Parr Home  
Inspections

INSPECTION DATE  
📅 6/2/2023  
🕒 09:00:00 AM

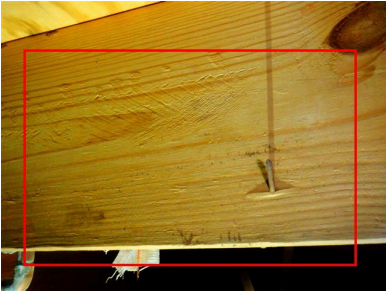
1.0 Item 1 (Picture)

1. Discoloration and some type of mold (Microbial) growth is present in the structure at several areas including but not limited to the crawl space and interior spaces. Evidence suggests that this condition is from a past or present elevated moisture conditions. We did not inspect, test or determine if this type of substance is or is not a health hazard. Further investigation is needed.

We recommend you contact a properly licensed expert for testing, investigation and or correction as deemed appropriate.

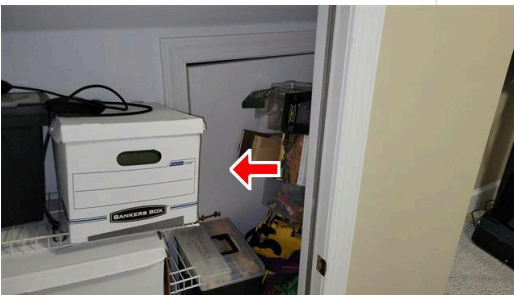
1.1 Item 1 (Picture)

1. Furniture, storage and or personal items in the garage and throughout the house. As a result the areas were not inspected. hidden damage may be present. Further investigation and repairs are needed.

We recommend having all personal items removed and these areas inspected prior to closing.

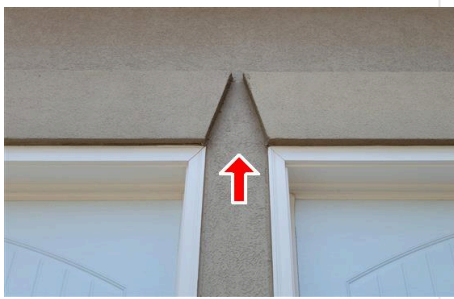
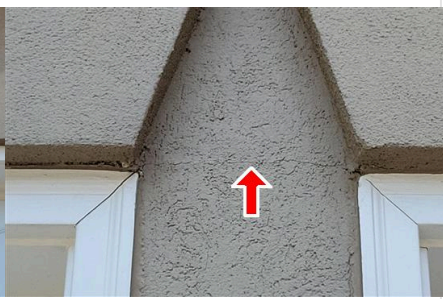
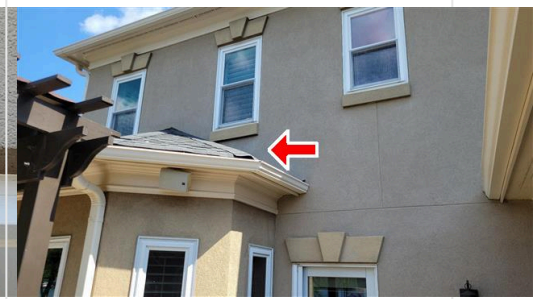
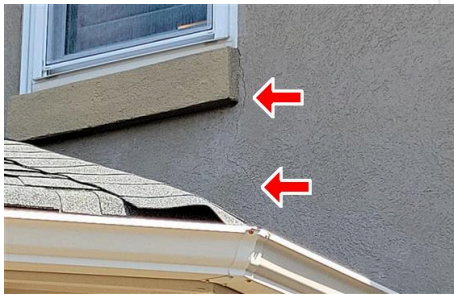
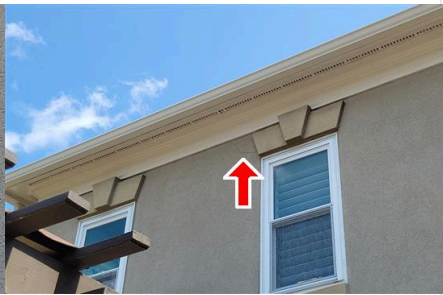
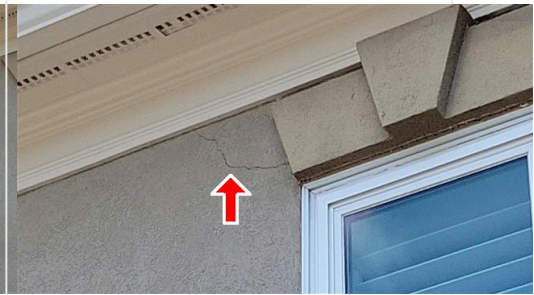
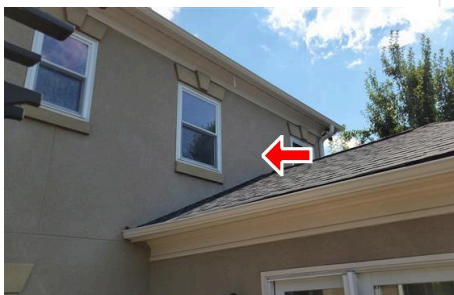
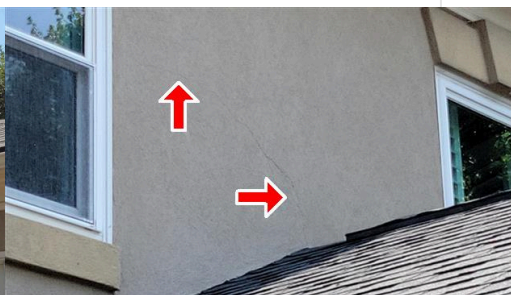
1. The stucco coating at the exterior in areas has hairline cracks. Deterioration can eventually occur if not corrected. Further investigation and repairs are needed.

A qualified contractor should inspect and repair as needed.

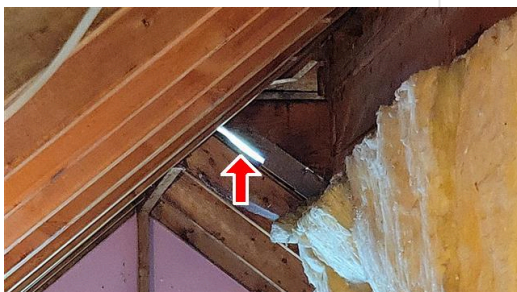
3.0 Item 9 (Picture)

1. The flashing at the front of home is missing. Deterioration can eventually occur if not corrected.  
Further investigation and repairs are needed.

A qualified person should repair or replace as needed.

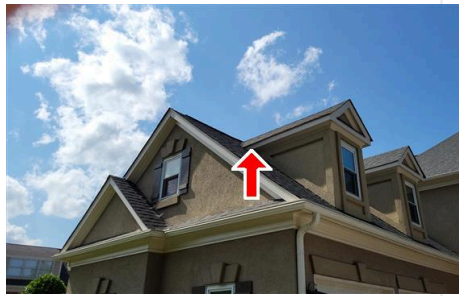
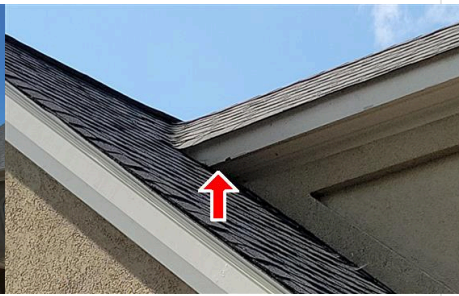
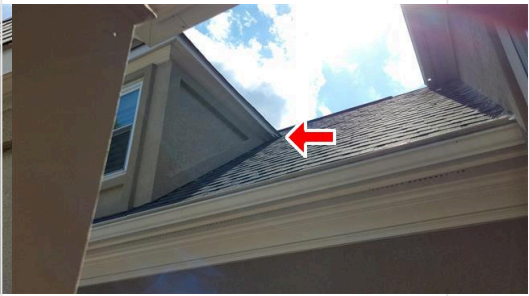
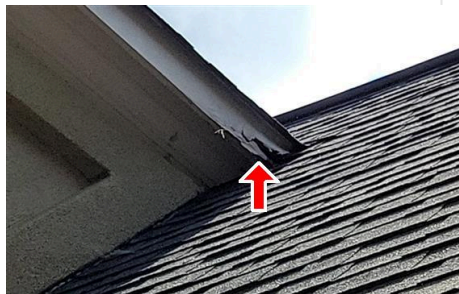
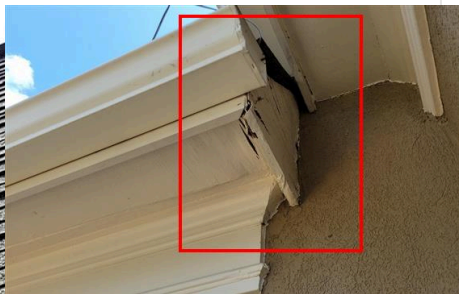
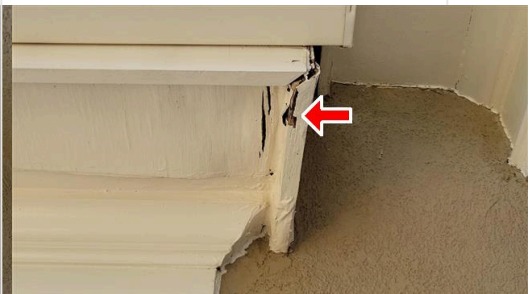
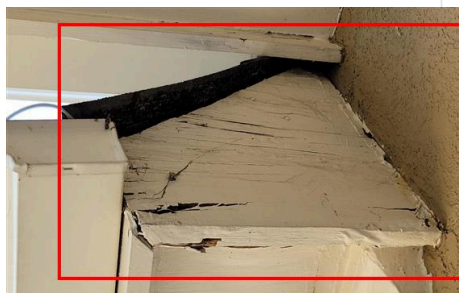
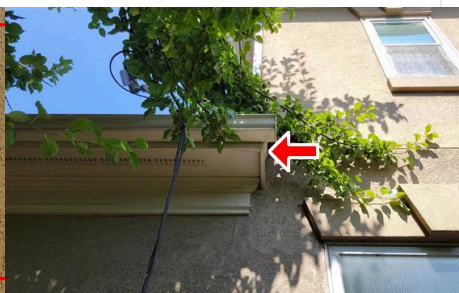
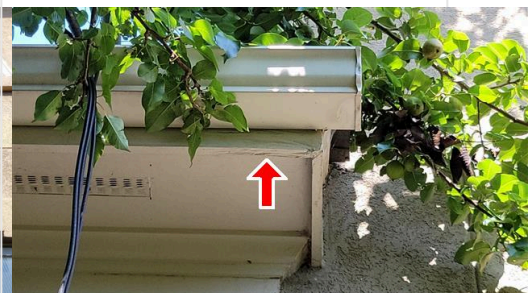
1. The wood fascia and soffit panels at the exterior in areas are deteriorated. Further deterioration may

occur if not repaired. Further investigation and repairs are needed.  
A qualified contractor should inspect and repair as needed.

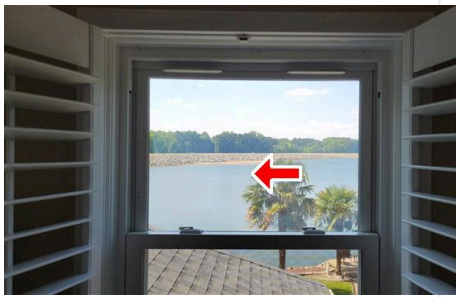
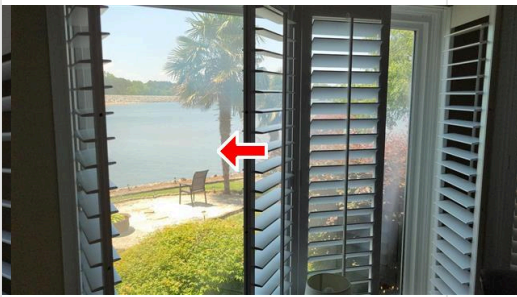
1. Several windows have failed/compromised thermal seals/fogged window panes. This is indicated by the visible moisture, discoloration, calcium deposits and or crystallization visible between the glass window panes. A certified window technician should recheck all the windows throughout the home. Due to weather conditions many times compromised/failed windows cannot be identified at the time of inspection. Further investigation and repairs are needed.

We recommend contacting a properly licensed window technician/contractor regarding these conditions and have repairs made deemed appropriate

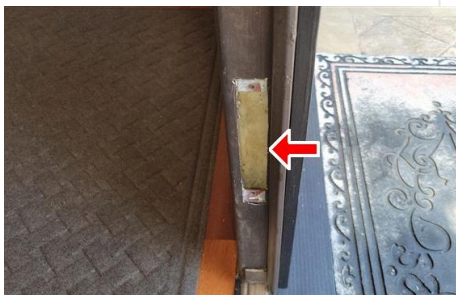
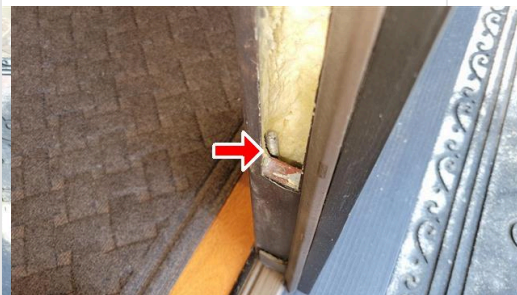
1. The main entry door lock is damaged and does not function as intended. Further investigation and repairs are needed.

A qualified person should repair or replace as needed.

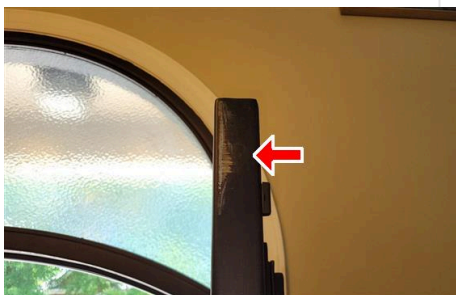
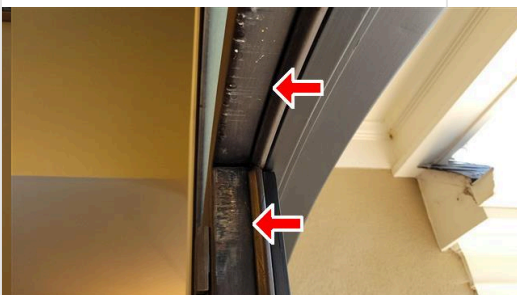
1. The main entry door rubs at jamb when closing. As a result the door will not close properly. Repairs are needed.

A qualified person should repair or replace as needed.

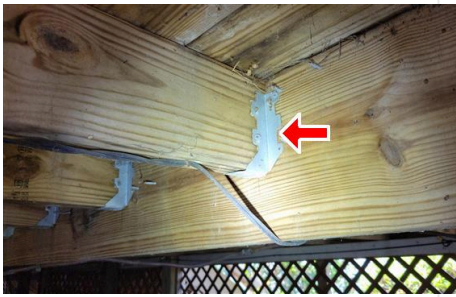
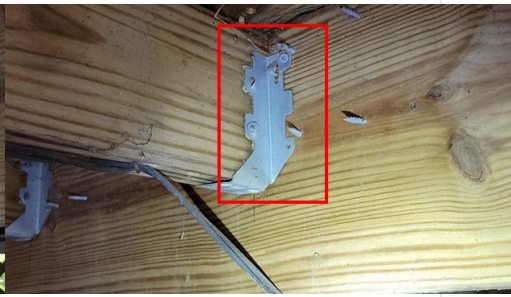
1. The floor joist hangers for the deck at the rear of the home were installed improperly. This can allow for a failure of the floor joist. Further investigation and repairs are needed.

A qualified contractor should repair or replace as needed.

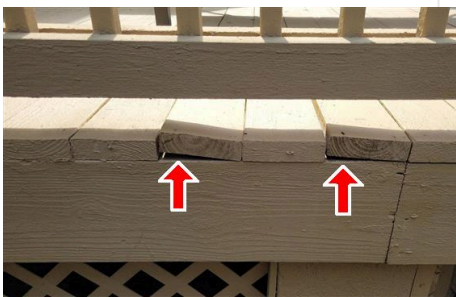
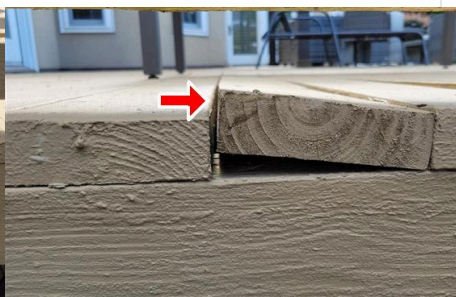
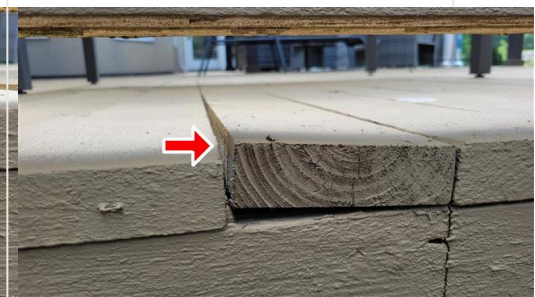
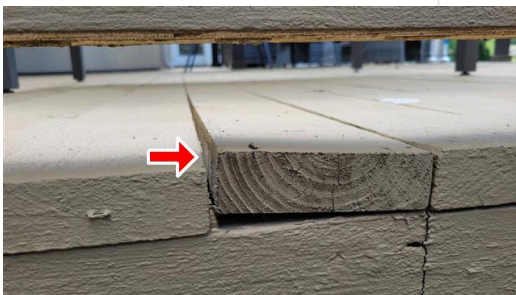
1. The deck floor on the deck at the rear of home loose. A fall or injury can occur if not corrected. Repairs are needed.

A qualified contractor should repair or replace as needed.

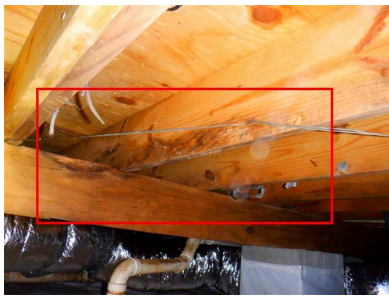
4.2 Item 1 (Picture)

1. Some of the floor system is deteriorated from moisture absorption or water intrusion under the kitchen. The floor system may need reinforcement in this area. Further investigation and repairs are needed.

A qualified licensed general contractor should inspect further and repair as needed.

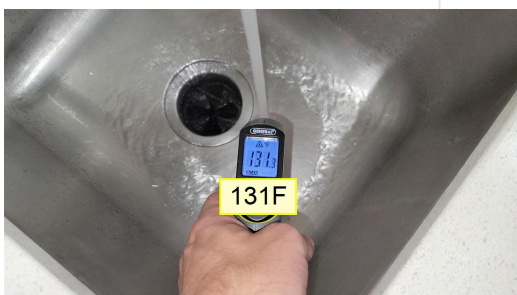
5.1 Item 1 (Picture)

1. The water heater is set over the recommended temperature. (Over 120) The risk is especially acute for infants, children, and the elderly. Water temperatures should never be set higher than 120 degrees.

This is a safety issue. Repairs are needed

A qualified contractor should inspect and repair as needed.

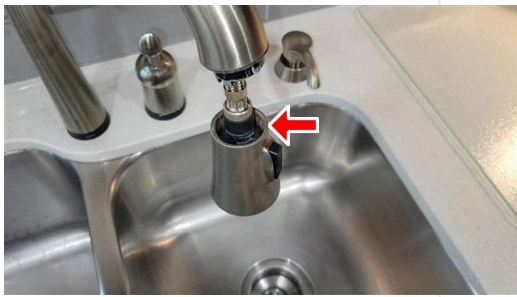
5.2 Item 1 (Picture)

1. The faucet is damaged at the kitchen sink. Further investigation and repairs are needed..

A qualified licensed plumber should repair or correct as needed.

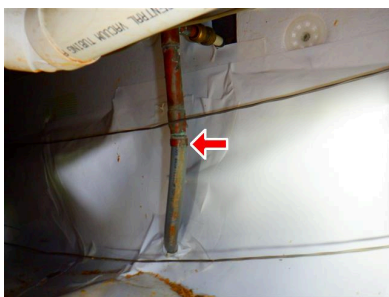
5.2 Item 2 (Picture)

1. Polybutylene plastic plumbing supply lines (PB) are installed in the subject house. Polybutylene has been used in this area for many years, but has had a higher than normal failure rate, and is no longer being widely used. Copper and Brass fittings used in later years have apparently reduced the failure rate. This subject house has copper fittings. For further details contact the Consumer Plumbing Recovery center at 1-800-392-7591 or the web at <http://www.pbpipe.com>

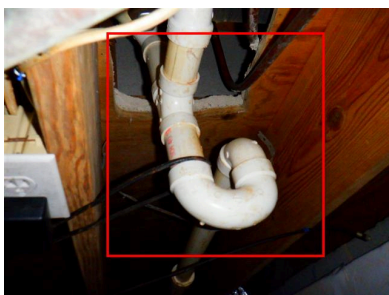
5.3 Item 1 (Picture)

1. The plumbing waste line leaks at the master bathroom tub. Repairs are needed to prevent water damage from occurring to the home. Further investigation and repairs are needed..

A qualified licensed plumber should repair or correct as needed.

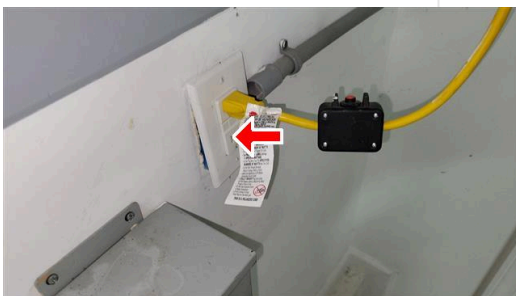
6.6 Item 1 (Picture)

1. The GFCI (Ground Fault Circuit Interrupter) outlet at the garage loose in the wall, and needs to be secured properly. Electrical issues are considered a hazard until repaired. Further investigation and repairs are needed..

A qualified licensed electrical contractor should correct as needed.

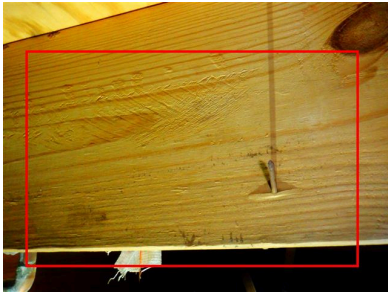
1.0 Item 1 (Picture)

1. Discoloration and some type of mold (Microbial) growth is present in the structure at several areas including but not limited to the crawl space and interior spaces. Evidence suggests that this condition is from a past or present elevated moisture conditions. We did not inspect, test or determine if this type of substance is or is not a health hazard. Further investigation is needed.

We recommend you contact a properly licensed expert for testing, investigation and or correction as deemed appropriate.

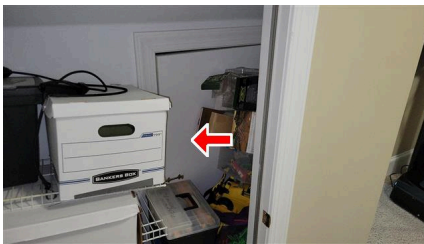
1.1 Item 1 (Picture)

1. Furniture, storage and or personal items in the garage and throughout the house. As a result the areas were not inspected. hidden damage may be present. Further investigation and repairs are needed.

We recommend having all personal items removed and these areas inspected prior to closing.

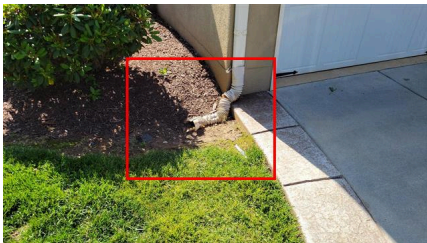
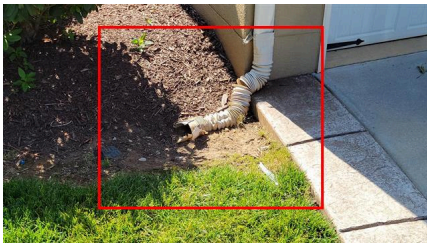
1. The downspout at the front (left of main entry). Erosion can continue or become worse if not corrected possibly leading to water intrusion. Repairs are needed.

A qualified person should repair or replace as needed.

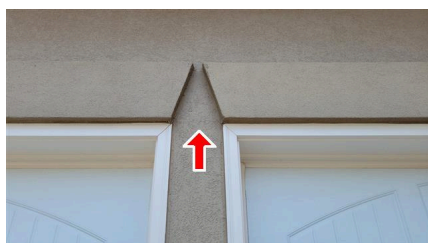
3.0 Item 1 (Picture)

1. The stucco coating at the exterior in areas has hairline cracks. Deterioration can eventually occur if not corrected. Further investigation and repairs are needed.

A qualified contractor should inspect and repair as needed.

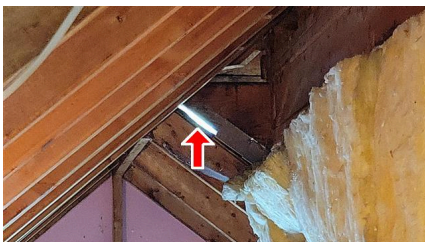
3.0 Item 9 (Picture)

1. The flashing at the front of home is missing. Deterioration can eventually occur if not corrected. Further investigation and repairs are needed.

A qualified person should repair or replace as needed.

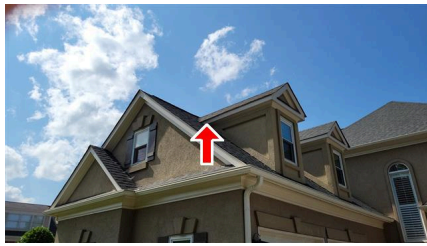
3.1 Item 1 (Picture)

1. The wood fascia and soffit panels at the exterior in areas are deteriorated. Further deterioration may occur if not repaired. Further investigation and repairs are needed.

A qualified contractor should inspect and repair as needed.

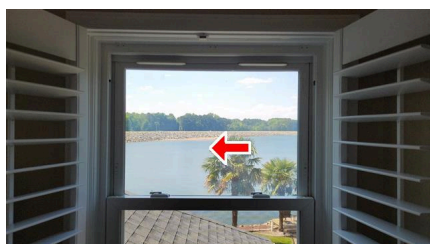
3.2 Item 1 (Picture)

1. Several windows have failed/compromised thermal seals/fogged window panes. This is indicated by the visible moisture, discoloration, calcium deposits and or crystallization visible between the glass window panes. A certified window technician should recheck all the windows throughout the home. Due to weather conditions many times compromised/failed windows cannot be identified at the time of inspection. Further investigation and repairs are needed.

We recommend contacting a properly licensed window technician/contractor regarding these conditions and have repairs made deemed appropriate

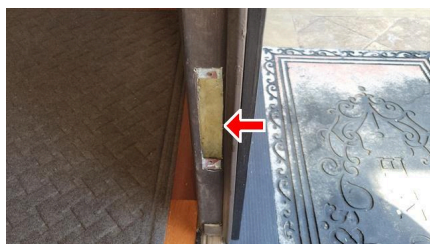
3.3 Item 1 (Picture)

1. The main entry door lock is damaged and does not function as intended. Further investigation and repairs are needed.

A qualified person should repair or replace as needed.

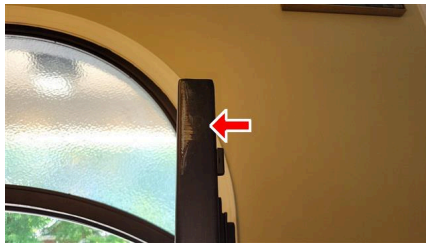
3.3 Item 3 (Picture)

1. The main entry door rubs at jamb when closing. As a result the door will not close properly. Repairs are needed.

A qualified person should repair or replace as needed.

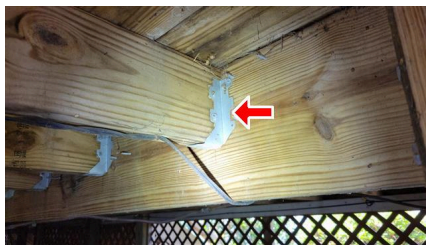
3.4 Item 1 (Picture)

1. The floor joist hangers for the deck at the rear of the home were installed improperly. This can allow for a failure of the floor joist. Further investigation and repairs are needed.

A qualified contractor should repair or replace as needed.

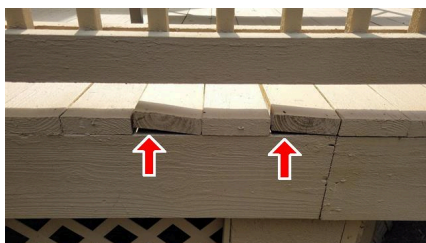
3.4 Item 3 (Picture)

1. The deck floor on the deck at the rear of home loose. A fall or injury can occur if not corrected. Repairs are needed.

A qualified contractor should repair or replace as needed.

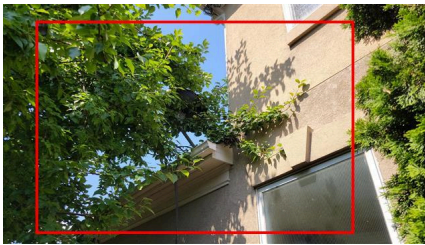
3.5 Item 1 (Picture)

1. The tree limbs that are in contact with roof or hanging near roof should be trimmed. This is a maintenance item in for your information.

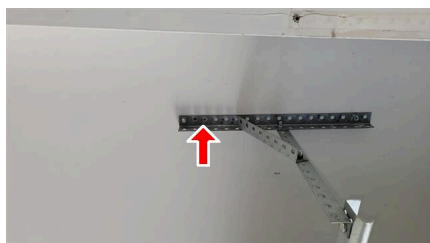
3.8 Item 1 (Picture)

1. The fire resistance sheathing that separates garage from heated space is compromised. This is considered unsafe until corrected. Repairs are needed.

A qualified person should correct for safety.

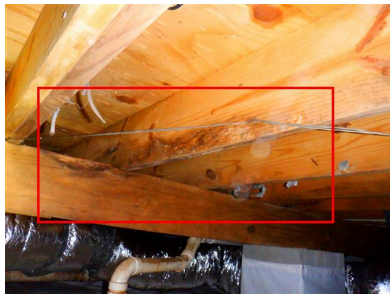
4.2 Item 1 (Picture)

1. Some of the floor system is deteriorated from moisture absorption or water intrusion under the kitchen. The floor system may need reinforcement in this area. Further investigation and repairs are needed.

A qualified licensed general contractor should inspect further and repair as needed.

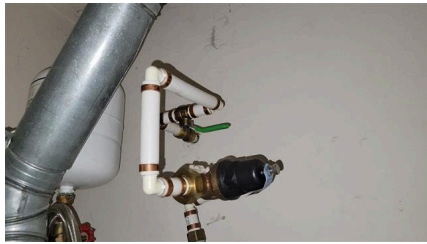
5.0 Item 1 (Picture)

The main shut off is the lever located beside the water heater. This is for your information.

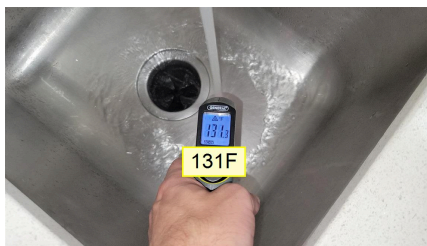
5.1 Item 1 (Picture)

1. The water heater is set over the recommended temperature. (Over 120) The risk is especially acute for infants, children, and the elderly. Water temperatures should never be set higher than 120 degrees. This is a safety issue. Repairs are needed

A qualified contractor should inspect and repair as needed.

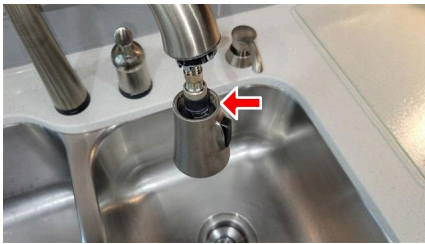
5.2 Item 1 (Picture)

1. The faucet is damaged at the kitchen sink. Further investigation and repairs are needed..  
A qualified licensed plumber should repair or correct as needed.

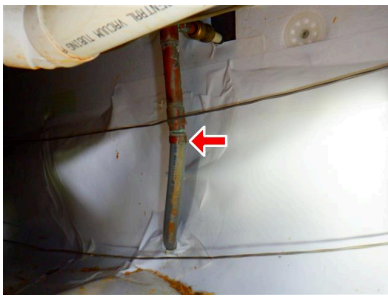
5.2 Item 2 (Picture)

1. Polybutylene plastic plumbing supply lines (PB) are installed in the subject house. Polybutylene has been used in this area for many years, but has had a higher than normal failure rate, and is no longer being widely used. Copper and Brass fittings used in later years have apparently reduced the failure rate. This subject house has copper fittings. For further details contact the Consumer Plumbing Recovery center at 1-800-392-7591 or the web at <http://www.pbpipe.com>

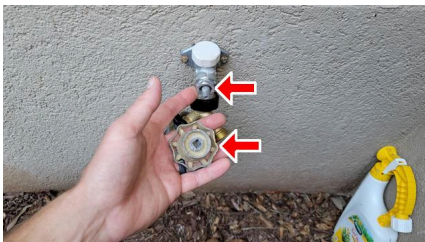
5.2 Item 3 (Picture)

1. The knob for hose bib at the right side (facing front) is damaged. Further investigation and repairs are needed..  
A qualified licensed plumber should repair or correct as needed.

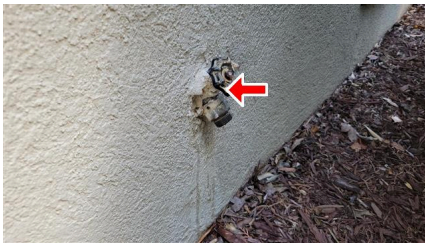
5.2 Item 4 (Picture)

1. The hose bib drips at knob when turned on at the left side (facing front). Repairs are needed to prevent water damage from occurring to the home. Repairs are needed.

A qualified licensed plumber should repair or correct as needed.

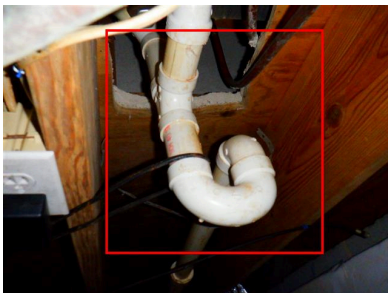
5.3 Item 1 (Picture)

1. The plumbing waste line leaks at the master bathroom tub. Repairs are needed to prevent water damage from occurring to the home. Further investigation and repairs are needed..

A qualified licensed plumber should repair or correct as needed.

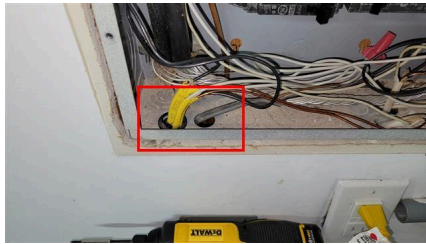
6.2 Item 1 (Picture)

1. The wire protection grommets are missing where the branch wiring enters the panel. Electrical issues are considered a hazard until repaired. Repairs are recommended.

A qualified licensed electrical contractor should correct as needed.

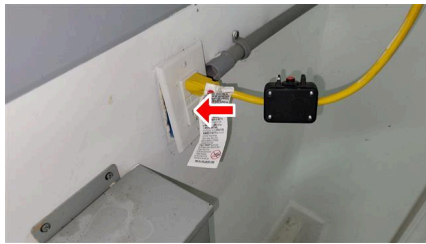
6.6 Item 1 (Picture)

1. The GFCI (Ground Fault Circuit Interrupter) outlet at the garage loose in the wall, and needs to be secured properly. Electrical issues are considered a hazard until repaired. Further investigation and repairs are needed..

A qualified licensed electrical contractor should correct as needed.

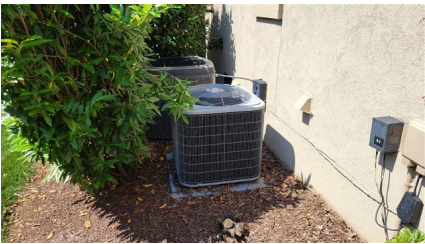
Complimentary photo of the AC units

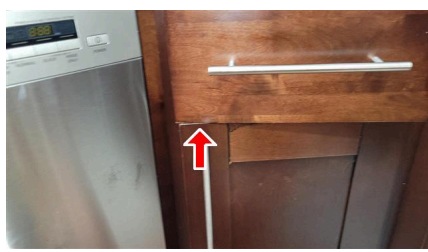
8.4 Item 1 (Picture)

1. Drawer face hits cabinet door (left of sink). Recommend repair or replace as necessary.  
A qualified person should repair or replace as needed

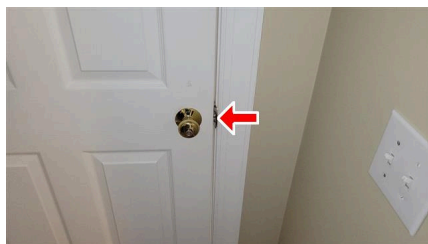
8.5 Item 1 (Picture)

1. The door at guest Bedroom will not latch properly. Evidence suggest that the door needs strike and latch adjustment to shut properly. This is a small repair.

A qualified person should repair or replace as needed.

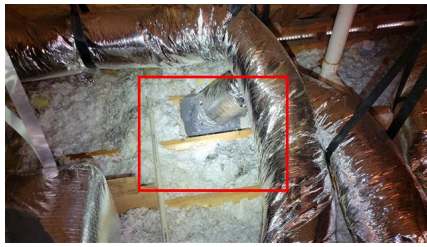
9.2 Item 1 (Picture)

1. Fiberglass (loose-fill) insulation is who is missing in areas in attic. Heat loss can occur more on this home than one that is properly insulated. Repairs are needed..

A qualified person should repair or replace as needed.

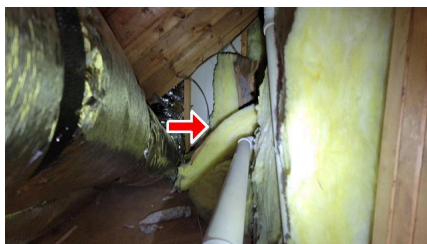
9.2 Item 4 (Picture)

1. Fiberglass (Batts) insulation is fallen in attic. Heat loss can occur more on this home than one that is properly insulated. Repairs are needed..

A qualified person should repair or replace as needed.
