INSPECTION REPORT  
246 Broadmoor Dr  
Advance NC 27006

INSPECTION DATE  
📅 7/2/2025  
🕒 09:00:00 AM

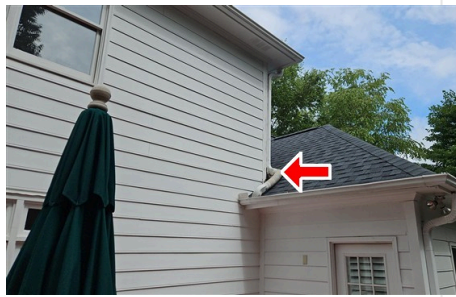
2.1 Item 1 (Picture)

1. The roof flashing has evidence of leaking above the master bedroom. Further damage may occur. Further investigation and repairs are needed.

A qualified person should repair or replace as needed.

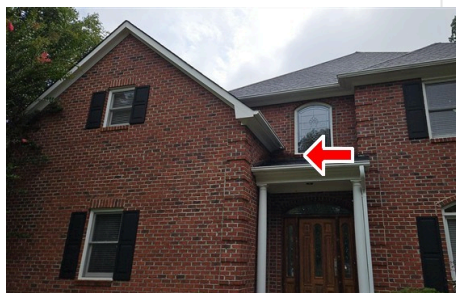
2.3 Item 1 (Picture)

1. The gutter do not appear to be draining properly. Gutters that drain poorly or clogged can lead to many costly problems such as deterioration of fascia, soffit or roof edge. It can also cause gutters to pull loose and lead to possible water intrusion. Further investigation and repairs are needed.

A qualified contractor should inspect and repair as needed.

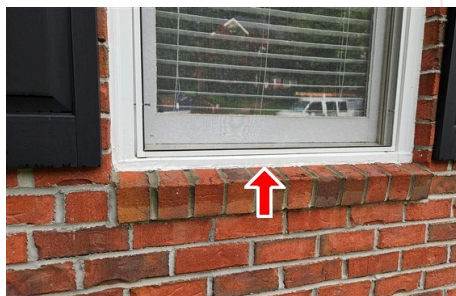
3.2 Item 1 (Picture)

1. The window frame deteriorated at most windows. Further deterioration may occur if not repaired.

Further investigation and repairs are needed.

A qualified contractor should inspect and repair as needed.

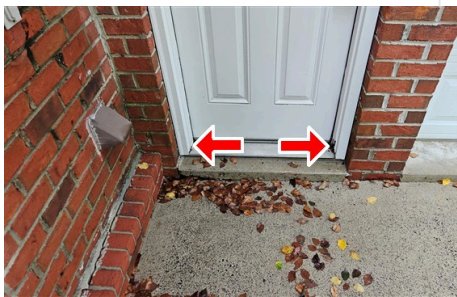
3.3 Item 1 (Picture)

(1) The main entry door deteriorated at bottom of jamb (s). This is allowing water damage to occur to the home. Further deterioration will occur if not repaired. A repair or replacement is needed.

A qualified contractor should inspect and repair as needed.

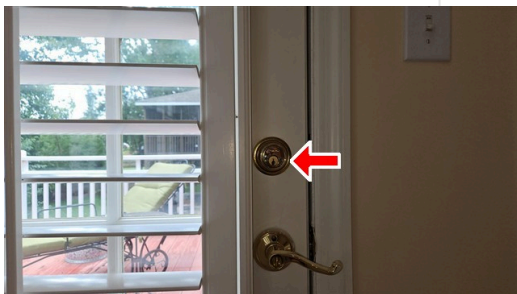
3.3 Item 15 (Picture)

1. The exterior entry door has a dead bolt that is keyed. (Safety issue) All exterior doors should not be keyed type locks, as this can impede exiting the home should a fire occur. Repairs are needed.

A qualified person should repair or replace as needed.

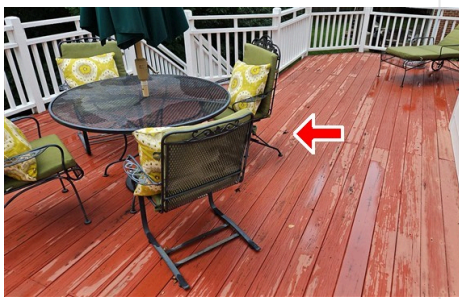
3.4 Item 1 (Picture)

1. The deck floor on the deck at the rear of home deteriorated. Further deterioration can occur if not repaired. A fall or injury can occur if not corrected. Repairs are needed.

A qualified contractor should repair or replace as needed.

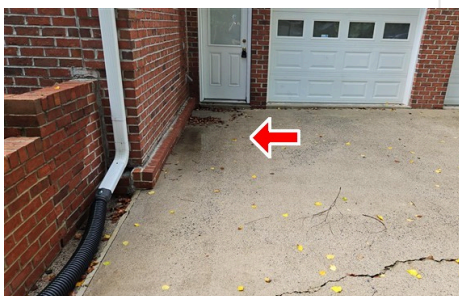
3.5 Item 1 (Picture)

1. The concrete drive at the front of home has settled and is directing storm water into the home. This is causing damage and water intrusion to occur to the home. Further deterioration will occur. Further investigation and repairs are needed.

A qualified contractor should inspect and repair as needed.

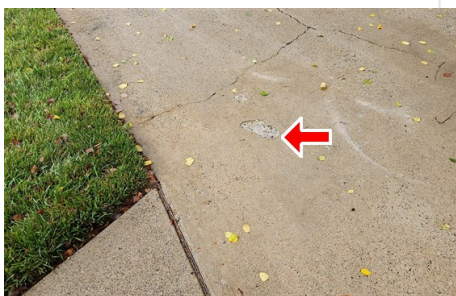
3.5 Item 10 (Picture)

1. The concrete drive at the front of home uneven, and can be a tripping hazard. Water can cause further deterioration if not repaired and sealed properly. A fall or injury can occur if not corrected. Repairs are needed.

A qualified contractor should inspect and repair as needed.

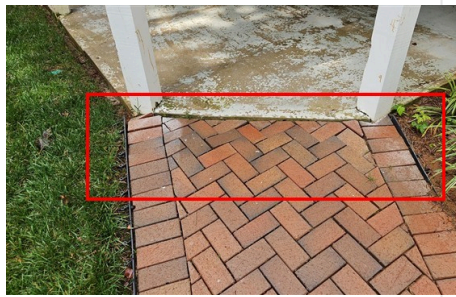
3.5 Item 14 (Picture)

1. The sidewalk at the rear of home uneven, and can be a tripping hazard. A fall or injury can occur if not corrected. Repairs are needed.

A qualified contractor should inspect and repair as needed.

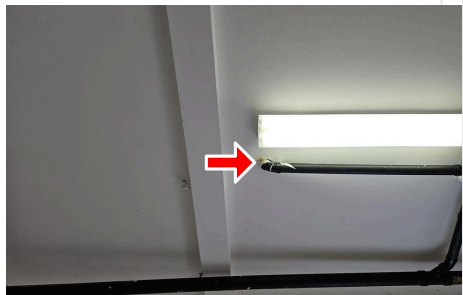
3.8 Item 1 (Picture)

1. The fire resistance sheathing that separates garage from heated space is compromised. This is considered unsafe until corrected. Repairs are needed.

A qualified person should correct for safety.

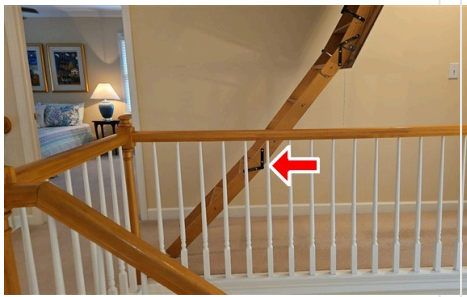
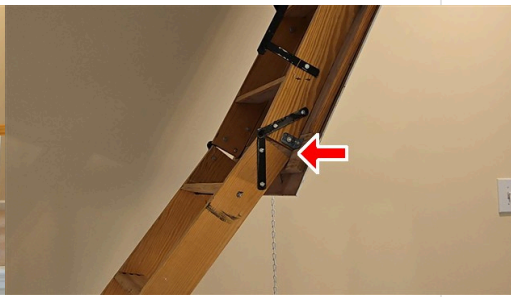
4.4 Item 1 (Picture)

1. The pull down stairs needs ladder trimmed at an angle to fit floor properly. Injury could result if not repaired. Repairs are needed.

A qualified contractor should inspect and repair as needed.

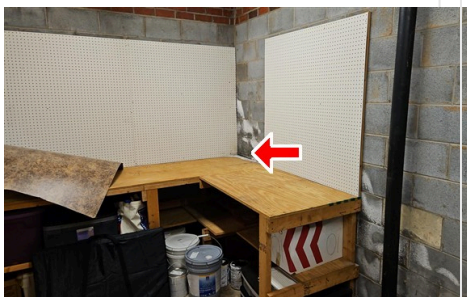
4.6 Item 1 (Picture)

1. Dark stains on the CMU (Concrete Masonry Unit) indicated that water is inside the block. Dark stains and white efflorescence (powder substance) on block wall indicates moisture is in contact with the masonry. This does not necessarily indicate that intrusion will occur. Efflorescence is found on many homes without water intrusion occurring inside the home. But, it should alert you to the possibility that future steps may be needed. Further investigation and repairs are needed.

I recommend contact a licensed water intrusion specialist regarding these conditions.

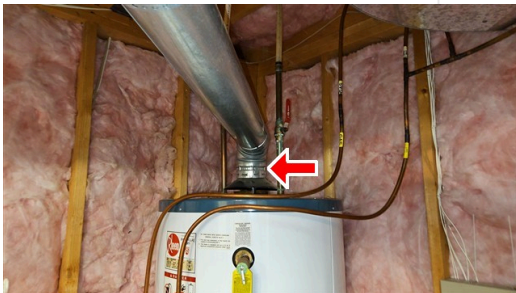
5.1 Item 1 (Picture)

1. The draft hood connection to flue vent connector: provide at least 12" vertical inches of the flue vent between the draft hood outlet and the first elbow. This is a safety issue and should be repaired. Further investigation and repairs are needed.

A qualified licensed plumber should repair or correct as needed.

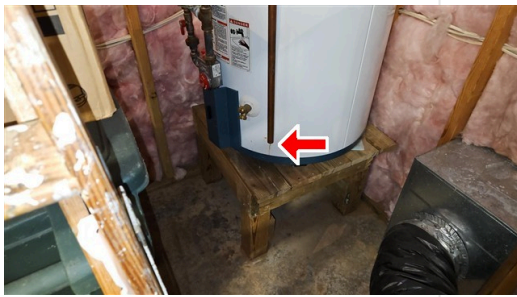
5.1 Item 2 (Picture)

1. The T&P (Test and Pressure) valve on water heater needs a 3/4 threaded pipe to extend within 6 inches of floor for safety. (PVC is not approved for hot water use). I recommend repair by a qualified person.

A qualified licensed plumber should repair or correct as needed.

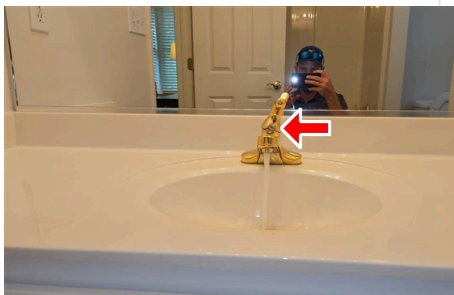
5.2 Item 1 (Picture)

1. The sink faucets leaks at the upstairs bath. Repairs are needed to prevent water damage from occurring to the home. Repairs are needed.

A qualified licensed plumber should repair or correct as needed.

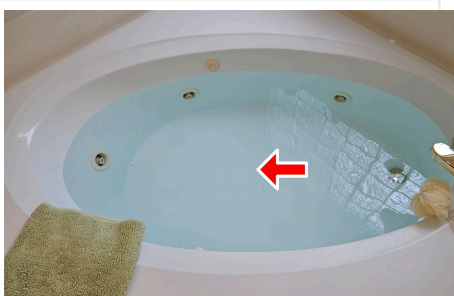
5.2 Item 4 (Picture)

1. The jacuzzi shows signs of improper cleaning and maintenance, as a result black residue is present (likely bacteria) when the tub was operated. (Health Safety Issue) Repairs are needed.

I recommend contacting a licensed plumber.

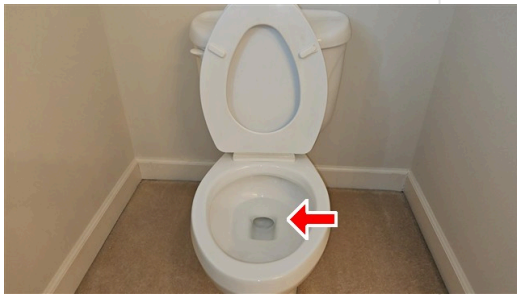
5.3 Item 1 (Picture)

1. The toilet will not stop running at the guest bath. The flapper will likely need replacing. Further investigation and repairs are needed.

A qualified licensed plumber should repair or correct as needed.

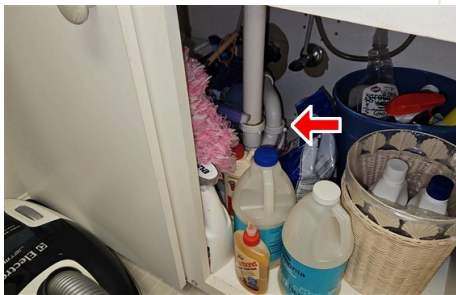
5.3 Item 2 (Picture)

1. The plumbing waste line leaks under the W/D room. Repairs are needed to prevent water damage from occurring to the home. Repairs are needed.

A qualified licensed plumber should repair or correct as needed.

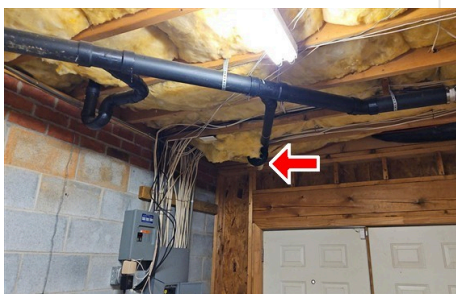
5.3 Item 4 (Picture)

1. The plumbing waste line leaks under the master bath. Repairs are needed to prevent water damage from occurring to the home. Further investigation and repairs are needed.

A qualified licensed plumber should repair or correct as needed.

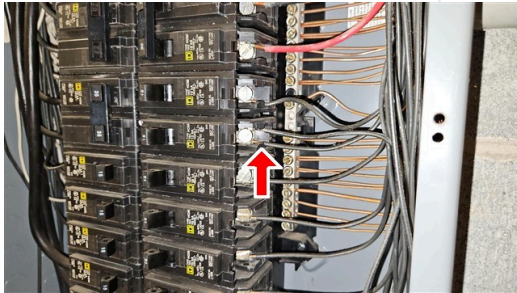
6.2 Item 1 (Picture)

1. Two wires were observed to be connected to one or more circuit breakers in the main panel. While often done, this is not permitted unless the device is so labeled. Double tapping often leads to overloaded circuits and loose connections that can overheat. Further investigation and repairs are needed.

A qualified licensed electrical contractor should correct as needed.

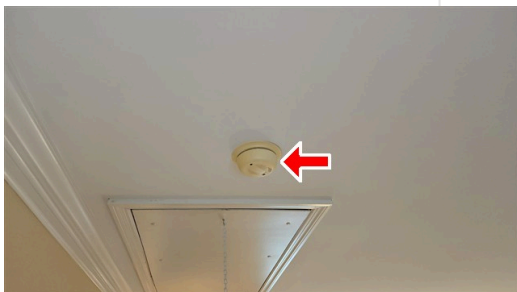
6.7 Item 1 (Picture)

1. The smoke detectors in the home have expired. Without a working smoke detector in your home you have no first alert to a possible fire. Repairs are needed.

I recommend repair or replace as needed using a qualified person.

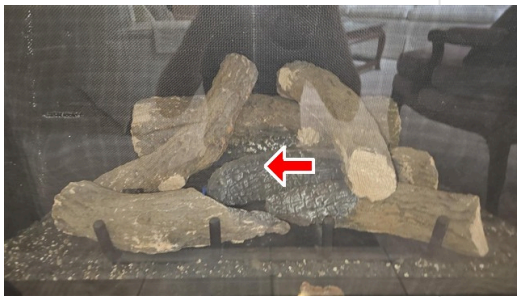
7.7 Item 1 (Picture)

1. The vented fire logs in the living room is not operable (burner would not ignite). Repairs should be made so unit works properly. Further investigation and repairs are needed.

A qualified licensed HVAC (Heat/Ventilation/Air conditioning Contractor) should inspect further and repair as needed.

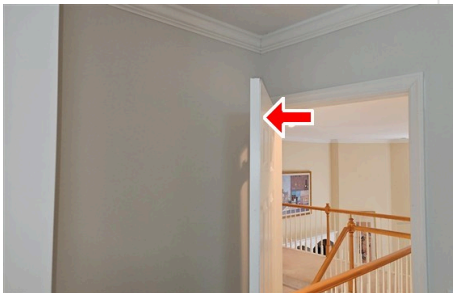
8.5 Item 1 (Picture)

1. The privacy door is damaged at the guest bedroom. As a result the door will not close properly. Repairs are needed.

A qualified person should repair or replace as needed.

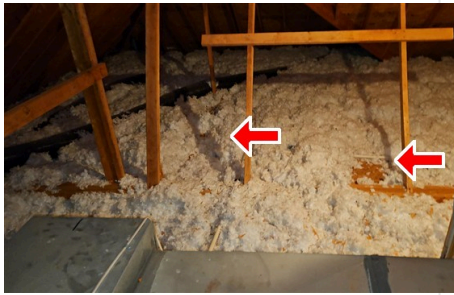
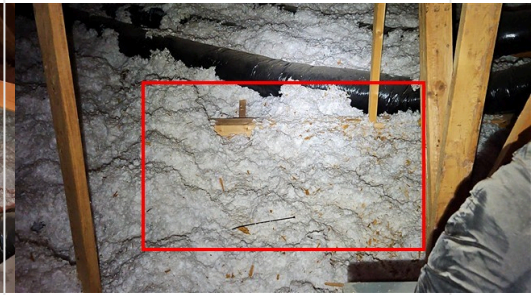
9.2 Item 1 (Picture)

1. Fiberglass (loose-fill) insulation is compressed in areas of the attic due to foot traffic or storage in attic. Heat loss can occur more on this home than one that is properly insulated. Repairs are recommended .

A qualified person should repair or replace as needed.

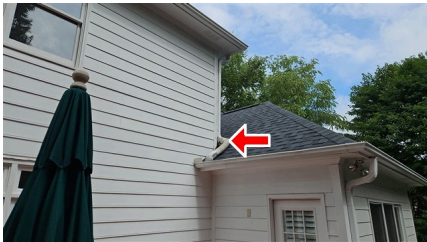
2.1 Item 1 (Picture)

1. The roof flashing has evidence of leaking above the master bedroom. Further damage may occur. Further investigation and repairs are needed.

A qualified person should repair or replace as needed.

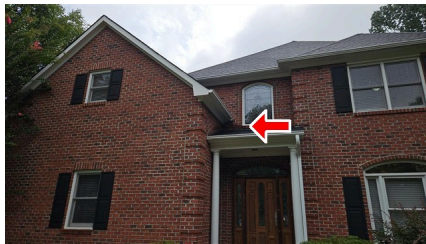
2.3 Item 1 (Picture)

1. The gutter do not appear to be draining properly. Gutters that drain poorly or clogged can lead to many costly problems such as deterioration of fascia, soffit or roof edge. It can also cause gutters to pull loose and lead to possible water intrusion. Further investigation and repairs are needed.

A qualified contractor should inspect and repair as needed.

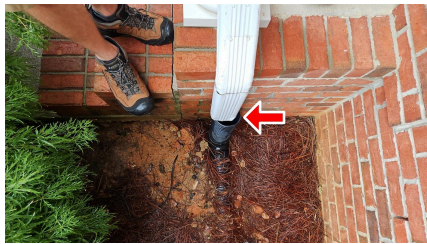
2.3 Item 6 (Picture)

1. The downspout needs reconnecting to existing drain line. Erosion can continue or become worse if not corrected possibly leading to water intrusion. Repairs are needed.

A qualified contractor should inspect and repair as needed.

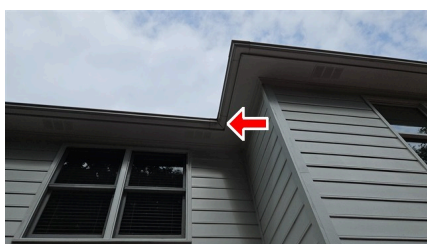
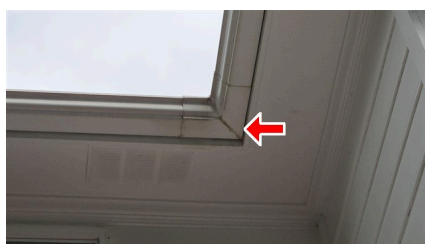
2.3 Item 10 (Picture)

1. The gutter leaks at seam (s) at the virtually all areas where gutters are installed. Gutters that drain poorly or clogged can lead to many costly problems such as deterioration of fascia, soffit or roof edge. It can also cause gutters to pull loose and lead to possible water intrusion. Repairs are needed.

A qualified person should repair or replace as needed.

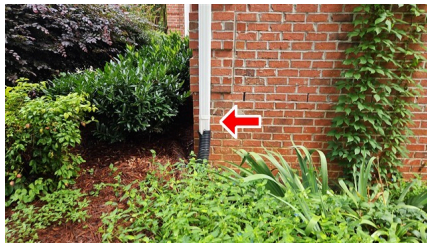
3.0 Item 1 (Picture)

1. I observed small cracks in the brick veneer at the front of home. These are typical in nature due to age and normal masonry shrinkage. Although the cracks in the brick veneer are typical, these areas should be re sealed to prevent any water penetration or damage. Further evaluation by a qualified masonry contractor is recommended for this entire condition.

I recommend repair or replace using a qualified contractor.

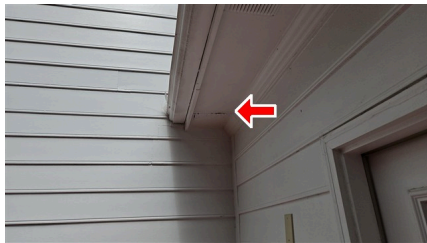
3.1 Item 1 (Picture)

1. The soffit panels at eave on the rear of home deteriorated. Further deterioration may occur if not repaired. Repairs are needed.

A qualified person should repair or replace as needed.

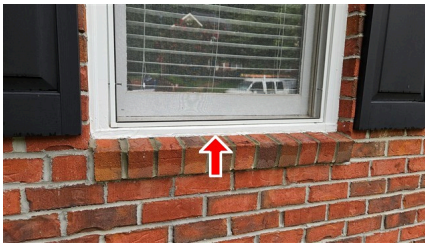
3.2 Item 1 (Picture)

1. The window frame deteriorated at most windows. Further deterioration may occur if not repaired.  
Further investigation and repairs are needed.

A qualified contractor should inspect and repair as needed.

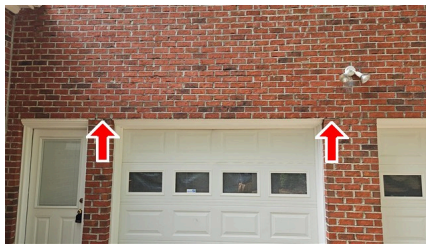
3.2 Item 9 (Picture)

1. The steel lintels around the exterior of the home are beginning to rust or have rust present. A lintel is a horizontal architectural member or steel beam support placed over a wall opening to carry the weight of the masonry placed over it. In most situation, the lintel above you windows and doors will be steel angle iron or I beam. Either due to age or improper rust proofing or weep chord and flashing placement during installation, lintels will begin to rust. Rusting lintels can expand to become mush thicker then their original size. The expansive forces of rusting steel can shift entire multi-story elevations. If your lintels are currently rusting, a telltale sign of expansion is diagonal "step" pattern cracks, which can be found on either end of the window or door opening. Repairs are needed to prevent further damage to the structure. Further deterioration may occur if not repaired.

I recommend a qualified contractor inspect and repair as needed.

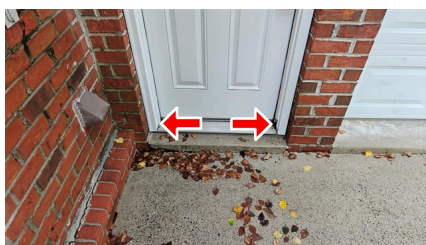
3.3 Item 1 (Picture)

- (1) The main entry door deteriorated at bottom of jamb (s). This is allowing water damage to occur to the home. Further deterioration will occur if not repaired. A repair or replacement is needed.

A qualified contractor should inspect and repair as needed.

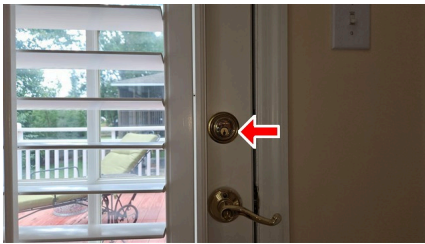
3.3 Item 15 (Picture)

1. The exterior entry door has a dead bolt that is keyed. (Safety issue) All exterior doors should not be keyed type locks, as this can impede exiting the home should a fire occur. Repairs are needed.

A qualified person should repair or replace as needed.

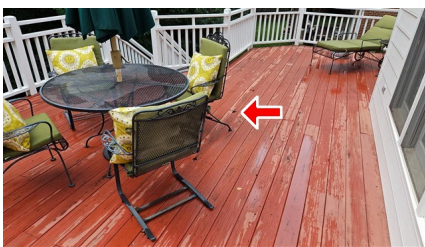
3.4 Item 1 (Picture)

1. The deck floor on the deck at the rear of home deteriorated. Further deterioration can occur if not repaired. A fall or injury can occur if not corrected. Repairs are needed.

A qualified contractor should repair or replace as needed.

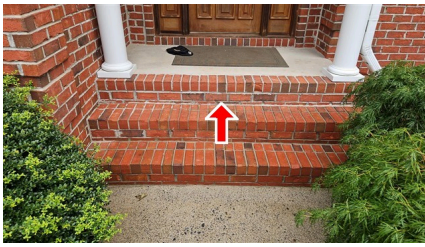
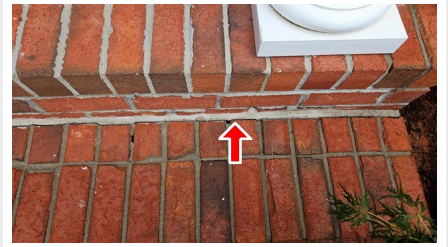
3.4 Item 6 (Picture)

1. The brick stairs on the front entry at the exterior needs mortar where loose or missing. Further deterioration can occur if not repaired. Repairs are needed.

A qualified contractor should repair or replace as needed.

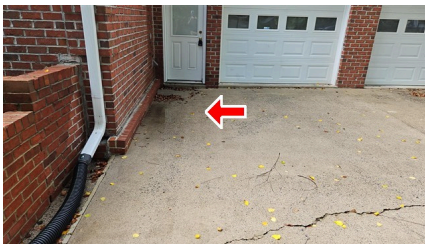
3.5 Item 1 (Picture)

1. The concrete drive at the front of home has settled and is directing storm water into the home. This is causing damage and water intrusion to occur to the home. Further deterioration will occur.  
Further investigation and repairs are needed.

A qualified contractor should inspect and repair as needed.

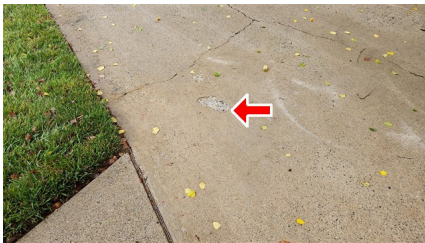
3.5 Item 10 (Picture)

1. The concrete drive at the front of home uneven, and can be a tripping hazard. Water can cause further deterioration if not repaired and sealed properly. A fall or injury can occur if not corrected. Repairs are needed.

A qualified contractor should inspect and repair as needed.

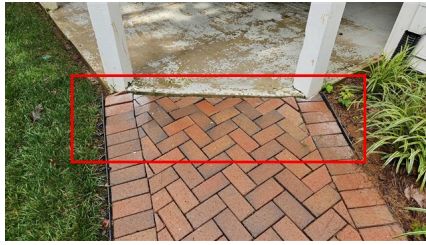
3.5 Item 14 (Picture)

1. The sidewalk at the rear of home uneven, and can be a tripping hazard. A fall or injury can occur if not corrected. Repairs are needed.

A qualified contractor should inspect and repair as needed.

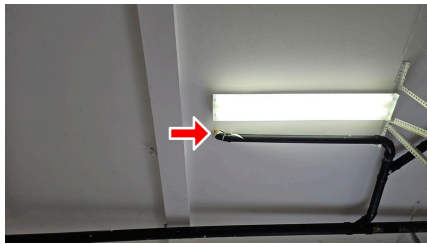
3.8 Item 1 (Picture)

1. The fire resistance sheathing that separates garage from heated space is compromised. This is considered unsafe until corrected. Repairs are needed.

A qualified person should correct for safety.

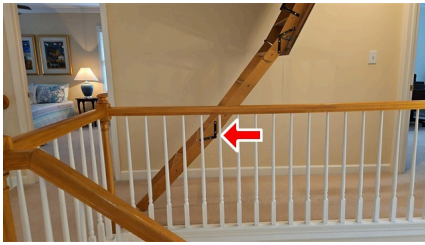
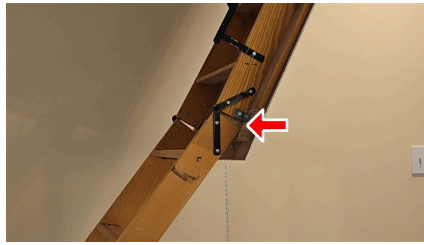
1. The pull down stairs needs ladder trimmed at an angle to fit floor properly. Injury could result if not repaired. Repairs are needed.

A qualified contractor should inspect and repair as needed.

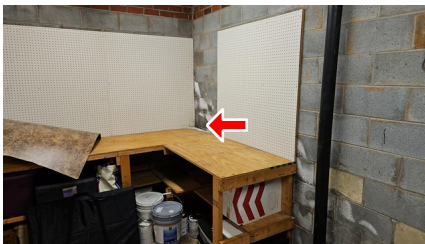
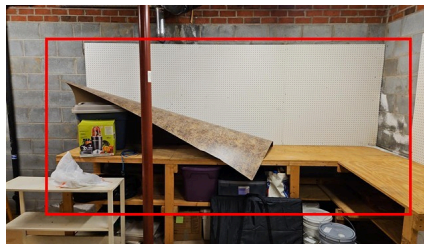
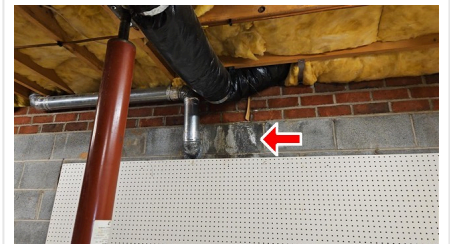
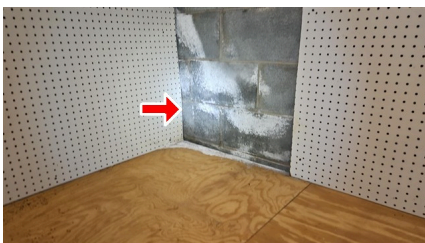
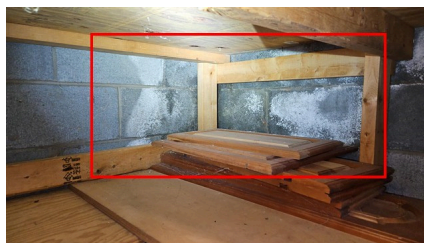
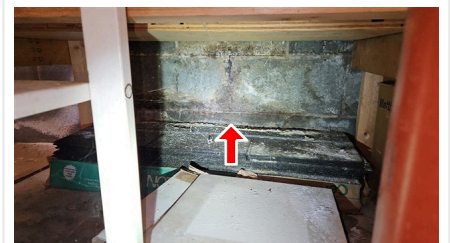
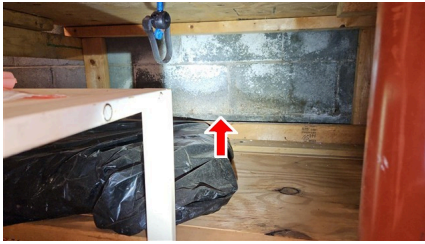
1. Dark stains on the CMU (Concrete Masonry Unit) Indicated that water is inside the block. Dark stains and white efflorescence (powder substance) on block wall indicates moisture is in contact with the masonry. This does not necessarily indicate that intrusion will occur. Efflorescence is found on many homes without water intrusion occurring inside the home. But, it should alert you to the possibility that future steps may be needed. Further investigation and repairs are needed.

I recommend contact a licensed water intrusion specialist regarding these conditions.

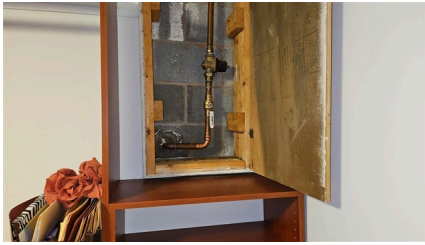
5.0 Item 1 (Picture)

The main shut off is the white lever located in the basement. This is for your information.

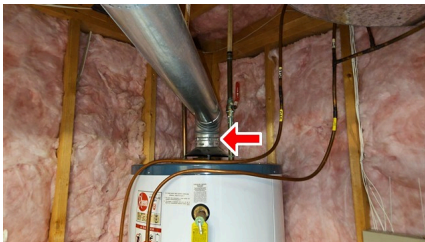
5.1 Item 1 (Picture)

1. The draft hood connection to flue vent connector: provide at least 12" vertical inches of the flue vent between the draft hood outlet and the first elbow. This is a safety issue and should be repaired. Further investigation and repairs are needed.

A qualified licensed plumber should repair or correct as needed.

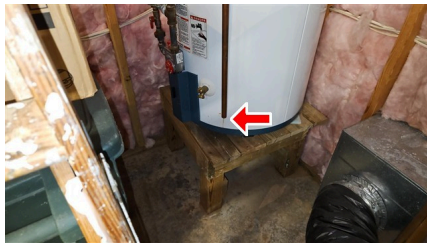
5.1 Item 2 (Picture)

1. The T&P (Test and Pressure) valve on water heater needs a 3/4 threaded pipe to extend within 6 inches of floor for safety. (PVC is not approved for hot water use). I recommend repair by a qualified person.

A qualified licensed plumber should repair or correct as needed.

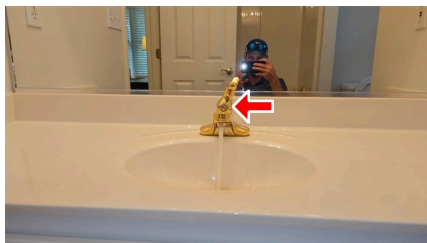
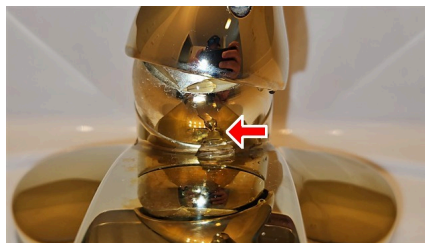
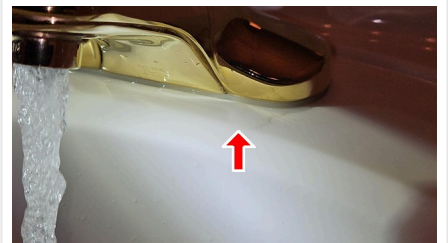
1. The sink faucets leaks at the upstairs bath. Repairs are needed to prevent water damage from occurring to the home. Repairs are needed.

A qualified licensed plumber should repair or correct as needed.

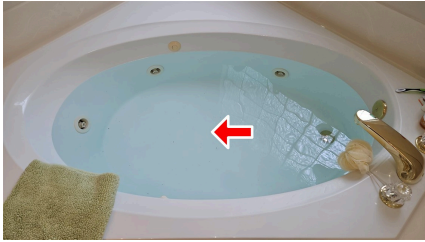
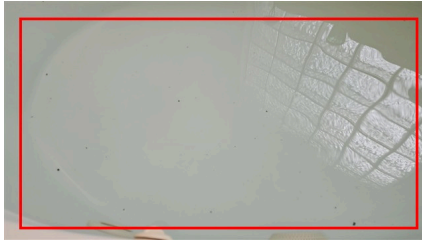
1. The jacuzzi shows signs of improper cleaning and maintenance, as a result black residue is present (likely bacteria) when the tub was operated. (Health Safety Issue) Repairs are needed.

I recommend contacting a licensed plumber.

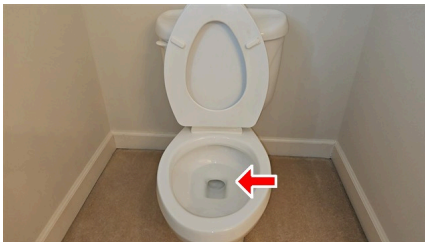
5.3 Item 1 (Picture)

1. The toilet will not stop running at the guest bath. The flapper will likely need replacing. Further investigation and repairs are needed.

A qualified licensed plumber should repair or correct as needed.

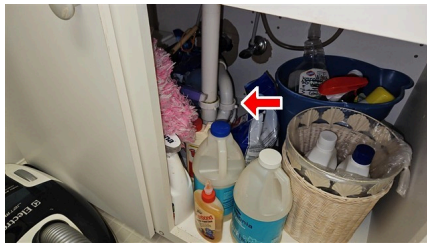
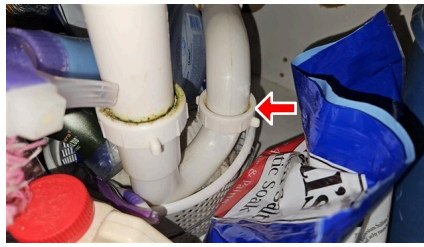
1. The plumbing waste line leaks under the W/D room. Repairs are needed to prevent water damage from occurring to the home. Repairs are needed.

A qualified licensed plumber should repair or correct as needed.

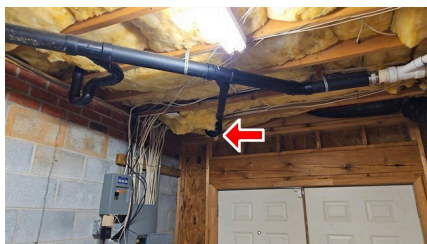
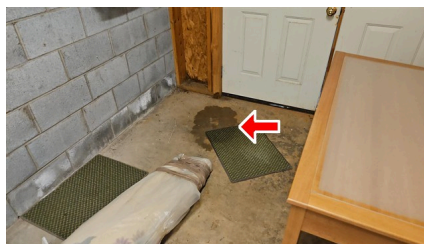
1. The plumbing waste line leaks under the master bath. Repairs are needed to prevent water damage from occurring to the home. Further investigation and repairs are needed.

A qualified licensed plumber should repair or correct as needed.

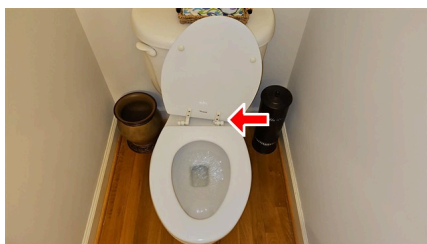
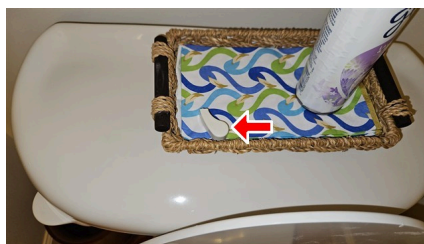
1. The toilet lid seat is damage at floor at the bath. This is for your information.

I recommend a qualified licensed plumber repair or correct as needed.

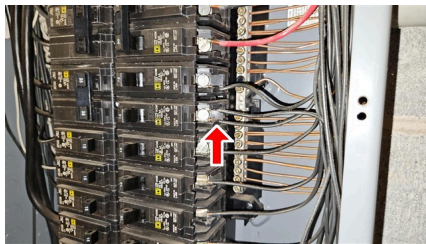
6.2 Item 1 (Picture)

1. Two wires were observed to be connected to one or more circuit breakers in the main panel. While often done, this is not permitted unless the device is so labeled. Double tapping often leads to overloaded circuits and loose connections that can overheat. Further investigation and repairs are needed.

A qualified licensed electrical contractor should correct as needed.

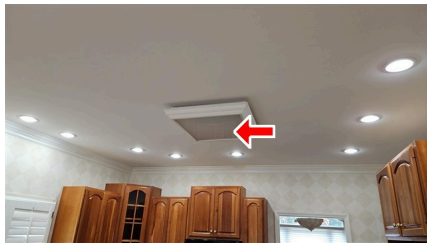
6.4 Item 1 (Picture)

1. The light fixture does not work (try bulb first) at the kitchen. Electrical issues are considered a hazard until repaired. Further investigation and repairs are needed.

A qualified licensed electrical contractor should correct as needed.

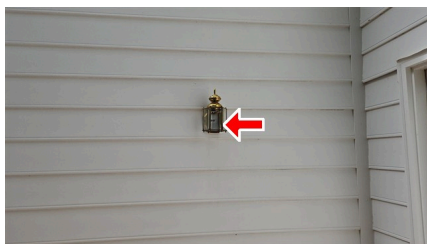
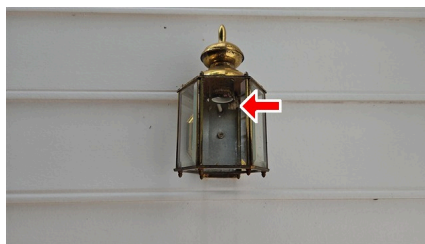
1. The light fixture does not work (try bulb first) at the exterior. Electrical issues are considered a hazard until repaired. Further investigation and repairs are needed..

A qualified licensed electrical contractor should correct as needed.

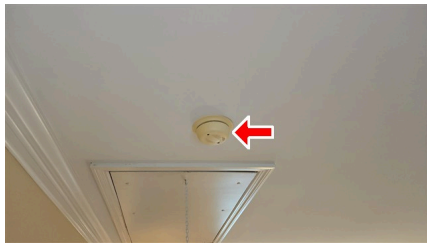
6.7 Item 1 (Picture)

1. The smoke detectors in the home have expired. Without a working smoke detector in your home you have no first alert to a possible fire. Repairs are needed.

I recommend repair or replace as needed using a qualified person.

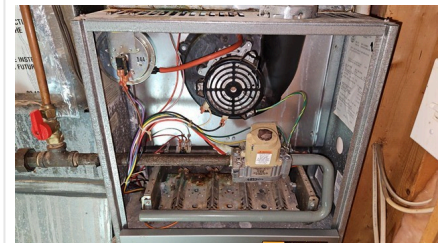
Complimentary photo of the gas furnace with the cover off

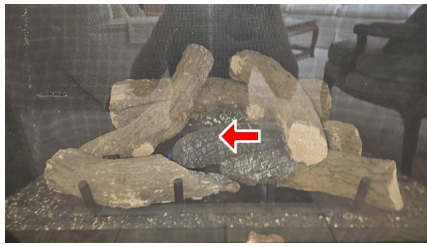
7.7 Item 1 (Picture)

1. The vented fire logs in the living room is not operable (burner would not ignite). Repairs should be made so unit works properly. Further investigation and repairs are needed.

A qualified licensed HVAC (Heat/Ventilation/Air conditioning Contractor) should inspect further and repair as needed.

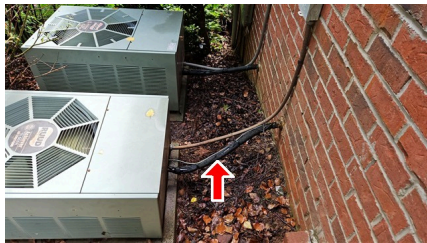
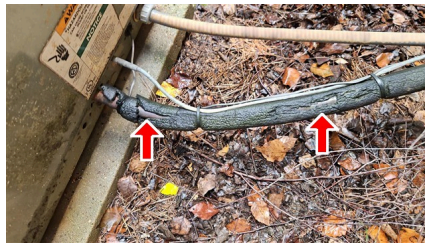
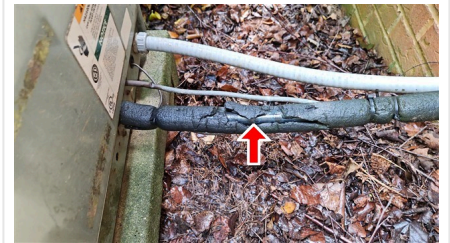
1. The foam sleeve on suction line is missing foam sleeve in area(s) at outside unit. Missing foam on suction line can cause energy loss and condensation. I recommend service or repair as needed.

A qualified licensed HVAC (Heat/Ventilation/Air conditioning Contractor) should inspect further and repair as needed.

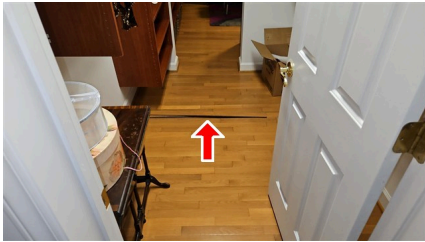
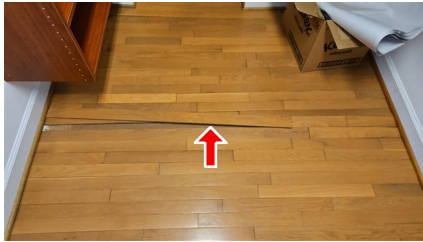
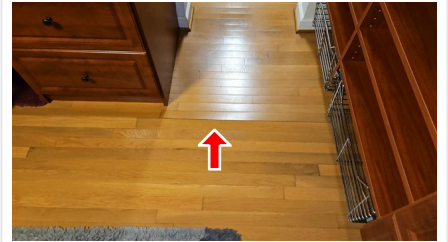
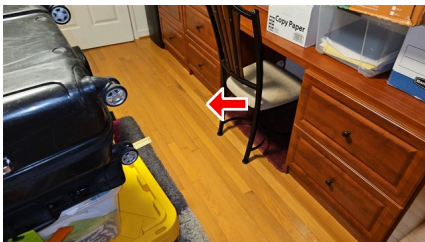
1. The wood covering warped or buckled in the basement. Further deterioration can occur. This can be a tripping hazard. Further investigation and repairs are needed.

A qualified contractor should inspect and repair as needed.

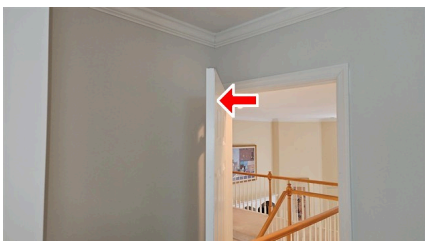
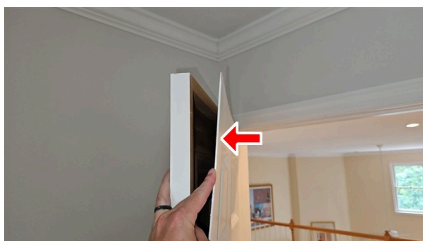
1. The privacy door is damaged at the guest bedroom. As a result the door will not close properly. Repairs are needed.

A qualified person should repair or replace as needed.

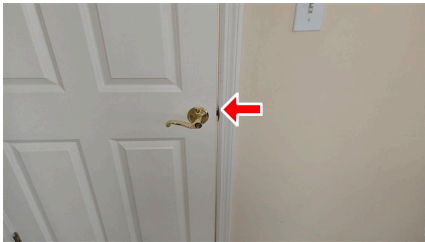
**8.5 Item 3 (Picture)**

1. The door at guest bedroom will not latch properly. Evidence suggest that the door needs strike and latch adjustment to shut properly. This is a small repair.

A qualified person should repair or replace as needed.

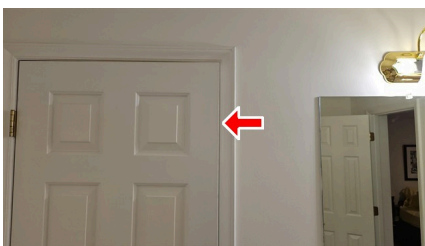
**8.5 Item 4 (Picture)**

1. The privacy door rubs at jamb when closing at the downstairs Guest bath. As a result the door will not close properly. Repairs are needed.

A qualified person should repair or replace as needed.

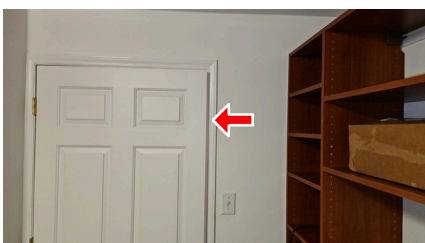
**8.5 Item 5 (Picture)**

1. The Privacy door rubs at jamb when closing at the downstairs. As a result the door will not close properly. Repairs are needed.

A qualified person should repair or replace as needed.

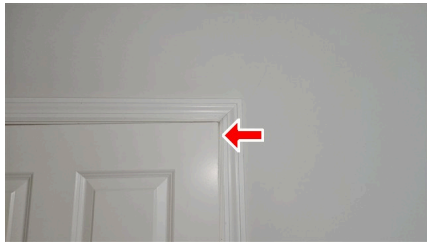
8.5 Item 6 (Picture)

1. The privacy door rubs at jamb when closing at the guest bedroom. As a result the door will not close properly. Repairs are needed.

A qualified person should repair or replace as needed.

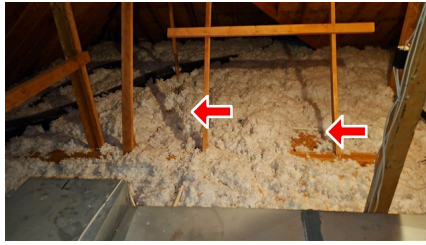
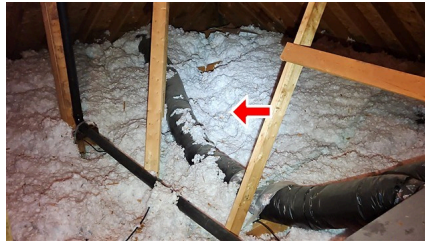
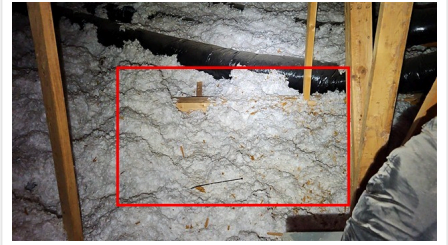
1. Fiberglass (loose-fill) insulation is is compressed in areas of the attic due to foot traffic or storage in attic. Heat loss can occur more on this home than one that is properly insulated. Repairs are recommended .

A qualified person should repair or replace as needed.

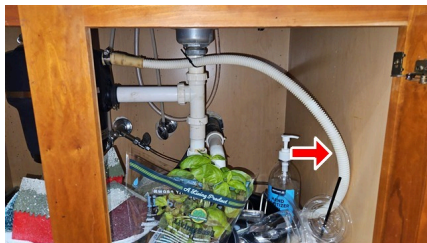
10.0 Item 1 (Picture)

1. The dishwasher drain hose needs to be looped above the level of the kitchen sink drain or an approved air gap installed to prevent back flow of waste water into the water supply. (food safety issue) This can allow waste for the sink to contaminate the dishwasher. This is a small repair.

A qualified licensed plumber should repair or correct as needed.
