INSPECTION REPORT  
3213 Lake Shore Rd S  
Denver NC 28037

INSPECTED BY  
Alex Parr 3692  
Above Parr Home  
Inspections

INSPECTION DATE  
📅 5/16/2023  
🕒 02:00:00 PM

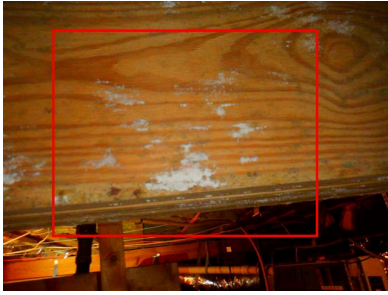
1.0 Item 1 (Picture)

Discoloration in some type of fungal growth (wood destroying fungus) is present in the structure at several areas including but not limited to the crawl space and or interior spaces. This type of substance commonly results in the building and finish type materials becoming weakened and or compromised. Evidence suggests that this condition is from a past or present elevated moisture conditions. The extent of the damage cannot be determined until the moisture issue is corrected. We did not inspect, test or determine if this type of substance is or is not a health hazard as this is above the scope of a home inspection. We recommend contacting a licensed expert for testing, investigation and or correction as deemed appropriate

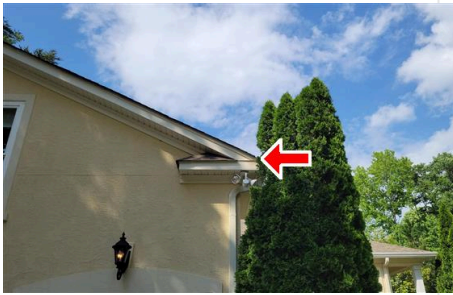
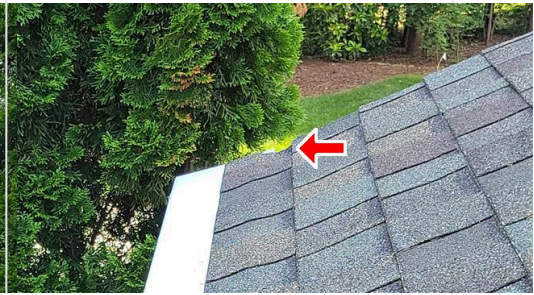
1. The roof shingles is damaged at the front of home. This damage should be repaired or replaced.  
Repairs are needed.

A qualified person should repair or replace as needed.

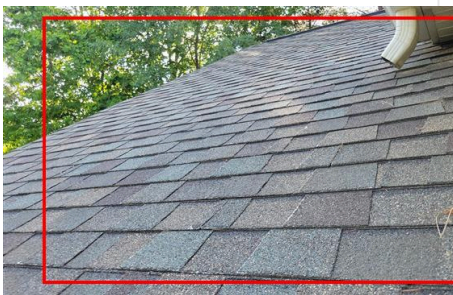
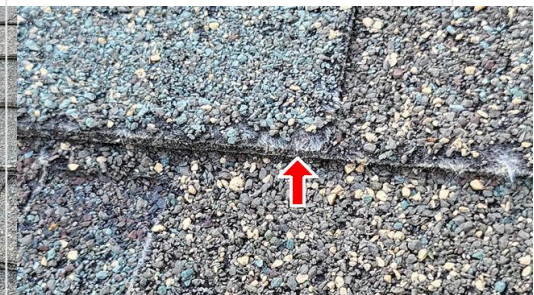
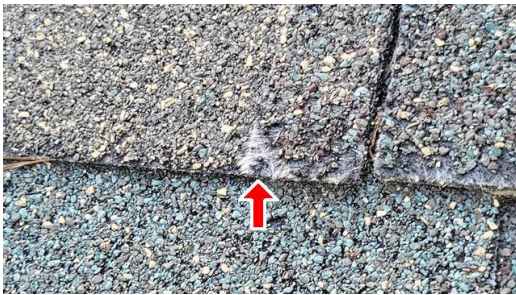
1. The asphalt/fiberglass shingles to be near the end of their service life. It appears that they will need replacing in the not too distant future. They show signs of heavy wear typical for their age consisting of heavy loss of moderate to heavy wear long edges of tabs. No signs of leaks were observed at the time of inspection. Further investigation and repairs are needed.

A qualified contractor should inspect and repair as needed.

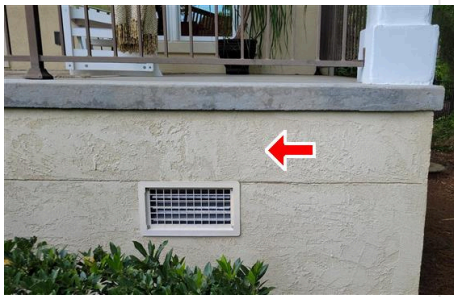
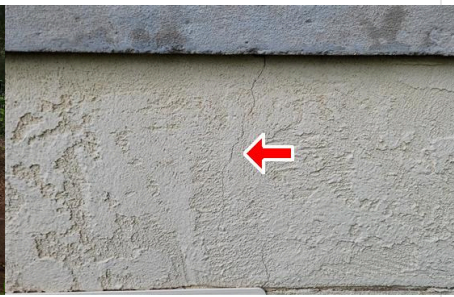
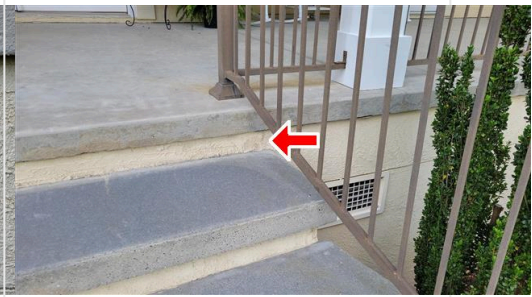
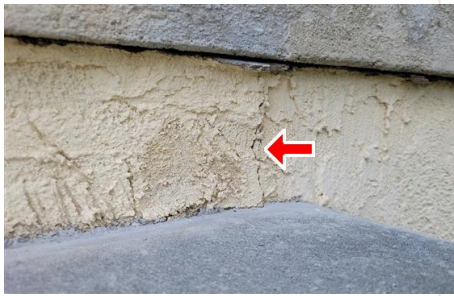
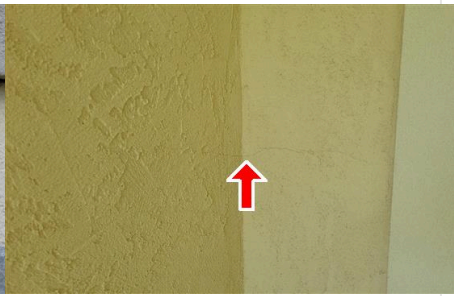
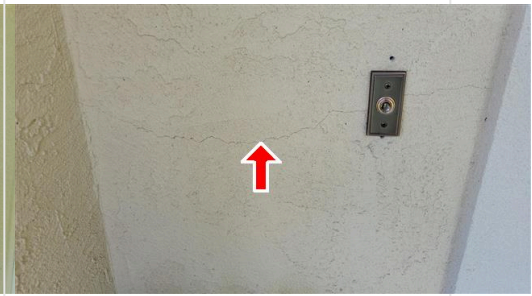
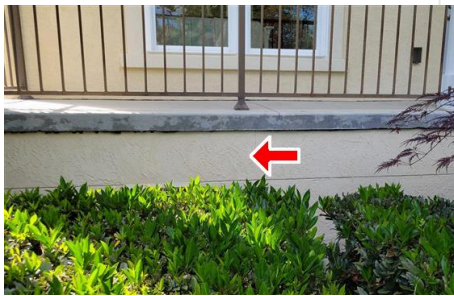
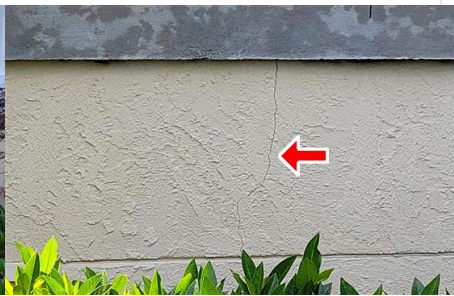
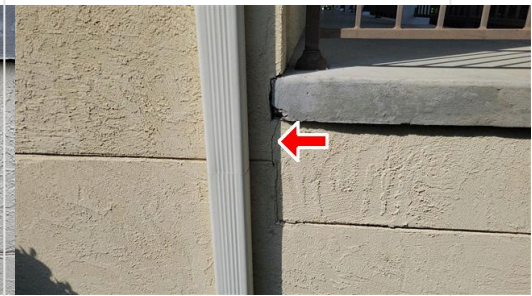
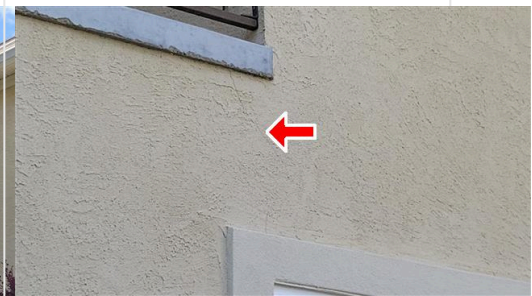
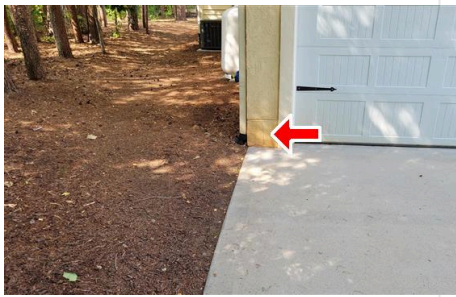
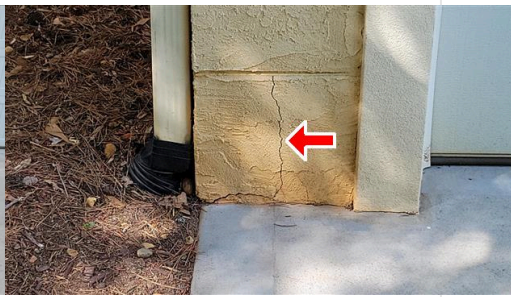
1. The stucco coating at the exterior in areas has hairline cracks. Deterioration can eventually occur if not corrected. Further investigation and repairs are needed.

A qualified contractor should inspect and repair as needed.

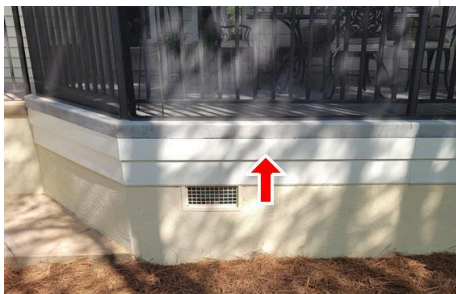
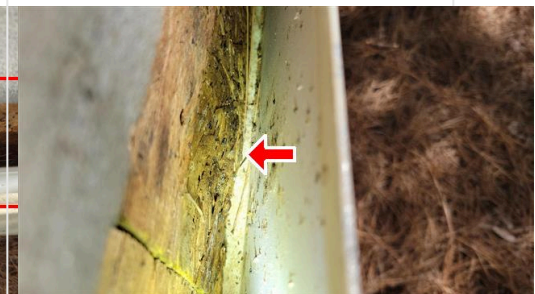
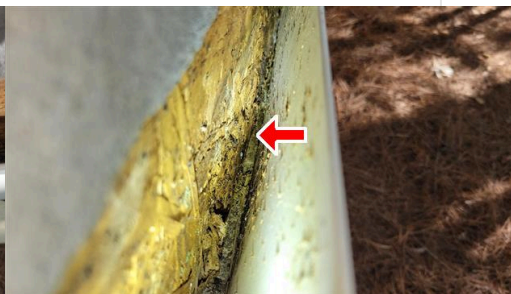
1. Water is being directed behind the siding under the covered porch at the rear of the home causing wood deterioration. Because of the extent of deterioration it is possible for some framing to be deteriorated. Further investigation and repairs are needed.

A qualified contractor should inspect and repair as needed.

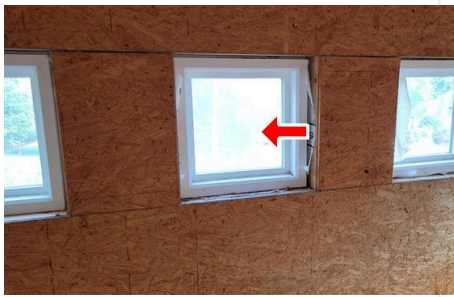
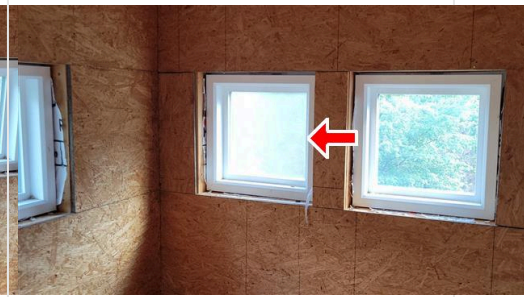
1. Several windows have failed/compromised thermal seals/fogged window panes. This is indicated by the visible moisture, discoloration, calcium deposits and or crystallization visible between the glass window panes. A certified window technician should recheck all the windows throughout the home. Due to weather conditions many times compromised/failed windows cannot be identified at the time of inspection. Further investigation and repairs are needed.

We recommend contacting a properly licensed window technician/contractor regarding these conditions and have repairs made deemed appropriate

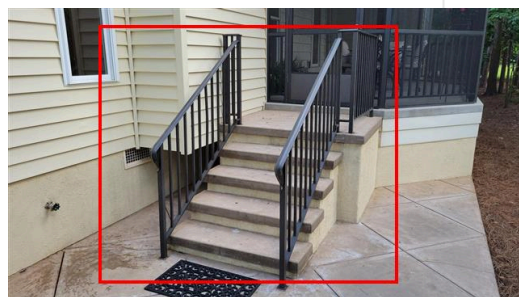
3.4 Item 1 (Picture)

1. The guardrails on steps at the rear of home are loose. A fall or injury could occur if not corrected. A repair or replacement is needed.

A qualified contractor should repair or replace as needed.

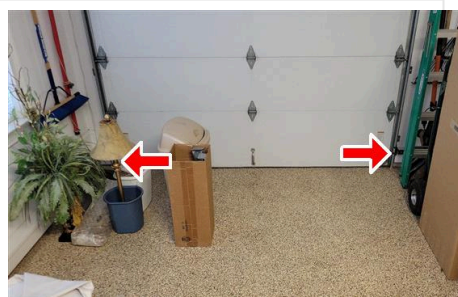
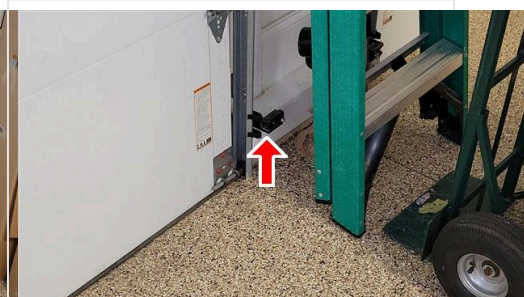
1. The garage door electronic sensors at the right side (facing front) did not function at time of inspection. This is considered unsafe and needs correcting. Further investigation and repairs are needed.

A qualified person should repair or replace as needed.

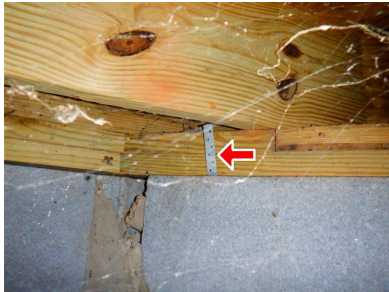
4.0 Item 1 (Picture)

1. Some sill plate straps are not bolted secured to the wood sills, as required. Installing sill plates involves fastening them down to the foundation walls with either metal straps or anchor bolts that are imbedded into the foundation. These straps/bolts resist shear forces and uplift forces that may occur. Further investigation and repairs are needed.

A qualified contractor should inspect and repair as needed.

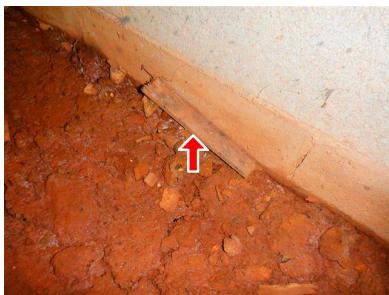
4.5 Item 1 (Picture)

1. Wood debris is in contact with the crawl space floor in numerous areas. This can attract wood destroying organisms. Removal is needed.

A qualified contractor should inspect and repair as needed.

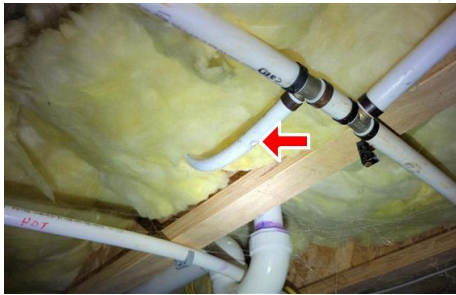
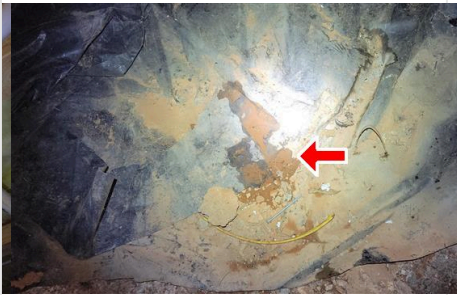
1. The cold supply line is leaking under the master bath. Repairs are needed to prevent water damage from occurring to the home. Further investigation and repairs are needed..

A qualified licensed plumber should repair or correct as needed.

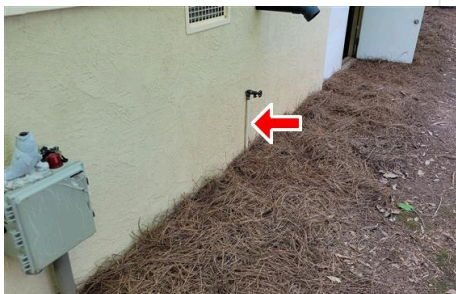
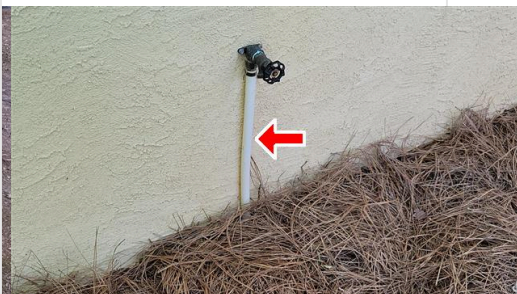
1. The pex supply line It is exposed at the right side of the home. Repairs are needed to prevent water damage from occurring to the home. Further investigation and repairs are needed.

A qualified licensed plumber should repair or correct as needed.

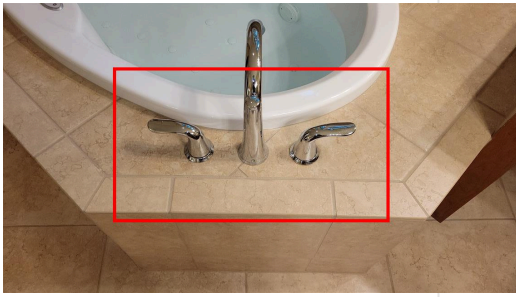
5.2 Item 6 (Picture)

1. The control lever is reversed (hot is cold, cold is hot) at the master bath. Hot should always be on the left and cold on the right for safety reasons. Scalding could occur if not corrected. Repairs are needed.

A qualified licensed plumber should repair or correct as needed.

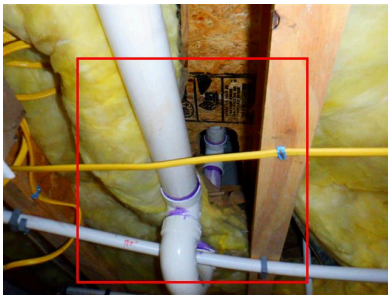
5.3 Item 1 (Picture)

1. The tub drain leaks under the master bath. Repairs are needed to prevent water damage from occurring to the home. Further investigation and repairs are needed.

A qualified licensed plumber should repair or correct as needed.

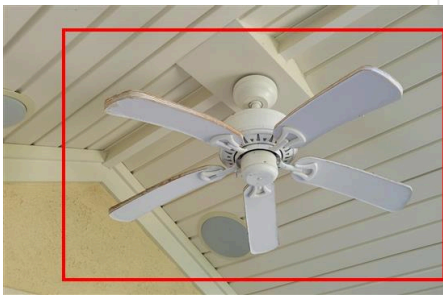
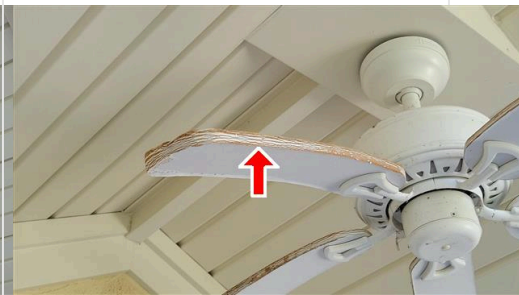
1. The ceiling fan blades are deteriorated. This is a safety issue. Further investigation and repairs are needed.

A qualified licensed electrical contractor should correct as needed.

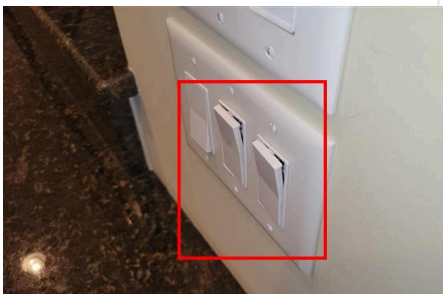
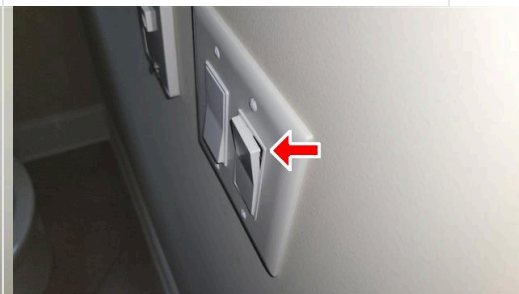
1. The wall switches are damaged at the throughout the home. Electrical issues are considered a hazard until repaired. Further investigation and repairs are needed.

A qualified licensed electrical contractor should correct as needed.

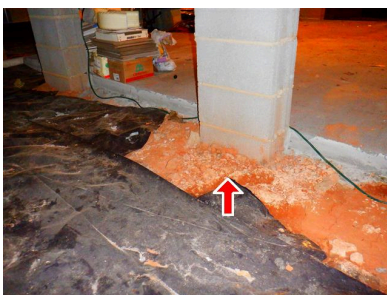
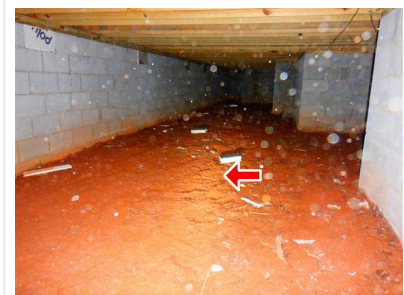
1. The vapor barrier (plastic) on the crawlspace ground is missing in areas. A vapor barrier provides added protection to the floor system from moisture or dampness that can enter from ground. Repairs are needed.

A qualified person should repair or replace as needed.

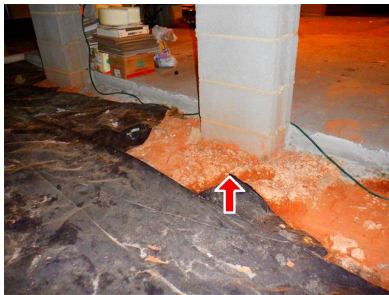
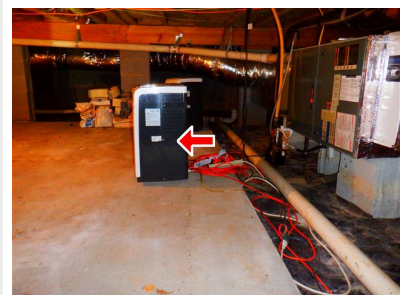
1. The sealed crawlspace was not installed properly. This may allow for moisture damage to occur to the home. I recommend having the entire sealed crawlspace evaluated. Further investigation and repairs are needed.

I recommend contacting a licensed general contractor who has experience with sealed crawlspaces for a complete evaluation and have the repairs made as deemed appropriate.

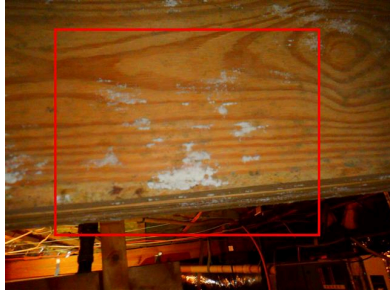
1.0 Item 1 (Picture)

Discoloration in some type of fungal growth (wood destroying fungus) is present in the structure at several areas including but not limited to the crawl space and or interior spaces. This type of substance commonly results in the building and finish type materials becoming weakened and or compromised. Evidence suggests that this condition is from a past or present elevated moisture conditions. The extent of the damage cannot be determined until the moisture issue is corrected. We did not inspect, test or determine if this type of substance is or is not a health hazard as this is above the scope of a home inspection. We recommend contacting a licensed expert for testing, investigation and or correction as deemed appropriate

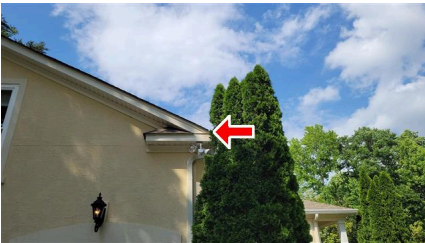
2.0 Item 1 (Picture)

- (1)
1. The roof shingles is damaged at the front of home. This damage should be repaired or replaced.  
Repairs are needed.

A qualified person should repair or replace as needed.

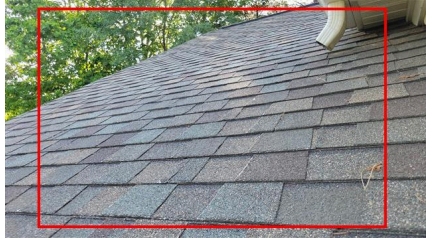
2.0 Item 4 (Picture)

1. The asphalt/fiberglass shingles to be near the end of their service life. It appears that they will need replacing in the not too distant future. They show signs of heavy wear typical for their age consisting of heavy loss of moderate to heavy wear long edges of tabs. No signs of leaks were observed at the time of inspection. Further investigation and repairs are needed.

A qualified contractor should inspect and repair as needed.

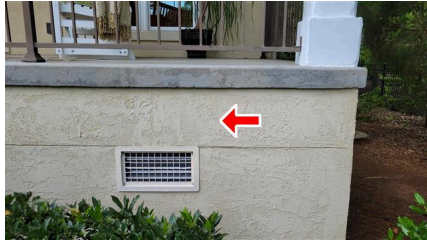
3.0 Item 1 (Picture)

1. The stucco coating at the exterior in areas has hairline cracks. Deterioration can eventually occur if not corrected. Further investigation and repairs are needed.

A qualified contractor should inspect and repair as needed.

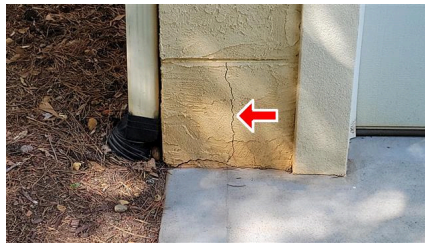
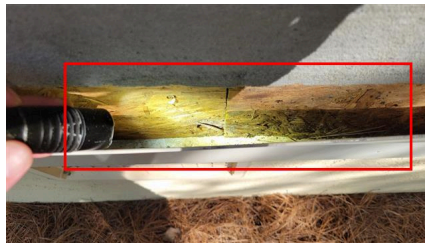
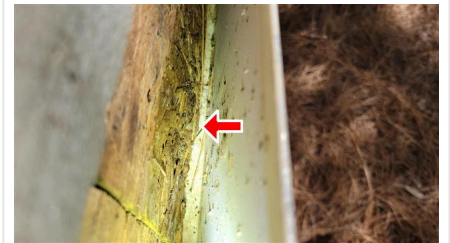
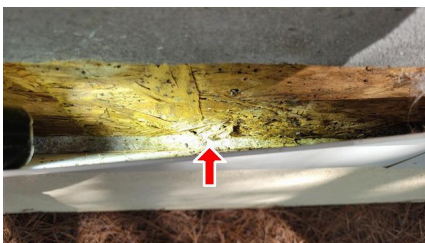
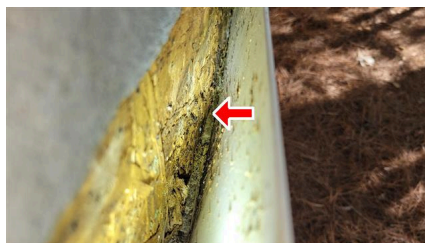
1. Water is being directed behind the siding under the covered porch at the rear of the home causing wood deterioration. Because of the extent of deterioration it is possible for some framing to be deteriorated. Further investigation and repairs are needed.

A qualified contractor should inspect and repair as needed.

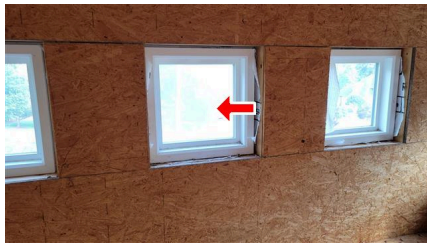
3.2 Item 1 (Picture)

1. Several windows have failed/compromised thermal seals/fogged window panes. This is indicated by the visible moisture, discoloration, calcium deposits and or crystallization visible between the glass window panes. A certified window technician should recheck all the windows throughout the home. Due to weather conditions many times compromised/failed windows cannot be identified at the time of inspection. Further investigation and repairs are needed.

We recommend contacting a properly licensed window technician/contractor regarding these conditions and have repairs made deemed appropriate

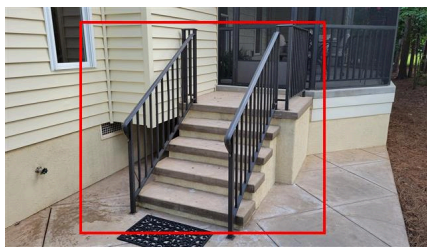
3.4 Item 1 (Picture)

1. The guardrails on steps at the rear of home are loose. A fall or injury could occur if not corrected A repair or replacement is needed.

A qualified contractor should repair or replace as needed.

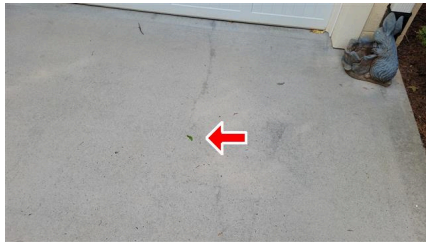
3.5 Item 1 (Picture)

1. The concrete driveway has cracks that should be sealed to prevent further damage, which is part of ongoing maintenance of a concrete driveway that will need to be performed on a regular basis. Repairs are recommended.

A qualified contractor should inspect and repair as needed.

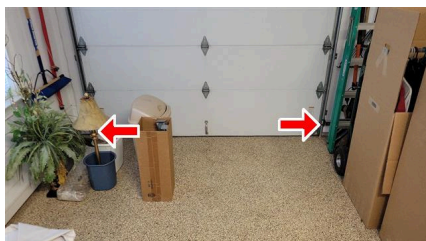
3.6 Item 1 (Picture)

1. The garage door electronic sensors at the right side (facing front) did not function at time of inspection. This is considered unsafe and needs correcting. Further investigation and repairs are needed.

A qualified person should repair or replace as needed.

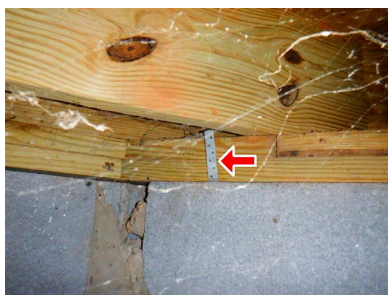
4.0 Item 1 (Picture)

1. Some sill plate straps are not bolted secured to the wood sills, as required. Installing sill plates involves fastening them down to the foundation walls with either metal straps or anchor bolts that are imbedded into the foundation. These straps/bolts resist shear forces and uplift forces that may occur. Further investigation and repairs are needed.

A qualified contractor should inspect and repair as needed.

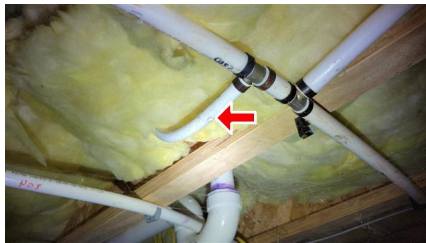
5.2 Item 1 (Picture)

1. The cold supply line is leaking under the master bath. Repairs are needed to prevent water damage from occurring to the home. Further investigation and repairs are needed..

A qualified licensed plumber should repair or correct as needed.

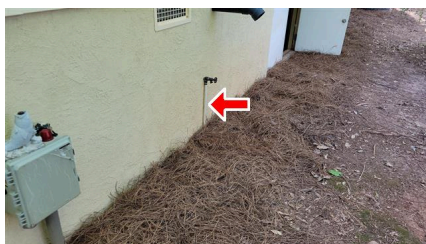
5.2 Item 4 (Picture)

1. The pex supply line It is exposed at the right side of the home. Repairs are needed to prevent water damage from occurring to the home. Further investigation and repairs are needed.

A qualified licensed plumber should repair or correct as needed.

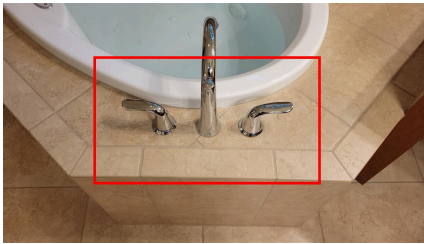
5.2 Item 6 (Picture)

1. The control lever is reversed (hot is cold, cold is hot) at the master bath. Hot should always be on the left and cold on the right for safety reasons. Scalding could occur if not corrected. Repairs are needed.

A qualified licensed plumber should repair or correct as needed.

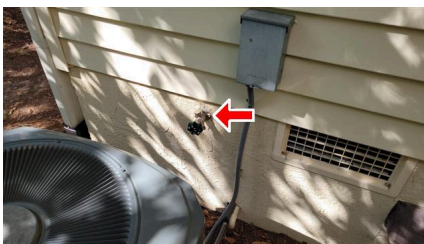
5.2 Item 7 (Picture)

1. The outside water faucet loose, and needs securing to wall at the rear of home. This can allow undue stress to occur on supply lines allowing leaks to occur. Repairs are needed..

A qualified licensed plumber should repair or correct as needed.

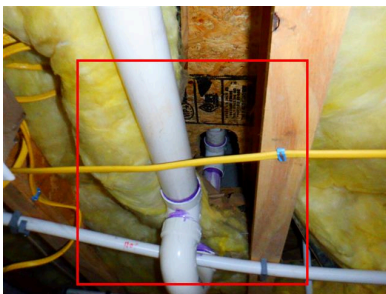
5.3 Item 1 (Picture)

1. The tub drain leaks under the master bath. Repairs are needed to prevent water damage from occurring to the home. Further investigation and repairs are needed.

A qualified licensed plumber should repair or correct as needed.

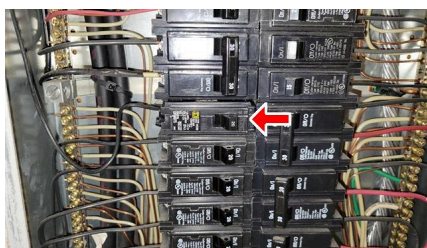
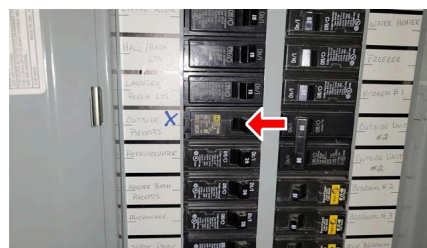
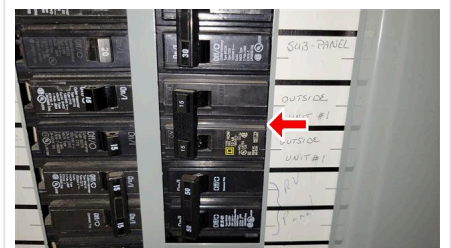
1. One or more circuit in main/sub panel is of a different brand than panel manufacturer. The manufacture requires that in order for the panel to be safe, only their brand is allowed to be used inside the panel. Even though these circuit breaker are all "UL approved," they are not approved to be used in panels of different manufactures unless so indicated on the panel label. Further investigation is needed.

A qualified licensed electrical contractor should correct as needed.

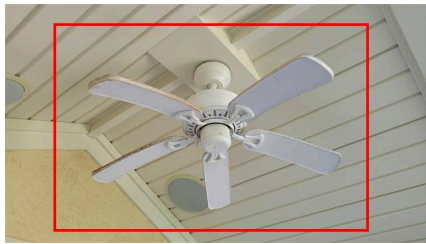
6.4 Item 1 (Picture)

1. The ceiling fan blades are deteriorated. This is a safety issue. Further investigation and repairs are needed.

A qualified licensed electrical contractor should correct as needed.

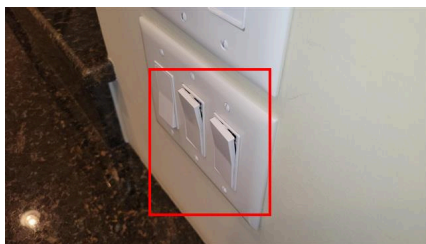
6.4 Item 3 (Picture)

1. The wall switches are damaged at the throughout the home. Electrical issues are considered a hazard until repaired. Further investigation and repairs are needed.

A qualified licensed electrical contractor should correct as needed.

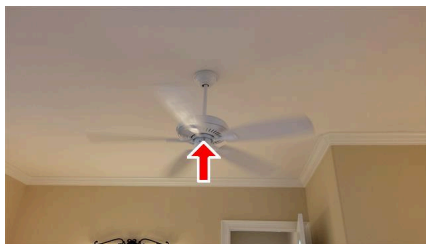
6.4 Item 5 (Picture)

1. The ceiling fan does work, but "wobbles" in the master bath. Some fans that wobble cannot be corrected without replacement. Repairs are needed.

A qualified licensed electrical contractor should correct as needed.

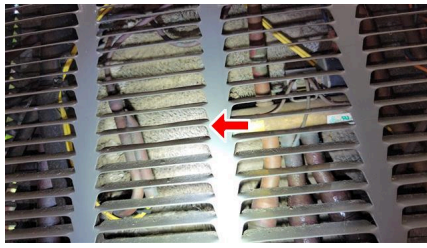
7.8 Item 1 (Picture)

1. The condenser(s) unit is dirty at the rear of the home. This can cause damage to the unit or shorten

its life span. Further investigation and repairs are needed.  
A licensed HVAC contractor should service or repair unit.

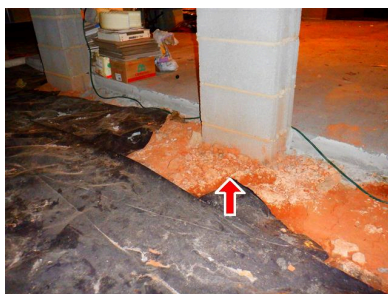
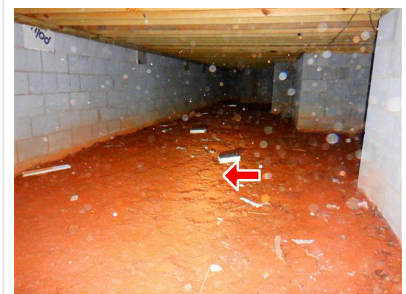
Repairs are needed.

A qualified person should repair or replace as needed.

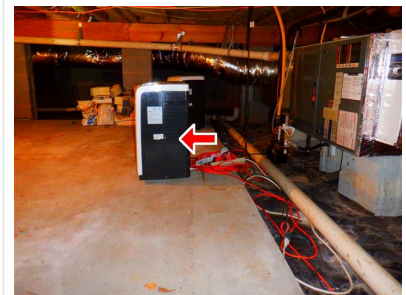
9.1 Item 9 (Picture)

1. The sealed crawlspace was not installed properly. This may allow for moisture damage to occur to the home. I recommend having the entire sealed crawlspace evaluated. Further investigation and repairs are needed.

I recommend contacting a licensed general contractor who has experience with sealed crawlspaces for a complete evaluation and have the repairs made as deemed appropriate.
