INSPECTION REPORT  
3617 Venetian Way  
York SC 29745

INSPECTION DATE  
📅 10/7/2025  
Home Inspection  
Carolina

Complete Home Inspection Report

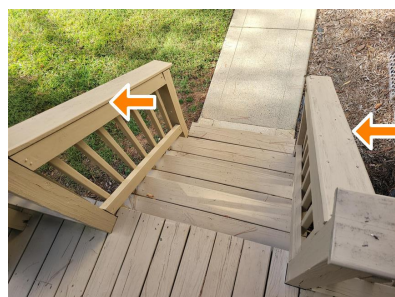
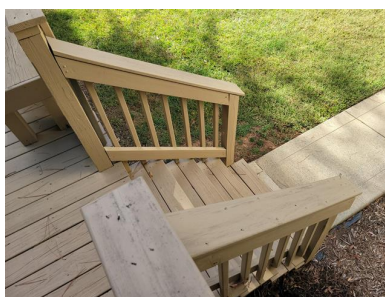
(1) The handrails at the steps of the rear porch were noted to be too wide at the time of inspection this should be repaired and or corrected for safety and to prevent any further damage. Consult with a qualified licensed contractor to evaluate the area(s) of concern and make any additional repairs as deemed necessary during their evaluation.

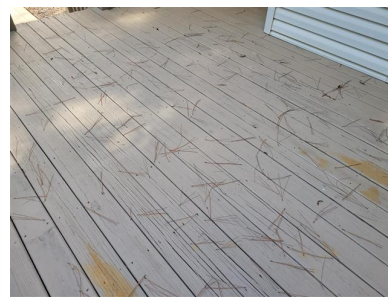
(2) The deck boards at the rear porch where noted to be fastened with nails at the time of inspection this should be corrected for safety and to ensure proper installation and to prevent any further damage. Consult with a qualified licensed contractor to evaluate the area(s) of concern and make any additional repairs as deemed necessary during their evaluation.

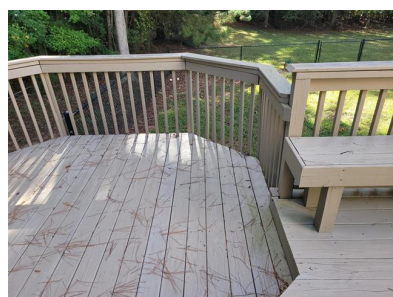
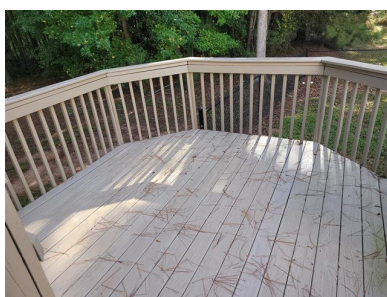
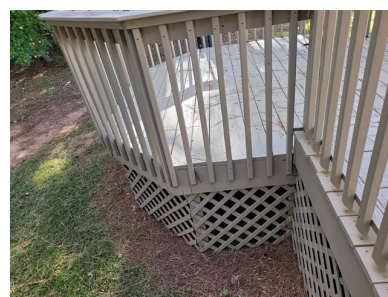
(3) **The railings were noted to be depending on the spindles as no posts were found or noted to be installed.** Post are needed at the base of the stairs/steps and approximately every six feet on center to properly support and secure the railing around the decking and stairs. Consult with a qualified licensed contractor to evaluate the area(s) of concern and make any additional repairs as deemed necessary during their evaluation.

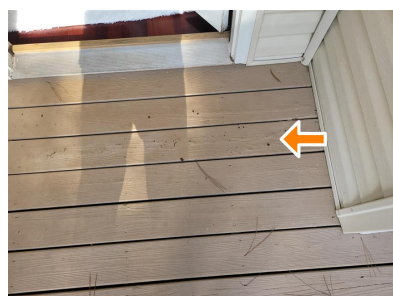
(4) Wood rot and or damage was noted to the deck boards at the rear porch at the time of inspection this should be corrected to prevent any further damage. Consult with a qualified licensed contractor to evaluate the area(s) of concern and make any additional repairs as deemed necessary during their evaluation.

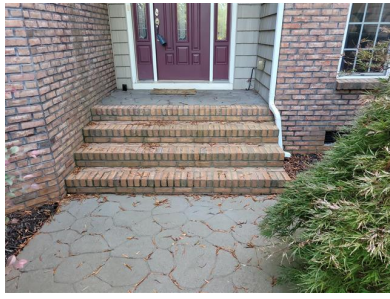
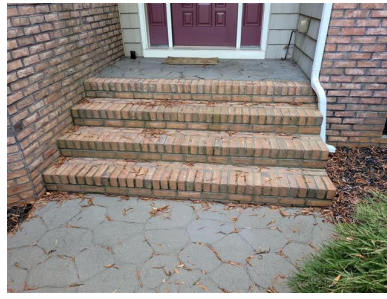
(5) **The stairs at front porch were found to be above 30", typically consisting of 3 or more steps.** Stairs, patios, and decks above 30" require a handrail to be installed to ensure safety. Consult with a qualified licensed contractor to evaluate the area(s) of concern and make any additional repairs as deemed necessary during their evaluation.

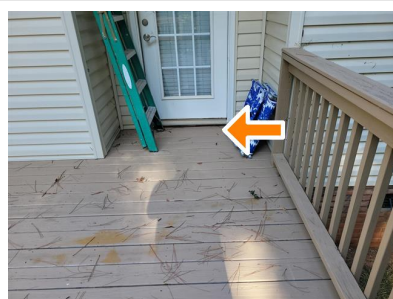
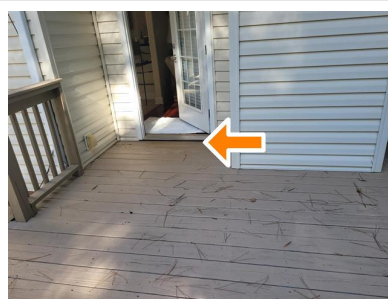
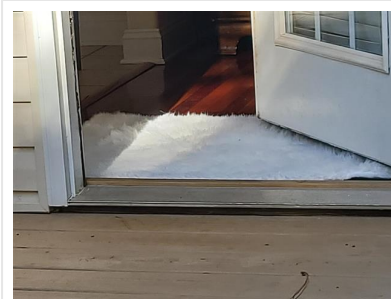
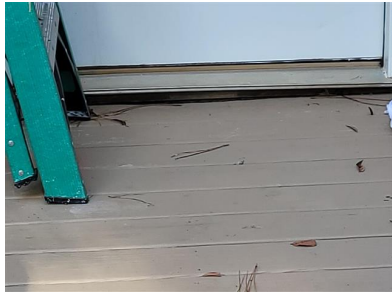
(1) Trim was noted to be missing and or not installed correctly under the threshold of both rear doors at the time of inspection this should be repaired and or corrected to ensure proper installation and to prevent water intrusion and to prevent any further damage hidden and will concealed damage may exist. Consult with a qualified licensed contractor to evaluate the area(s) of concern and make any additional repairs as deemed necessary during their evaluation.

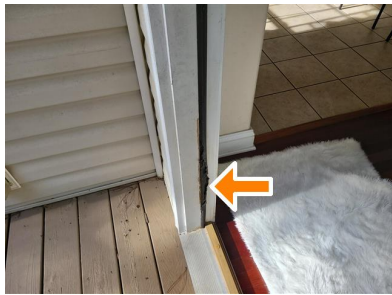
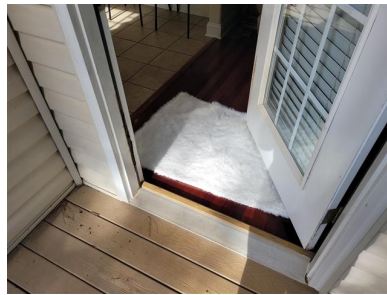
(2) The weather strip at the rear door Was noted to be torn and or damaged at the time of inspection this should be repaired and or replaced to ensure proper function and to prevent any further damage. Consult with a qualified licensed contractor to evaluate the area(s) of concern and make any additional repairs as deemed necessary during their evaluation.

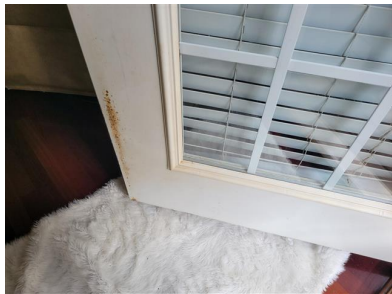
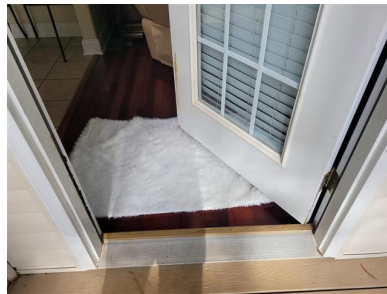
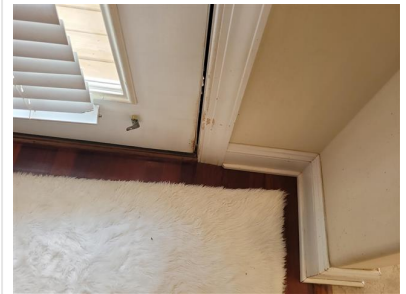
(3) Rust and or damage was noted to the rear door door trim and or threshold at the time of inspection this should be repaired and or corrected to ensure proper installation and function and to prevent any further damage. Consult with a qualified licensed contractor to evaluate the area(s) of concern and make any additional repairs as deemed necessary during their evaluation.

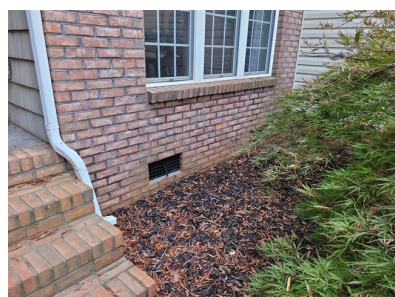
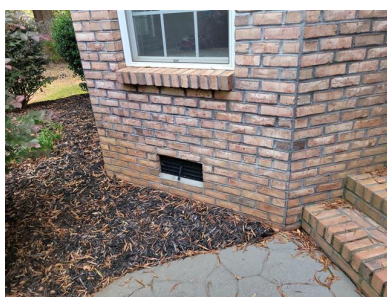
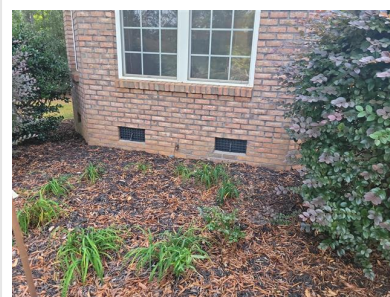
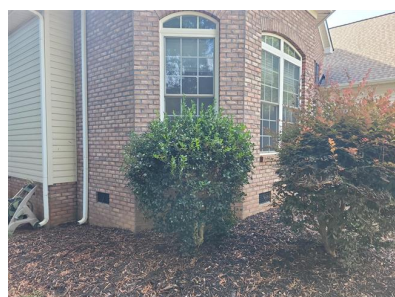
(4) No weep holes were detected in the brick siding surrounding the house. Weep holes, which are drilled openings or slots, are typically situated around the foundation and positioned above or below windows in brick veneer structures. These openings serve the purpose of facilitating the drainage of accumulated moisture within or behind building elements, as well as providing an outlet for water that could potentially gather in window sills and veneers. Consult with a qualified licensed contractor to evaluate the area(s) of concern and make any additional repairs as deemed necessary during their evaluation.

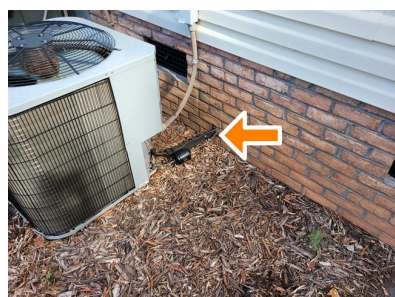
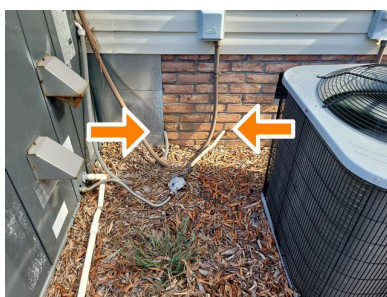
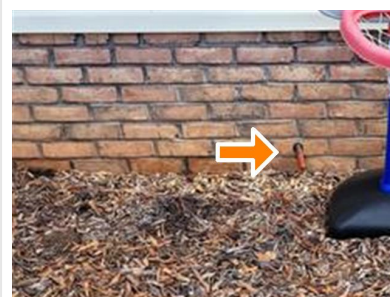
(5) Sealant is important for safeguarding against water damage and potential rodent intrusion at entry points where phone, cable, or electrical lines enter the home. This protective measure helps maintain the integrity of the home's infrastructure and prevents costly repairs in the long run. Consult with a qualified licensed contractor to evaluate the area(s) of concern and make any additional repairs as deemed necessary during their evaluation.

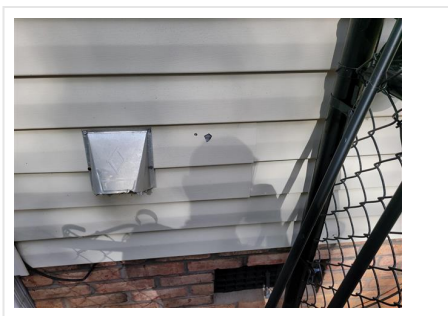
(6) Holes were noted to the siding at the rear right corner of the home at the time of inspection this should be repaired and or corrected to prevent water and or pest intrusion and to prevent any further damage. Consult with a qualified licensed contractor to evaluate the area(s) of concern and make any additional repairs as deemed necessary during their evaluation.

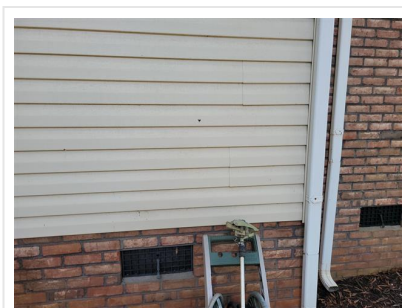
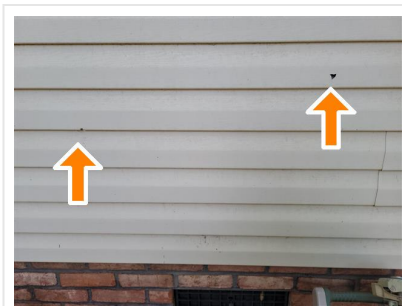
(7) Holes were noted to the siding at the left side of the home at the time of inspection this should be repaired and or corrected to prevent moisture and or pest intrusion and to prevent any further damage. Consult with a qualified licensed contractor to evaluate the area(s) of concern and make any additional repairs as deemed necessary during their evaluation.

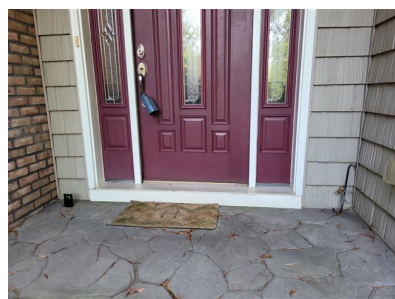
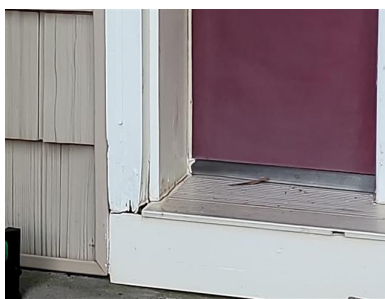
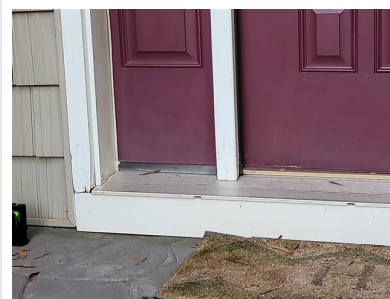
Wood rot and or damage was noted to the trim at the front door area of the home at the time of inspection this should be repaired and or corrected to ensure proper installation and to prevent any further damage. Hidden and or concealed damage may exist. Consult with a qualified licensed contractor to evaluate the area(s) of concern and make any additional repairs as deemed necessary during their evaluation.

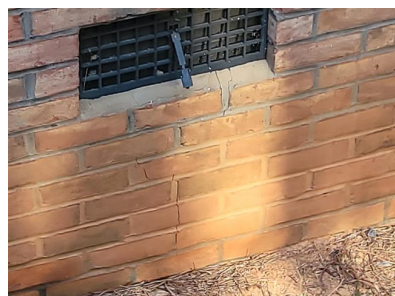
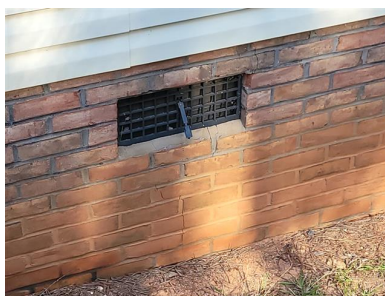
(1) A crack was noted to the brick foundation at the back left portion of the home at the time of inspection this should be repaired and or corrected to prevent any further damage hidden and concealed damage may exist. Consult with a qualified licensed contractor to evaluate the area(s) of concern and make any additional repairs as deemed necessary during their evaluation.

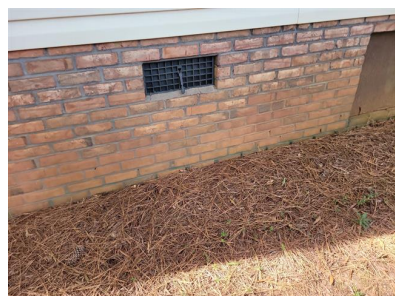
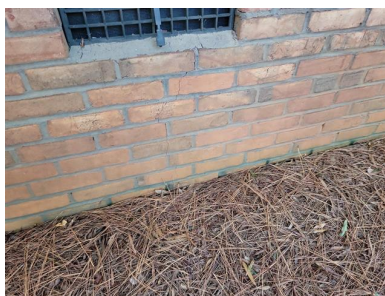
(2) A crack was noted to the brick Foundation at the left side of the home at the time of inspection this should be repaired and or corrected to prevent any further damage hidden and will concealed damage may exist. Consult with a qualified licensed contractor to evaluate the area(s) of concern and make any additional repairs as deemed necessary during their evaluation.

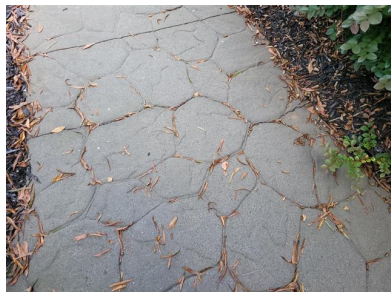
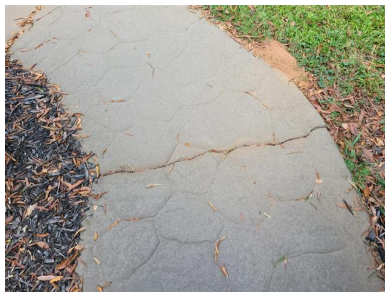
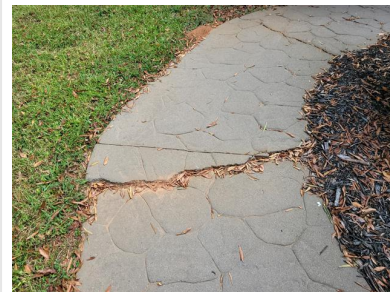
**There are cracks noted at the sidewalk that need to be sealed and/or repaired properly to prevent water penetration and/or continual cracking.** Consult with a qualified licensed contractor to evaluate the area(s) of concern and make any additional repairs as deemed necessary during their evaluation.

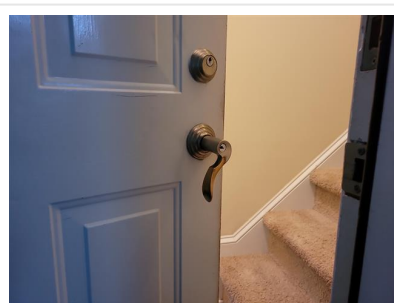
(1) The door knob at the garage entry door with nutted to be damaged at the time of inspection this should be repaired and or replaced for safety and to ensure proper installation and function and to prevent any further damage Consult with a qualified licensed contractor to evaluate the area(s) of concern and make any additional repairs as deemed necessary during their evaluation.

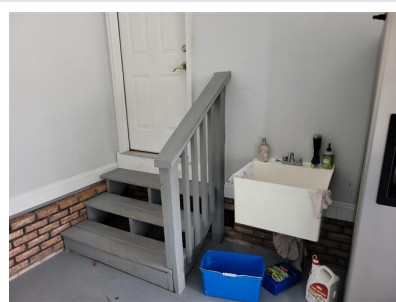
(2) The handrail was noted to be too wide at the railing at the steps in the garage at the time of inspection this should be repaired and or corrected for safety to prevent any further damage. Consult with a qualified licensed contractor to evaluate the area(s) of concern and make any additional repairs as deemed necessary during their evaluation.

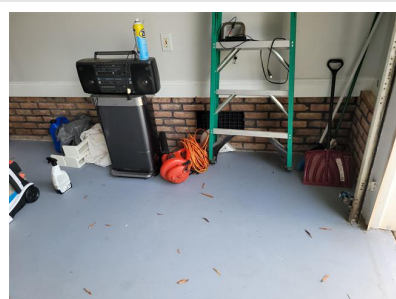
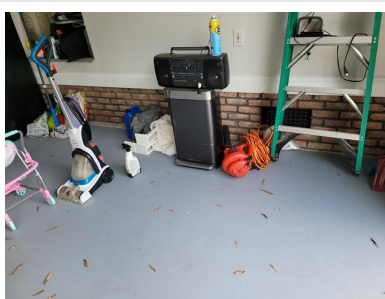
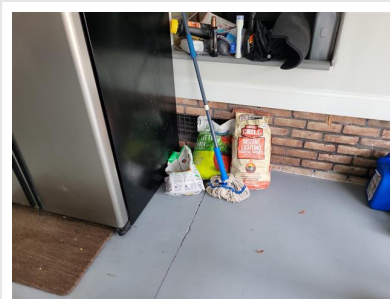
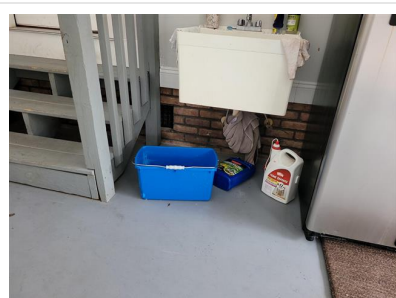
(3) Multiple crawl space vents were noted in the garage at the time of inspection this should be sealed and or corrected to prevent carbon monoxide exchange and to ensure proper construction and to prevent any further damage. Consult with a qualified licensed contractor to evaluate the area(s) of concern and make any additional repairs as deemed necessary during their evaluation.

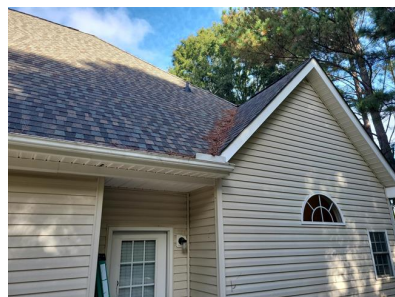
(1) **The debris on the roof needs to be corrected to prevent the collection of debris, weathering, or damage at the rear of the home.** Corrections are needed to prolong life of the roof shingle and/or prevent leaks. Consult with a qualified licensed contractor to evaluate the area(s) of concern and make any additional repairs as deemed necessary during their evaluation.

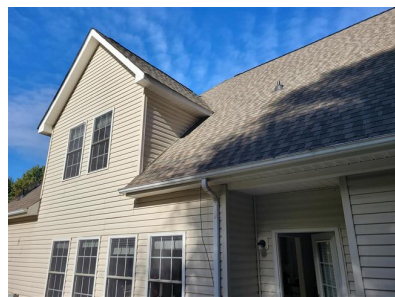
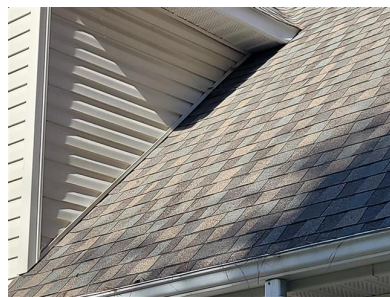
(2) **The siding is touching the roof shingles along the roof line where the siding and roof meet.** The siding needs to be trimmed back properly to prevent water damage to the siding and/or water from penetrating into the home. Consult with a qualified licensed contractor to evaluate the area(s) of concern and make any additional repairs as deemed necessary during their evaluation.

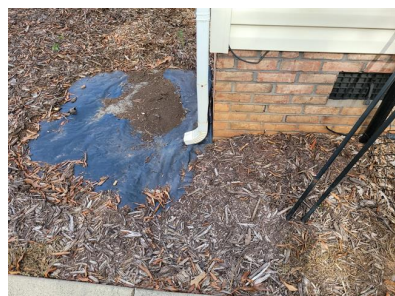
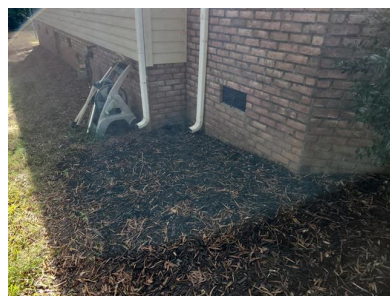
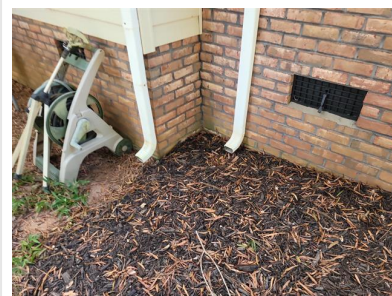
(1) **A splash block is needed to properly direct water away from the foundation of the home at the front and rear corner of the home.** Consult with a qualified licensed contractor to evaluate the area(s) of concern and make any additional repairs as deemed necessary during their evaluation.

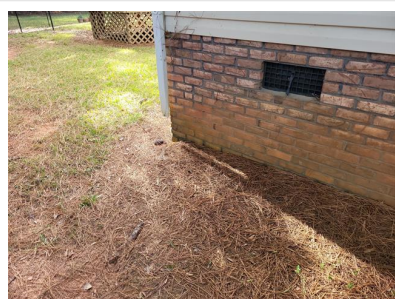
(2) The downspout was noted to be missing at the rear left corner of the home at the time of inspection this it could be corrected to ensure proper installation and to ensure proper water disbursements and to prevent any further damage Consult with a qualified licensed contractor to evaluate the area(s) of concern and make any additional repairs as deemed necessary during their evaluation.

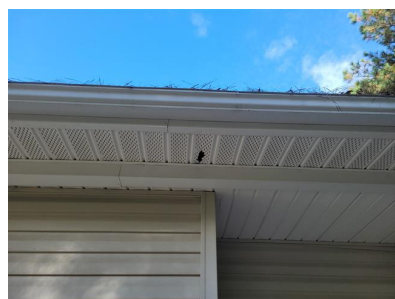
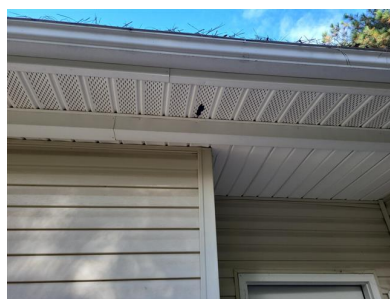
(1) A hole was noted in the soffit at the back of the house at the time of inspection this should be corrected to prevent any further damage. Consult with a qualified licensed contractor to evaluate the area(s) of concern and make any additional repairs as deemed necessary during their evaluation.

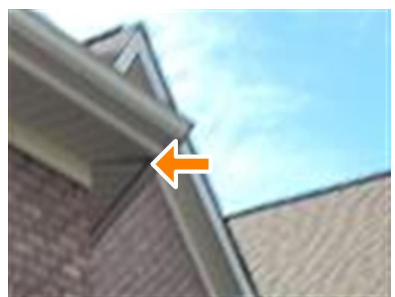
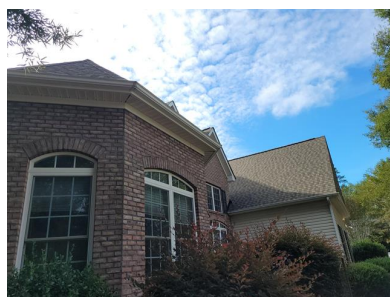
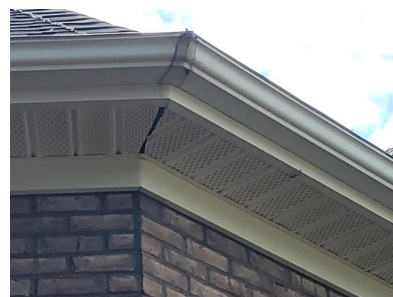
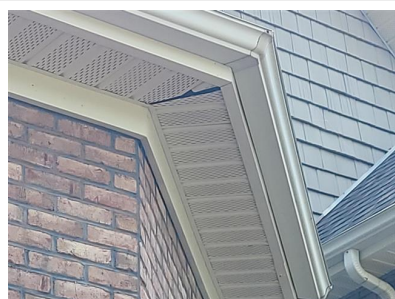
(2) A gap was noted in the soffit at the front of the home in multiple locations at the time of inspection this should be corrected to ensure proper installation and to prevent water and or pest intrusion and to prevent any further damage. Consult with a qualified licensed contractor to evaluate the area(s) of concern and make any additional repairs as deemed necessary during their evaluation.

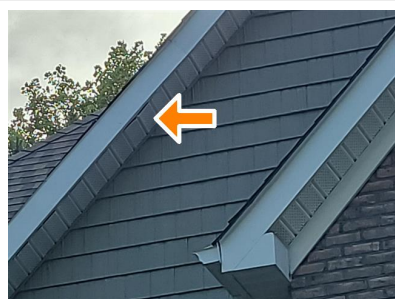
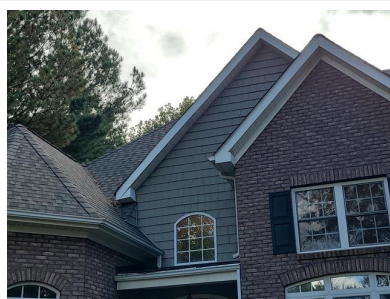
(3) The soffit was noted to be loose and or damaged at the front of the home at the time of inspection this should be corrected to ensure proper installation and to prevent water intrusion and to prevent any further damage. Consult with a qualified licensed contractor to evaluate the area(s) of concern and make any additional repairs as deemed necessary during their evaluation.

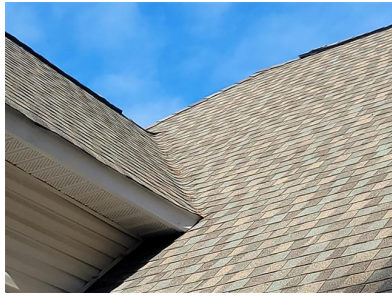
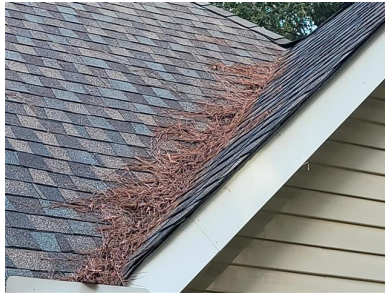
The roof was installed with architectural shingles in a weaving method at the valleys. Some manufactures may approve this method. However, during the inspection, it is unable to determine the manufacture or the manufactures installation requirements. Because of this, you may want to consult with a roofing contractor to ensure proper installation.

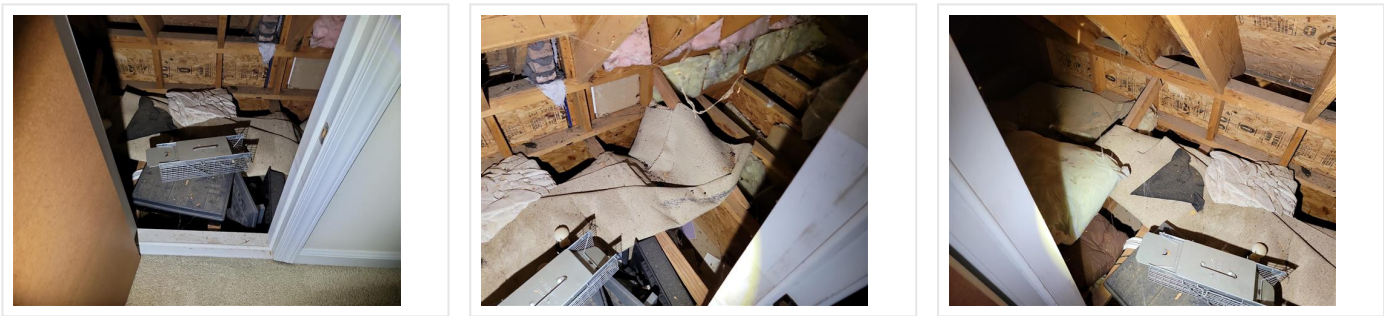
Walk boards were noted to be missing at the attic access in the upstairs portion of the home at the time of inspection this should be corrected for safety and to prevent further damage Consult with a qualified licensed contractor to evaluate the area(s) of concern and make any additional repairs as deemed necessary during their evaluation.

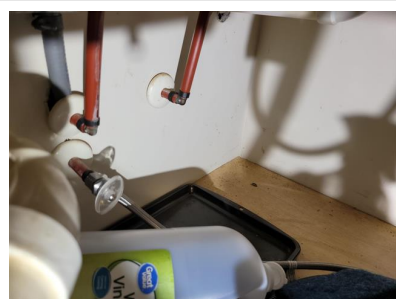
(1) The visible plumbing lines in this home are plastic PEX with brass metal fittings. **Evidence of fitting deterioration was noted during the inspection in a few/several locations.** The deterioration could be the result of a known problem referred to as "dezincification". Dezincification occurs when brass fittings that are considered a high-zinc copper alloy are exposed to water and the zinc is leached from the fitting or component leaving the fitting in a weakened state. This process also leads to a buildup inside the fitting, restricting water flow and ultimately leaving the plumbing system prone to breakage and leaking. Consult with a qualified licensed contractor to evaluate the area(s) of concern and make any additional repairs as deemed necessary during their evaluation.

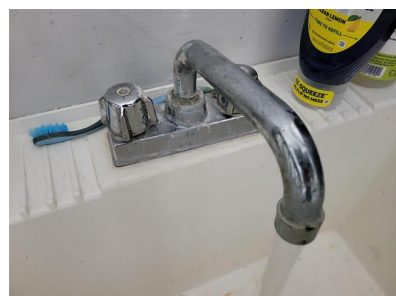
(2) A leak was noted at least faucet at the sink in the garage at the time of inspection, This should be repaired and or replaced to prevent any further damage. Consult with a qualified licensed contractor to evaluate the area(s) of concern and make any additional repairs as deemed necessary during their evaluation.

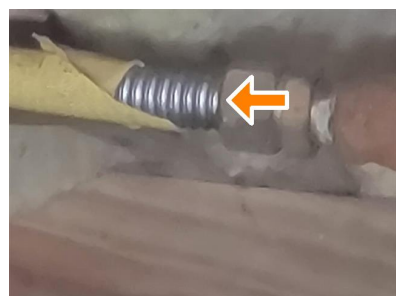
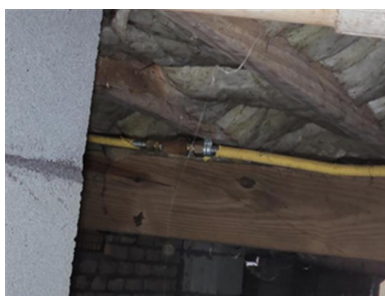
(3) There is CSST (corrugated stainless steel tubing) noted within the crawl space that was found to have the stainless steel areas exposed near the fittings. The exposed stainless steel needs to be sealed or covered with the proper and/or approved tape to prevent corrosion and/or rusting. Consult with a qualified licensed contractor to evaluate the area(s) of concern and make any additional repairs as deemed necessary during their evaluation.

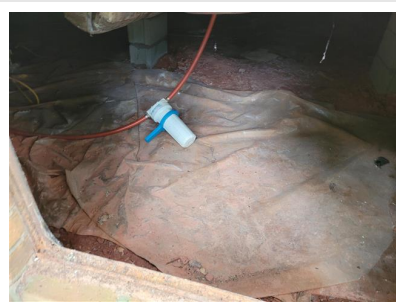
(4) The filter was noted to be unsupported and laying on the ground in the crawlspace at the time of inspection should be corrected to ensure proper installation and function and damage Consult with a qualified licensed contractor to evaluate the area(s) of concern and make any additional repairs as deemed necessary during their evaluation.

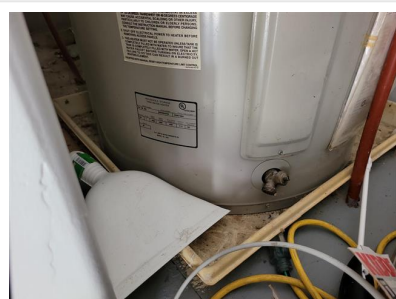
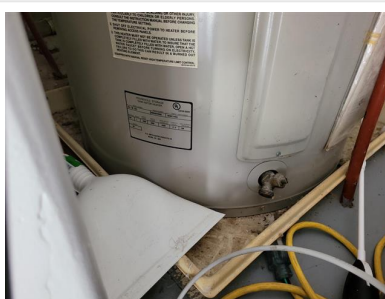
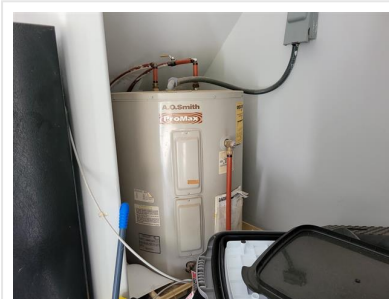
**The water heater appears to be above ten years of age. The lifespan of a typical water heater is noted to be 10-15 years for an electric water heater and 15-18 years for a gas water heater.** The lifespan can depend on several things: the condition of the water; if the water heater is maintained properly; the location of the water heater (crawl space, interior closet, garage, etc.); and several other factors. Due to additional factors, it is impossible to determine the lifespan of the water heater(s) currently installed and/or the additional years left for the water heater. Consult with a qualified licensed contractor to evaluate the area(s) of concern and make any additional repairs as deemed necessary during their evaluation.

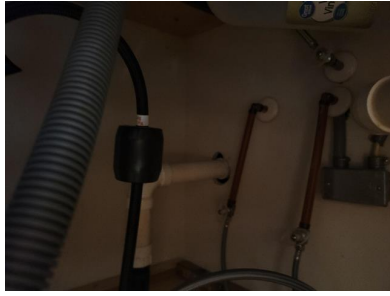
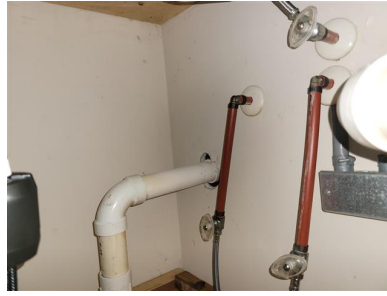
(1) Dura-Pex/NIBCO PEX tubing is prone to oxidization, which is when oxygen negatively affects the quality of a material, like metal or plastic. This can happen if the material isn't treated properly or has a flawed design. Oxidization of PEX tubing can lead to the development of cracks and ruptures, resulting in water leaks. These leaks can also cause damage to NIBCO's fittings and clamps. No leaks were observed during the inspection. It is

advisable to continue monitoring for leaks. If leaks were found, consult with a licensed plumbing contractor to thoroughly evaluate and repair any issues that may arise.

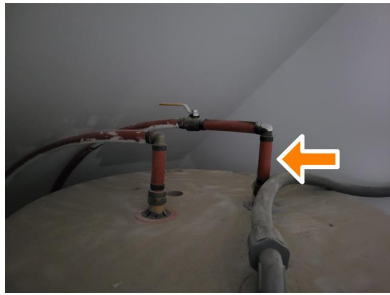
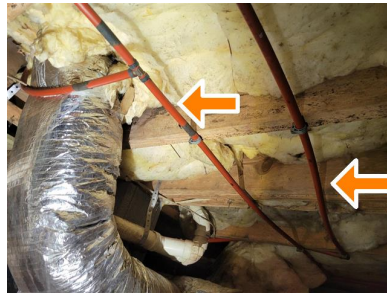
(2) Dura-Pex/NIBCO PEX tubing is prone to oxidization, which is when oxygen negatively affects the quality of a material, like metal or plastic. This can happen if the material isn't treated properly or has a flawed design. Oxidization of PEX tubing can lead to the development of cracks and ruptures, resulting in water leaks. These leaks can also cause damage to NIBCO's fittings and clamps. No leaks were observed during the inspection. It is advisable to continue monitoring for leaks. If leaks were found, consult with a licensed plumbing contractor to thoroughly evaluate and repair any issues that may arise.

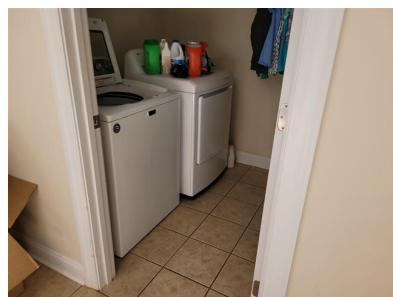
Unable to view the walls, flooring, and piping at the time of inspection due to the washing machine and/or dryer being installed obstructing viewing of these areas. No claims can be made to the condition of these areas at the time of inspection.

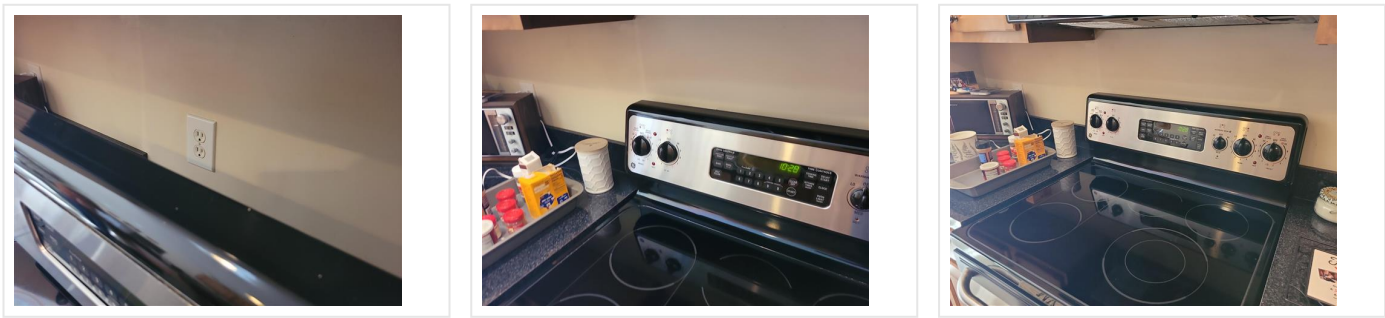
(1) A electrical outlet was noted to be installed behind the stove in the kitchen at the time of inspection this should be corrected for safety and to ensure proper installation and to prevent any further damage. Consult with a qualified licensed contractor to evaluate the area(s) of concern and make any additional repairs as deemed necessary during their evaluation.

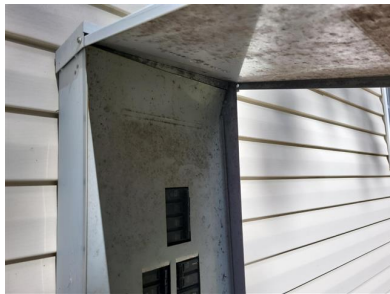
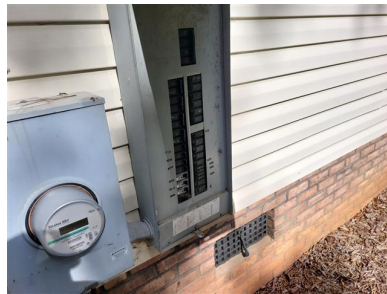
(2) The inside breaker cover was noted to be damaged at the Exterior electric panel at the time of inspection this should be corrected for safety and to prevent any further damage. Consult with a qualified licensed contractor to evaluate the area(s) of concern and make any additional repairs as deemed necessary during their evaluation.

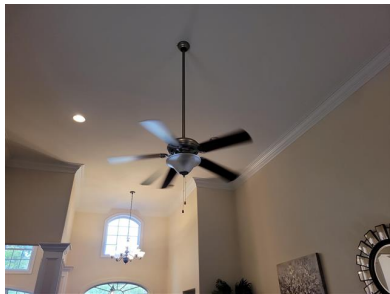
(3) The ceiling fan in the living room was there to be noisy at the time of inspection this should be repaired and or corrected to prevent any further damage. Consult with a qualified licensed contractor to evaluate the area(s) of concern and make any additional repairs as deemed necessary during their evaluation.

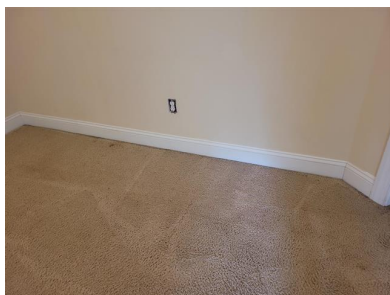
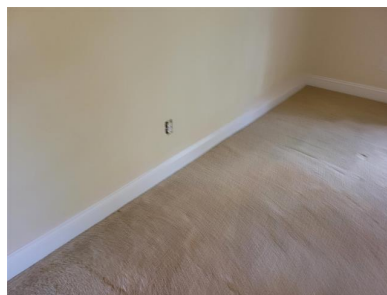
(4) **Missing or damaged cover plates noted within the home.** Repair and/or replace as needed. Consult with a qualified licensed contractor to evaluate the area(s) of concern and make any additional repairs as deemed necessary during their evaluation.

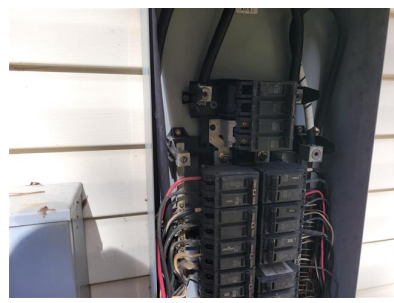
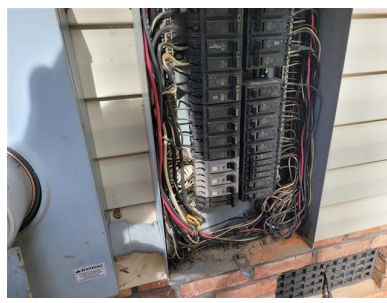
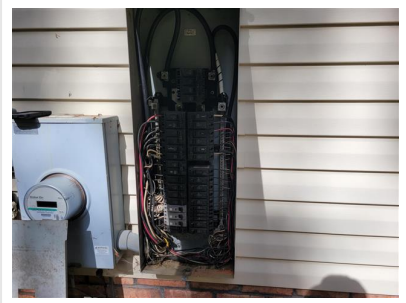
(5) Electric panel inspected.

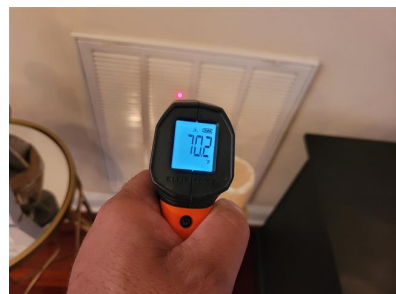
Main Return Air Temperature- 70 degrees.

Main Supply Air Temperature- 57 degrees.

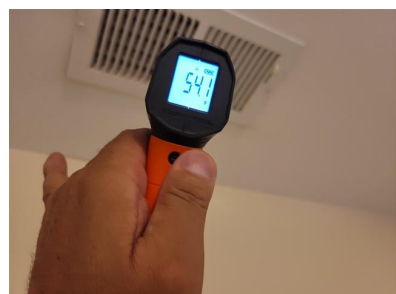
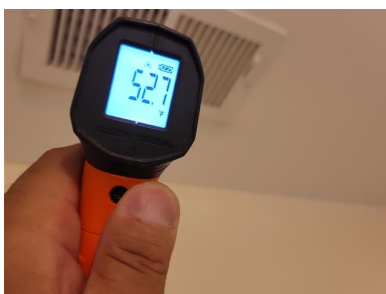
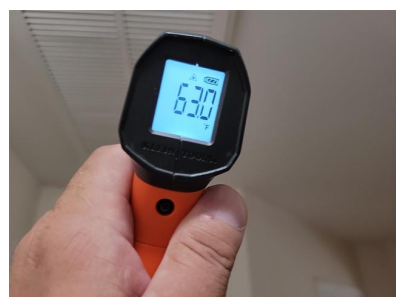
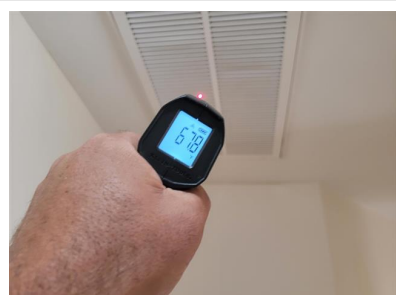
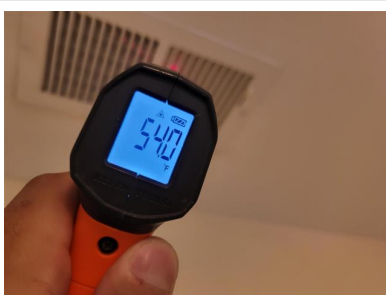
(2) **second floor unit differential** - The second floor unit is producing an adequate air temperature drop. The temperature differentials when tested should be between 14 and 24 degrees. The differentials at the time of inspection were at 13 degrees.

Main Return Air Temperature- 67 degrees.

Main Supply Air Temperature- 54 degrees.

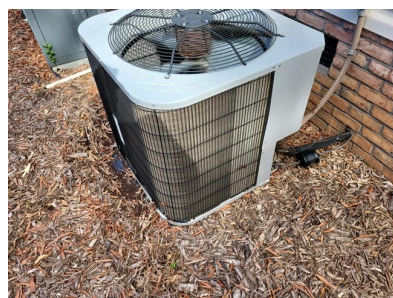
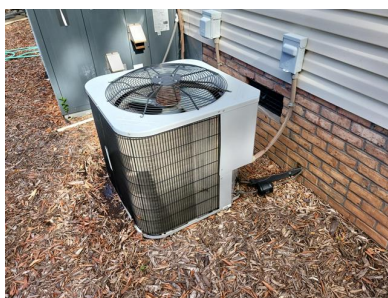
(1) The air conditioner at the right side of the home was noted to be sitting directly on the ground at the time of inspection this should be corrected to ensure proper installation and to prevent any further damage. Consult a qualified licensed contractor to assess the areas of concern and perform any additional repairs deemed necessary during their evaluation.

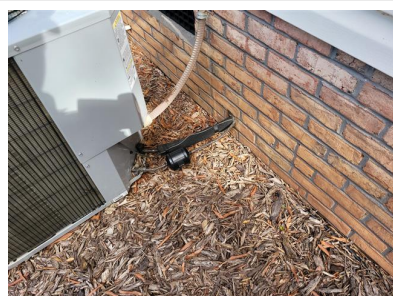
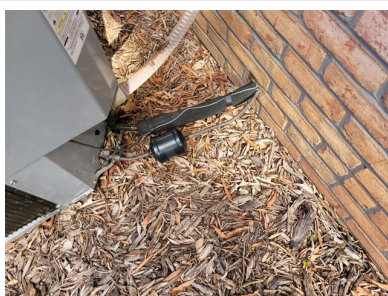
(2) The insulation is damaged, deteriorated, or torn and must be replaced at the Freon line to prevent potential harm or damage at the second floor unit. Insulation helps maintain the coolant's temperature, preventing it from heating up due to external conditions, which could lead to it converting to liquid and potentially damaging the unit. Consult a qualified licensed contractor to assess the areas of concern and perform any additional repairs deemed necessary during their evaluation.

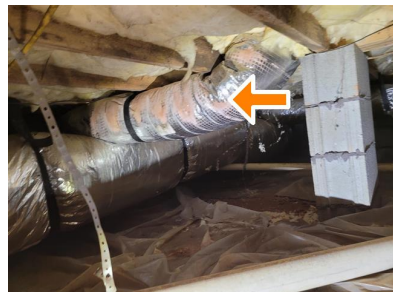
Water damage was noted to the ducts in the crawlspace in multiple locations at the time of inspection this should be repaired or corrected to ensure proper function and to prevent the damage. Consult with a qualified licensed contractor to evaluate the area(s) of concern and make any additional repairs as deemed necessary during their evaluation.

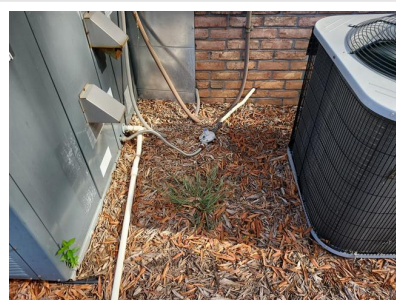
(1) The **drip leg was missing** and is needed at the gas line where it enters the heating unit. This is needed to create a collection point for moisture and foreign particles (i.e copper sulfide) that may be in the gas line **at the primary unit**. Consult with a qualified licensed contractor to evaluate the area(s) of concern and make any additional repairs as deemed necessary during their evaluation.

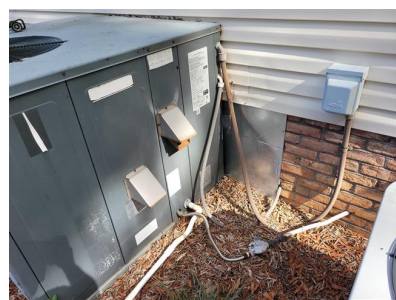
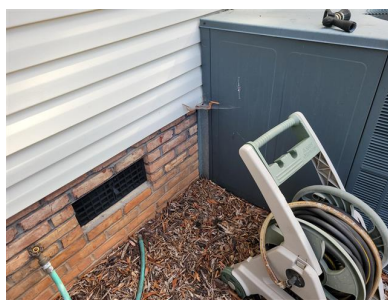
(2) The package unit at the right side of the home was noted to be improperly sealed to the foundation at the time of inspection this should be repaired and or corrected to ensure proper installation and to prevent any further damage. Consult with a qualified licensed contractor to evaluate the area(s) of concern and make any additional repairs as deemed necessary during their evaluation.

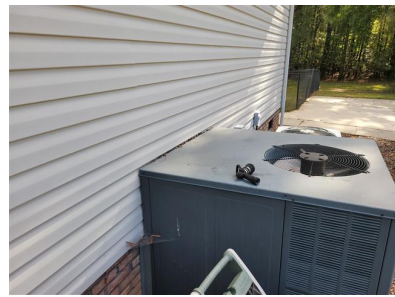
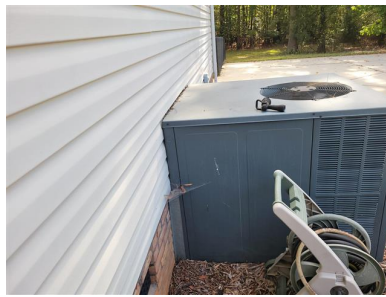
(4) A shroud was noted to be missing where the package unit fastens to the home at the right side of the house at the time of inspection this should be corrected to ensure proper installation and to prevent water and or pest intrusion and to prevent any further damage. Consult with a qualified licensed contractor to evaluate the area(s) of concern and make any additional repairs as deemed necessary during their evaluation.

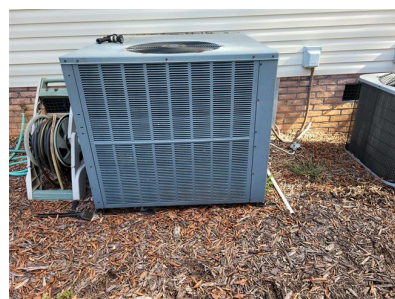
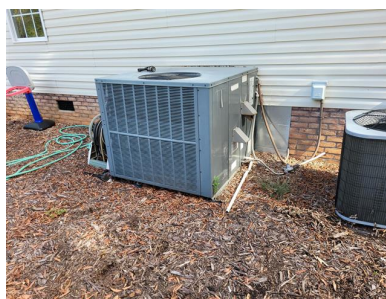
(5) The package unit was noted To be sitting directly on the ground at the right side of the home at the time of inspection this should be repaired and or corrected to ensure proper installation and to prevent any further damage. Consult with a qualified licensed contractor to evaluate the area(s) of concern and make any additional repairs as deemed necessary during their evaluation.

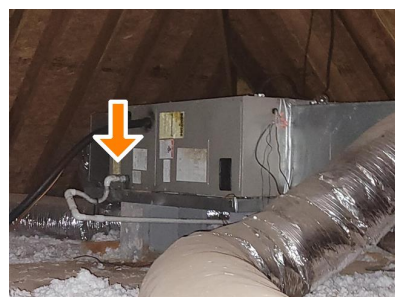
(6) The **secondary or emergency condensate line is capped** and needs correction in the event that the main drain line were to become clogged. The secondary line is designed to allow water to drain down into the overflow pan below turning off the unit or draining the water from the pan to the exterior of the home notifying the homeowner that a problem exists. Without a secondary line installed and/or being blocked from allowing the water to drain into the pan, the water that is trapped in the evaporator coil would eventually leak into the burner chamber potentially creating additional problems at the second floor unit. Consult with a qualified licensed contractor to evaluate the area(s) of concern and make any additional repairs as deemed necessary during their evaluation.

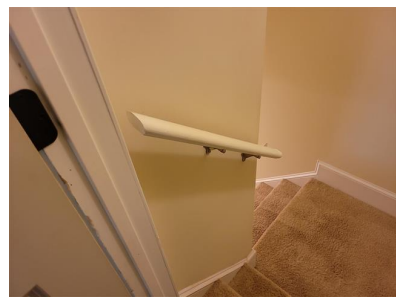
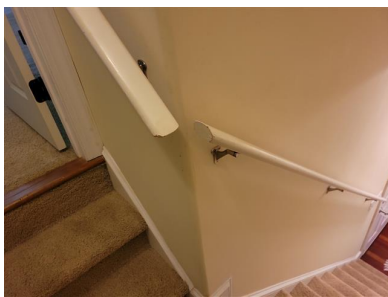
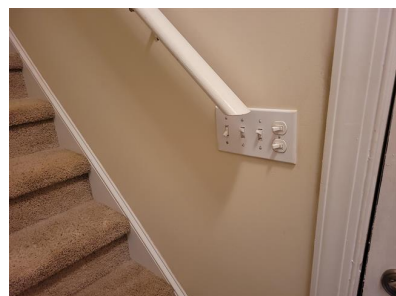
(1) Railing returns where noted to be missing at the handrails at the interior stairs at the time of inspection this should be corrected for safety and to ensure proper installation and to prevent further damage. Consult with a qualified licensed contractor to evaluate the area(s) of concern and make any additional repairs as deemed necessary during their evaluation.

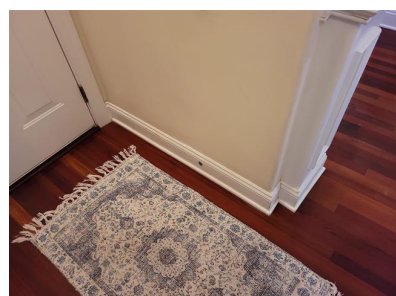
(2) **There are door stops missing/damaged behind doors in areas throughout the home;** replacement needed to prevent possible damage to the walls behind the doors. Consult with a qualified licensed contractor to evaluate the area(s) of concern and make any additional repairs as deemed necessary during their evaluation.

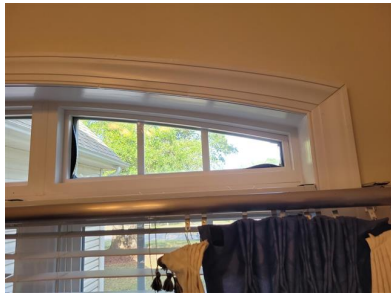
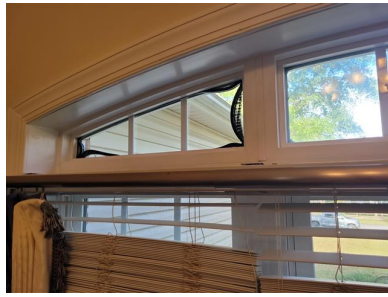
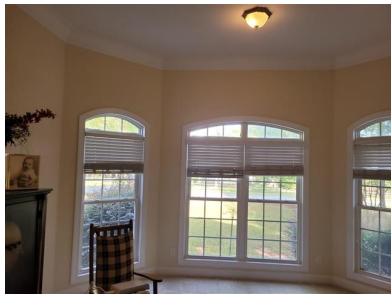
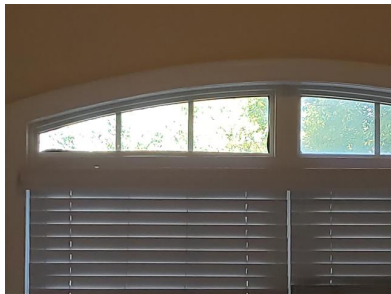
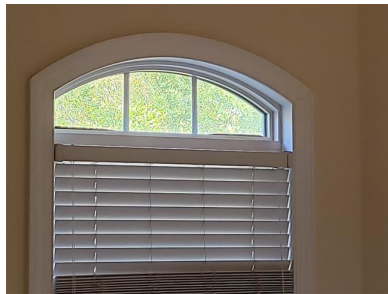
(1) **The inner seal/gasket is bubbling and/or expanding inside the following window(s).** This is an indication that either the seal is broken or going to break in the near future. Consult with a qualified licensed contractor to evaluate the area(s) of concern and make any additional repairs as deemed necessary during their evaluation.

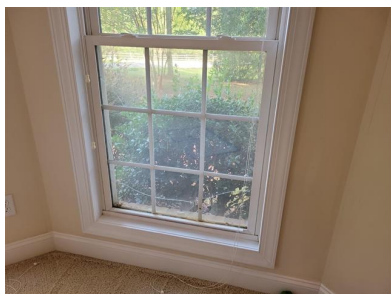
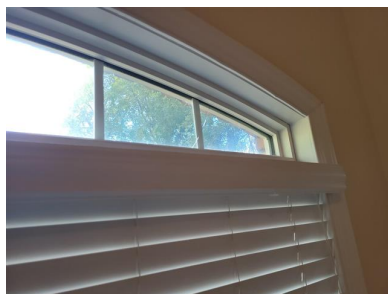
(2) **The window glass was broken and/or cracked at the time of inspection located in the master bedroom.** Proper corrections and/or repairs are needed for safety, prevention of heating and air loss, and/or water penetration. Consult with a qualified licensed contractor to evaluate the area(s) of concern and make any additional repairs as deemed necessary during their evaluation.

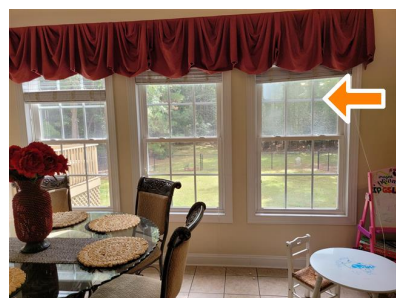
(3) **The following window(s) and/or sashes were found to have a bad or broken thermal seal.** When a bad or broken thermal seal is found, it is possible there may be more that cannot be found at the time of inspection. Because of this it is recommended that all windows be evaluated to prevent heating and air loss. dining room

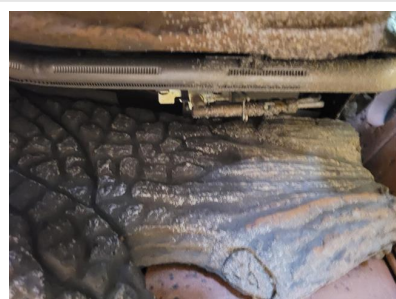
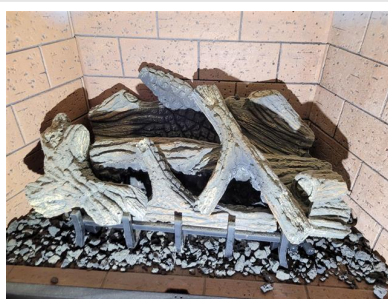
The pilot light was not lit at the time of inspection. Note: Pilot lights must be lit at the time of inspection to ensure safety. When pilots are off and/or the fireplace has not been used for sometime, it may take a long time to light the unit. The units may not light at all due to the lines needing to be bled. Because of the time constraints of a home inspection, pilot lights cannot be lit. Please Note: Unable to determine if the unit functions and/or functions properly at the time of inspection due to the pilot not being lit.

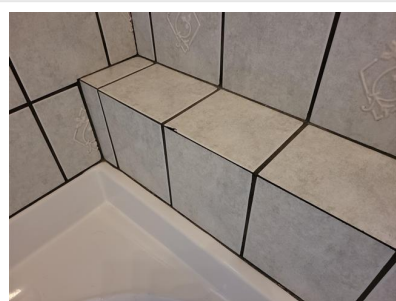
(1) The tile at the bathtub area of the master bathroom was there to be cracked and or damaged at the time of inspection this should be repaired and or replaced to ensure proper installation and to prevent water intrusion and to prevent any further damage Consult with a qualified licensed contractor to evaluate the area(s) of concern and make any additional repairs as deemed necessary during their evaluation.

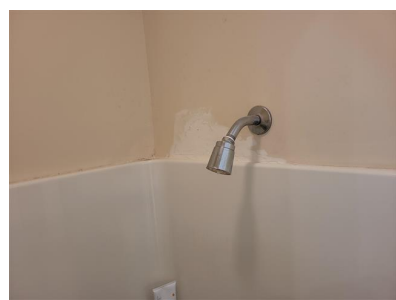
(3) The wall was noted be damaged at the shower area of the master bathroom at the time of inspection this should be repaired and or corrected for Aesthetics and to prevent any further damage Consult with a qualified licensed contractor to evaluate the area(s) of concern and make any additional repairs as deemed necessary during their evaluation.

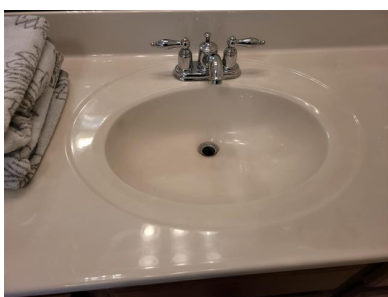
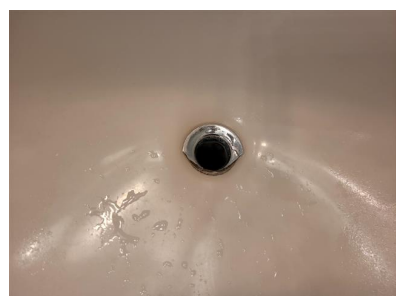
(4) The drain and stopper were noted to be damaged at the vanity in the master bathroom at the time of inspection this should be corrected to ensure proper installation and to prevent water leakage and any further damage. Consult with a qualified licensed contractor to evaluate the area(s) of concern and make any additional repairs as deemed necessary during their evaluation.

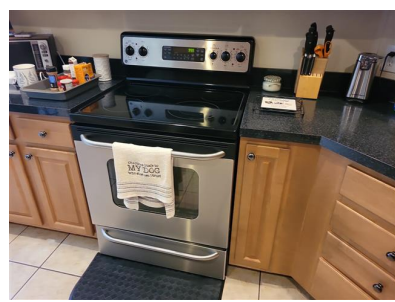
The range lacks an anti-tip device, which is a bracket securing the rear foot of the stove to the wall/floor behind it. This safety feature prevents the stove from tipping forward if a child, who is learning to walk, pulls up on the oven handle. It effectively avoids any risk of hot items spilling from the stove onto the child. Consult with a qualified licensed contractor to evaluate the area(s) of concern and make any additional repairs as deemed necessary during their evaluation.
