INSPECTION REPORT  
3617 Venetian Way  
York SC 29745

INSPECTION DATE  
📅 10/7/2025  
Home Inspection  
Carolina

Complete Home Inspection Report

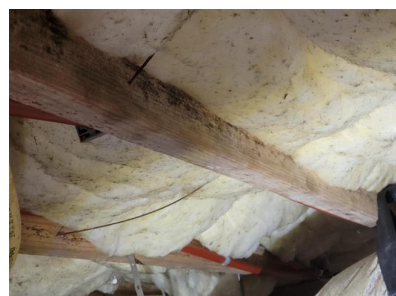
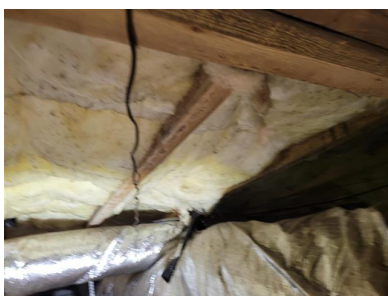
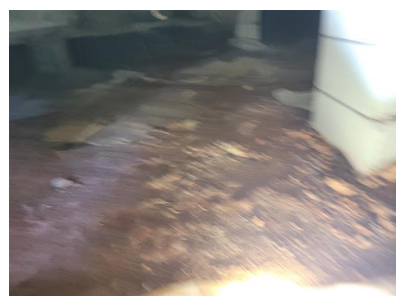
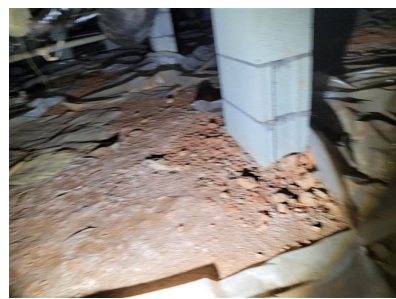
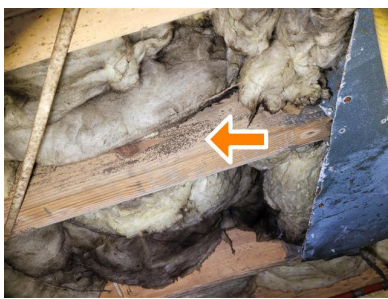
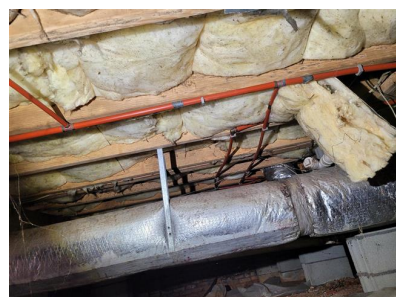
A. Wood rot and or damage was noted in multiple locations in the crawlspace at the time of inspection this should be corrected to prevent any damage hidden and concealed damage may exist The entirety of the crawlspace of this home.

B.Organic and microbial growth was noted on the floor joist, girder, subfloor and sill in multiple locations throughout the crawlspace and the inspection this should be repaired and corrected and THE damage may

**C. Exposed ductwork in unheated space is not insulated where it meets the sub flooring.** The efficiency of the heating and air conditioning systems is greatly reduced due to the heat loss or gain. The metal duct work that is exposed sweats when the cold air and humid air in the crawl space meet. This creates condensation on the subfloor, causing possible wood rot and fungal growth. Staining and fungal growth was noted on the bottom of the subfloor around the ducts where they meet the subfloor throughout the crawl space.

D. Fungal/Organic growth was identified in the crawl space area. Depending on the types mold it may be common to see some types of growth. It is important to address this issue for the health and safety of your home. We recommend having a mold sampling to assess the type of molds and the home's air quality. If you have concerns about the fungus/organic growth found, contact us for testing. Additional services, such as testing for mold, are not included in the standard home inspection. To schedule mold sampling with one of our certified mold specialists, contact us at 704-542-6575 or email us at [info@hicarolina.com](mailto:info@hicarolina.com).

**E. The floor joists were found to have fungus or organic growth along them throughout the crawl space.**

F. There is fungal growth noted along the framing within the crawl space area. The fungal growth was noted to have a root type structure indicating a wood destroying fungus. A wood-destroying fungus can deteriorate the wood causing structural instability. Further evaluation is needed to determine if the structural components of the framing have been compromised as there may be hidden and of concealed damage that was otherwise unseen at the time of the inspection. Please note the integrity of the structure may change as the environment changes within the crawl space area do to corrections with high moisture levels.

**G. There is not a vapor barrier installed in the crawl space exposing the soil within and throughout the crawl space.** Exposed soils in a crawlspace should be covered with a retardant material to prevent moisture or standing water from possibly causing deterioration to the wood framing above. A vapor barrier is recommended to reduce or keep moisture levels down within the crawl space area.

Due to the following (but not limited to), a licensed general contractor should be consulted to further evaluate entire framing, girders, and band sills and determine the full extent of the damage and/or if additional repairs are required or deemed necessary, as there may be additional defects that were concealed and/or otherwise unseen at the time of the original inspection.

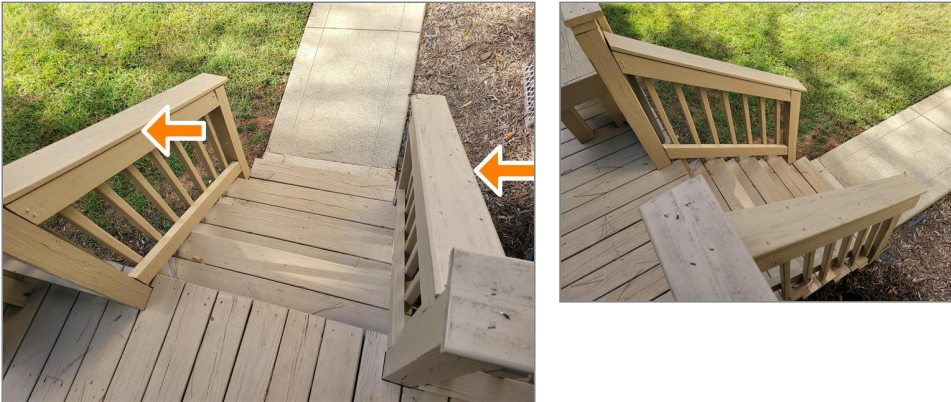
(1) The handrails at the steps of the rear porch were noted to be too wide at the time of inspection this should be repaired and or corrected for safety and to prevent any further damage. Consult with a qualified licensed contractor to evaluate the area(s) of concern and make any additional repairs as deemed necessary during their evaluation.

1. (1) The handrails at the steps of the rear porch were noted to be too wide at the time of inspection this should be repaired and or corrected for safety and to prevent any further damage. Consult with a qualified licensed contractor to evaluate the area(s) of concern and make any additional repairs as deemed necessary during their evaluation.

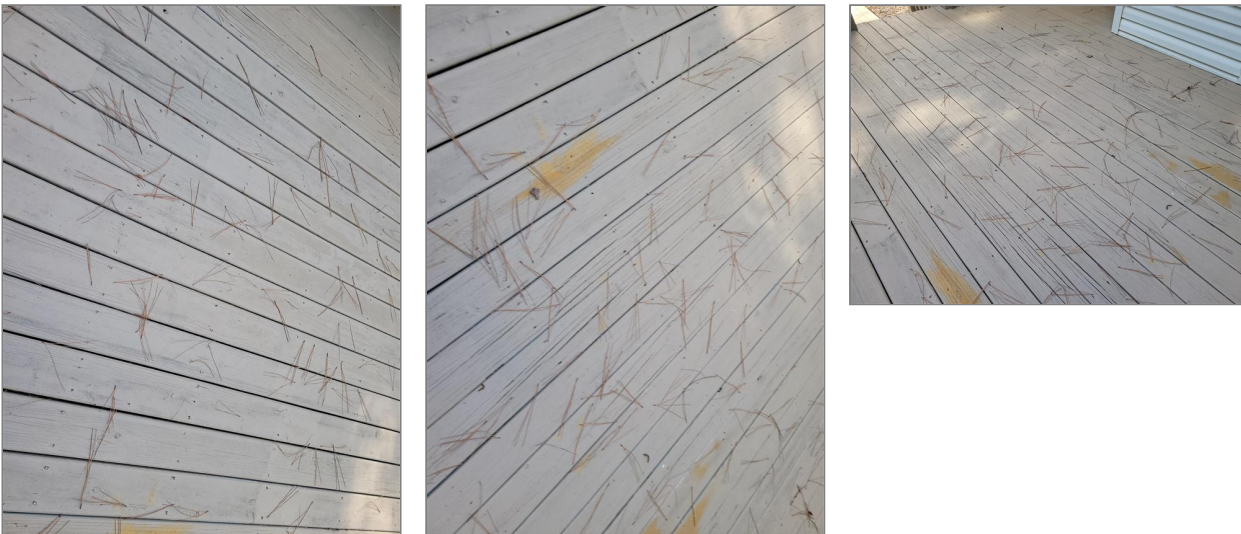
(2) The deck boards at the rear porch where noted to be fastened with nails at the time of inspection this should be corrected for safety and to ensure proper installation and to prevent any further damage. Consult with a qualified licensed contractor to evaluate the area(s) of concern and make any additional repairs as deemed necessary during their evaluation.

2. (2) The deck boards at the rear porch were noted to be fastened with nails at the time of inspection this should be corrected for safety and to ensure proper installation and to prevent any further damage. Consult with a qualified licensed contractor to evaluate the area(s) of concern and make any additional repairs as deemed necessary during their evaluation.

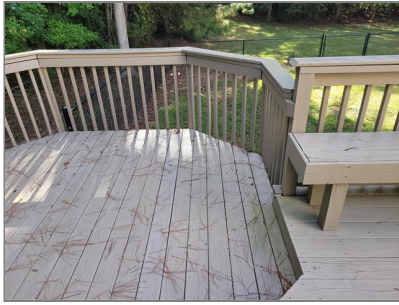
3. (3) **The railings were noted to be depending on the spindles as no posts were found or noted to be installed.** Post are needed at the base of the stairs/steps and approximately every six feet on center to properly support and secure the railing around the decking and stairs. Consult with a qualified licensed contractor to evaluate the area(s) of concern and make any additional repairs as deemed necessary during their evaluation.

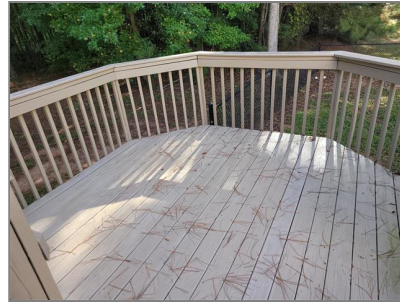
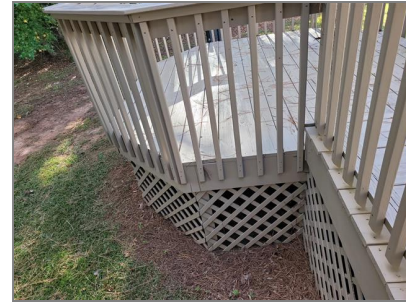
(3) **The railings were noted to be depending on the spindles as no posts were found or noted to be installed.** Post are needed at the base of the stairs/steps and approximately every six feet on center to properly support and secure the railing around the decking and stairs. Consult with a qualified licensed contractor to evaluate the area(s) of concern and make any additional repairs as deemed necessary during their evaluation.

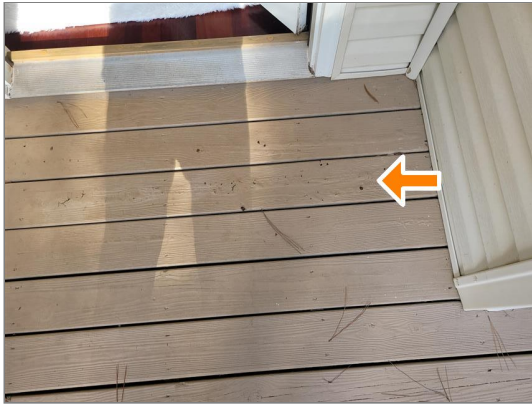
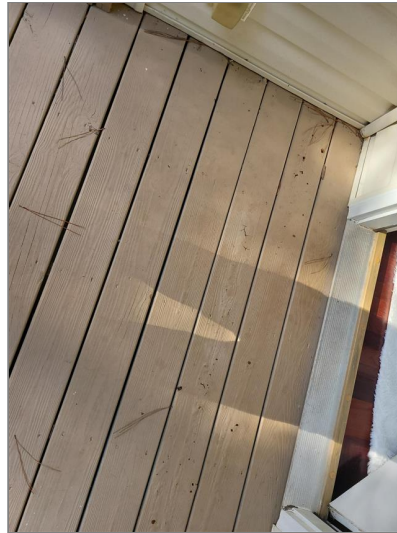
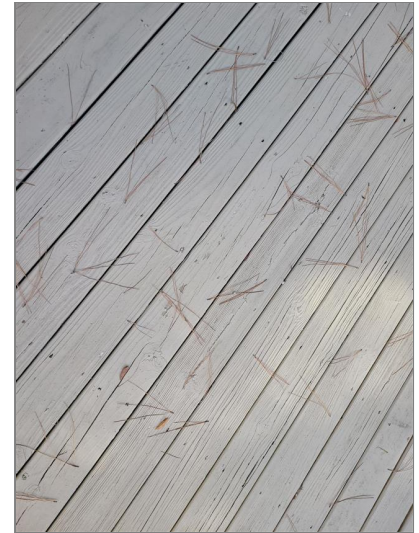
(4) Wood rot and or damage was noted to the deck boards at the rear porch at the time of inspection this should be corrected to prevent any further damage. Consult with a qualified licensed contractor to evaluate the area(s) of concern and make any additional repairs as deemed necessary during their evaluation.

4. (4) Wood rot and or damage was noted to the deck boards at the rear porch at the time of inspection this should be corrected to prevent any further damage. Consult with a qualified licensed contractor to evaluate the area(s) of concern and make any additional repairs as deemed necessary during their evaluation.

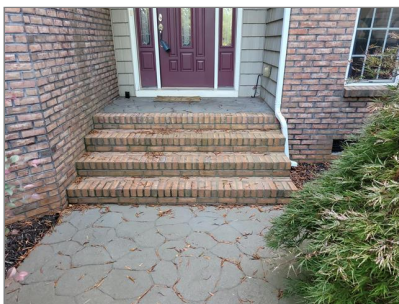
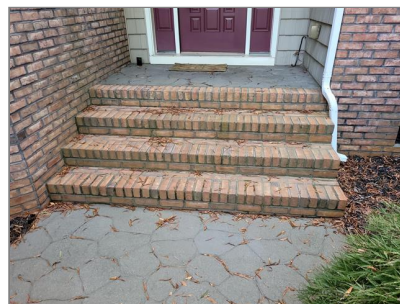
5. (5) **The stairs at front porch were found to be above 30", typically consisting of 3 or more steps.** Stairs, patios, and decks above 30" require a handrail to be installed to ensure safety. Consult with a qualified licensed contractor to evaluate the area(s) of concern and make any additional repairs as deemed necessary during their evaluation.

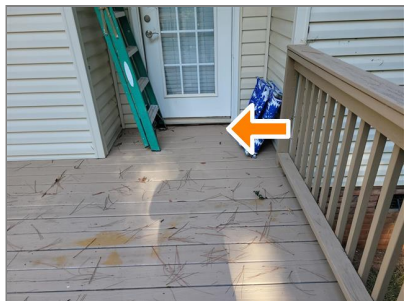
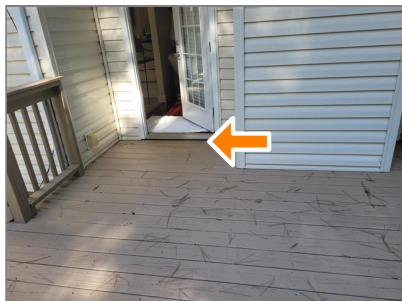
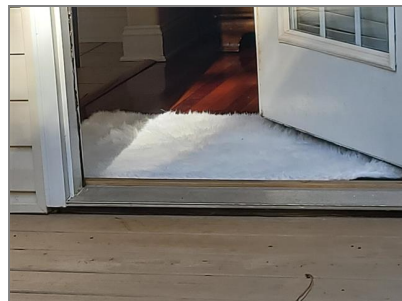
6. (1) Trim was noted to be missing and or not installed correctly under the threshold of both rear doors at the time of inspection this should be repaired and or corrected to ensure proper installation and to prevent water intrusion and to prevent any further damage hidden and will concealed damage may exist. Consult with a qualified licensed contractor to evaluate the area(s) of concern and make any additional repairs as deemed necessary during their evaluation.

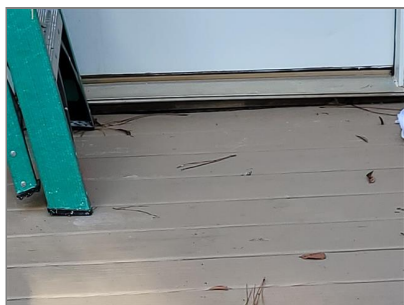
(1) Trim was noted to be missing and or not installed correctly under the threshold of both rear doors at the time of inspection this should be repaired and or corrected to ensure proper installation and to prevent water intrusion and to prevent any further damage hidden and will concealed damage may exist. Consult with a qualified licensed contractor to evaluate the area(s) of concern and make any additional repairs as deemed necessary during their evaluation.

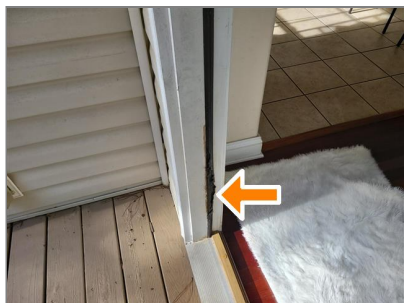
(2) The weather strip at the rear door Was noted to be torn and or damaged at the time of inspection this should be repaired and or replaced to ensure proper function and to prevent any further damage. Consult with a qualified licensed contractor to evaluate the area(s) of concern and make any additional repairs as deemed necessary during their evaluation.

7. (2) The weather strip at the rear door Was noted to be torn and or damaged at the time of inspection this should be repaired and or replaced to ensure proper function and to prevent any further damage. Consult with a qualified licensed contractor to evaluate the area(s) of concern and make any additional repairs as deemed necessary during their evaluation.

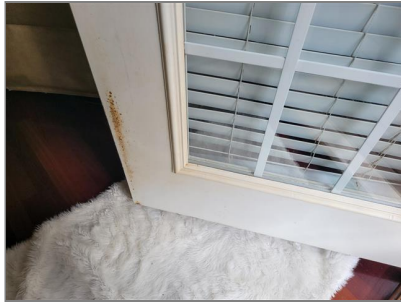
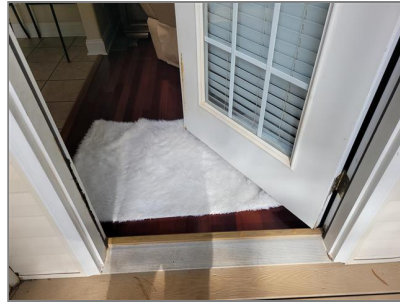
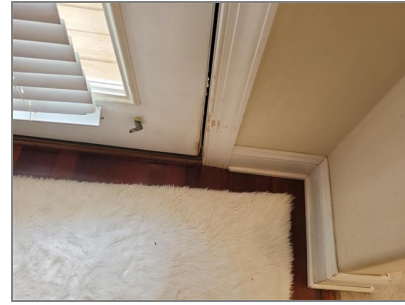
(3) Rust and or damage was noted to the rear door door trim and or threshold at the time of inspection this should be repaired and or corrected to ensure proper installation and function and to prevent any further damage. Consult with a qualified licensed contractor to evaluate the area(s) of concern and make any additional repairs as deemed necessary during their evaluation.

8. (3) Rust and or damage was noted to the rear door door trim and or threshold at the time of inspection this should be repaired and or corrected to ensure proper installation and function and to prevent any further damage. Consult with a qualified licensed contractor to evaluate the area(s) of concern and make any additional repairs as deemed necessary during their evaluation.

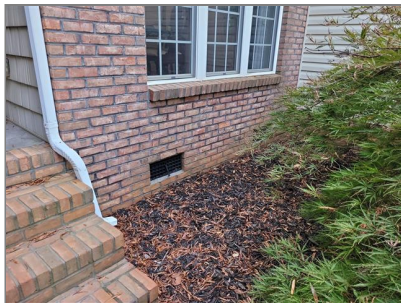
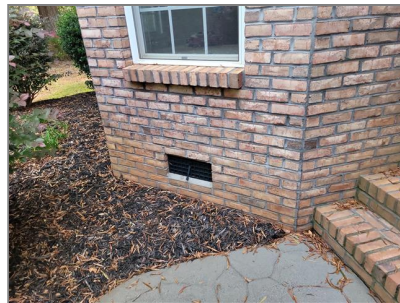
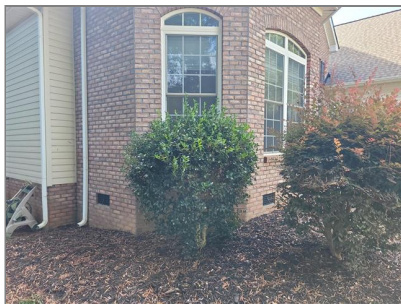
9. (4) No weep holes were detected in the brick siding surrounding the house. Weep holes, which are drilled openings or slots, are typically situated around the foundation and positioned above or below windows in brick veneer structures. These openings serve the purpose of facilitating the drainage of accumulated moisture within or behind building elements, as well as providing an outlet for water that could potentially gather in window sills and veneers. Consult with a qualified licensed contractor to evaluate the area(s) of concern and make any additional repairs as deemed necessary during their evaluation.

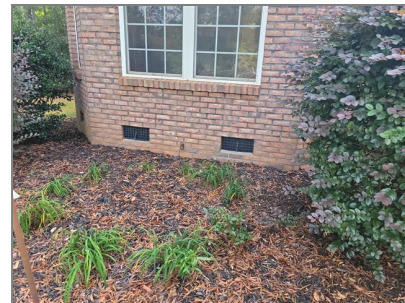
(4) No weep holes were detected in the brick siding surrounding the house. Weep holes, which are drilled openings or slots, are typically situated around the foundation and positioned above or below windows in brick veneer structures. These openings serve the purpose of facilitating the drainage of accumulated moisture within or behind building elements, as well as providing an outlet for water that could potentially gather in window sills and veneers. Consult with a qualified licensed contractor to evaluate the area(s) of concern and make any additional repairs as deemed necessary during their evaluation.

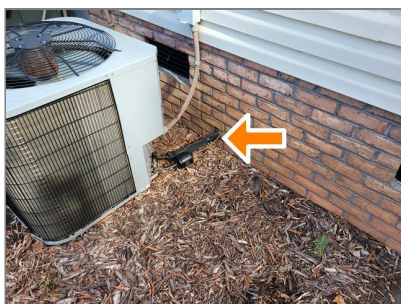
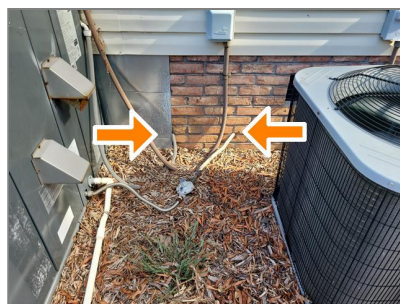
10. (5) Sealant is important for safeguarding against water damage and potential rodent intrusion at entry points where phone, cable, or electrical lines enter the home. This protective measure helps maintain the integrity of the home's infrastructure and prevents costly repairs in the long run. Consult with a qualified licensed contractor to evaluate the area(s) of concern and make any additional repairs as deemed necessary during their evaluation.

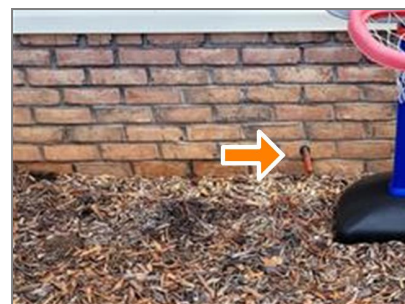
(5) Sealant is important for safeguarding against water damage and potential rodent intrusion at entry points where phone, cable, or electrical lines enter the home. This protective measure helps maintain the integrity of the home's infrastructure and prevents costly repairs in the long run. Consult with a qualified licensed contractor to evaluate the area(s) of concern and make any additional repairs as deemed necessary during their evaluation.

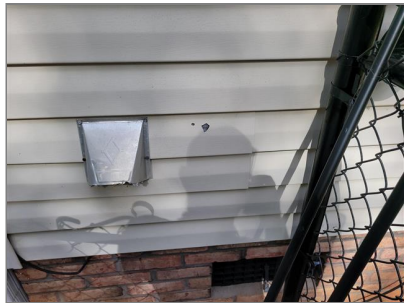
11. (6) Holes were noted to the siding at the rear right corner of the home at the time of inspection this should be repaired and or corrected to prevent water and or pest intrusion and to prevent any further damage. Consult with a qualified licensed contractor to evaluate the area(s) of concern and make any additional repairs as deemed necessary during their evaluation.

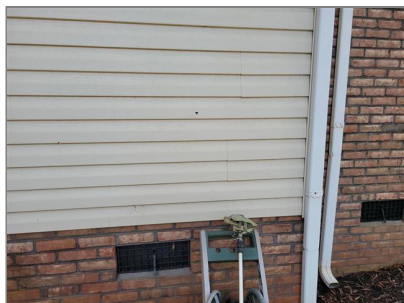
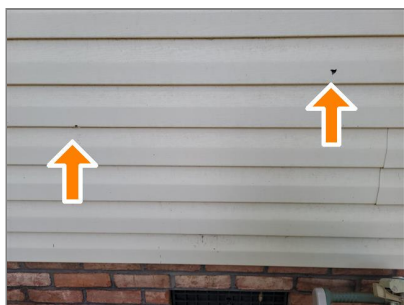
12. (7) Holes were noted to the siding at the left side of the home at the time of inspection this should be repaired and or corrected to prevent moisture and or pest intrusion and to prevent any further damage. Consult with a qualified licensed contractor to evaluate the area(s) of concern and make any additional repairs as deemed necessary during their evaluation.

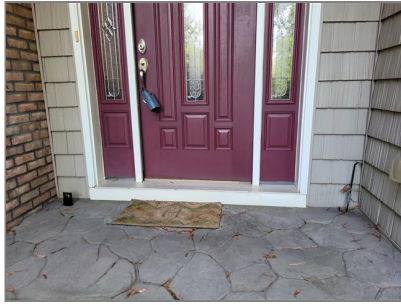
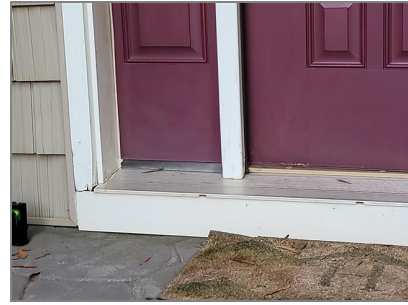
Wood rot and or damage was noted to the trim at the front door area of the home at the time of inspection this should be repaired and or corrected to ensure proper installation and to prevent any further damage. Hidden and or concealed damage may exist. Consult with a qualified licensed contractor to evaluate the area(s) of concern and make any additional repairs as deemed necessary during their evaluation.

13. Wood rot and or damage was noted to the trim at the front door area of the home at the time of inspection this should be repaired and or corrected to ensure proper installation and to prevent any further damage. Hidden and or concealed damage may exist. Consult with a qualified licensed contractor to evaluate the area(s) of concern and make any additional repairs as deemed necessary during their evaluation.

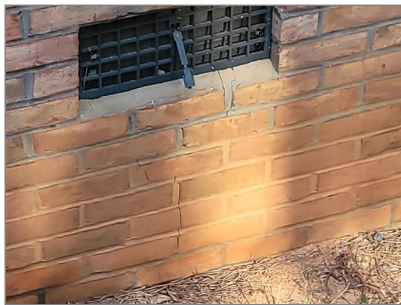
(1) A crack was noted to the brick foundation at the back left portion of the home at the time of inspection this should be repaired and or corrected to prevent any further damage hidden and concealed damage may exist. Consult with a qualified licensed contractor to evaluate the area(s) of concern and make any additional repairs as deemed necessary during their evaluation.

14. (1) A crack was noted to the brick foundation at the back left portion of the home at the time of inspection this should be repaired and or corrected to prevent any further damage hidden Edward concealed damage may exist. Consult with a qualified licensed contractor to evaluate the area(s) of concern and make any additional repairs as deemed necessary during their evaluation.

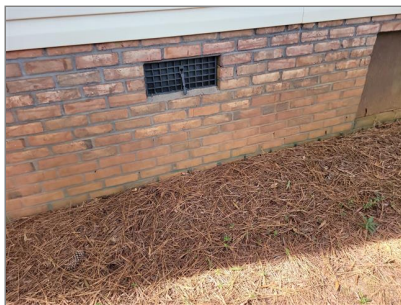
(2) A crack was noted to the brick Foundation at the left side of the home at the time of inspection this should be repaired and or corrected to prevent any further damage hidden and will concealed damage may exist. Consult with a qualified licensed contractor to evaluate the area(s) of concern and make any additional repairs as deemed necessary during their evaluation.

15. (2) A crack was noted to the brick Foundation at the left side of the home at the time of inspection this should be repaired and or corrected to prevent any further damage hidden and will concealed damage may exist. Consult with a qualified licensed contractor to evaluate the area(s) of concern and make any additional repairs as deemed necessary during their evaluation.

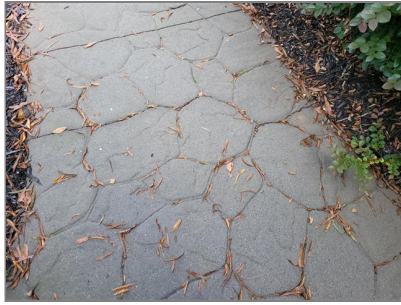
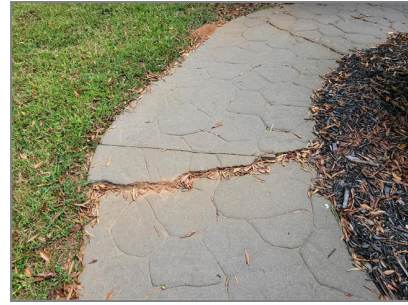
**There are cracks noted at the sidewalk that need to be sealed and/or repaired properly to prevent water penetration and/or continual cracking.** Consult with a qualified licensed contractor to evaluate the area(s) of concern and make any additional repairs as deemed necessary during their evaluation.

16. **There are cracks noted at the sidewalk that need to be sealed and/or repaired properly to prevent water penetration and/or continual cracking.** Consult with a qualified licensed contractor to evaluate the area(s) of concern and make any additional repairs as deemed necessary during their evaluation.

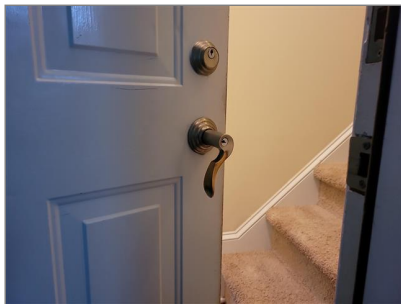
17. (1) The door knob at the garage entry door with nutted to be damaged at the time of inspection this should be repaired and or replaced for safety and to ensure proper installation and function and to prevent any further damage Consult with a qualified licensed contractor to evaluate the area(s) of concern and make any additional repairs as deemed necessary during their evaluation.

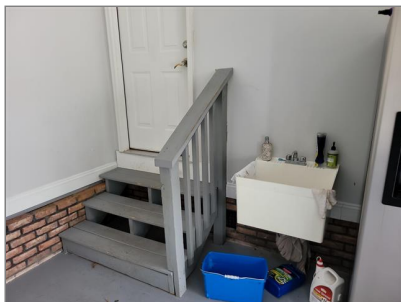
18. (2) The handrail was noted to be too wide at the railing at the steps in the garage at the time of inspection this should be repaired and or corrected for safety to prevent any further damage. Consult with a qualified licensed contractor to evaluate the area(s) of concern and make any additional repairs as deemed necessary during their evaluation.

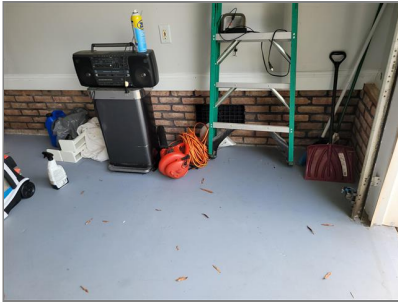
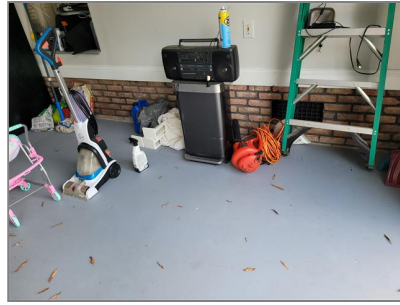
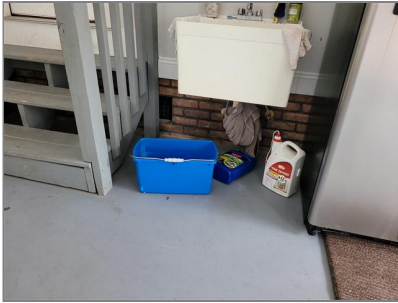
19. (3) Multiple crawl space vents were noted in the garage at the time of inspection this should be sealed and or corrected to prevent carbon monoxide exchange and to ensure proper construction and to prevent any further damage. Consult with a qualified licensed contractor to evaluate the area(s) of concern and make any additional repairs as deemed necessary during their evaluation.

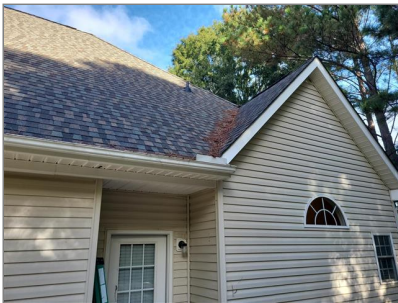
20. (1) **The debris on the roof needs to be corrected to prevent the collection of debris, weathering, or damage at the rear of the home.** Corrections are needed to prolong life or the roof shingle and/or prevent leaks. Consult with a qualified licensed contractor to evaluate the area(s) of concern and make any additional repairs as deemed necessary during their evaluation.

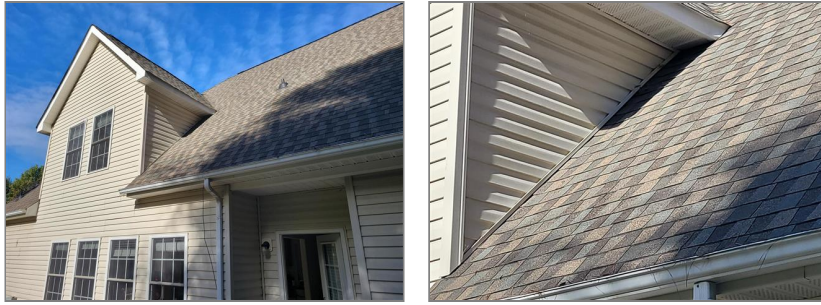
21. (2) **The siding is touching the roof shingles along the roof line where the siding and roof meet.** The siding needs to be trimmed back properly to prevent water damage to the siding and/or water from penetrating into the home. Consult with a qualified licensed contractor to evaluate the area(s) of concern and make any additional repairs as deemed necessary during their evaluation.

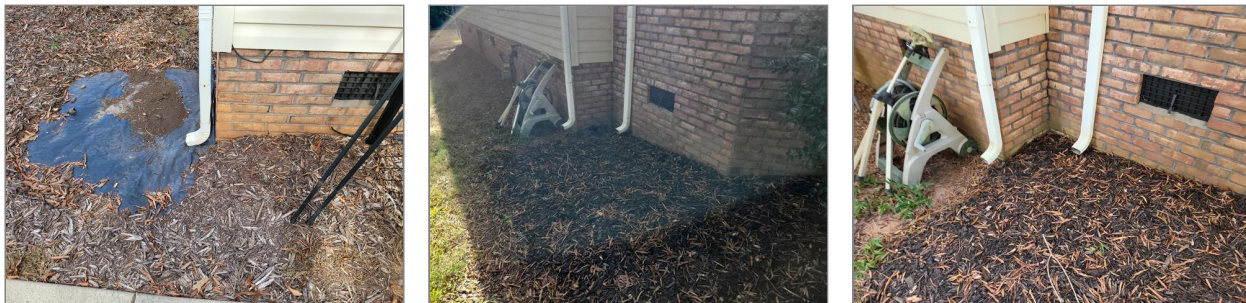
22. (1) **A splash block is needed to properly direct water away from the foundation of the home at the front and rear corner of the home.** Consult with a qualified licensed contractor to evaluate the area(s) of concern and make any additional repairs as deemed necessary during their evaluation.

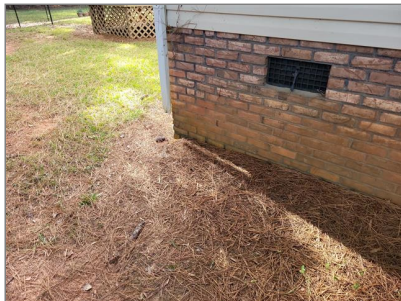
23. (2) The downspout was noted to be missing at the rear left corner of the home at the time of inspection this it could be corrected to ensure proper installation and to ensure proper water disbursements and to prevent any further damage Consult with a qualified licensed contractor to evaluate the area(s) of concern and make any additional repairs as deemed necessary during their evaluation.

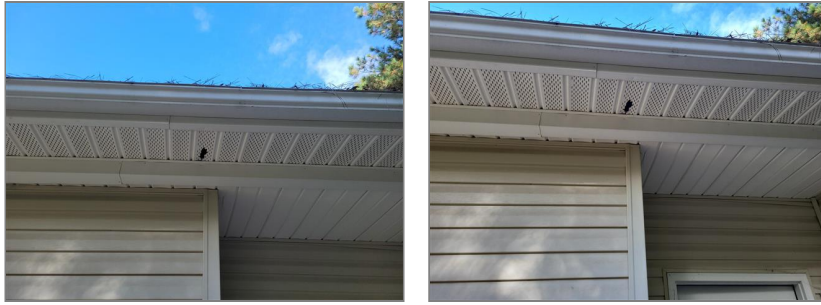
24. (1) **A hole was noted in the soffit at the back of the house at the time of inspection this should be corrected to prevent any further damage.** Consult with a qualified licensed contractor to evaluate the area(s) of concern and make any additional repairs as deemed necessary during their evaluation.

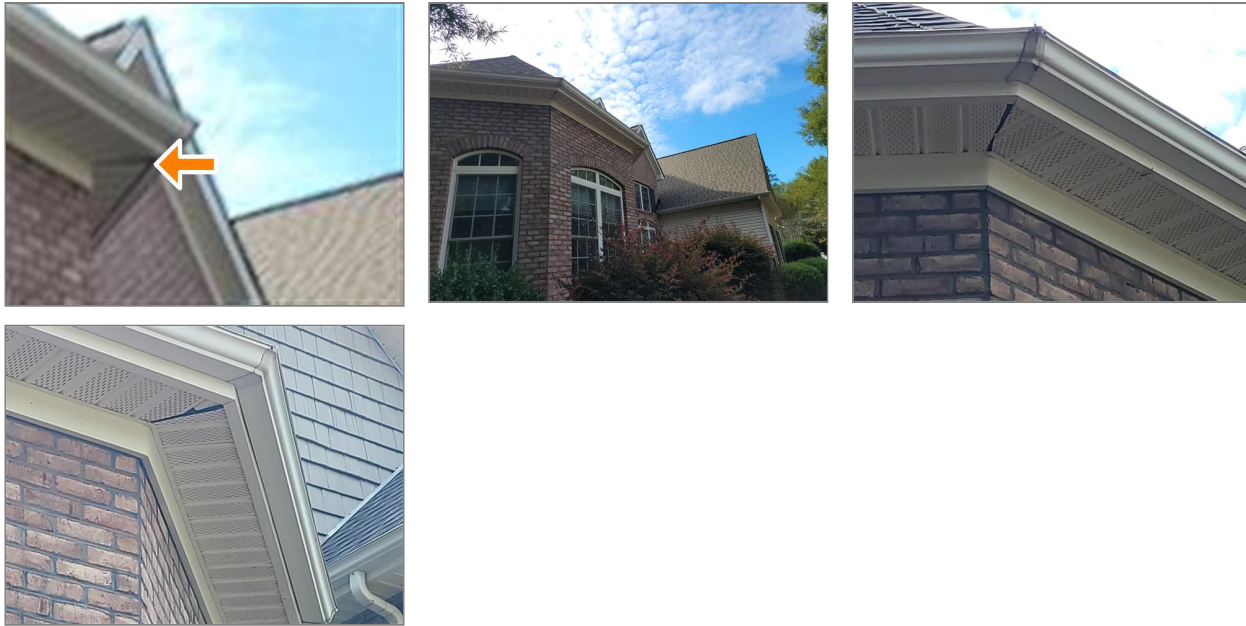
25. (2) A gap was noted in the soffit at the front of the home in multiple locations at the time of inspection this should be corrected to ensure proper installation and to prevent water and or pest intrusion and to prevent any further damage. Consult with a qualified licensed contractor to evaluate the area(s) of concern and make any additional repairs as deemed necessary during their evaluation.

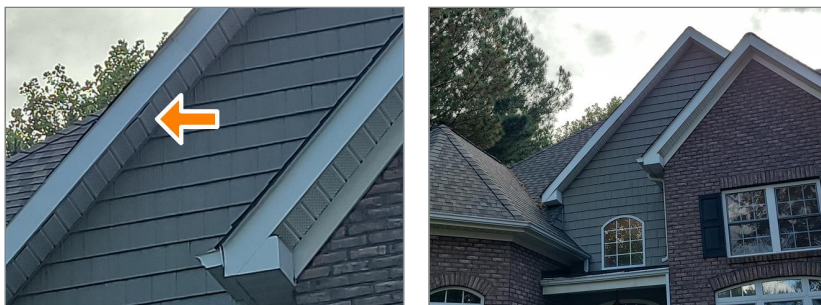
26. (3) The soffit was noted to be loose and or damaged at the front of the home at the time of inspection this should be corrected to ensure proper installation and to prevent water intrusion and to prevent any further damage. Consult with a qualified licensed contractor to evaluate the area(s) of concern and make any additional repairs as deemed necessary during their evaluation.

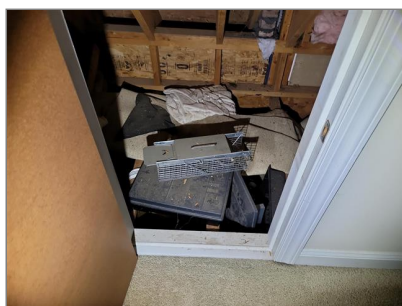
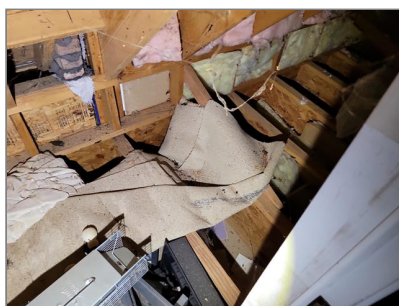
27. Walk boards were noted to be missing at the attic access in the upstairs portion of the home at the time of inspection this should be corrected for safety and to prevent further damage Consult with a qualified licensed contractor to evaluate the area(s) of concern and make any additional repairs as deemed necessary during their evaluation.

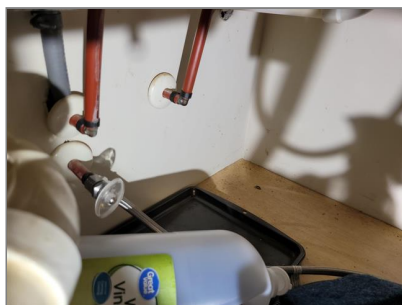
28. (1) The visible plumbing lines in this home are plastic PEX with brass metal fittings. **Evidence of fitting deterioration was noted during the inspection in a few/several locations.** The deterioration could be the result of a known problem referred to as "dezincification". Dezincification occurs when brass fittings that are considered a high-zinc copper alloy are exposed to water and the zinc is leached from the fitting or component leaving the fitting in a weakened state. This process also leads to a buildup inside the fitting, restricting water flow and ultimately leaving the plumbing system prone to breakage and leaking. Consult with a qualified licensed contractor to evaluate the area(s) of concern and make any additional repairs as deemed necessary during their evaluation.

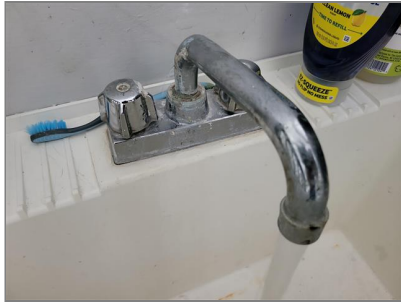
29. (2) A leak was noted at least faucet at the sink in the garage at the time of inspection, This should be repaired and or replaced to prevent any further damage. Consult with a qualified licensed contractor to evaluate the area(s) of concern and make any additional repairs as deemed necessary during their evaluation.

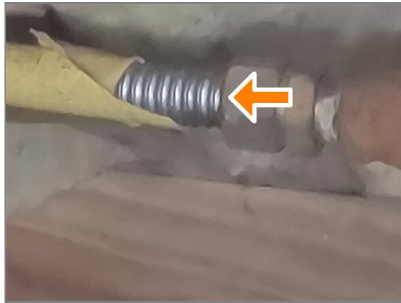
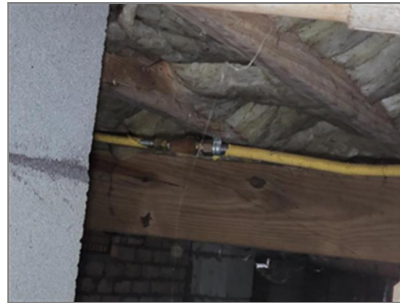
30. (3) There is CSST (corrugated stainless steel tubing) noted within the crawl space that was found to have the stainless steel areas exposed near the fittings. The exposed stainless steel needs to be sealed or covered with the proper and/or approved tape to prevent corrosion and/or rusting. Consult with a qualified licensed contractor to evaluate the area(s) of concern and make any additional repairs as deemed necessary during their evaluation.

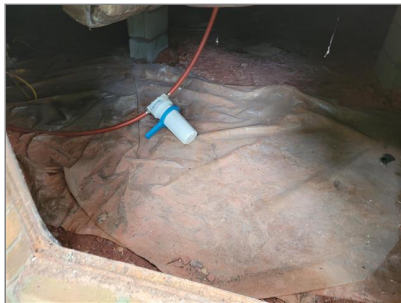
31. (4) The filter was noted to be unsupported and laying on the ground in the crawlspace at the time of inspection should be corrected to ensure proper installation and function and damage. Consult with a qualified licensed contractor to evaluate the area(s) of concern and make any additional repairs as deemed necessary during their evaluation.

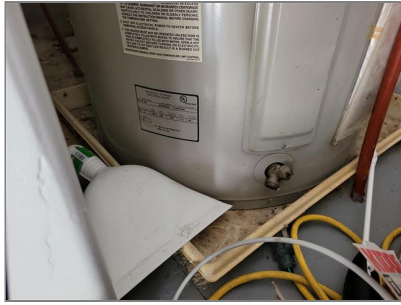
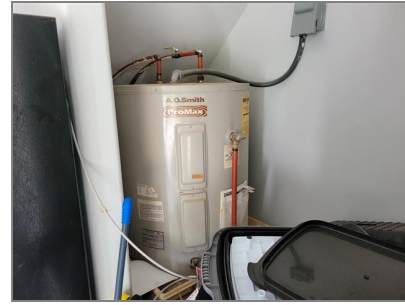
32. **The water heater appears to be above ten years of age. The lifespan of a typical water heater is noted to be 10-15 years for an electric water heater and 15-18 years for a gas water heater.** The lifespan can depend on several things: the condition of the water; if the water heater is maintained properly; the location of the water heater (crawl space, interior closet, garage, etc.); and several other factors. Due to additional factors, it is impossible to determine the lifespan of the water heater(s) currently installed and/or the additional years left for the water heater. Consult with a qualified licensed contractor to evaluate the area(s) of concern and make any additional repairs as deemed necessary during their evaluation.

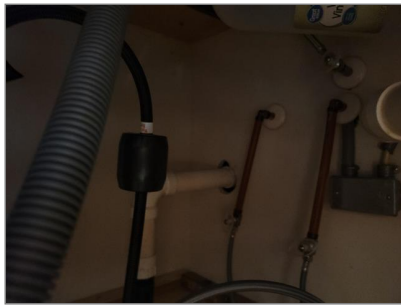
33. (1) Dura-Pex/NIBCO PEX tubing is prone to oxidization, which is when oxygen negatively affects the quality of a material, like metal or plastic. This can happen if the material isn't treated properly or has a flawed design. Oxidization of PEX tubing can lead to the development of cracks and ruptures, resulting in water leaks. These leaks can also cause damage to NIBCO's fittings and clamps. No leaks were observed during the inspection. It is advisable to continue monitoring for leaks. If leaks were found, consult with a licensed plumbing contractor to thoroughly evaluate and repair any issues that may arise.

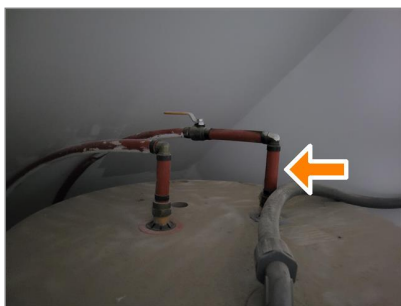
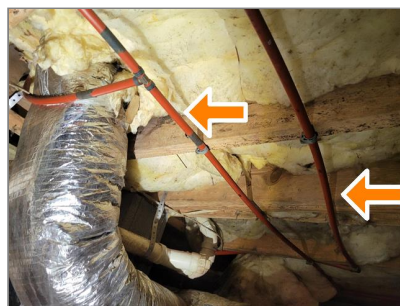
34. (2) Dura-Pex/NIBCO PEX tubing is prone to oxidization, which is when oxygen negatively affects the quality of a material, like metal or plastic. This can happen if the material isn't treated properly or has a flawed design. Oxidization of PEX tubing can lead to the development of cracks and ruptures, resulting in water leaks. These leaks can also cause damage to NIBCO's fittings and clamps. No leaks were observed during the inspection. It is advisable to continue monitoring for leaks. If leaks were found, consult with a licensed plumbing contractor to thoroughly evaluate and repair any issues that may arise.

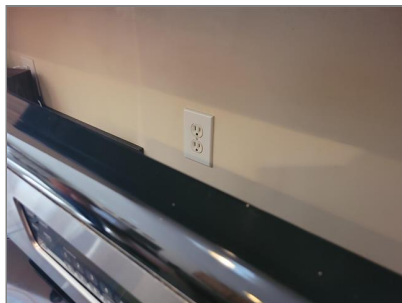
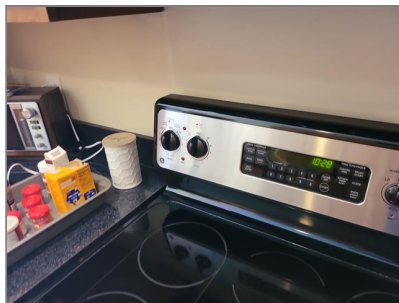
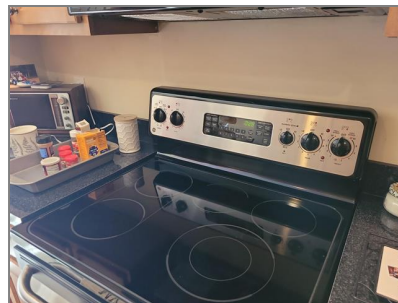
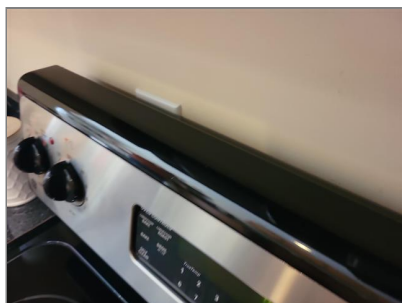
35. (1) A electrical outlet was noted to be installed behind the stove in the kitchen at the time of inspection this should be corrected for safety and to ensure proper installation and to prevent any further damage. Consult with a qualified licensed contractor to evaluate the area(s) of concern and make any additional repairs as deemed necessary during their evaluation.

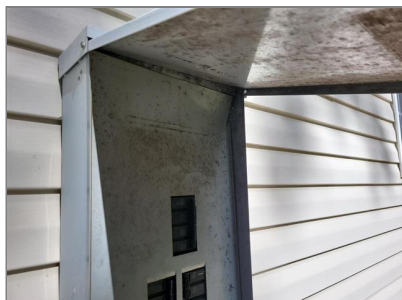
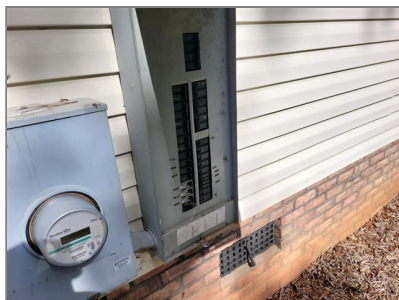
36. (2) The inside breaker cover was noted to be damaged at the Exterior electric panel at the time of inspection this should be corrected for safety and to prevent any further damage. Consult with a qualified licensed contractor to evaluate the area(s) of concern and make any additional repairs as deemed necessary during their evaluation.

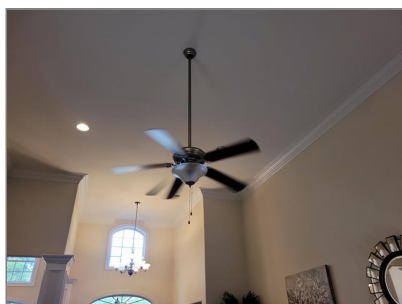
37. (3) The ceiling fan in the living room was there to be noisy at the time of inspection this should be repaired and or corrected to prevent any further damage. Consult with a qualified licensed contractor to evaluate the area(s) of concern and make any additional repairs as deemed necessary during their evaluation.

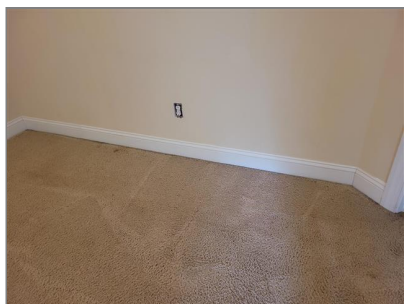
38. (4) **Missing or damaged cover plates noted within the home.** Repair and/or replace as needed. Consult with a qualified licensed contractor to evaluate the area(s) of concern and make any additional repairs as deemed necessary during their evaluation.

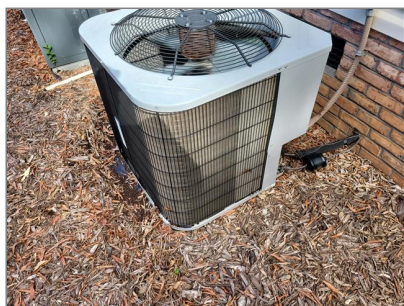
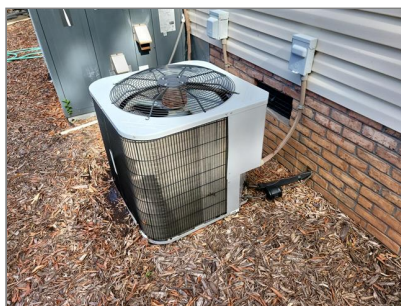
39. (1) The air conditioner at the right side of the home was noted to be sitting directly on the ground at the time of inspection this should be corrected to ensure proper installation and to prevent any further damage. Consult a qualified licensed contractor to assess the areas of concern and perform any additional repairs deemed necessary during their evaluation.

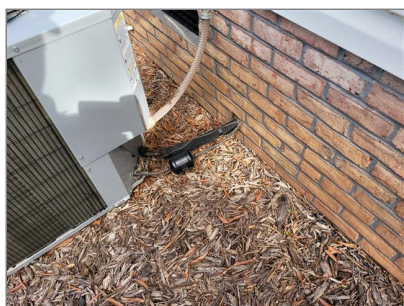
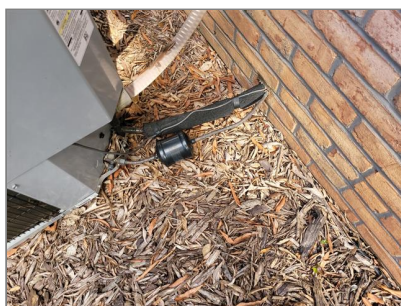
40. (2) The insulation is damaged, deteriorated, or torn and must be replaced at the Freon line to prevent potential harm or damage at the second floor unit. Insulation helps maintain the coolant's temperature, preventing it from heating up due to external conditions, which could lead to it converting to liquid and potentially damaging the unit. Consult a qualified licensed contractor to assess the areas of concern and perform any additional repairs deemed necessary during their evaluation.

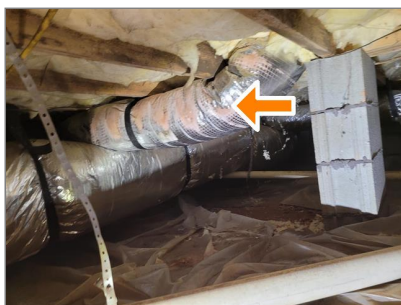
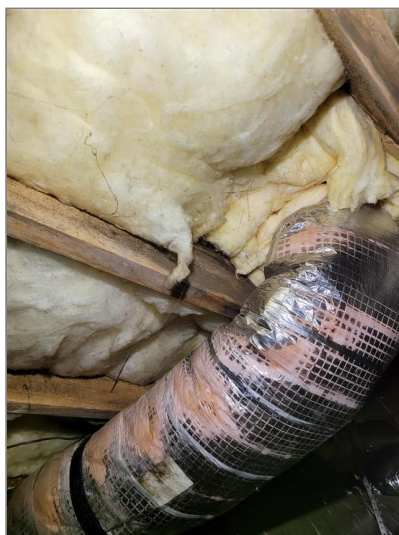
42. Water damage was noted to the ducts in the crawlspace in multiple locations at the time of inspection this should be repaired or corrected to ensure proper function and to prevent the damage. Consult with a qualified licensed contractor to evaluate the area(s) of concern and make any additional repairs as deemed necessary during their evaluation.

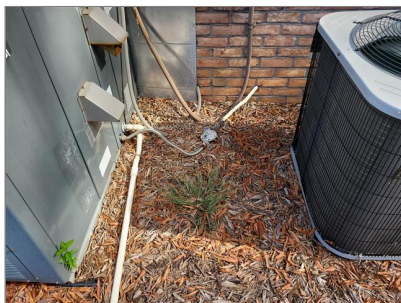
43. (1) The **drip leg was missing** and is needed at the gas line where it enters the heating unit. This is needed to create a collection point for moisture and foreign particles (i.e copper sulfide) that may be in the gas line **at the primary unit**. Consult with a qualified licensed contractor to evaluate the area(s) of concern and make any additional repairs as deemed necessary during their evaluation.

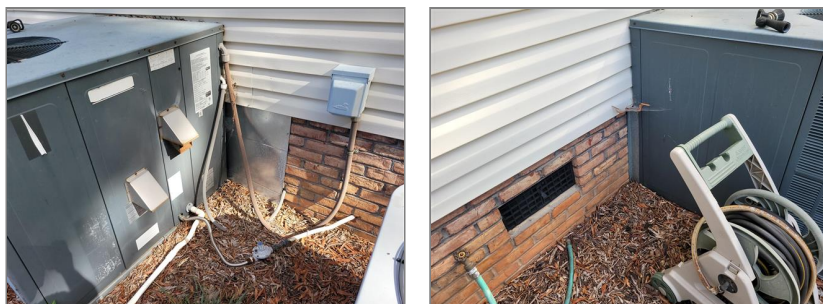
damage. Consult with a qualified licensed contractor to evaluate the area(s) of concern and make any additional repairs as deemed necessary during their evaluation.

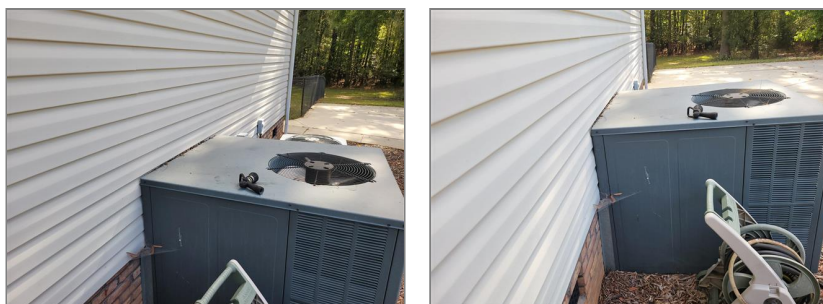
45. (3) The gas line was noted to be laying on the ground at the package unit at the time of inspection this is an improper installation and Corrections should be made to ensure proper installation and to prevent further damage. Consult with a qualified licensed contractor to evaluate the area(s) of concern and make any additional repairs as deemed necessary during their evaluation.
46. (4) A shroud was noted to be missing where the package unit fastens to the home at the right side of the house at the time of inspection this should be corrected to ensure proper installation and to prevent water and or pest intrusion and to prevent any further damage. Consult with a qualified licensed contractor to evaluate the area(s) of concern and make any additional repairs as deemed necessary during their evaluation.

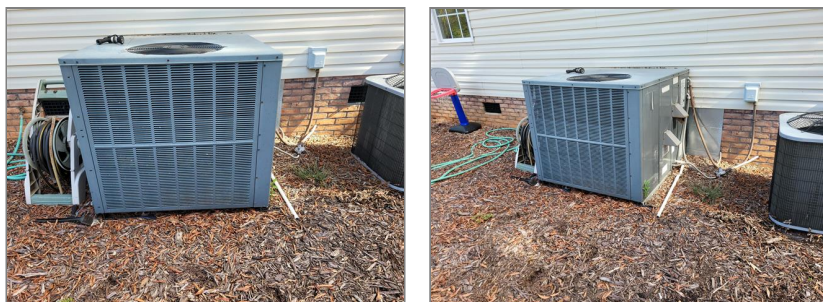
47. (5) The package unit was noted To be sitting directly on the ground at the right side of the home at the time of inspection this should be repaired and or corrected to ensure proper installation and to prevent any further damage. Consult with a qualified licensed contractor to evaluate the area(s) of concern and make any additional repairs as deemed necessary during their evaluation.

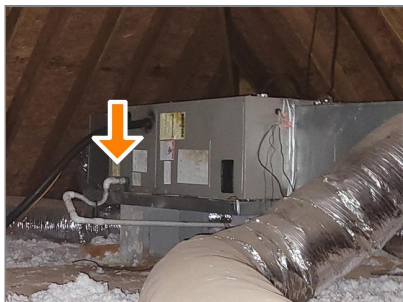
48. (6) The **secondary or emergency condensate line is capped** and needs correction in the event that the main drain line were to become clogged. The secondary line is designed to allow water to drain down into the overflow pan below turning off the unit or draining the water from the pan to the exterior of the home notifying the homeowner that a problem exists. Without a secondary line installed and/or being blocked from allowing the water to drain into the pan, the water that is trapped in the evaporator coil would eventually leak into the burner chamber

potentially creating additional problems **at the second floor unit**. Consult with a qualified licensed contractor to evaluate the area(s) of concern and make any additional repairs as deemed necessary during their evaluation.

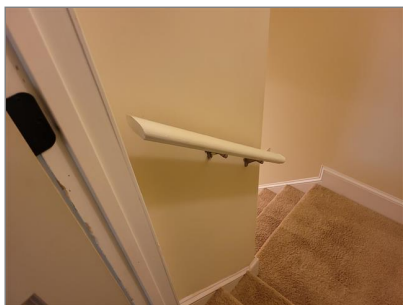
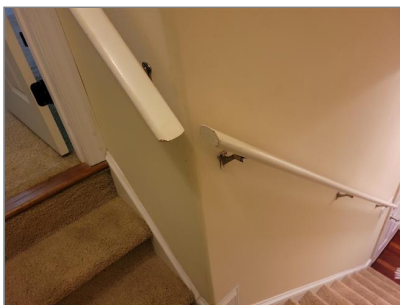
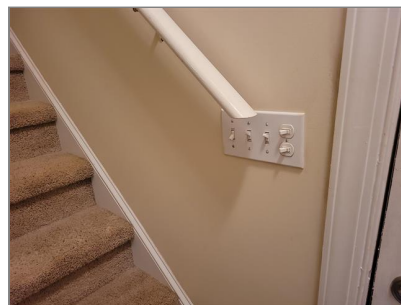
49. (1) Railing returns where noted to be missing at the handrails at the interior stairs at the time of inspection this should be corrected for safety and to ensure proper installation and to prevent further damage. Consult with a qualified licensed contractor to evaluate the area(s) of concern and make any additional repairs as deemed necessary during their evaluation.

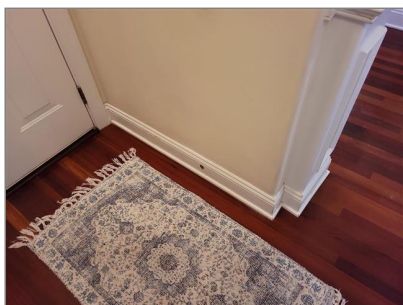
50. (2) **There are door stops missing/damaged behind doors in areas throughout the home**; replacement needed to prevent possible damage to the walls behind the doors. Consult with a qualified licensed contractor to evaluate the area(s) of concern and make any additional repairs as deemed necessary during their evaluation.

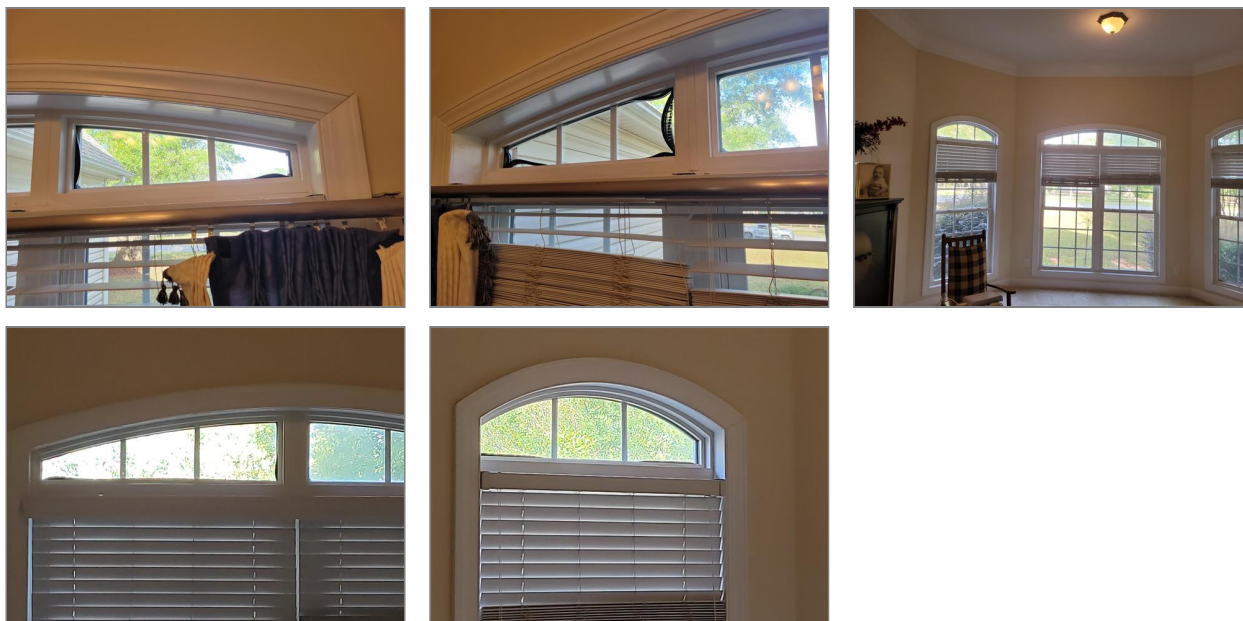
51. (1) **The inner seal/gasket is bubbling and/or expanding inside the following window(s).** This is an indication that either the seal is broken or going to break in the near future. Consult with a qualified licensed contractor to evaluate the area(s) of concern and make any additional repairs as deemed necessary during their evaluation.
