INSPECTION REPORT  
3617 Venetian Way  
York SC 29745

INSPECTION DATE  
📅 10/7/2025  
Home Inspection  
Carolina

Complete Home Inspection Report

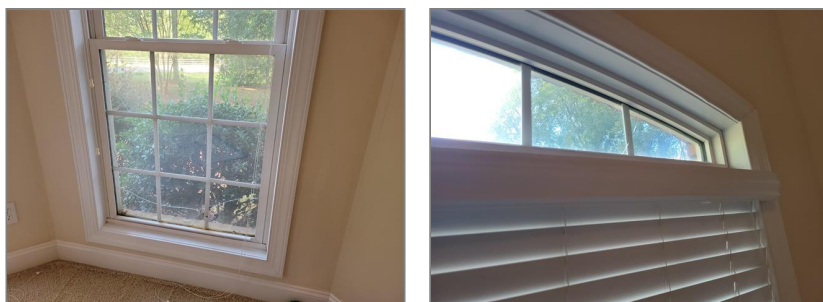
52. (2) **The window glass was broken and/or cracked at the time of inspection located in the master bedroom.** Proper corrections and/or repairs are needed for safety, prevention of heating and air loss, and/or water penetration. Consult with a qualified licensed contractor to evaluate the area(s) of concern and make any additional repairs as deemed necessary during their evaluation.

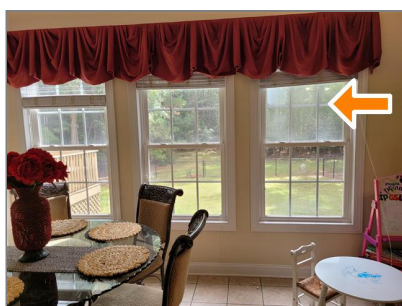
53. (3) **The following window(s) and/or sashes were found to have a bad or broken thermal seal.** When a bad or broken thermal seal is found, it is possible there may be more that cannot be found at the time of inspection. Because of this it is recommended that all windows be evaluated to prevent heating and air loss. dining room

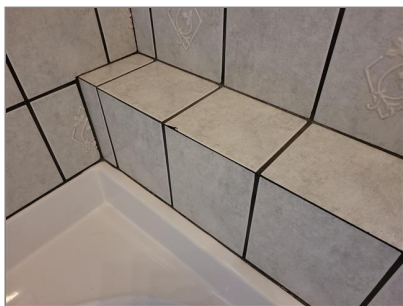
54. (1) The tile at the bathtub area of the master bathroom was there to be cracked and or damaged at the time of inspection this should be repaired and or replaced to ensure proper installation and to prevent water intrusion and to prevent any further damage Consult with a qualified licensed contractor to evaluate the area(s) of concern and make any additional repairs as deemed necessary during their evaluation.

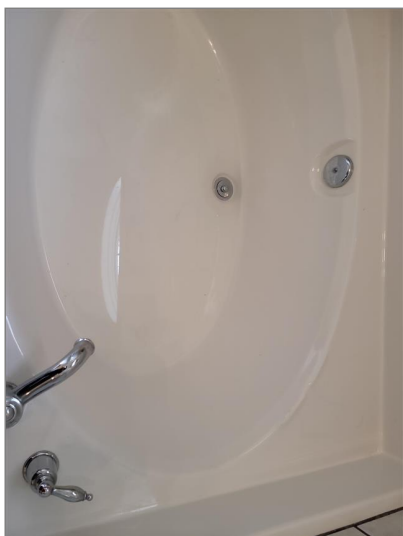
55. (2) A chip and or damage was noted at the bottom of the bathtub in the master bathroom at the time of inspection this should be sealed and or corrected to prevent water leakage and or any further damage. Consult with a qualified licensed contractor to evaluate the area(s) of concern and make any additional repairs as deemed necessary during their evaluation.

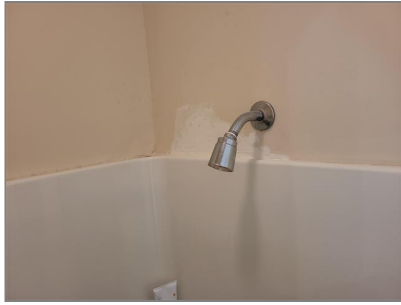
56. (3) The wall was noted be damaged at the shower area of the master bathroom at the time of inspection this should be repaired and or corrected for Aesthetics and to prevent any further damage Consult with a qualified licensed contractor to evaluate the area(s) of concern and make any additional repairs as deemed necessary during their evaluation.

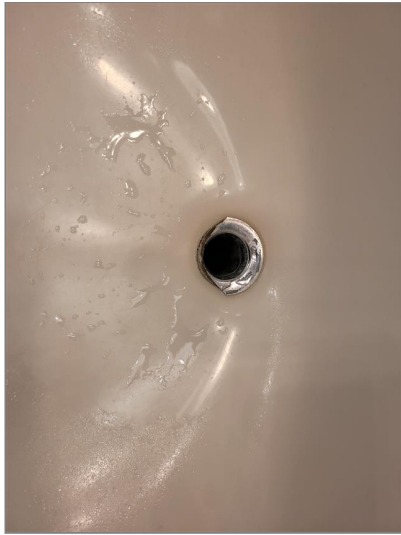
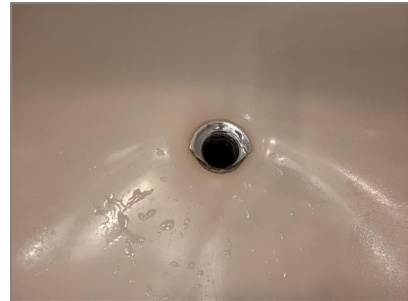
57. (4) The drain and stopper were noted to be damaged at the vanity in the master bathroom at the time of inspection this should be corrected to ensure proper installation and to prevent water leakage and any further damage. Consult with a qualified licensed contractor to evaluate the area(s) of concern and make any additional repairs as deemed necessary during their evaluation.

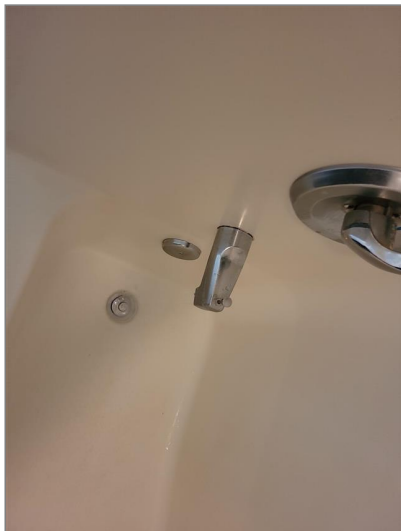
58. **Caulk is needed around the tub faucet** where it meets the shower wall to prevent water penetration. Consult with a qualified licensed contractor to evaluate the area(s) of concern and make any additional repairs as deemed necessary during their evaluation.

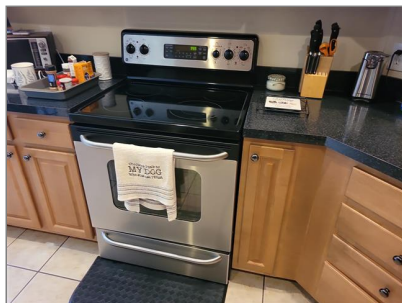
59. The range lacks an anti-tip device, which is a bracket securing the rear foot of the stove to the wall/floor behind it. This safety feature prevents the stove from tipping forward if a child, who is learning to walk, pulls up on the oven handle. It effectively avoids any risk of hot items spilling from the stove onto the child. Consult with a qualified licensed contractor to evaluate the area(s) of concern and make any additional repairs as deemed necessary during their evaluation.

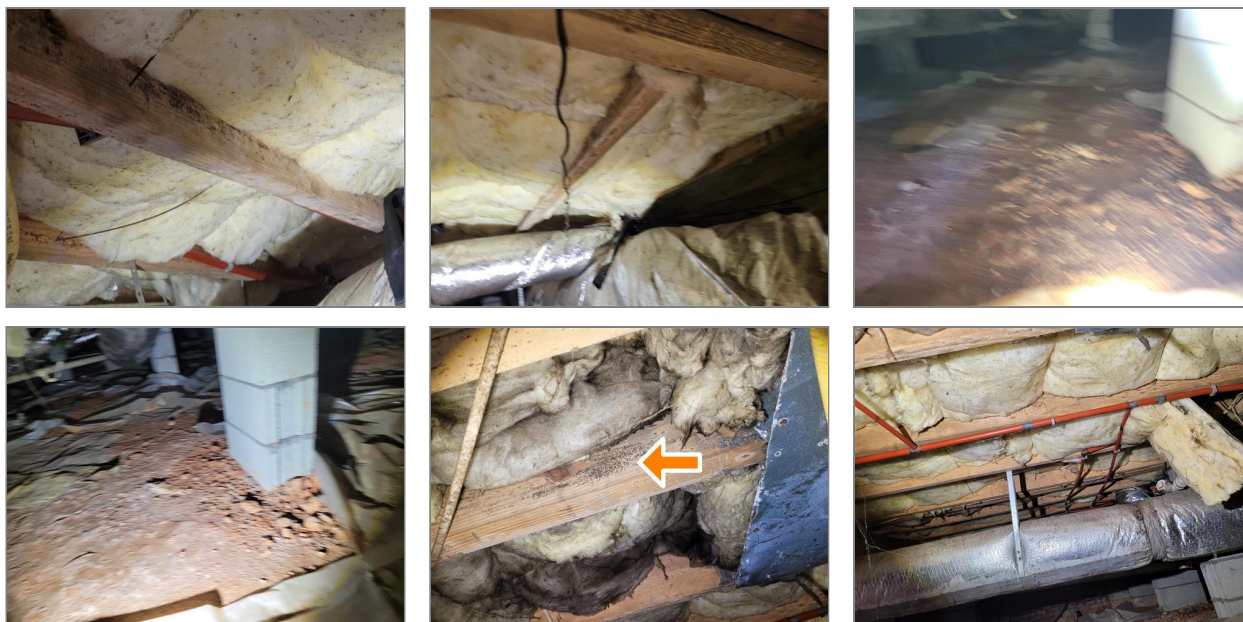
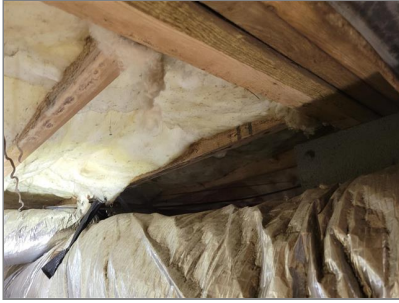
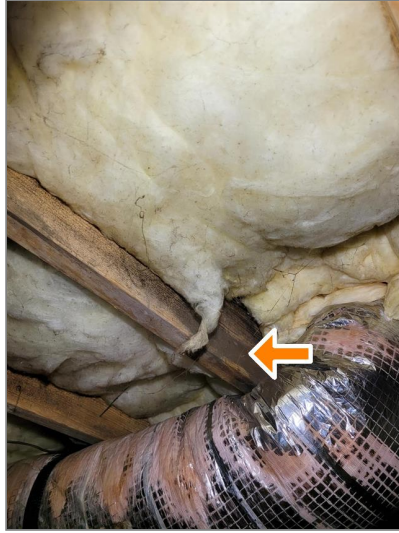
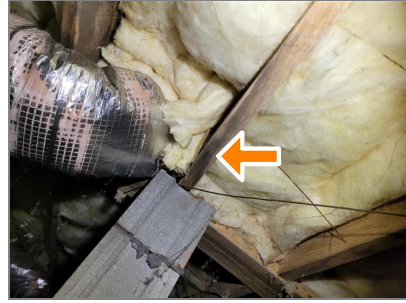
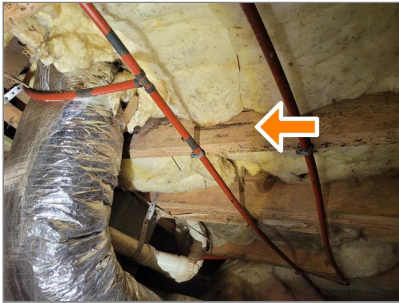
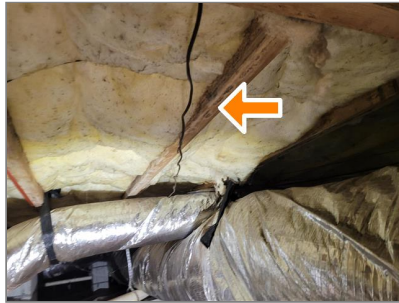
A. Wood rot and or damage was noted in multiple locations in the crawlspace at the time of inspection this should be corrected to prevent any damage hidden and concealed damage may exist The entirety of the crawlspace of this home.

B. Organic and microbial growth was noted on the floor joist, girder, subfloor and sill in multiple locations throughout the crawlspace and the inspection this should be repaired and corrected and THE damage may exist throughout the entirety of the crawlspace in this home

**C. Exposed ductwork in unheated space is not insulated where it meets the sub flooring.** The efficiency of the heating and air conditioning systems is greatly reduced due to the heat loss or gain. The metal duct work that is exposed sweats when the cold air and humid air in the crawl space meet. This creates condensation on the subfloor, causing possible wood rot and fungal growth. Staining and fungal growth was noted on the bottom of the subfloor around the ducts where they meet the subfloor throughout the crawl space.

**E. The floor joists were found to have fungus or organic growth along them throughout the crawl space.**

F. There is fungal growth noted along the framing within the crawl space area. The fungal growth was noted to have a root type structure indicating a wood destroying fungus. A wood-destroying fungus can deteriorate the wood causing structural instability. Further evaluation is needed to determine if the structural components of the framing have been compromised as there may be hidden and of concealed damage that was otherwise unseen at the time of the inspection. Please note the integrity of the structure may change as the environment changes within the crawl space area do to corrections with high moisture levels.

**G. There is not a vapor barrier installed in the crawl space exposing the soil within and throughout the crawl space.** Exposed soils in a crawlspace should be covered with a retardant material to prevent moisture or standing water from possibly causing deterioration to the wood framing above. A vapor barrier is recommended to reduce or keep moisture levels down within the crawl space area.

60. Due to the following (but not limited to), a licensed general contractor should be consulted to further evaluate entire framing, girders, and band sills and determine the full extent of the damage and/or if additional repairs are required or deemed necessary, as there may be additional defects that were concealed and/or otherwise unseen at the time of the original inspection.
