INSPECTION REPORT  
4030 Stadler Dr NE  
Conover NC 28613

INSPECTED BY  
Alex Parr 3692  
Above Parr Home  
Inspections

INSPECTION DATE  
📅 9/12/2023  
🕒 02:00:00 PM

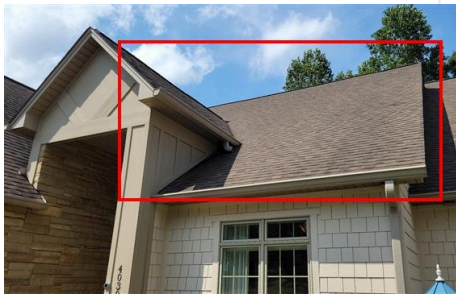
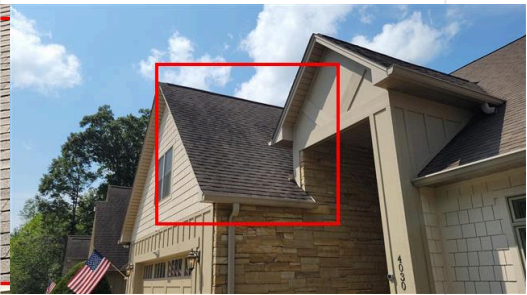
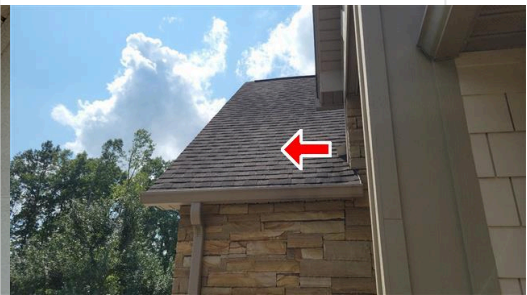
wear typical for their age consisting of heavy loss of moderate to heavy wear long edges of tabs. The shingles are brittle, which is a sign of aging. Cracking, splitting and or missing shingles were observed in some areas. No signs of leaks were observed at the time of inspection. Further investigation and repairs are needed.

A qualified contractor should inspect and repair as needed.

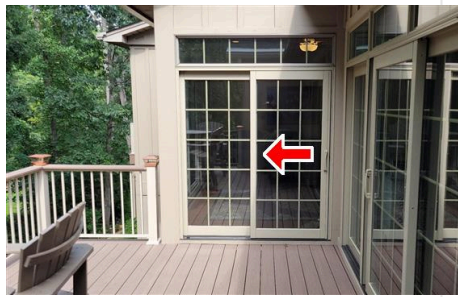
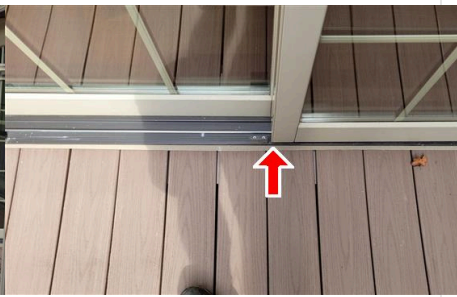
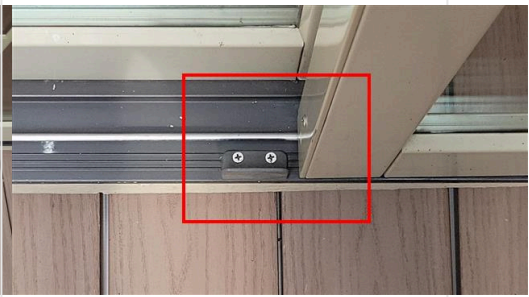
1. The sliding glass door at the rear of the home did not function properly. As a result the door will not close properly. Repairs are needed.

A qualified person should repair or replace as needed.

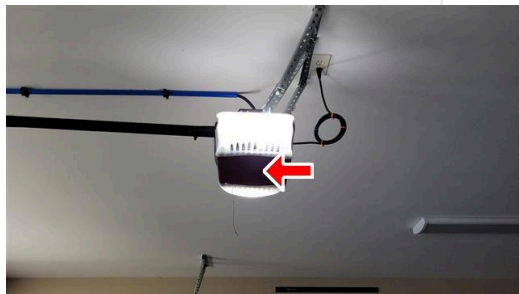
3.7 Item 1 (Picture)

1. The garage door operator safety reverse will not reverse properly when met with resistance. This is a safety issue. Further investigation and repairs are needed.

A qualified person should repair or replace as needed.

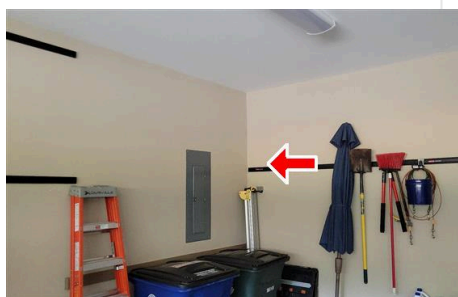
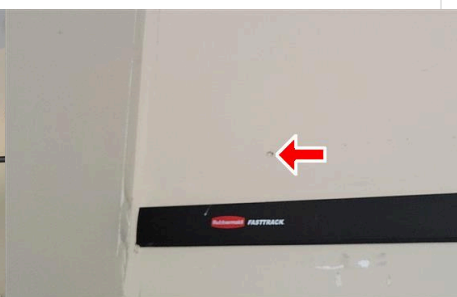
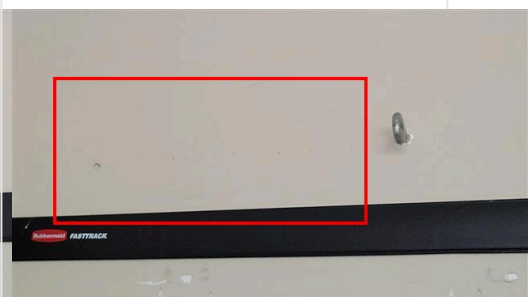
1. The fire resistance sheathing that separates garage from heated space is compromised. This is considered unsafe until corrected. Repairs are needed.

A qualified person should correct for safety.

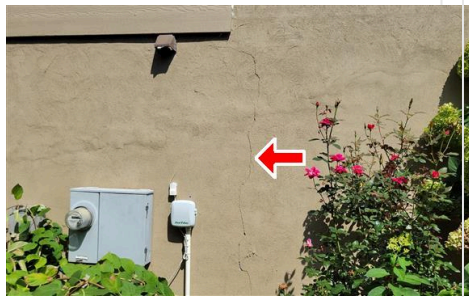
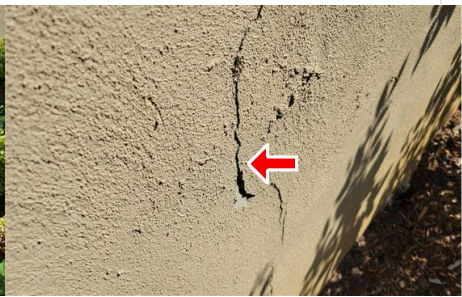
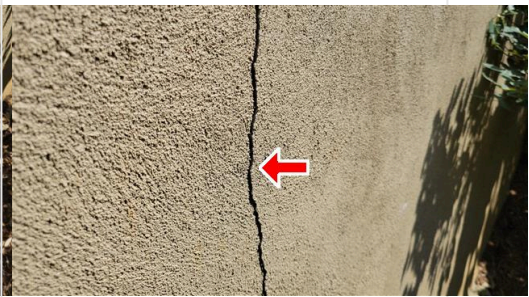
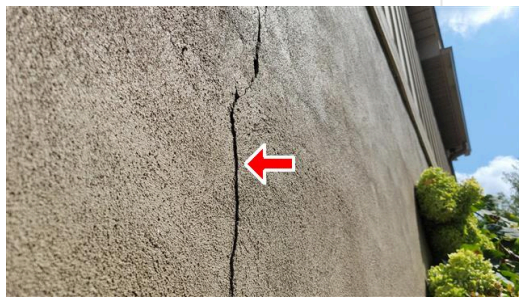
1. The foundation wall at the left side (facing front) has cracks present with outward displacement/movement present. The wall(s) may need reinforcement. Further investigation and repairs are needed.

A qualified licensed general contractor should inspect further and repair as needed.

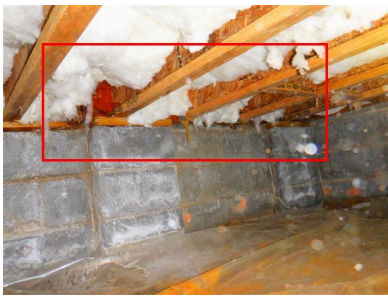
4.2 Item 1 (Picture)

1. The floor system is deteriorated from moisture absorption or water intrusion in the crawl space at the front of the home. Water intrusion if not corrected can lead to other problems including mold and cause excessive moisture to floor system that can lead to deterioration and increased repair cost. Further investigation and repairs are needed.

I recommend further investigation or correction by a qualified licensed contractor or water infiltration specialist.

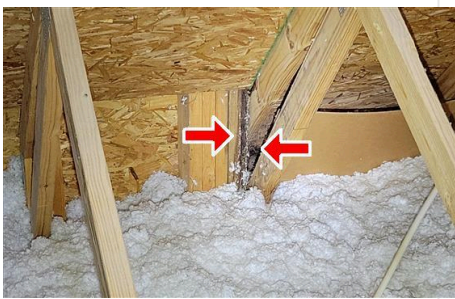
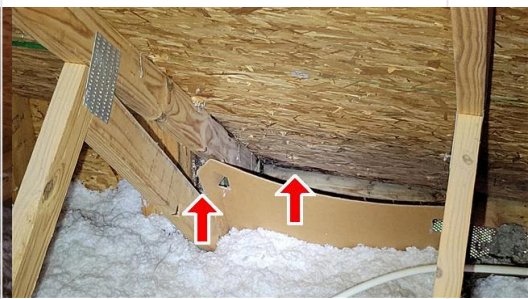
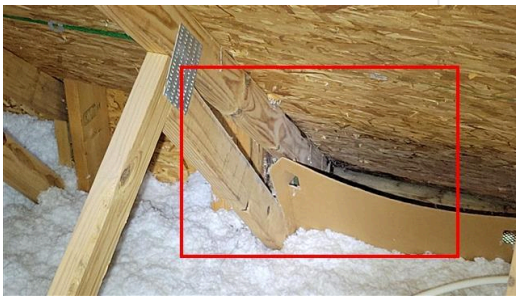
1. Evidence of water intrusion in attic at the front of the home. I am unable to determine if this is still an active leak. Further investigation and repairs are needed.

A qualified licensed general contractor should inspect further and repair as needed.

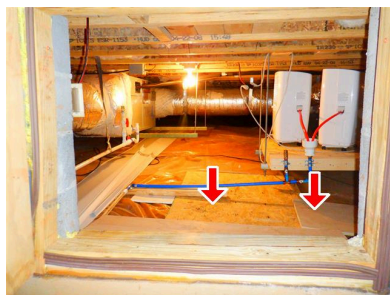
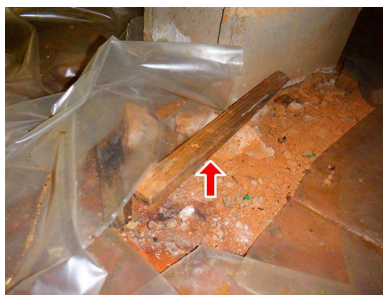
1. Wood debris is in contact with the crawl space floor in numerous areas. This can attract wood destroying organisms. Removal is needed.

A qualified contractor should inspect and repair as needed.

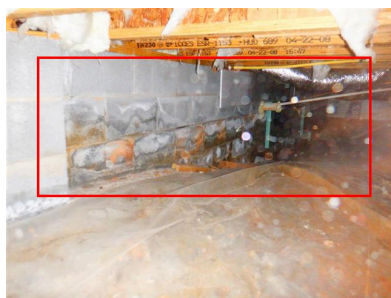
4.6 Item 1 (Picture)

1. Dark stains on the CMU (Concrete Masonry Unit) indicated that water is inside the block. Dark stains and white efflorescence (powder substance) on block wall indicates moisture is in contact with the masonry. This does not necessarily indicate that intrusion will occur. Efflorescence is found on many homes without water intrusion occurring inside the home. But, it should alert you to the possibility that future steps may be needed. Further investigation and repairs are needed.

I recommend contact a licensed water intrusion specialist regarding these conditions.

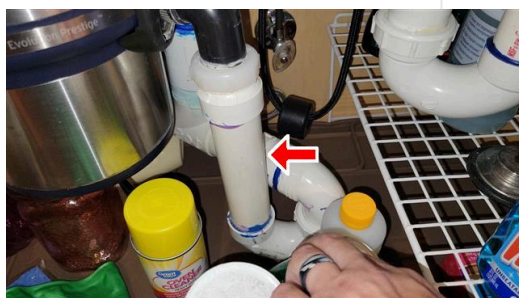
5.3 Item 1 (Picture)

1. The p-trap at the kitchen sink is incorrect. This condition could allow for draining issues to occur. Further investigation and repairs are needed.

A qualified licensed plumber should repair or correct as needed.

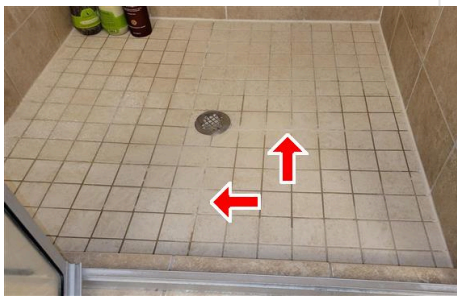
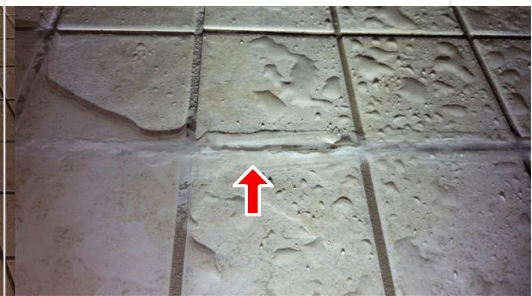
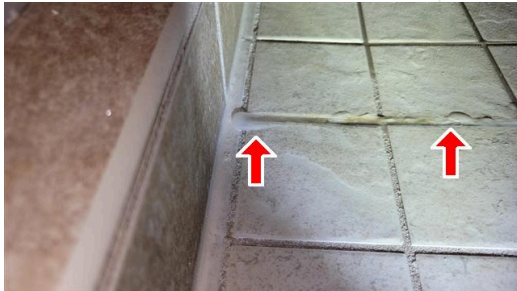
1. The master bath shower floor has signs of repairs. This may allow water damage to occur to the home.

Further investigation and repairs are needed.  
I recommend contacting a licensed plumber.

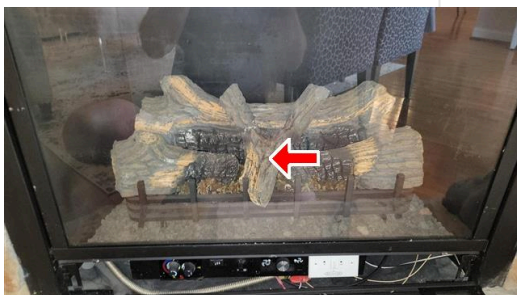
7.7 Item 1 (Picture)

1. The vented fire logs in the living room is not operable (pilot would not ignite). Repairs should be made so unit works properly. Repairs are needed.

A qualified licensed HVAC (Heat/Ventilation/Air conditioning Contractor) should inspect further and repair as needed.

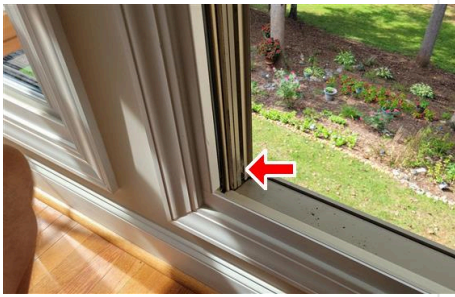
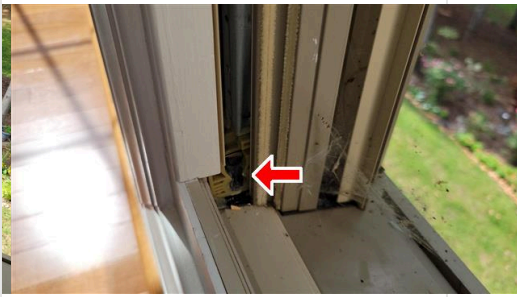
1. The windows at the sunroom have damaged sash springs. This can allow the window to come down suddenly causing glass breakage and or injury. (Safety Issue) Repairs are needed. A qualified person should repair or replace as needed.

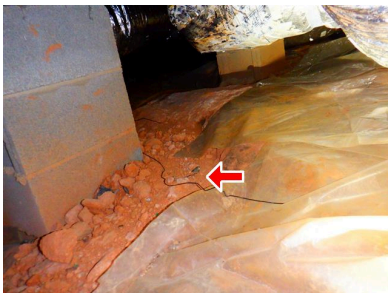
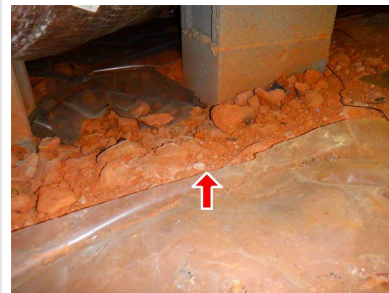
1. The vapor barrier (plastic) on the crawlspace ground is missing in areas. A vapor barrier provides added protection to the floor system from moisture or dampness that can enter from ground. Repairs are needed.

A qualified person should repair or replace as needed.

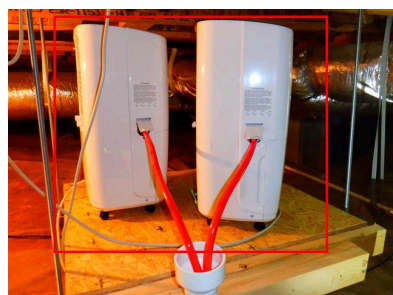
9.1 Item 1 (Picture)

1. The sealed crawlspace was not installed properly. This may allow for moisture damage to occur to the home. I recommend having the entire sealed crawlspace evaluated. Further investigation and repairs are needed.

I recommend contacting a licensed general contractor who has experience with sealed crawlspaces for a complete evaluation and have the repairs made as deemed appropriate.

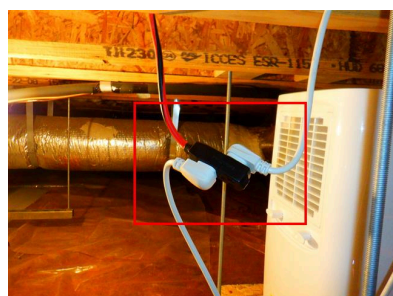
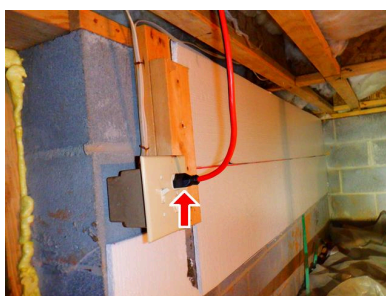
1. The existing dehumidifiers uses an extension cord and should have its own GFCI outlet. Electrical issues are considered a hazard until repaired. Further investigation and repairs are needed.

I recommend a qualified licensed electrical contractor correct.

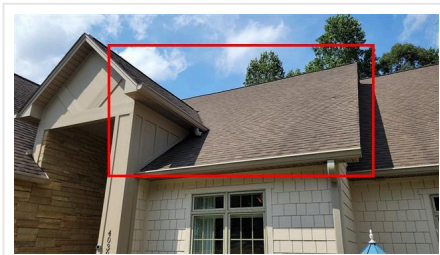
2.0 Item 1 (Picture)

1. The asphalt/fiberglass shingles and penetration flashings appear to be near the end of their service life. It appears that they will need replacing in the not too distant future. They show signs of heavy wear typical for their age consisting of heavy loss of moderate to heavy wear long edges of tabs. The shingles are brittle, which is a sign of aging. Cracking, splitting and or missing shingles were observed in some areas. No signs of leaks were observed at the time of inspection. Further investigation and repairs are needed.

A qualified contractor should inspect and repair as needed.

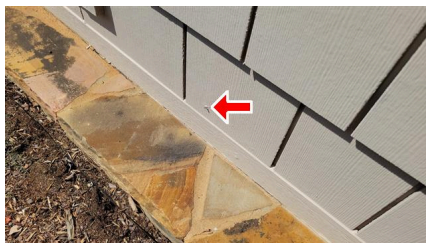
3.0 Item 1 (Picture)

1. The cement board at the exterior in areas installed improperly or not according to standard workmanlike practices. Deterioration can eventually occur if not corrected. Further investigation and repairs are needed.

A qualified contractor should inspect and repair as needed.

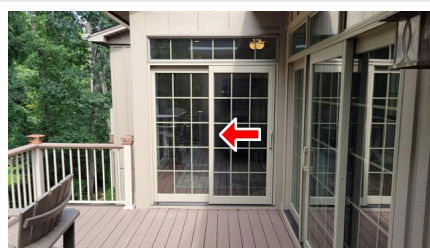
3.3 Item 1 (Picture)

1. The sliding glass door at the rear of the home did not function properly. As a result the door will not close properly. Repairs are needed.

A qualified person should repair or replace as needed.

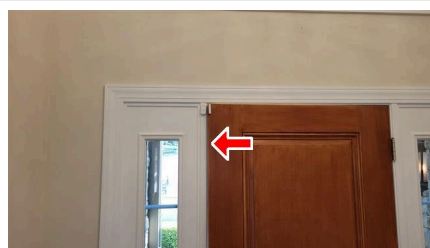
3.3 Item 4 (Picture)

1. The main entry door rubs at jamb when closing. As a result the door will not close properly. Repairs are needed.

A qualified person should repair or replace as needed.

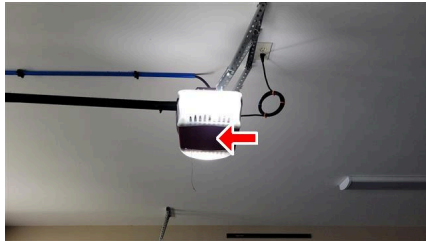
3.7 Item 1 (Picture)

1. The garage door operator safety reverse will not reverse properly when met with resistance. This is a safety issue. Further investigation and repairs are needed.

A qualified person should repair or replace as needed.

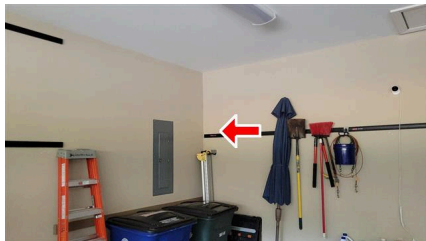
3.8 Item 1 (Picture)

1. The fire resistance sheathing that separates garage from heated space is compromised. This is considered unsafe until corrected. Repairs are needed.

A qualified person should correct for safety.

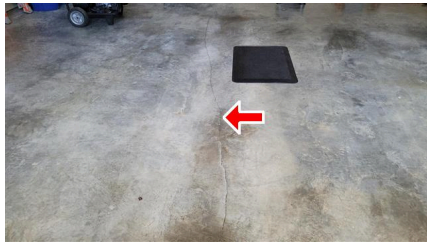
**3.10 Item 1 (Picture)**

1. The concrete floor of garage has settled or settlement is occurring due to cracks or uneven cracks in the surface. Further settlement may occur. Further investigation and repairs are needed.

A qualified contractor should inspect and repair as needed.

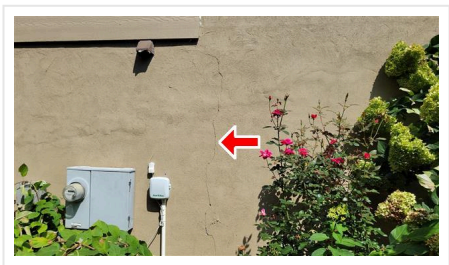
4.0 Item 1 (Picture)

1. The foundation wall at the left side (facing front) has cracks present with outward displacement/ movement present. The wall(s) may need reinforcement. Further investigation and repairs are needed.

A qualified licensed general contractor should inspect further and repair as needed.

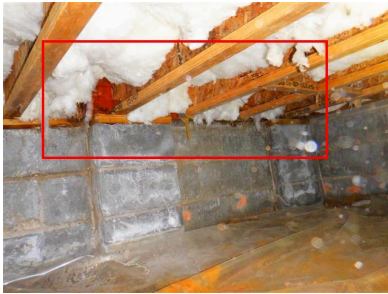
4.2 Item 1 (Picture)

1. The floor system is deteriorated from moisture absorption or water intrusion in the crawl space at the front of the home. Water intrusion if not corrected can lead to other problems including mold and cause excessive moisture to floor system that can lead to deterioration and increased repair cost. Further investigation and repairs are needed.

I recommend further investigation or correction by a qualified licensed contractor or water infiltration specialist.

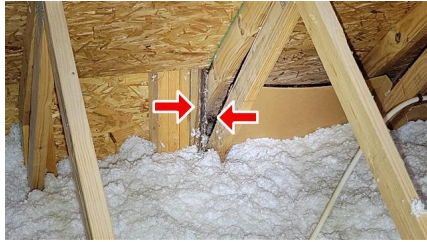
4.4 Item 1 (Picture)

1. Evidence of water intrusion in attic at the front of the home. I am unable to determine if this is still an active leak. Further investigation and repairs are needed.

A qualified licensed general contractor should inspect further and repair as needed.

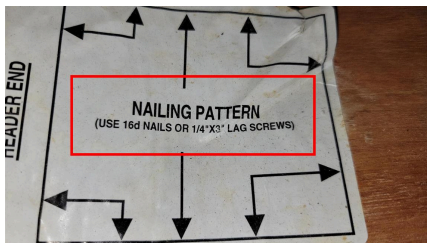
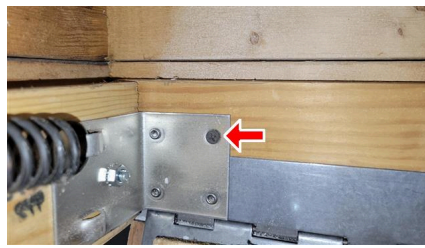
1. The pull down stairs for the attic is installed with screws. The only approved means of securing attic stairs is a 16 penny nail per manufacture. An injury could occur if not corrected. Repairs are needed.

A qualified person should repair or replace as needed.

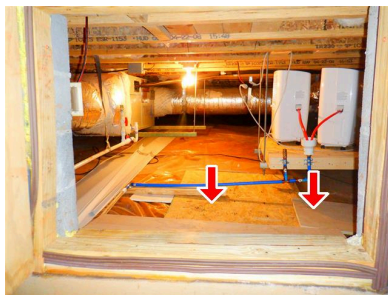
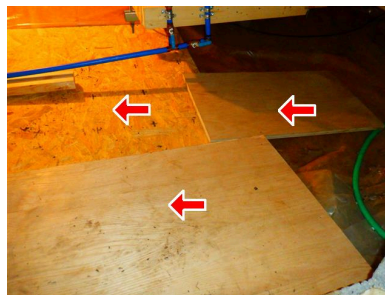
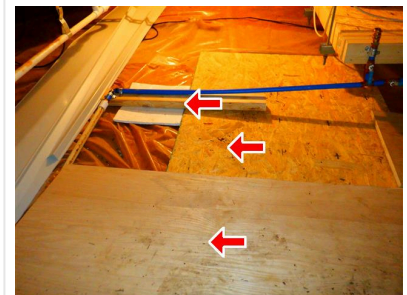
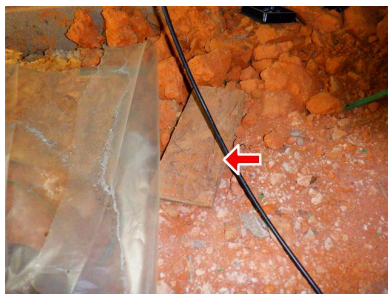
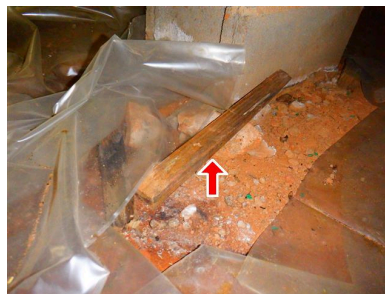
1. Wood debris is in contact with the crawl space floor in numerous areas. This can attract wood destroying organisms. Removal is needed.

A qualified contractor should inspect and repair as needed.

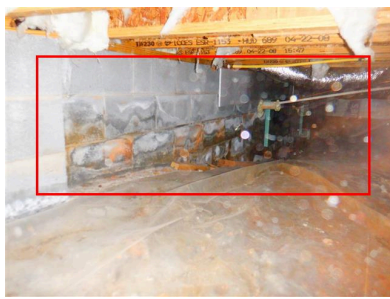
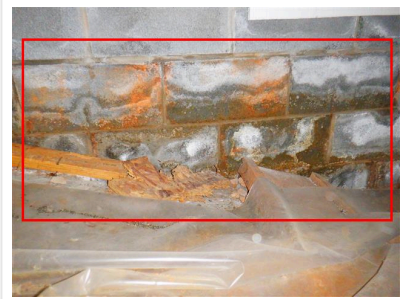
1. Dark stains on the CMU (Concrete Masonry Unit) Indicated that water is inside the block. Dark stains and white efflorescence (powder substance) on block wall indicates moisture is in contact with the masonry. This does not necessarily indicate that intrusion will occur. Efflorescence is found on many homes without water intrusion occurring inside the home. But, it should alert you to the possibility that future steps may be needed. Further investigation and repairs are needed.

I recommend contact a licensed water intrusion specialist regarding these conditions.

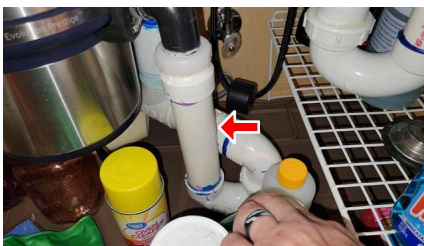
5.3 Item 1 (Picture)

1. The p-trap at the kitchen sink is incorrect. This condition could allow for draining issues to occur. Further investigation and repairs are needed.

A qualified licensed plumber should repair or correct as needed.

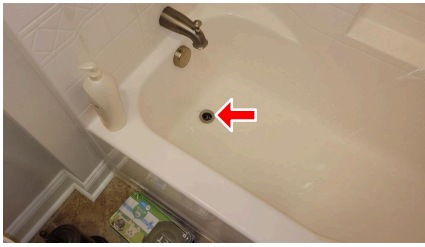
5.3 Item 2 (Picture)

1. The stop-valve is missing at the guest bathroom tub. As a result you cannot fill up the tub. Repairs are needed.

A qualified licensed plumber should repair or correct as needed.

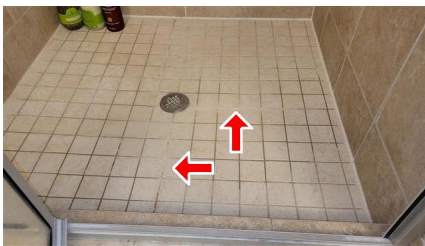
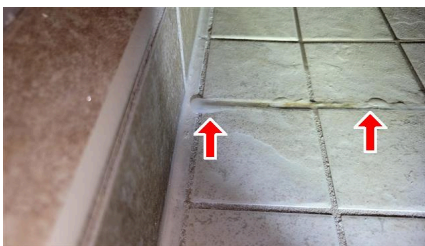
1. The master bath shower floor has signs of repairs. This may allow water damage to occur to the home. Further investigation and repairs are needed.

I recommend contacting a licensed plumber.

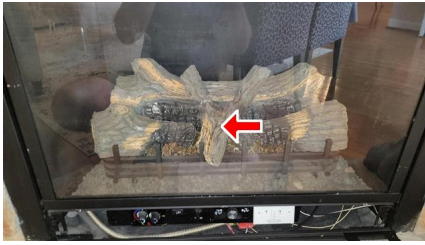
7.7 Item 1 (Picture)

1. The vented fire logs in the living room is not operable (pilot would not ignite). Repairs should be made so unit works properly. Repairs are needed.

A qualified licensed HVAC (Heat/Ventilation/Air conditioning Contractor) should inspect further and repair as needed.

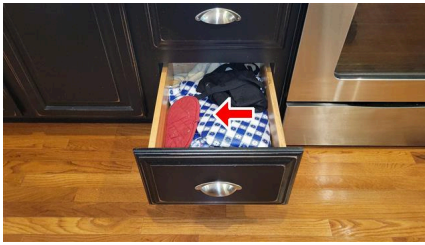
8.4 Item 1 (Picture)

1. Drawer track does not work smoothly (left of stove). This is a cosmetic issue for your information. Recommend repair or replace as necessary.

A qualified person should repair or replace as needed

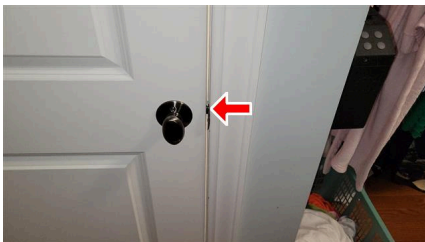
8.5 Item 1 (Picture)

1. The door at master bath closet will not latch properly. Evidence suggest that the door needs strike and latch adjustment to shut properly. This is a small repair.

A qualified person should repair or replace as needed.

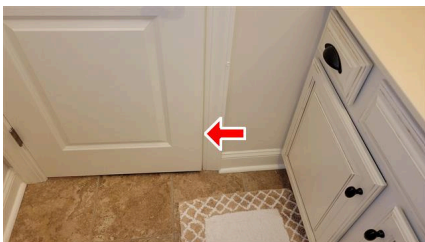
8.5 Item 2 (Picture)

1. The privacy door rubs at jamb when closing at the guest bath. As a result the door will not close properly. Repairs are needed.

A qualified person should repair or replace as needed.

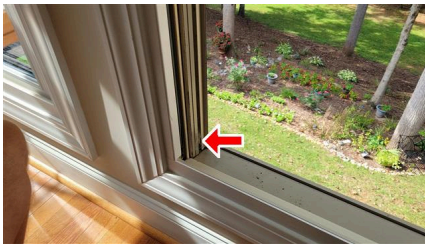
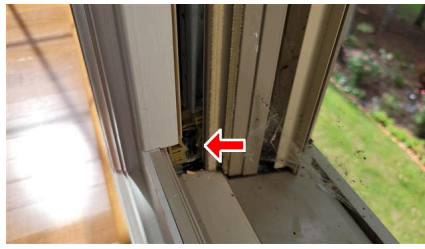
1. The windows at the sunroom have damaged sash springs. This can allow the window to come down suddenly causing glass breakage and or injury. (Safety Issue) Repairs are needed.

A qualified person should repair or replace as needed.

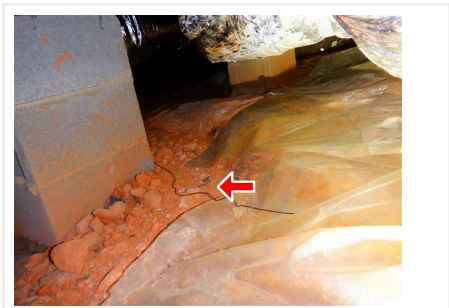
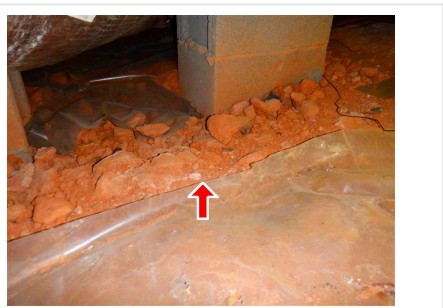
1. The vapor barrier (plastic) on the crawlspace ground is missing in areas. A vapor barrier provides added protection to the floor system from moisture or dampness that can enter from ground.  
Repairs are needed.

A qualified person should repair or replace as needed.

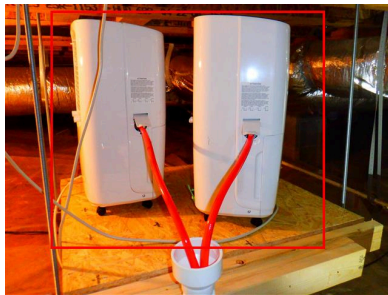
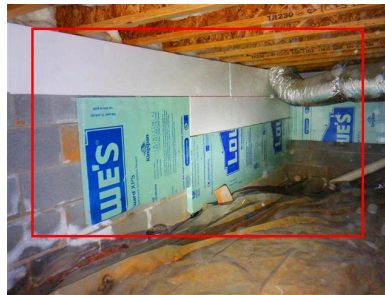
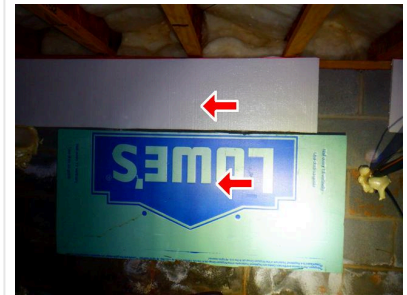
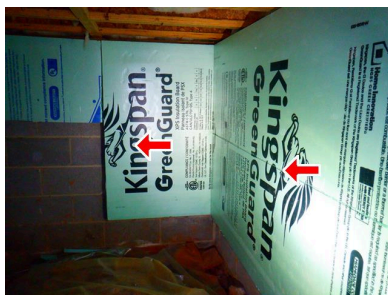
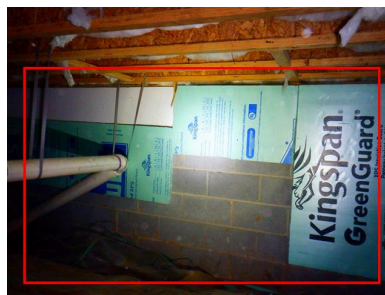
1. The sealed crawlspace was not installed properly. This may allow for moisture damage to occur to the home. I recommend having the entire sealed crawlspace evaluated. Further investigation and repairs are needed.

I recommend contacting a licensed general contractor who has experience with sealed crawlspaces for a complete evaluation and have the repairs made as deemed appropriate.

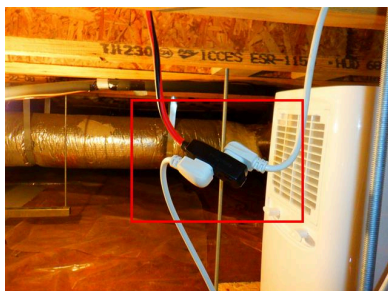
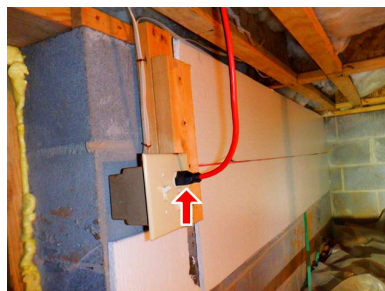
1. The existing dehumidifiers use an extension cord and should have its own GFCI outlet. Electrical issues are considered a hazard until repaired. Further investigation and repairs are needed.

I recommend a qualified licensed electrical contractor correct.

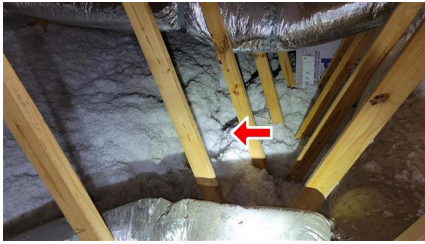
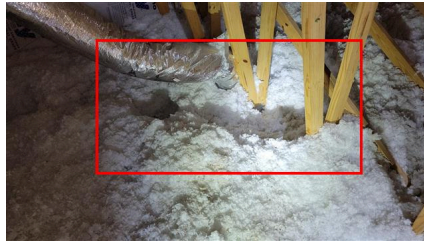
1. Fiberglass (loose-fill) insulation is compressed in areas of the attic due to foot traffic or storage

in attic. Heat loss can occur more on this home than one that is properly insulated. Repairs are recommended.

A qualified person should repair or replace as needed.

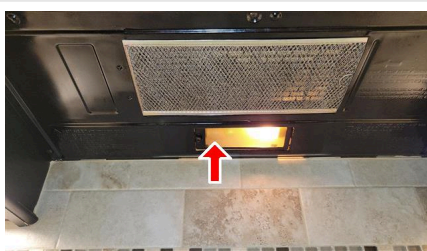
10.2 Item 1 (Picture)

1. The light bulb for fan did not work when tested. I recommend repair or replace as needed. I recommend contacting a appliance repair company.
