INSPECTION REPORT  
404 Debanne Rd  
McLeansville NC 27301

INSPECTED BY  
Alex Parr 3692  
Above Parr Home  
Inspections

INSPECTION DATE  
📅 10/2/2023  
🕒 09:00:00 AM

Inspection Date: 10/2/2023  
Report ID: 100223AP1

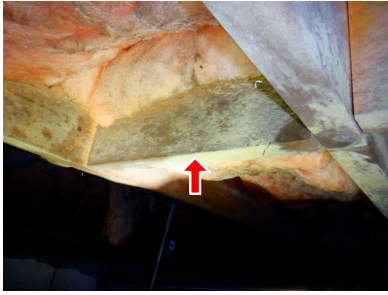
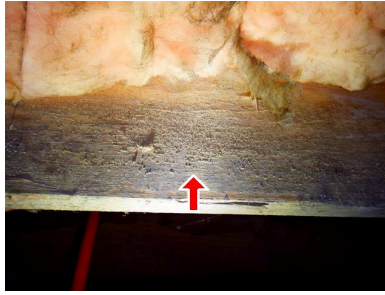
1. Discoloration and some type of mold (Microbial) growth is present in the structure at several areas including but not limited to the crawl space and interior spaces. Evidence suggests that this condition is from a past or present elevated moisture conditions. We did not inspect, test or determine if this type of substance is or is not a health hazard. Further investigation is needed.

We recommend you contact a properly licensed expert for testing, investigation and or correction as deemed appropriate.

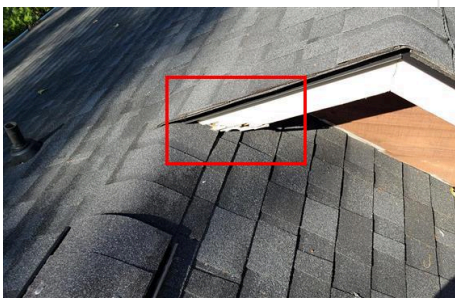
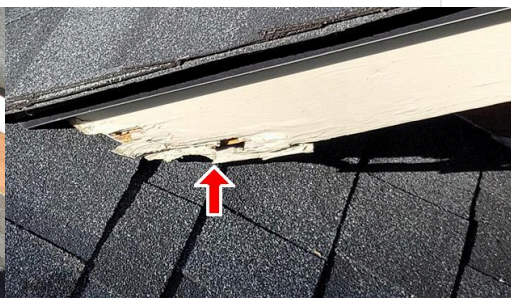
1. The wood fascia at eave on the exterior in areas deteriorated. Further deterioration may occur if not repaired. Repairs are needed.

A qualified person should repair or replace as needed.

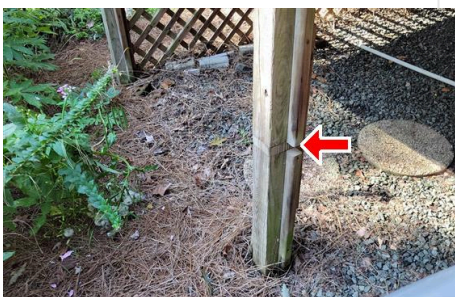
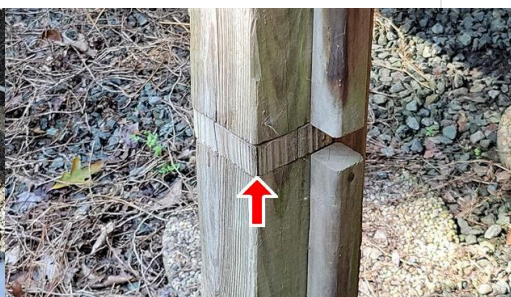
1. The support post(s) on the deck at the rear of home is repaired improperly. A more proper repair is needed to ensure stability or an injury might occur. Further investigation and repairs are needed.

A qualified contractor should repair or replace as needed.

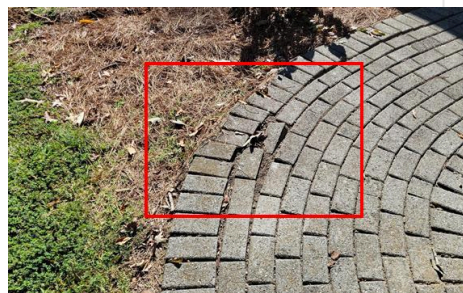
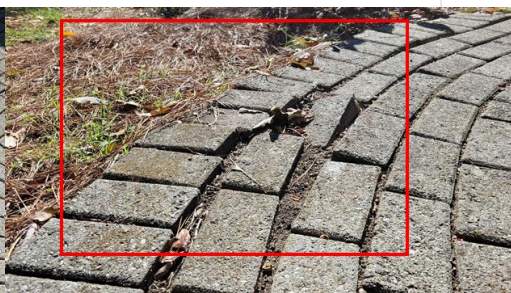
1. The sidewalk at the front of home uneven, and can be a tripping hazard. A fall or injury can occur if not corrected. Further investigation and repairs are needed.

A qualified contractor should inspect and repair as needed.

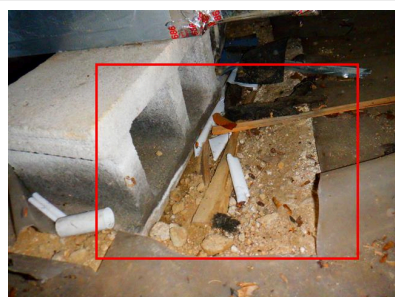
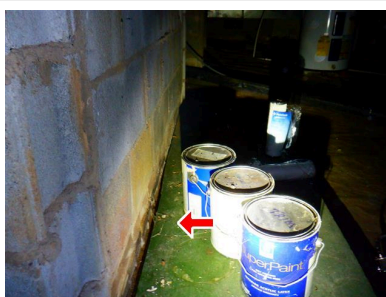
1. Wood debris is in contact with the crawl space floor in numerous areas. This can attract wood destroying organisms. Removal is needed.

A qualified contractor should inspect and repair as needed.

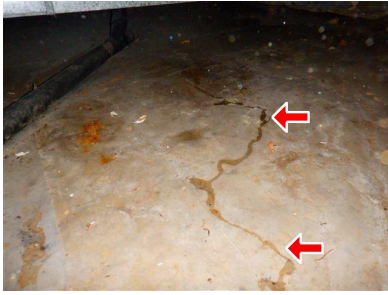
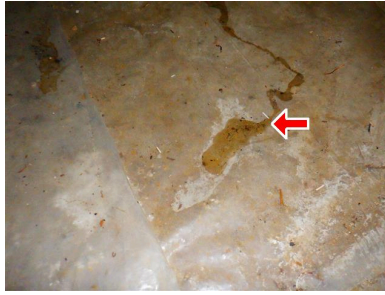
1. The is leaking under the master bathroom . Repairs are needed to prevent water damage from occurring to the home. I was unable to determine the source of the leak. Further investigation and repairs are needed.

A licensed plumber should troubleshoot further to determine cause or remedy.

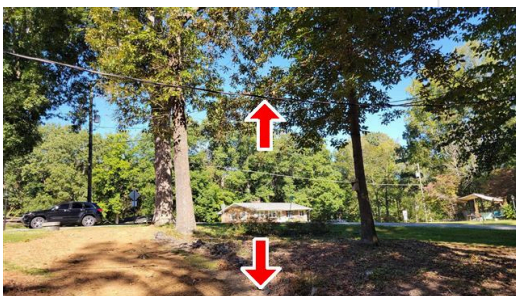
6.1 Item 1 (Picture)

1. The electrical service conductors clearance (outside) from the ground is lower than 12 feet, and needs correcting for safety. Repairs are needed.

I recommend a licensed electrical contractor inspect further and correct as needed.

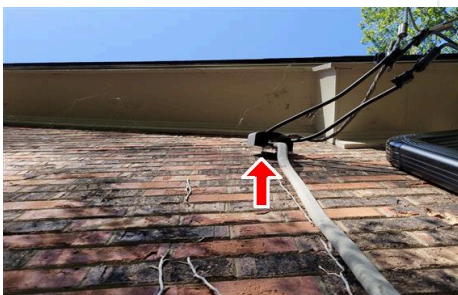
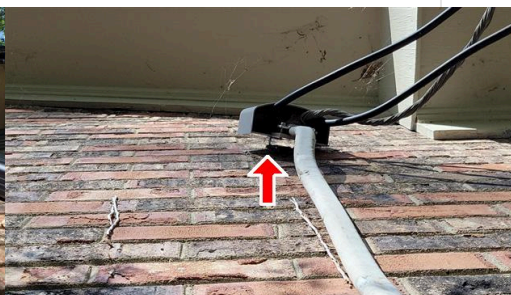
1. The problem(s) discovered with the service mast is being loose and any other problems that an electrical contractor may discover while performing repairs need correcting.

I recommend a licensed electrical contractor inspect further and correct as needed.

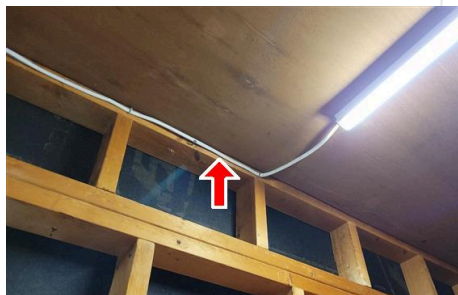
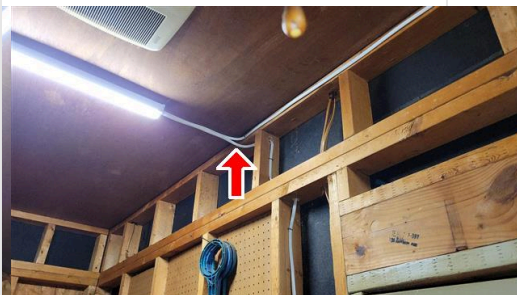
1. Exposed electrical wires were present at the storage room of the home. Even though standard NM cable has a vinyl outer jacket and waterproof insulation around the individual conducting wires, it is not intended for use in outdoor locations. Exposed or buried wiring must be listed for this application. Evidence suggests that the current wiring is not allowed for safety reasons. Further investigation and repairs are needed.

A qualified licensed electrical contractor should correct as needed.

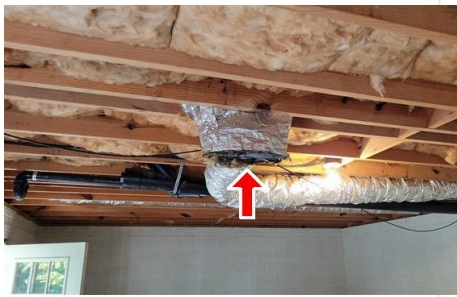
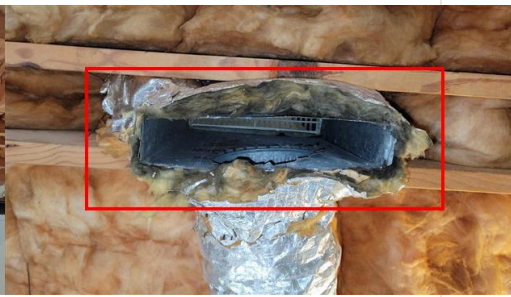
1. The supply duct pipe is damaged in the basement. Energy loss is occurring. Further investigation and repairs are needed.

A licensed HVAC contractor should service or repair unit.

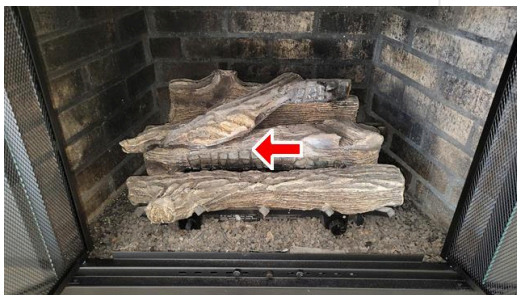
7.7 Item 1 (Picture)

1. The vented fire logs (propane) in the Living room is not operable (out of fuel). There was no propane hookup found for the home. Further investigation and repairs are needed.

A qualified person should repair or replace as needed.

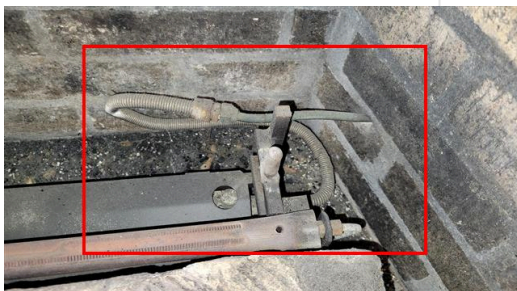
7.7 Item 2 (Picture)

1. The vented fire logs (natural gas) in the Living room does not have a "Shut off" valve above floor (not easily accessible). This is a safety issue. Further investigation and repairs are needed.

A qualified licensed HVAC (Heat/Ventilation/Air conditioning Contractor) should inspect further and repair as needed.

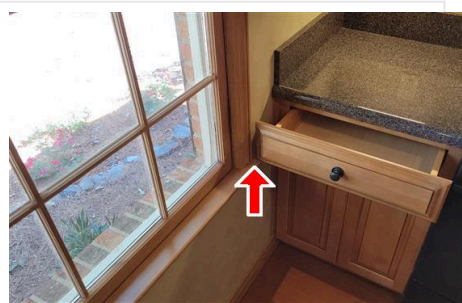
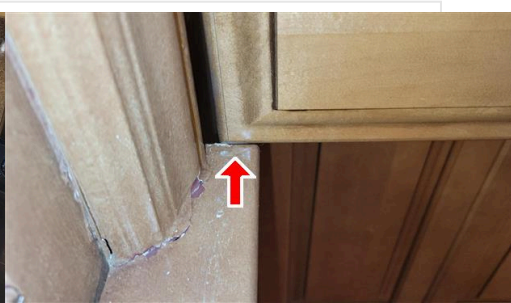
1. Drawer face rubs the window (left of stove). Therefore the drawer cannot function as intended.  
Recommend repair or replace as necessary.

A qualified person should repair or replace as needed

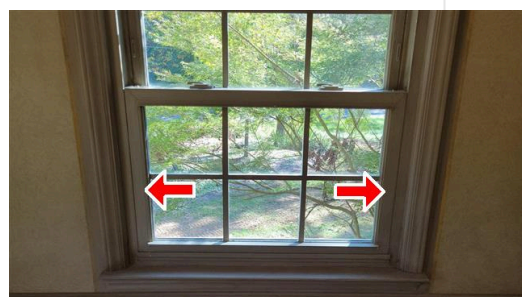
8.6 Item 1 (Picture)

1. The windows at the guest bedroom have damaged sash springs. This can allow the window to come down suddenly causing glass breakage and or injury. (Safety Issue) Repairs are needed.

A qualified person should repair or replace as needed.

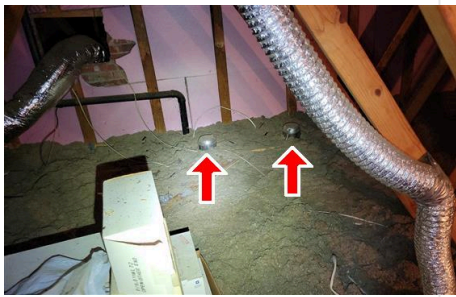
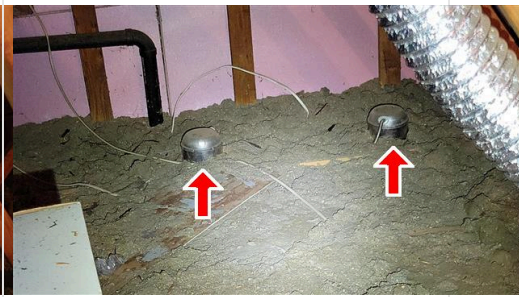
1. The recessed can lights are in contact with insulation. Some recessed can lights are rated for insulation, these do not appear to be rated for insulation to be in contact with the lights. This can allow for heat buildup to occur and should be considered a fire hazard until addressed. Further investigation and repairs are needed.

A qualified person should repair or replace as needed.

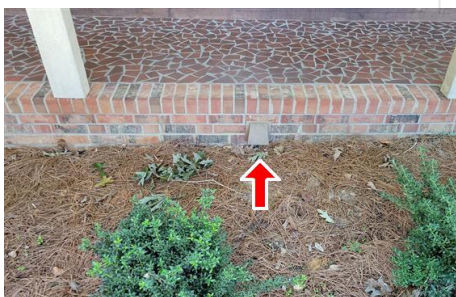
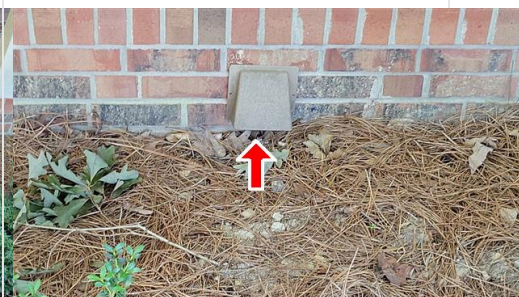
1. The dryer vent hood at the front of home does not have the proper clearance from the grade/ground to function as intended. Dryer vent exhaust shall terminate not less than 12 inches above finish grade to prevent blockages. Current conditions should be considered a fire hazard until repaired. Repairs are needed.

A qualified person should repair or replace as needed.

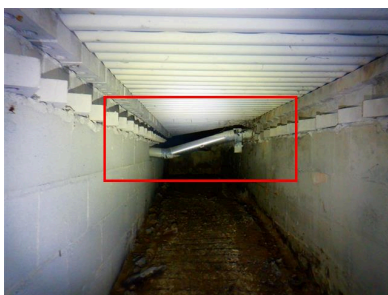
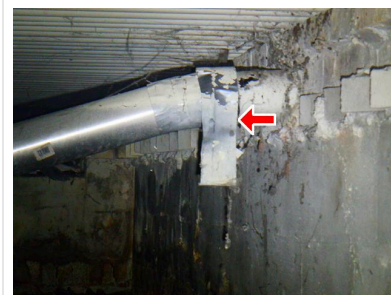
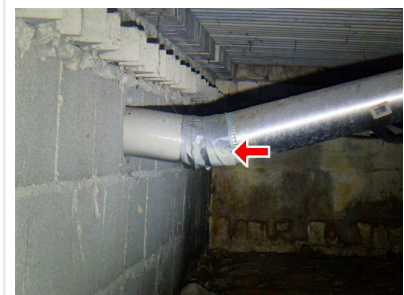
1. The dryer vent piping is improperly put together with duct tape. "Duct tape is not UL rated for this application." Repairs are needed.

A qualified person should repair or replace as needed.

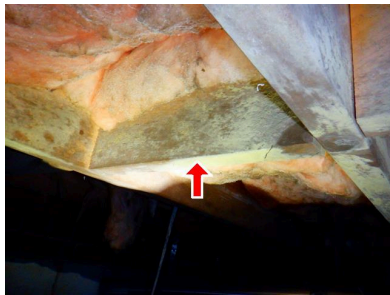
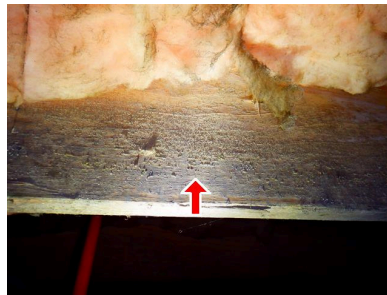
1. Discoloration and some type of mold (Microbial) growth is present in the structure at several areas including but not limited to the crawl space and interior spaces. Evidence suggests that this condition is from a past or present elevated moisture conditions. We did not inspect, test or determine if this type of substance is or is not a health hazard. Further investigation is needed.

We recommend you contact a properly licensed expert for testing, investigation and or correction as deemed appropriate.

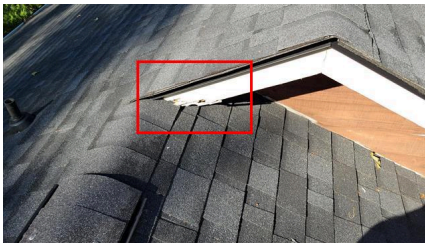
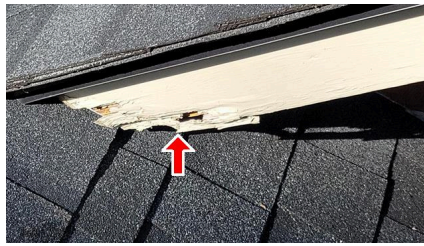
1. The wood fascia at eave on the exterior in areas deteriorated. Further deterioration may occur if not repaired. Repairs are needed.

A qualified person should repair or replace as needed.

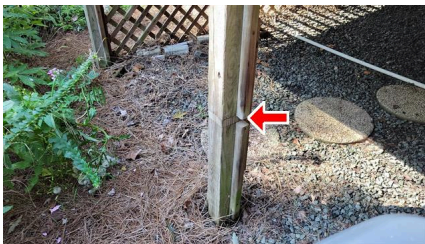
3.4 Item 1 (Picture)

1. The support post(s) on the deck at the rear of home is repaired improperly. A more proper repair is needed to ensure stability or an injury might occur. Further investigation and repairs are needed.

A qualified contractor should repair or replace as needed.

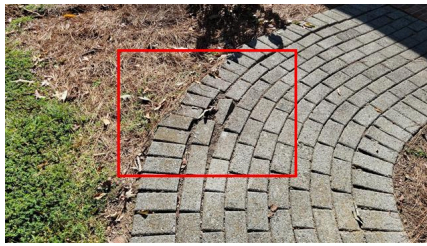
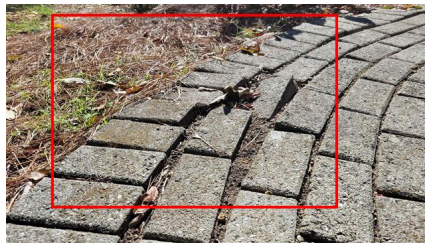
1. The sidewalk at the front of home uneven, and can be a tripping hazard. A fall or injury can occur if not corrected. Further investigation and repairs are needed.

A qualified contractor should inspect and repair as needed.

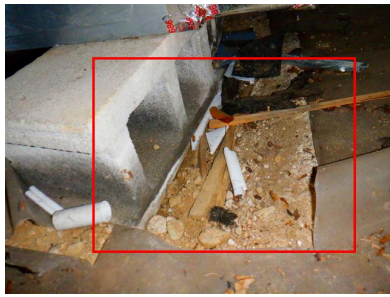
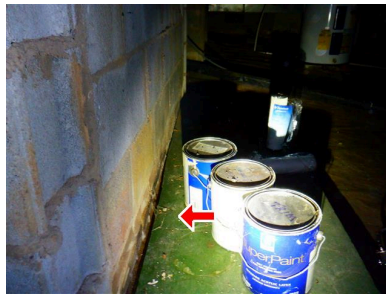
1. Wood debris is in contact with the crawl space floor in numerous areas. This can attract wood destroying organisms. Removal is needed.

A qualified contractor should inspect and repair as needed.

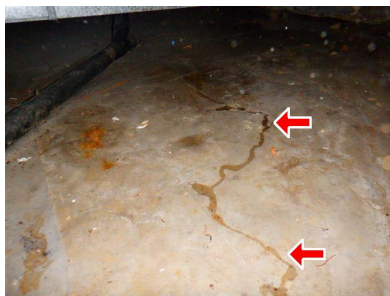
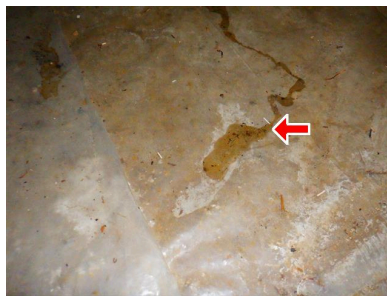
1. The is leaking under the master bathroom . Repairs are needed to prevent water damage from occurring to the home. I was unable to determine the source of the leak. Further investigation and repairs are needed.

A licensed plumber should troubleshoot further to determine cause or remedy.

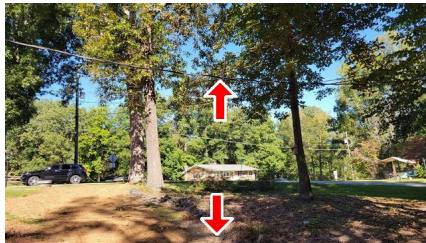
6.1 Item 1 (Picture)

1. The electrical service conductors clearance (outside) from the ground is lower than 12 feet, and needs correcting for safety. Repairs are needed.

I recommend a licensed electrical contractor inspect further and correct as needed.

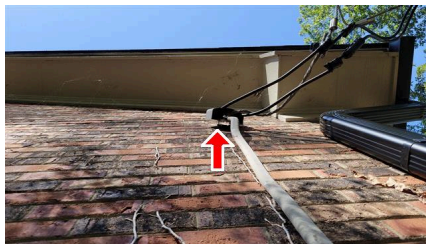
6.1 Item 2 (Picture)

1. The problem(s) discovered with the service mast is being loose and any other problems that an electrical contractor may discover while performing repairs need correcting.

I recommend a licensed electrical contractor inspect further and correct as needed.

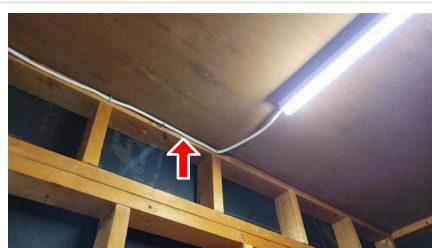
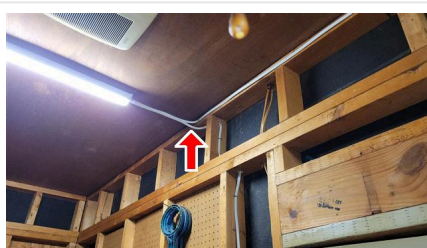
1. Exposed electrical wires were present at the storage room of the home. Even though standard NM cable has a vinyl outer jacket and waterproof insulation around the individual conducting wires, it is not intended for use in outdoor locations. Exposed or buried wiring must be listed for this application. Evidence suggests that the current wiring is not allowed for safety reasons. Further investigation and repairs are needed.

A qualified licensed electrical contractor should correct as needed.

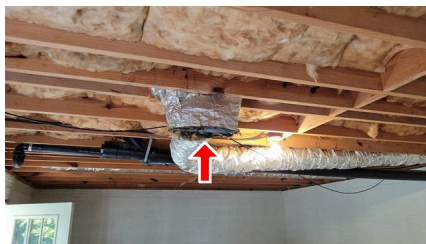
7.3 Item 1 (Picture)

1. The supply duct pipe is damaged in the basement. Energy loss is occurring. Further investigation and repairs are needed.

A licensed HVAC contractor should service or repair unit.

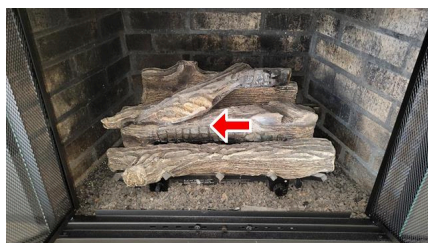
7.7 Item 1 (Picture)

1. The vented fire logs (propane) in the Living room is not operable (out of fuel). There was no propane hookup found for the home. Further investigation and repairs are needed.

A qualified person should repair or replace as needed.

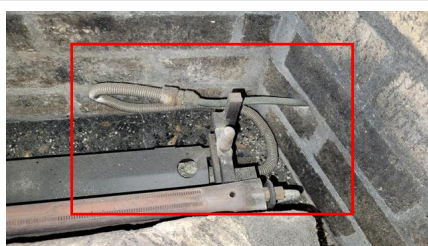
7.7 Item 2 (Picture)

1. The vented fire logs (natural gas) in the Living room does not have a "Shut off" valve above floor (not easily accessible). This is a safety issue. Further investigation and repairs are needed.

A qualified licensed HVAC (Heat/Ventilation/Air conditioning Contractor) should inspect further and repair as needed.

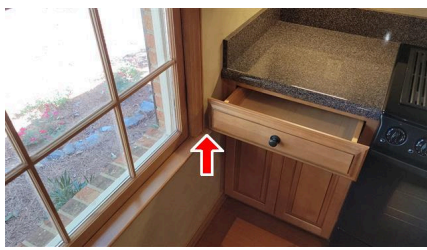
8.4 Item 1 (Picture)

1. Drawer face rubs the window (left of stove). Therefore the drawer cannot function as intended.  
Recommend repair or replace as necessary.

A qualified person should repair or replace as needed

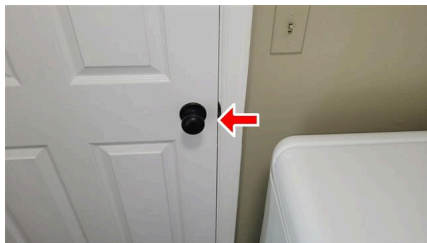
8.5 Item 1 (Picture)

1. The door at the laundry room will not latch properly. Evidence suggest that the door needs strike and latch adjustment to shut properly. This is a small repair.

A qualified person should repair or replace as needed.

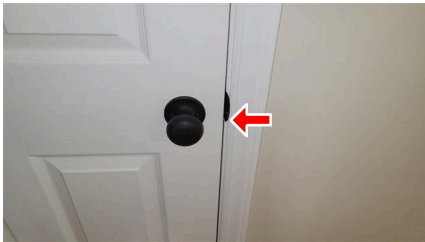
8.5 Item 2 (Picture)

1. The door at master Bedroom will not latch properly. Evidence suggest that the door needs strike and latch adjustment to shut properly. This is a small repair.

A qualified person should repair or replace as needed.

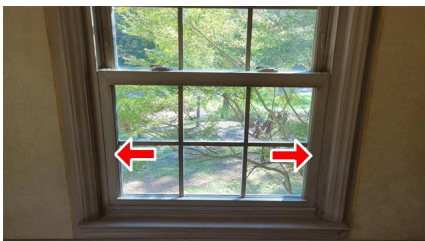
8.6 Item 1 (Picture)

1. The windows at the guest bedroom have damaged sash springs. This can allow the window to come down suddenly causing glass breakage and or injury. (Safety Issue) Repairs are needed.

A qualified person should repair or replace as needed.

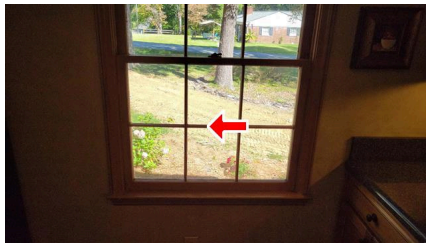
8.6 Item 2 (Picture)

1. Numerous windows stuck or painted shut at the throughout the home. This is a maintenance issue and is for your information.

A qualified person should repair or replace as needed.

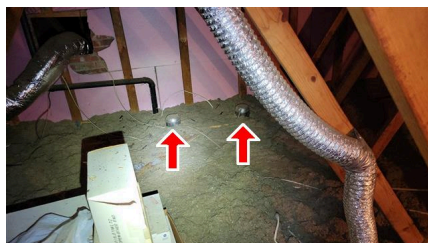
9.2 Item 1 (Picture)

1. The recessed can lights are in contact with insulation. Some recessed can lights are rated for insulation, these do not appear to be rated for insulation to be in contact with the lights. This can allow for heat buildup to occur and should be considered a fire hazard until addressed. Further investigation and repairs are needed.

A qualified person should repair or replace as needed.

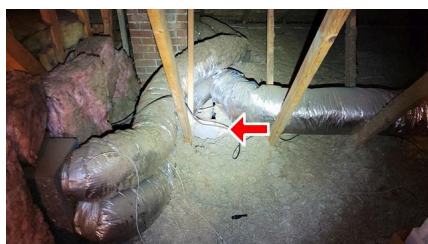
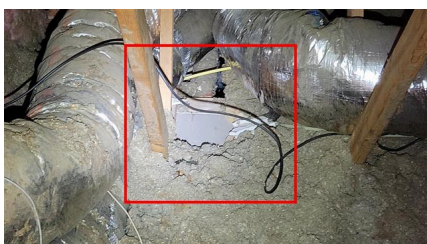
1. Fiberglass (loose-fill) insulation is missing in the attic. Heat loss can occur more on this home than one that is properly insulated. Repairs are needed..

A qualified person should repair or replace as needed.

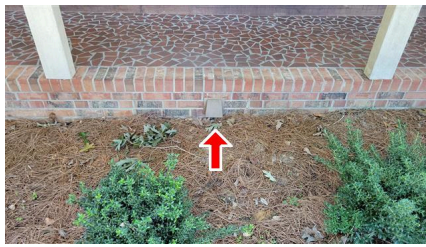
9.5 Item 1 (Picture)

1. The dryer vent hood at the front of home does not have the proper clearance from the grade/ ground to function as intended. Dryer vent exhaust shall terminate not less than 12 inches above finish grade to prevent blockages. Current conditions should be considered a fire hazard until repaired. Repairs are needed.

A qualified person should repair or replace as needed.

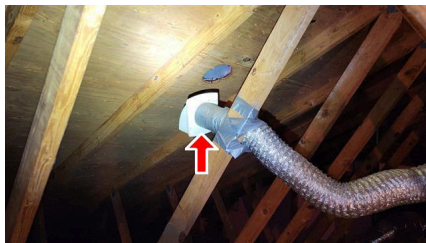
9.5 Item 3 (Picture)

1. The Exhaust fan does not vent to outside at the master bath. Vent pipes should terminate outside and not in the attic. Many homes have their vent pipe poised at the roof vent such as yours. It is up to you to determine whether or not this is a concern or needs further consideration from a general contractor.

A qualified licensed HVAC (Heat/Ventilation/Air conditioning Contractor) should inspect further and repair as needed.

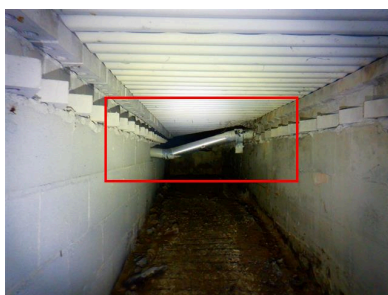
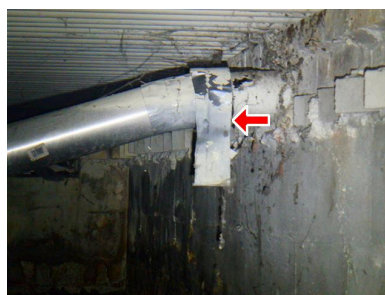
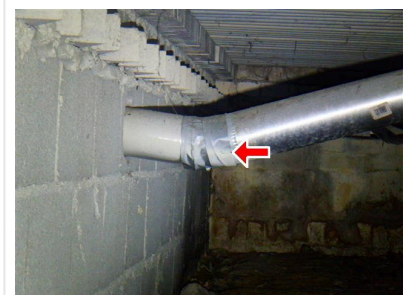
1. The dryer vent piping is improperly put together with duct tape. "Duct tape is not UL rated for this application." Repairs are needed.

A qualified person should repair or replace as needed.
