INSPECTION REPORT  
4286 Lake Shore Rd N  
Denver NC 28037

Report ID: 013123AP2

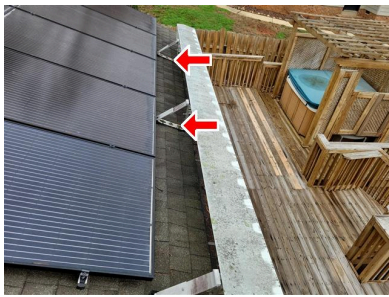
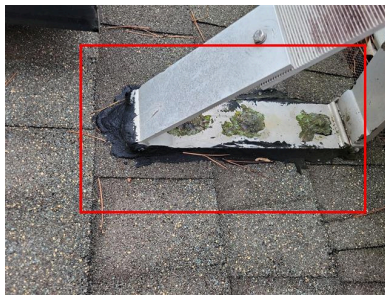
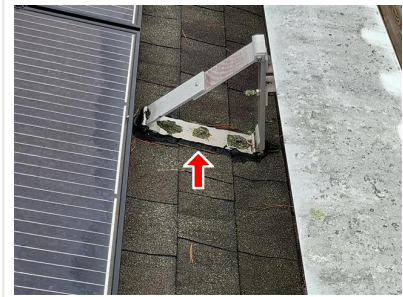
1. The roof at the rear of the home has evidence of repairs. This may allow water intrusion to occur. Further investigation and repairs are needed.

A qualified person should repair or replace as needed.

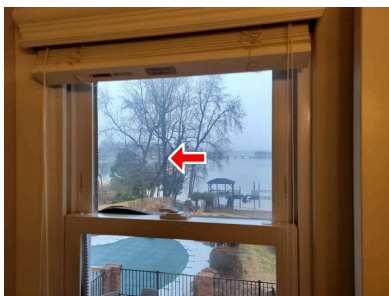
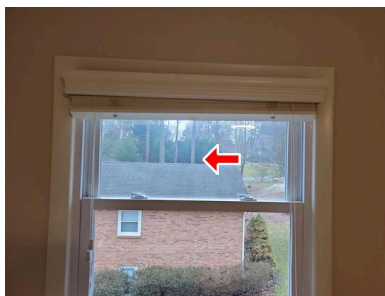
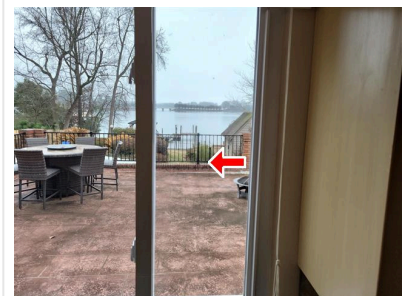
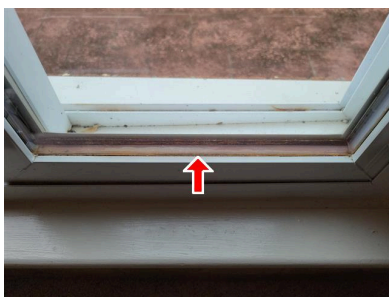
1. Several windows have failed/compromised thermal seals/fogged window panes. This is indicated by the visible moisture, discoloration, calcium deposits and or crystallization visible between the glass window panes. A certified window technician should recheck all the windows throughout the home. Due to weather conditions many times compromised/failed windows cannot be identified at the time of inspection. Further investigation and repairs are needed.

We recommend contacting a properly licensed window technician/contractor regarding these conditions and have repairs made deemed appropriate

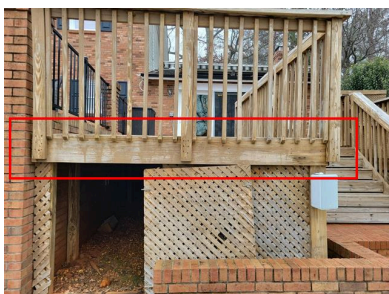
3.4 Item 6 (Picture)

1. The exterior girders for the wood deck are attached to the support posts by simple nail connections only. This is an uncommon construction method. Typically girders require through bolt connections, structural screws or direct bearing at end points to prevent framing movement and or failure. Deck failure could occur if not addressed. Further investigation and repairs are needed.

A qualified contractor should perform the work.

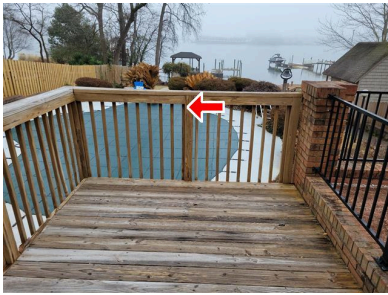
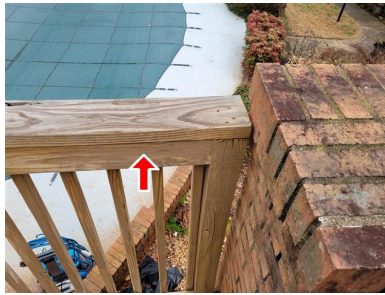
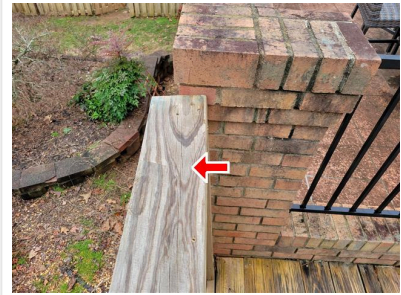
1. The guardrails on deck at the rear of home are loose. A fall or injury could occur if not corrected. A repair or replacement is needed.

A qualified contractor should repair or replace as needed.

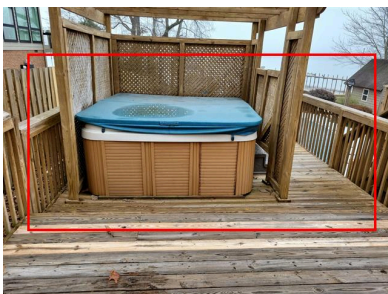
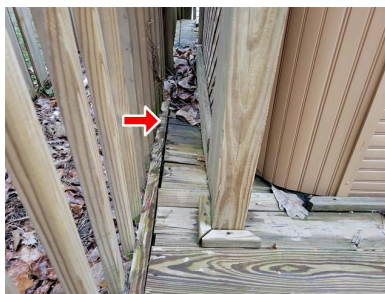
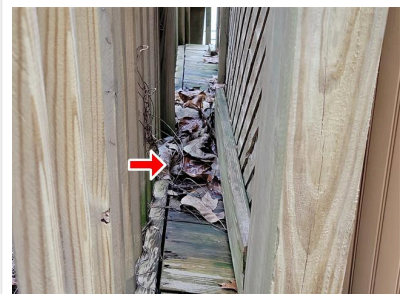
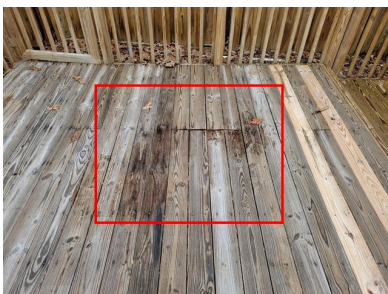
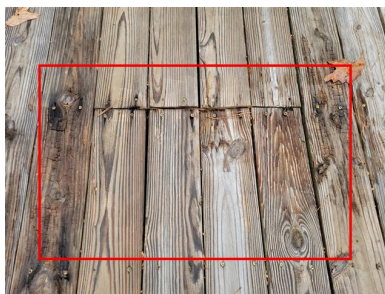
1. The deck at the rear of the home is showing signs of failing. I recommend having the entire deck evaluated for structural stability. Further investigation and repairs are needed.

A qualified contractor should repair or replace as needed.

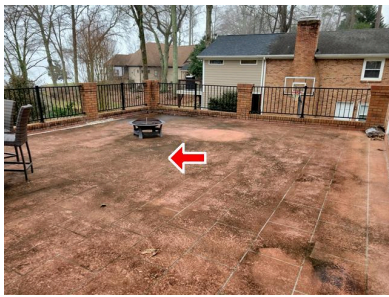
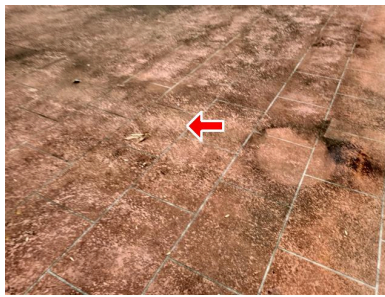
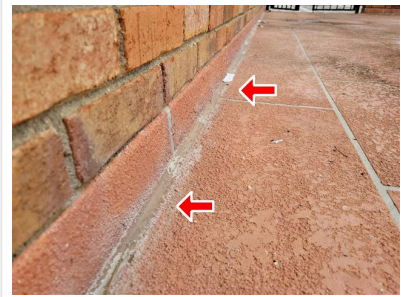
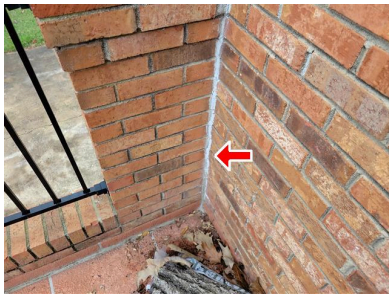
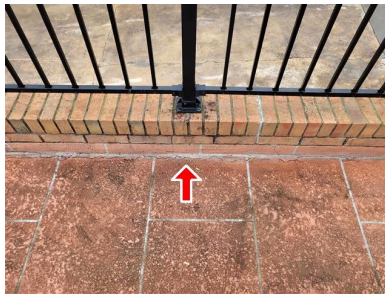
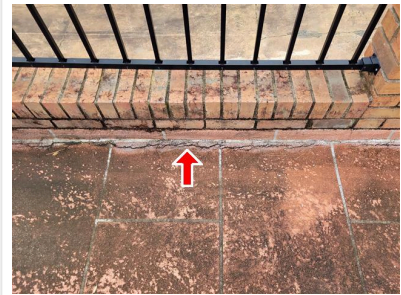
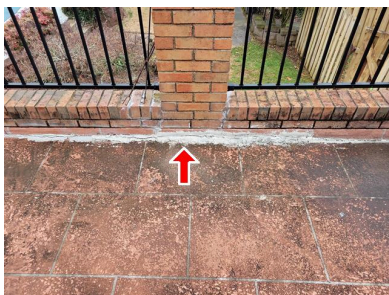
1. The patio at the rear of home is deteriorated. This is allowing water intrusion to occur. Further deterioration can occur if not repaired. Further investigation and repairs are needed.

A qualified contractor should repair or replace as needed.

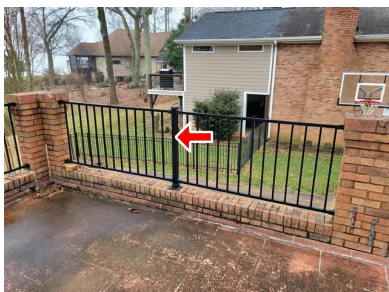
3.4 Item 22 (Picture)

1. The guardrails on patio at the rear of home is loose. A fall or injury could occur if not corrected. A repair or replacement is needed.

A qualified contractor should repair or replace as needed.

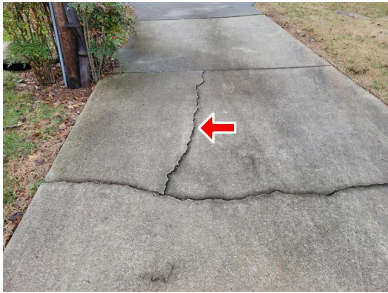
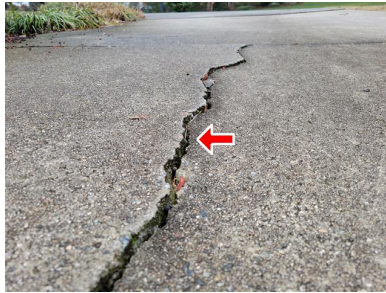
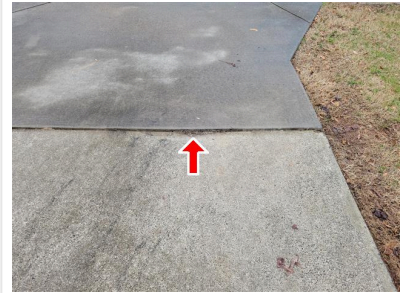
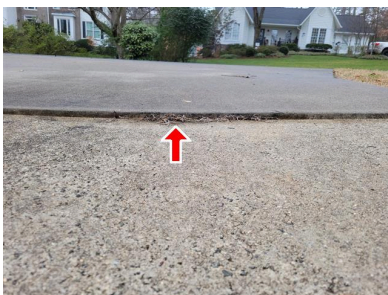
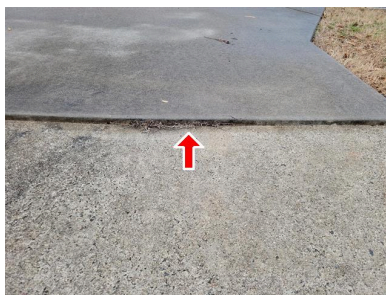
1. The concrete drive at the front of home uneven, and can be a tripping hazard. Water can cause further deterioration if not repaired and sealed properly. A fall or injury can occur if not corrected. Repairs are needed.

A qualified person should repair or replace as needed.

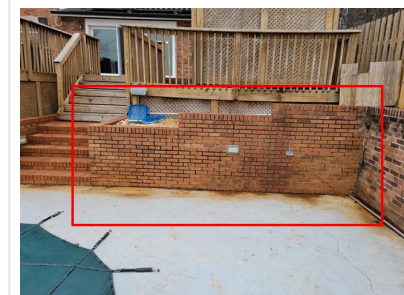
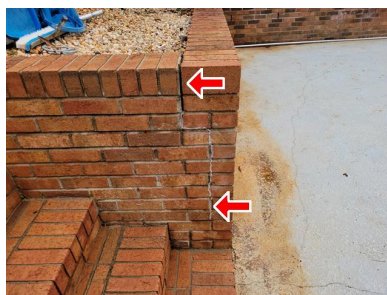
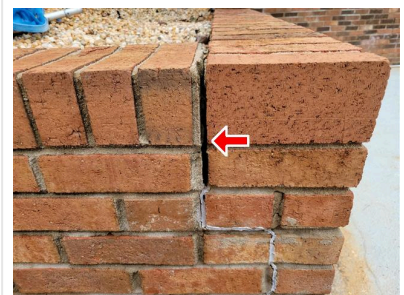
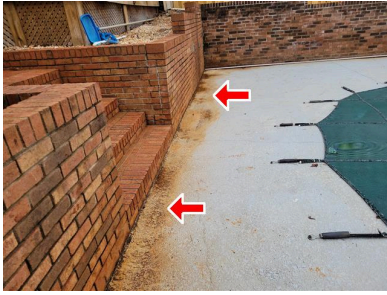
1. The retaining wall at the rear of the home has evidence of movement. Further deterioration could occur. Further investigation and repairs are needed.

A qualified contractor should repair or replace as needed.

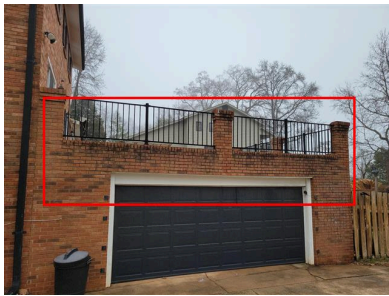
4.0 Item 1 (Picture)

1. The brick at the right side (facing front) and the rear have cracks present with outward displacement/movement present. The wall(s) may need reinforcement. Further investigation and repairs are needed. A qualified licensed general contractor should inspect further and repair as needed.

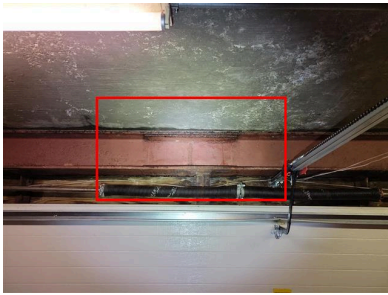
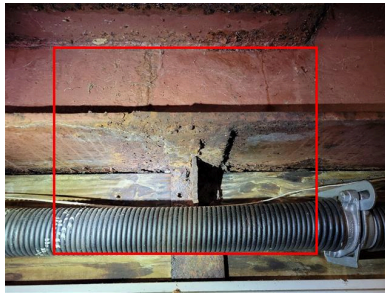
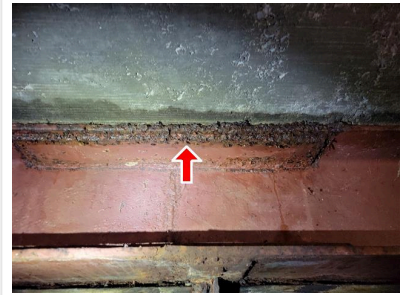
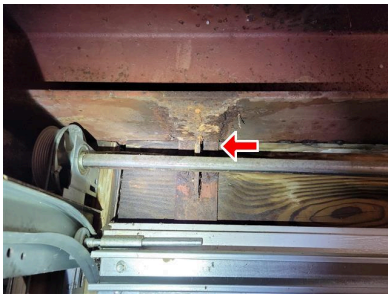
1. Steel truss is rusting under the concrete patio. I recommend having the steel truss evaluated for structural stability. Further investigation and repairs are needed.

A qualified licensed general contractor should inspect further and repair as needed.

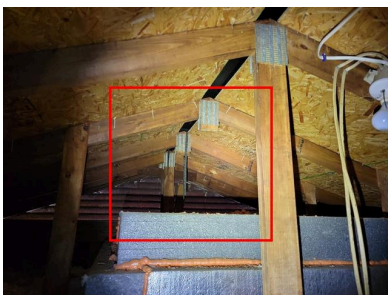
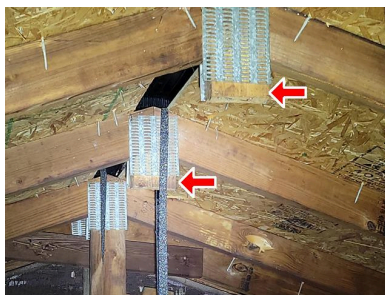
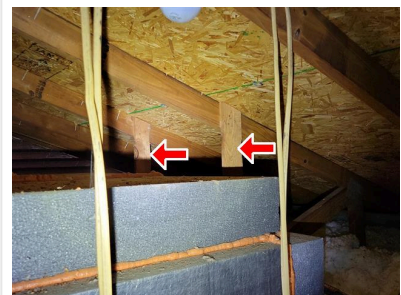
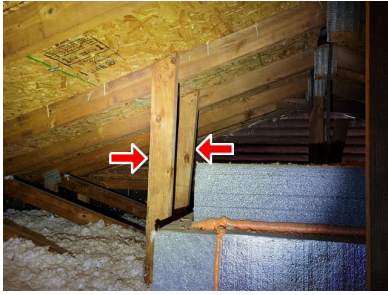
1. The truss system installed in the attic have been repaired due to damage during or before installation of the truss. All truss repairs should be repaired via an approved method specified by the manufacturer and or approved and stamped by licensed structural engineer. Note: No letter was present at repair. Further evaluation and repairs are needed. A qualified licensed structural engineer/design professional is recommended to evaluate the trusses for any repairs. This should include a site specific letter from the registered design professional/engineer stating what repairs (if any) are needed approval of performed repairs, signature, state license number, and state registered stamp of the engineer.

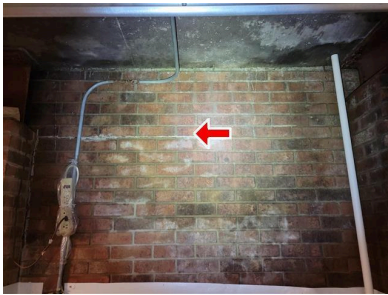
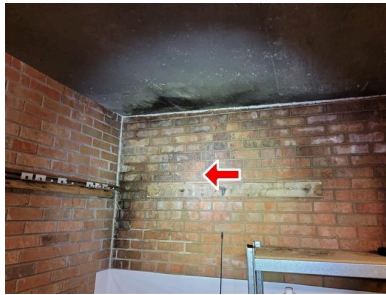
1. Visible signs of water intrusion in the garage are present from water on wall. Water intrusion if not corrected can lead to other problems including mold and cause excessive moisture to floor system that can lead to deterioration and increased repair cost. Further investigation and repairs are needed.

I recommend further investigation or correction by a qualified licensed contractor or water infiltration specialist.

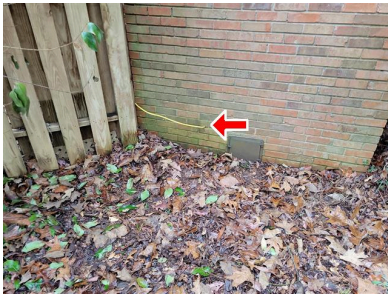
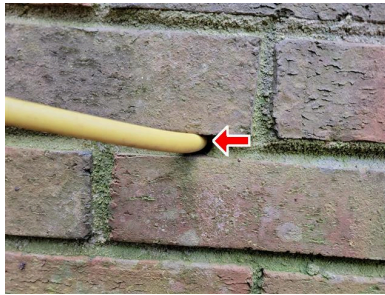
1. The gas line was installed improperly using soft copper through wall instead of hard piping at the fireplace. This is a safety issue and should be repaired. Further investigation and repairs are needed.

A qualified person should repair or replace as needed

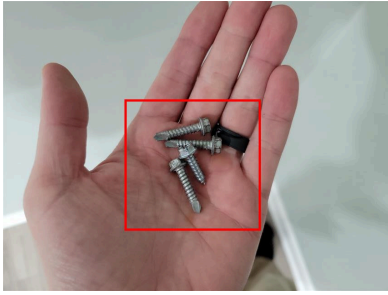
1. The electrical panel cover sub panel has been secured with sheet metal screw. This is considered unsafe as sheet metal screws are not rated for electrical panel use. The use of sheet metal screws with panel cover have been known to short hot wires, as they can pierce the branch wiring protective coverings. (Safety Issue) Repairs are needed.

A qualified licensed electrical contractor should correct as needed.

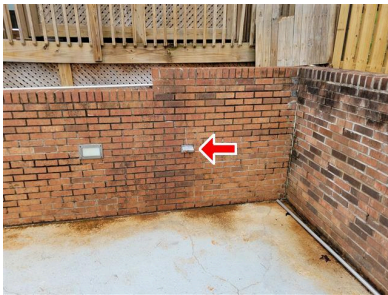
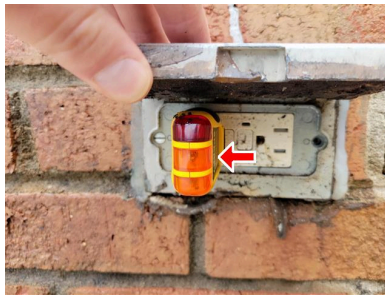
1. At least one GFCI (Ground Fault Circuit Interrupter) outlet at the exterior did not work or there is no power to outlet. Electrical issues are considered a hazard until repaired. Further investigation and repairs are needed.

A qualified licensed electrical contractor should correct as needed.

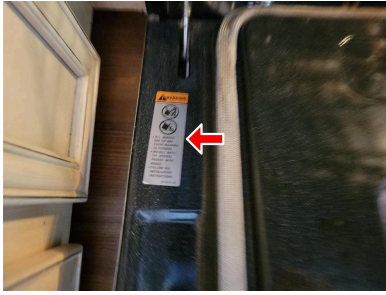
1. The range/oven needs to be properly attached/anchored to the structure as to keep it from tipping over when the oven door is opened and/or oven racks are pulled out during use. This is a safety issue. Repairs are needed.

I recommend contacting appliance repair company.

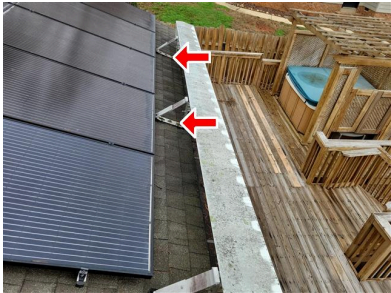
2.0 Item 1 (Picture)

- (1)
1. The roof at the rear of the home has evidence of repairs. This may allow water intrusion to occur. Further investigation and repairs are needed.

A qualified person should repair or replace as needed.

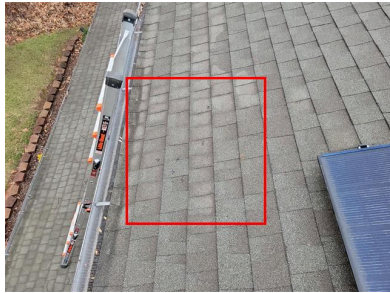
2.0 Item 4 (Picture)

1. The roof shingles is damaged at the front of home. Unable to determine if this area will leak. Repairs are needed.

A qualified person should repair or replace as needed.

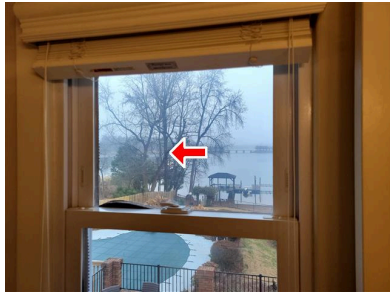
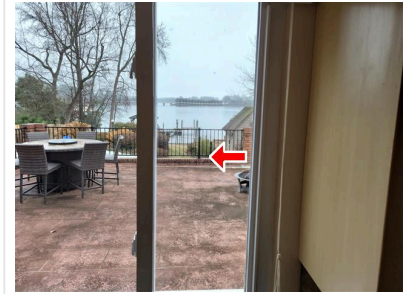
3.2 Item 1 (Picture)

- Several windows have failed/compromised thermal seals/fogged window panes. This is indicated by the visible moisture, discoloration, calcium deposits and or crystallization visible between the glass window panes. A certified window technician should recheck all the windows throughout the home. Due to weather conditions many times compromised/failed windows cannot be identified at the time of inspection. Further investigation and repairs are needed.

We recommend contacting a properly licensed window technician/contractor regarding these conditions and have repairs made deemed appropriate

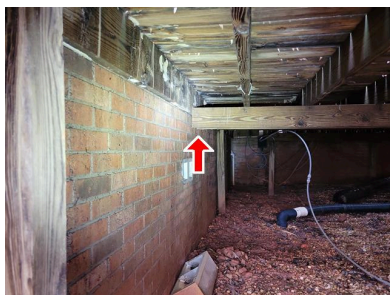
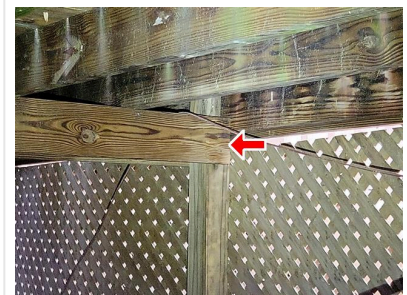
3.4 Item 1 (Picture)

1. The deck floor system at the rear of home is not supported properly. A fall or injury can occur if not corrected. I recommend having the entire deck evaluated for structural stability. Further investigation and repairs are needed.

A qualified contractor should repair or replace as needed.

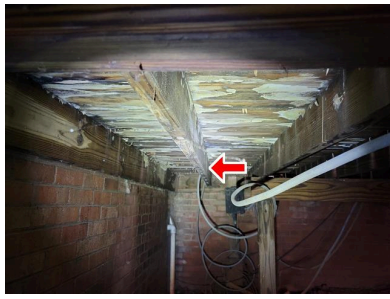
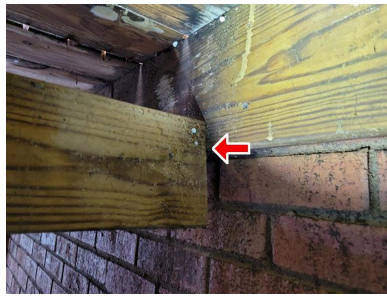
1. The exterior girders for the wood deck are attached to the support posts by simple nail connections only. This is an uncommon construction method. Typically girders require through bolt connections, structural screws or direct bearing at end points to prevent framing movement and or failure. Deck failure could occur if not addressed. Further investigation and repairs are needed.

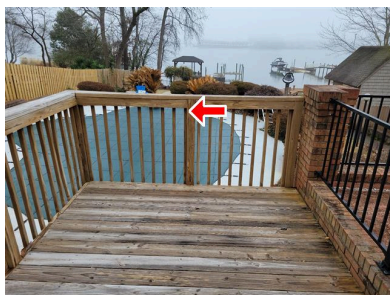
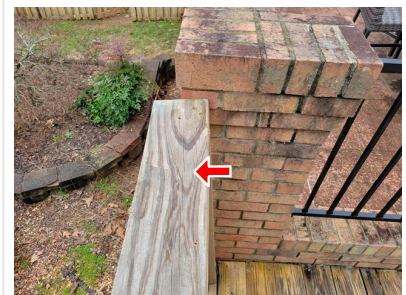
3.4 Item 7 (Picture)

1. The guardrails on deck at the rear of home are loose. A fall or injury could occur if not corrected. A repair or replacement is needed.

A qualified contractor should repair or replace as needed.

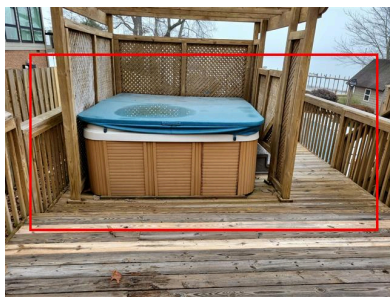
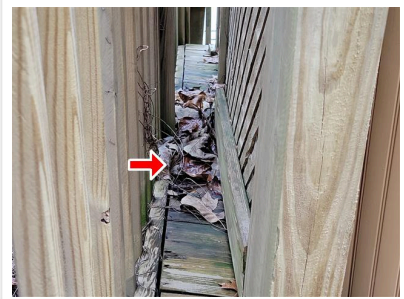
3.4 Item 10 (Picture)

1. The deck at the rear of the home is showing signs of failing. I recommend having the entire deck evaluated for structural stability. Further investigation and repairs are needed.

A qualified contractor should repair or replace as needed.

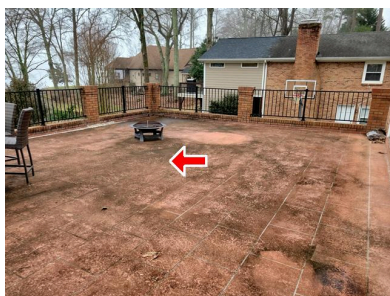
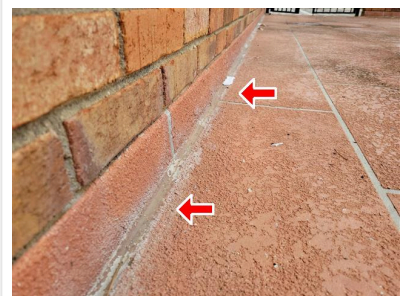
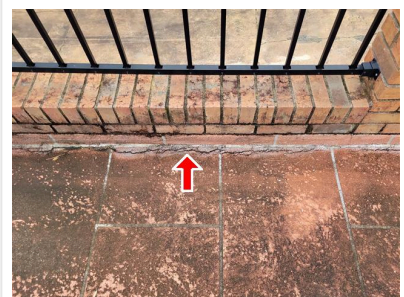
3.4 Item 15 (Picture)

1. The patio at the rear of home is deteriorated. This is allowing water intrusion to occur. Further deterioration can occur if not repaired. Further investigation and repairs are needed.

A qualified contractor should repair or replace as needed.

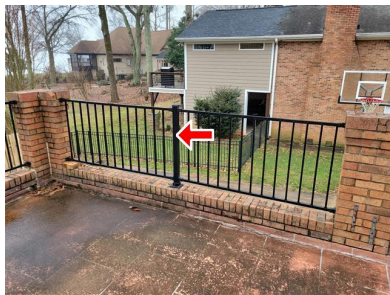
**3.4 Item 22 (Picture)**

1. The guardrails on patio at the rear of home is loose. A fall or injury could occur if not corrected. A repair or replacement is needed.

A qualified contractor should repair or replace as needed.

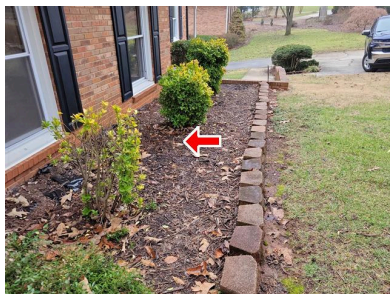
**3.5 Item 1 (Picture)**

1. There is a negative slope at the front of home and can cause or contribute to water intrusion or deterioration. Repairs are needed.

I recommend correcting landscape to drain water away from home.

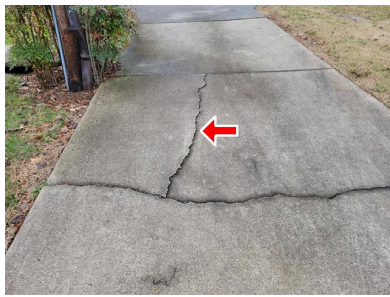
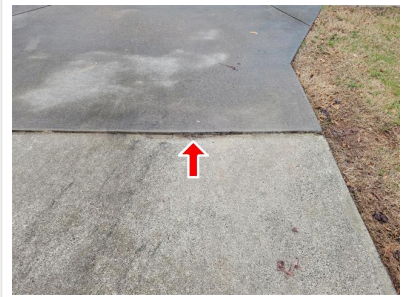
3.5 Item 2 (Picture)

1. The concrete drive at the front of home uneven, and can be a tripping hazard. Water can cause further deterioration if not repaired and sealed properly. A fall or injury can occur if not corrected. Repairs are needed.

A qualified person should repair or replace as needed.

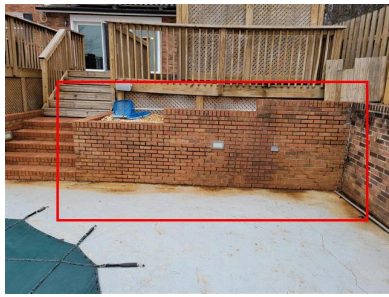
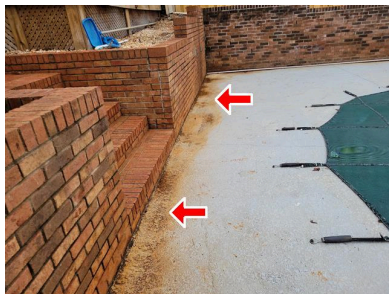
3.11 Item 1 (Picture)

1. The retaining wall at the rear of the home has evidence of movement. Further deterioration could occur. Further investigation and repairs are needed.

A qualified contractor should repair or replace as needed.

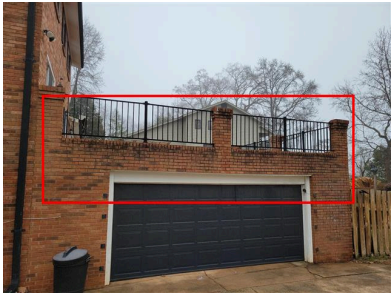
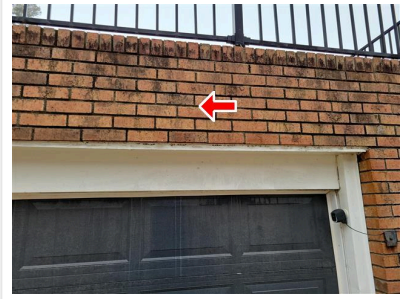
4.0 Item 1 (Picture)

1. The brick at the right side (facing front) and the rear have cracks present with outward displacement/ movement present. The wall(s) may need reinforcement. Further investigation and repairs are needed.

A qualified licensed general contractor should inspect further and repair as needed.

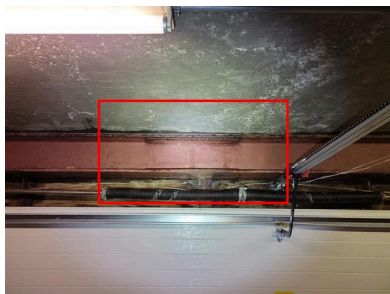
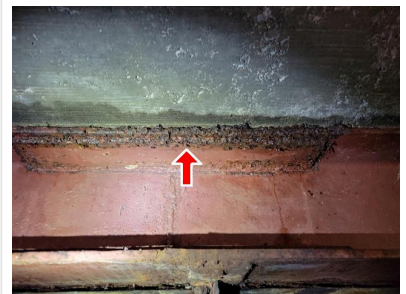
4.2 Item 1 (Picture)

1. Steel truss is rusting under the concrete patio. I recommend having the steel truss evaluated for structural stability. Further investigation and repairs are needed.

A qualified licensed general contractor should inspect further and repair as needed.

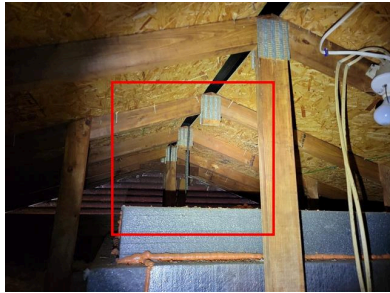
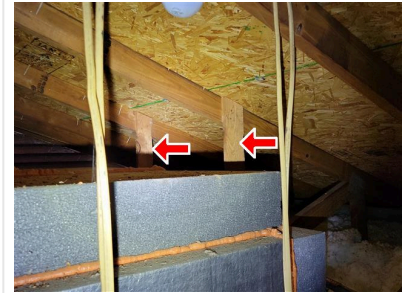
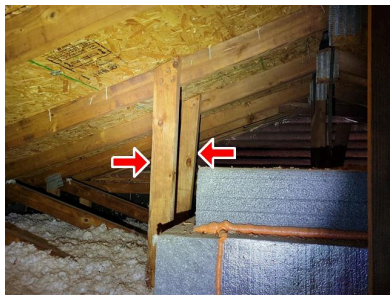
4.4 Item 1 (Picture)

1. The truss system installed in the attic have been repaired due to damage during or before installation of the truss. All truss repairs should be repaired via an approved method specified by the manufacture and or approved and stamped by licensed structural engineer. Note: No letter was present at repair. Further evaluation and repairs are needed. A qualified licensed structural engineer/design professional is recommended to evaluate the trusses for any repairs. This should include a site specific letter from the registered design professional/engineer stating what repairs (if any) are needed approval of performed repairs, signature, state license number, and state registered stamp of the engineer.

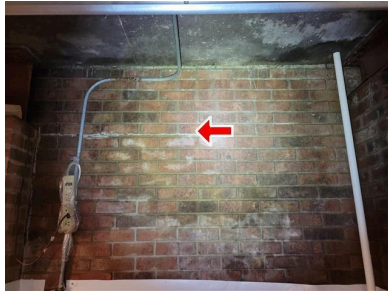
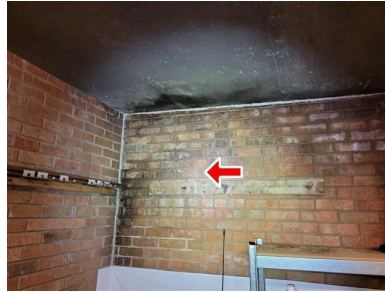
4.6 Item 1 (Picture)

1. Visible signs of water intrusion in the garage are present from water on wall. Water intrusion if not corrected can lead to other problems including mold and cause excessive moisture to floor system that can lead to deterioration and increased repair cost. Further investigation and repairs are needed.

I recommend further investigation or correction by a qualified licensed contractor or water infiltration specialist.

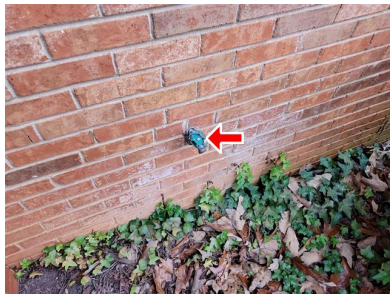
5.2 Item 1 (Picture)

1. The hose bib outside water faucet loose, and needs securing to wall at the front of home. This can allow undue stress to occur on supply lines allowing leaks to occur. Repairs are needed..

A qualified licensed plumber should repair or correct as needed.

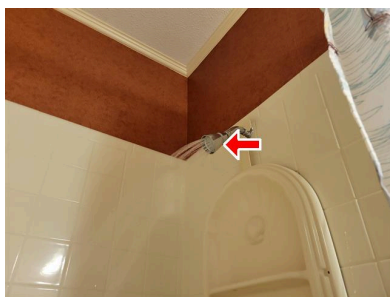
5.2 Item 3 (Picture)

1. The tub spout diverter is does not function properly at the guest bath. Further investigation and repairs are needed..

A qualified licensed plumber should repair or correct as needed.

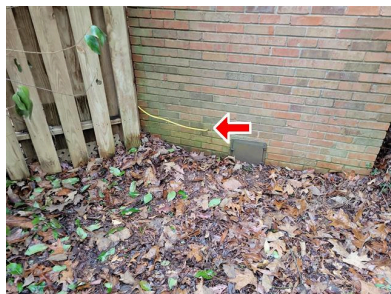
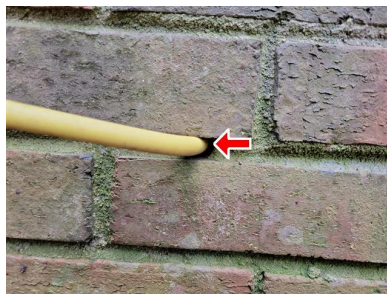
5.5 Item 1 (Picture)

1. The gas line was installed improperly using soft copper through wall instead of hard piping at the fireplace. This is a safety issue and should be repaired. Further investigation and repairs are needed.

A qualified person should repair or replace as needed

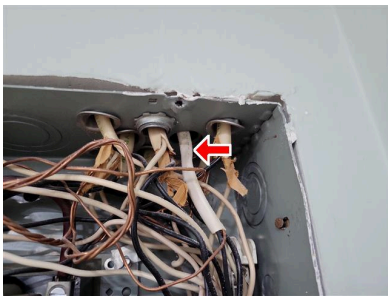
6.2 Item 1 (Picture)

1. The wire protection grommets are missing where the branch wiring enters the panel. Electrical issues are considered a hazard until repaired. Repairs are recommended.

A qualified licensed electrical contractor should correct as needed.

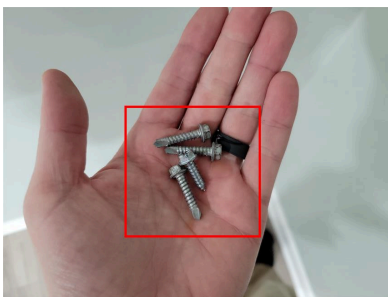
6.2 Item 2 (Picture)

1. The electrical panel cover sub panel has been secured with sheet metal screws. This is considered unsafe as sheet metal screws are not rated for electrical panel use. The use of sheet metal screws with panel cover has been known to short hot wires, as they can pierce the branch wiring protective coverings. (Safety Issue) Repairs are needed.

A qualified licensed electrical contractor should correct as needed.

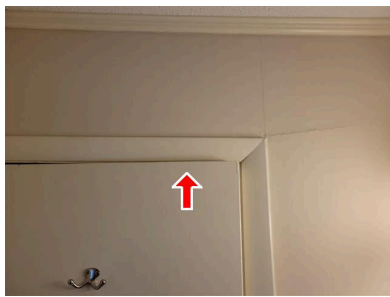
8.5 Item 1 (Picture)

1. The privacy door rubs at top when closing at the master bath. As a result the door will not close properly. Repairs are needed.

A qualified person should repair or replace as needed.

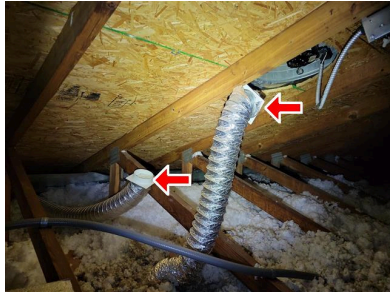
9.5 Item 1 (Picture)

1. The exhaust fan does not vent to outside at the guest and master bath. Vent pipes should terminate outside and not in the attic. Many homes have their vent pipe poised at the roof vent such as yours. It is up to you to determine whether or not this is a concern or needs further consideration from a general contractor. Repairs are needed.

A qualified person should repair or replace as needed.

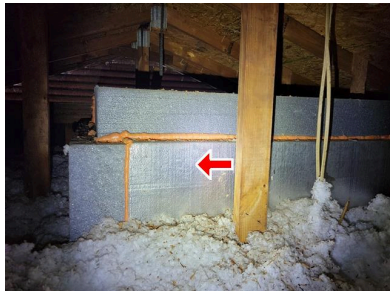
9.6 Item 1 (Picture)

1. Whole house fan in the attic was insulated or blocked during inspection for winterization. Damage can occur if someone turns on switch. I did not inspect this unit.

A qualified person should repair or replace as needed.

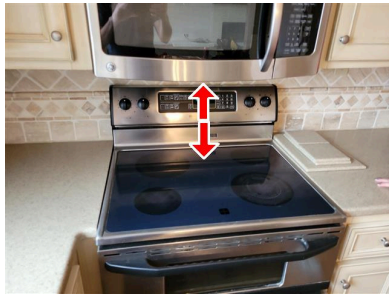
10.5 Item 1 (Picture)

1. The microwave has improper clearance from the stove top. This can cause damage to the microwave. I recommend repair as needed.

I recommend contacting appliance repair company.
