INSPECTION REPORT  
5000 Meadow Hill Ct  
Winston-Salem NC 27106

INSPECTION DATE  
📅 5/30/2024  
🕒 09:00:00 AM

Inspection Date: 5/30/2024  
Report ID: 053024AP2

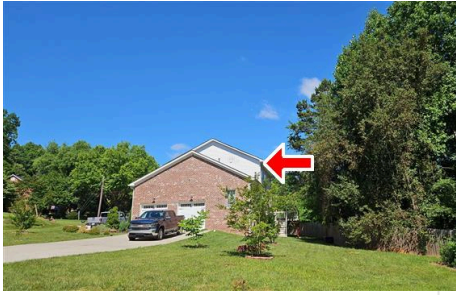
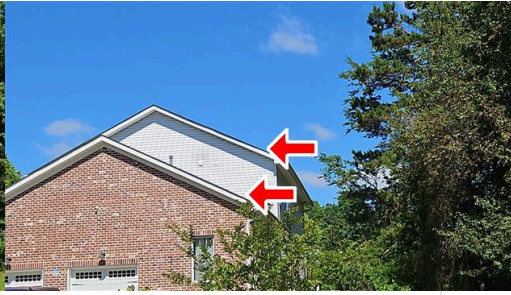
1. The roof at the rear of the home cannot be viewed. As a result the areas were not inspected. Hidden damage may be present. Further investigation and repairs are needed.

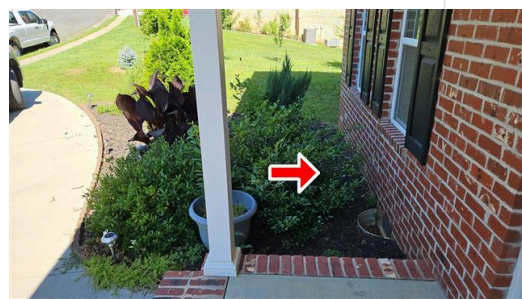
3.5 Item 1 (Picture)

1. There is a negative slope at the front of home and can cause or contribute to water intrusion or deterioration. I recommend correcting landscape to drain water away from home. Repairs are needed.

A qualified contractor should inspect and repair as needed.

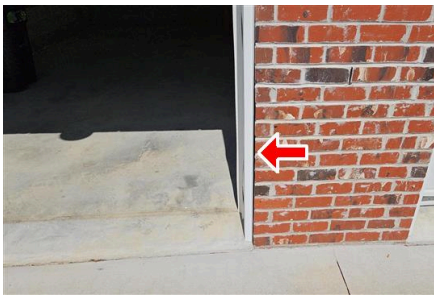
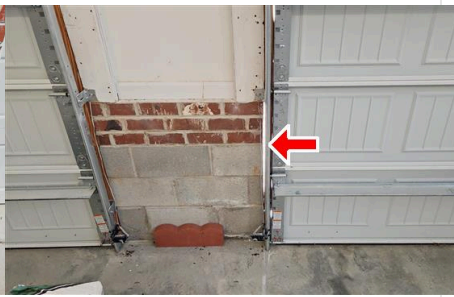
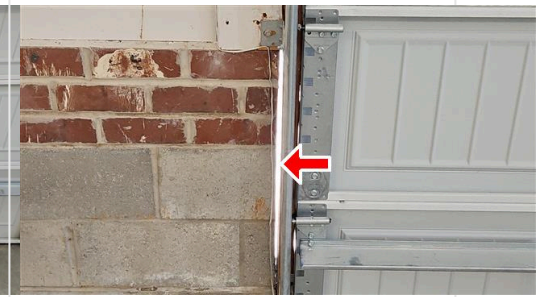
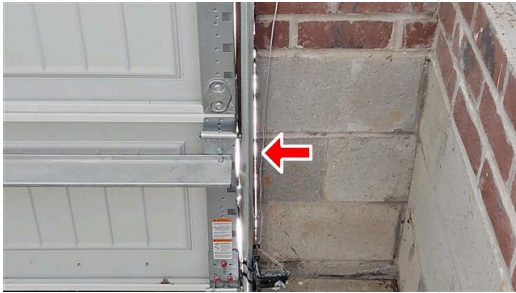
1. The garage door at the right side (facing front) has an air gap. This can cause some heat loss in winter and loss of cool air in summer if not corrected. A repair or replacement is needed.

A qualified contractor should inspect and repair as needed.

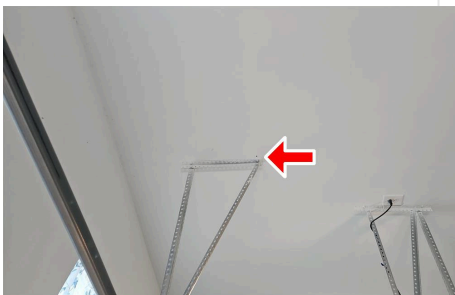
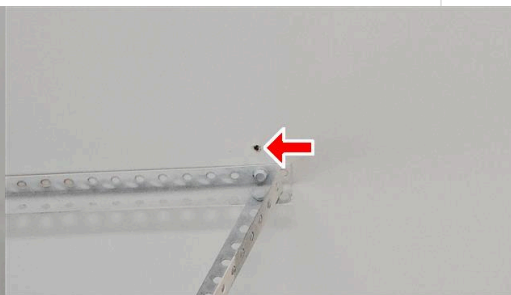
1. The fire resistance sheathing in garage is compromised. This is considered unsafe until corrected. A qualified person should correct for safety.

A qualified contractor should inspect and repair as needed.

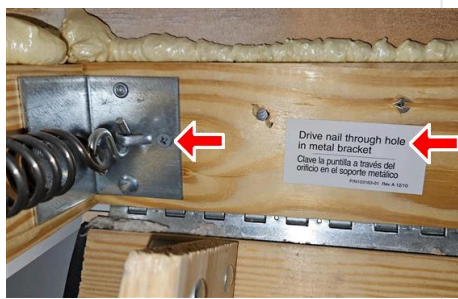
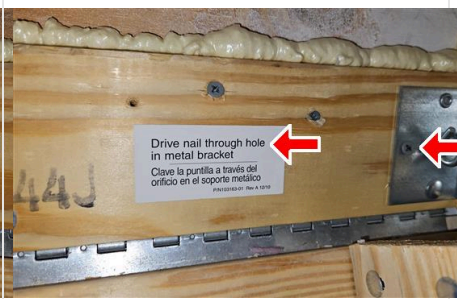
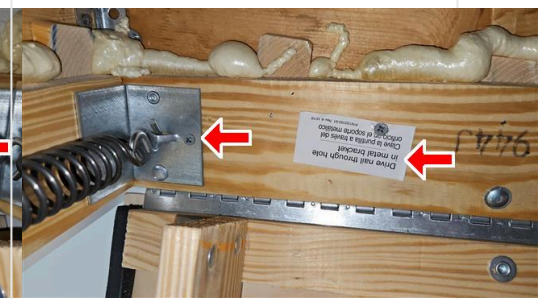
1. The pull down stairs for the attic is installed with deck screws. The only approved means of securing attic stairs is a 16 penny nail per manufacture. An injury could occur if not corrected. Repairs are needed.

A qualified person should repair or replace as needed.

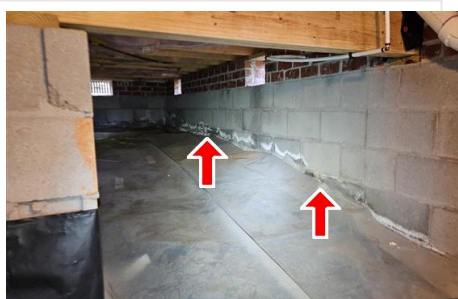
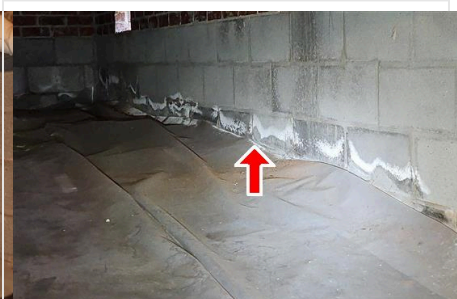
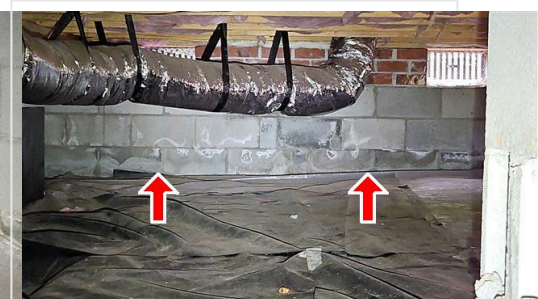
1. White efflorescence (powder substance) on block wall indicates moisture is in contact with the masonry. This does not necessarily indicate that intrusion will occur. I recommend checking the gutters and the downspout drain lines for proper operation. Also, a water proofing paint could be applied to the interior side of the block if necessary. Efflorescence is found on many homes without water intrusion occurring inside the home. But, it should alert you to the possibility that future steps may be needed.

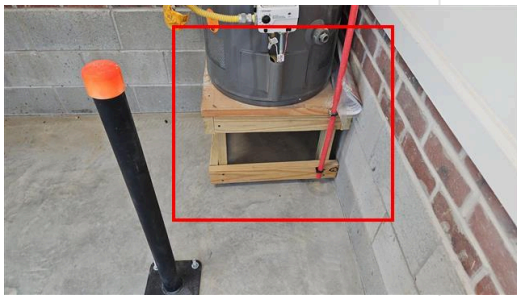
5.1 Item 1 (Picture)

1. The stand for the water heater is wood structure that does not appear to meet typical construction methods for a standard floor framing. Due to the unit's weight and safety related to a field water heater, water heater stands are typically required to be rated and labeled. Further investigation is needed.

A qualified contractor should inspect and repair as needed.

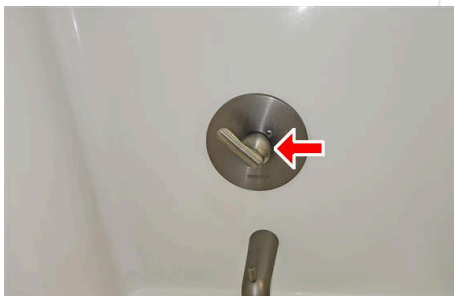
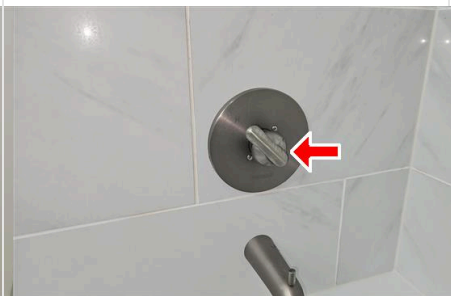
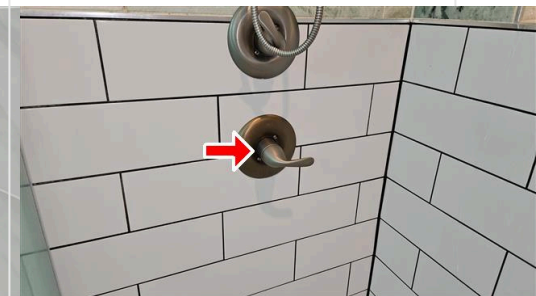
1. The control lever is reversed (hot is cold, cold is hot) at the guest and master bath. Hot should always be on the left and cold on the right for safety reasons. Scalding could occur if not corrected. Repairs are needed.

A qualified licensed plumber should repair or correct as needed.

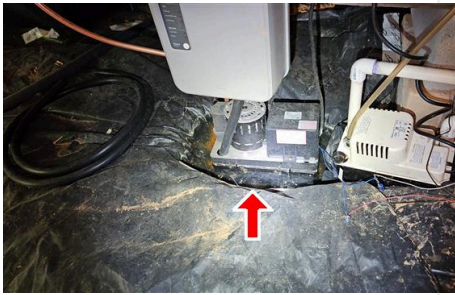
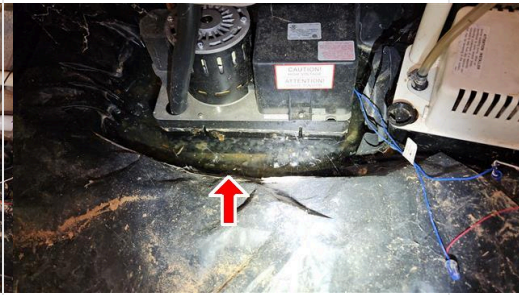
1. The condensation pump is leaking in the crawl space. Leaks can cause damage to unit or home. Further investing and repairs are needed.

A qualified HVAC person should inspect further and repair or replace as needed.

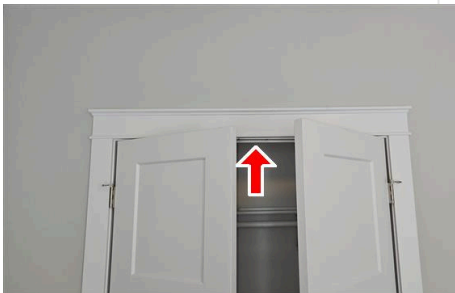
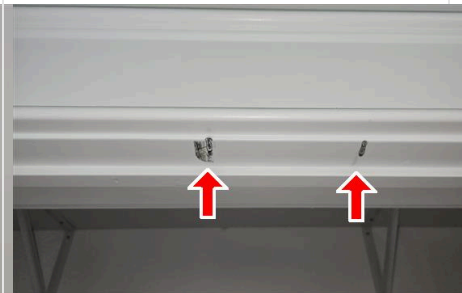
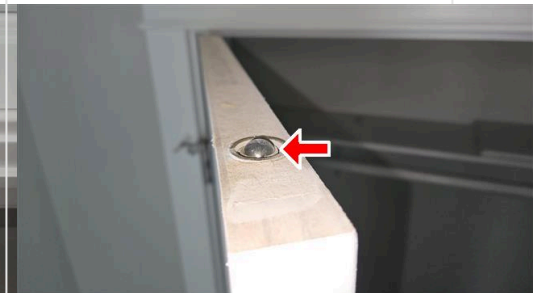
1. The closet door is missing the latch at the guest Bedroom. As a result the door will not close properly. Repairs are needed.

A qualified person should repair or replace as needed.

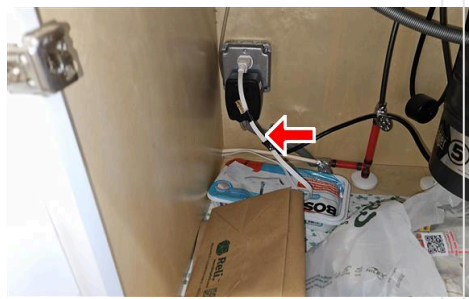
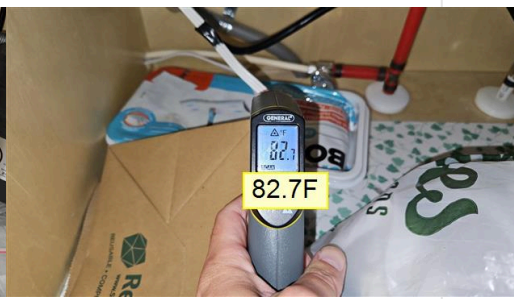
1. The power cord for dishwasher appears to be undersized and warm to the touch. This is a fire hazard. Further investigation repairs are needed.

I recommend contacting appliance repair company.

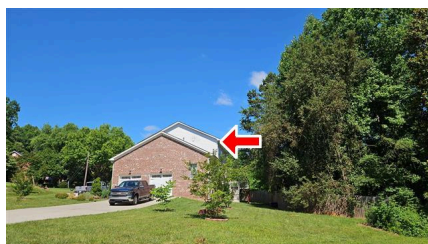
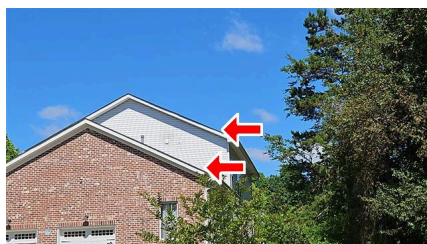
1. The roof at the rear of the home cannot be viewed. As a result the areas were not inspected. Hidden damage may be present. Further investigation and repairs are needed.

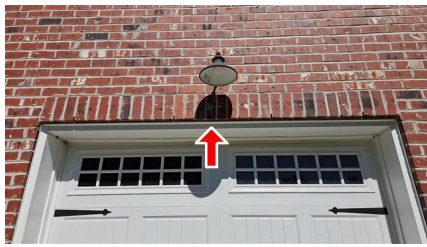
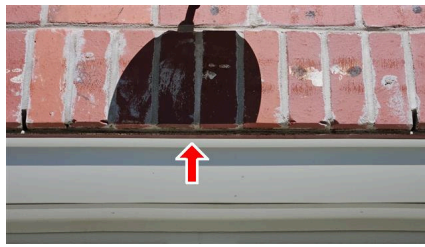
1. The steel lintels around the exterior of the home are beginning to rust or have rust present. A lintel is a horizontal architectural member or steel beam support placed over a wall opening to carry the weight of the masonry placed over it. In most situation, the lintel above you windows and doors will be steel angle iron or I beam. Either due to age or improper rust proofing or weep chord and flashing placement during installation, lintels will begin to rust. Rusting lintels can expand to become mush thicker then their original size. The expansive forces of rusting steel can shift entire multi-story elevations. If your lintels are currently rusting, a telltale sign of expansion is diagonal "step" pattern cracks, which can be found on either end of the window or door opening. Repairs are needed to prevent further damage to the structure. Further deterioration may occur if not repaired.

I recommend a qualified contractor inspect and repair as needed.

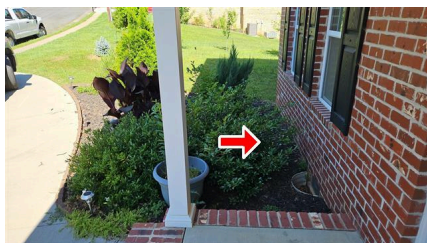
3.5 Item 1 (Picture)

1. There is a negative slope at the front of home and can cause or contribute to water intrusion or deterioration. I recommend correcting landscape to drain water away from home. Repairs are needed.

A qualified contractor should inspect and repair as needed.

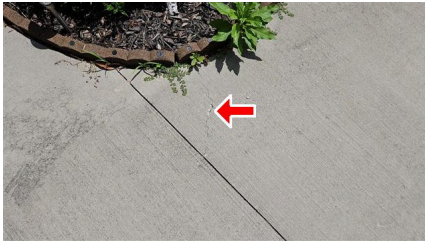
3.5 Item 2 (Picture)

1. The concrete driveway has cracks that should be sealed to prevent further damage, which is part of ongoing maintenance of a concrete driveway that will need to be performed on a regular basis. Repairs are recommended.

A qualified contractor should inspect and repair as needed.

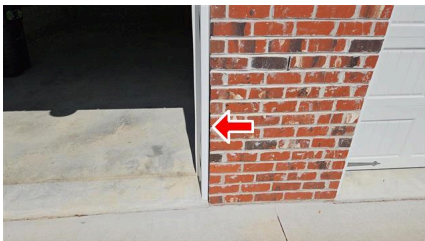
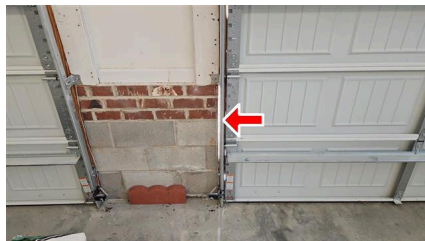
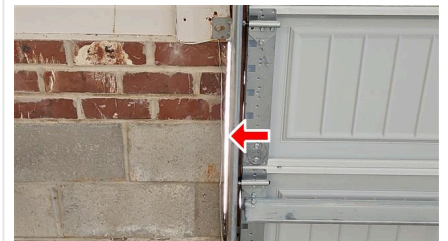
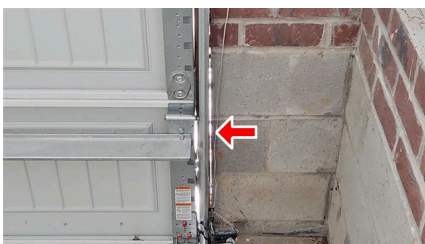
1. The garage door at the right side (facing front) has an air gap. This can cause some heat loss in winter and loss of cool air in summer if not corrected. A repair or replacement is needed.

A qualified contractor should inspect and repair as needed.

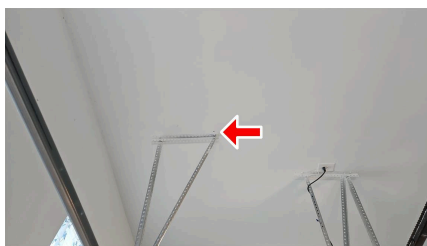
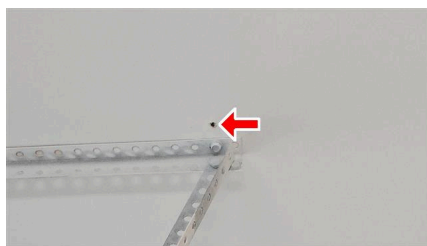
1. The fire resistance sheathing in garage is compromised. This is considered unsafe until corrected. A qualified person should correct for safety.

A qualified contractor should inspect and repair as needed.

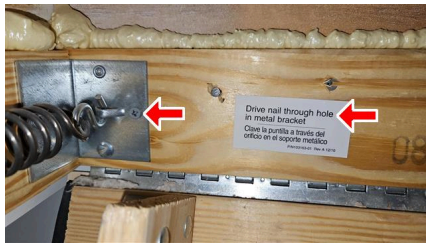
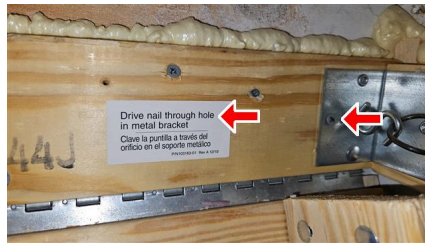
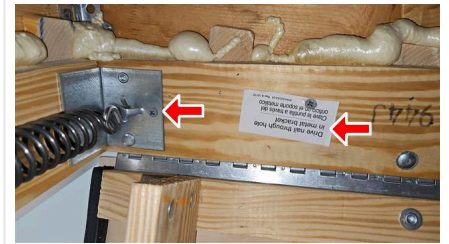
Repairs are needed.

A qualified person should repair or replace as needed.

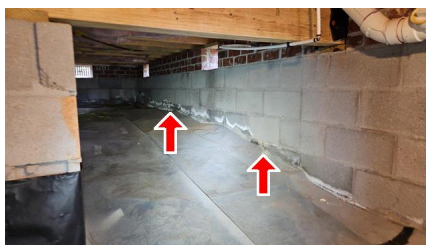
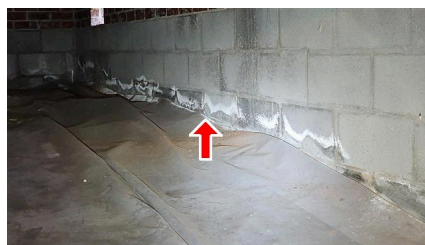
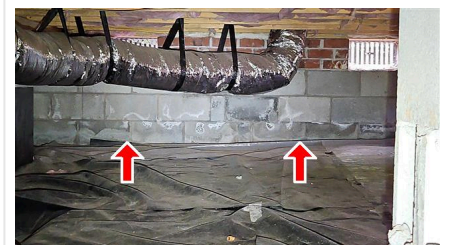
1. White efflorescence (powder substance) on block wall indicates moisture is in contact with the masonry. This does not necessarily indicate that intrusion will occur. I recommend checking the gutters and the downspout drain lines for proper operation. Also, a water proofing paint could be applied to the interior side of the block if necessary. Efflorescence is found on many homes without water intrusion occurring inside the home. But, it should alert you to the possibility that future steps may be needed.

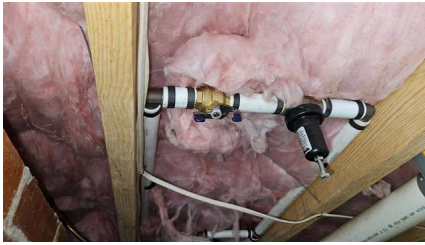
5.0 Item 1 (Picture)

The main shut off is the blue knob located underneath in the crawlspace. This is for your information.

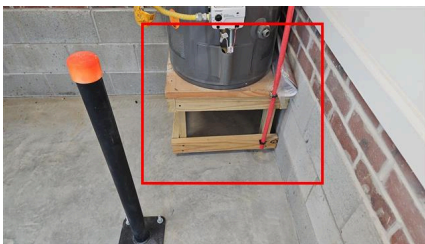
5.1 Item 1 (Picture)

1. The stand for the water heater is wood structure that does not appear to meet typical construction methods for a standard floor framing. Due to the unit's weight and safety related to a field water heater, water heater stands are typically required to be rated and labeled. Further investigation is needed.

A qualified contractor should inspect and repair as needed.

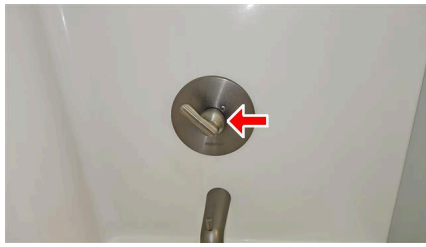
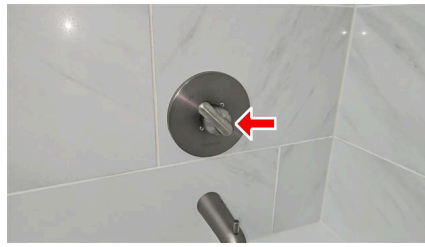
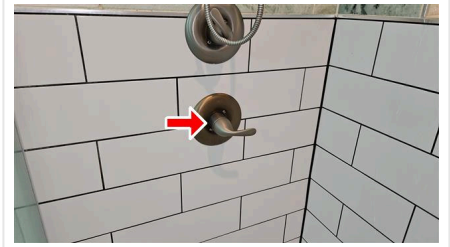
1. The control lever is reversed (hot is cold, cold is hot) at the guest and master bath. Hot should always be on the left and cold on the right for safety reasons. Scalding could occur if not corrected. Repairs are needed.

A qualified licensed plumber should repair or correct as needed.

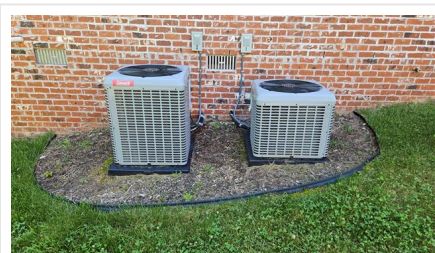
Complimentary photo of the heat pump and AC unit

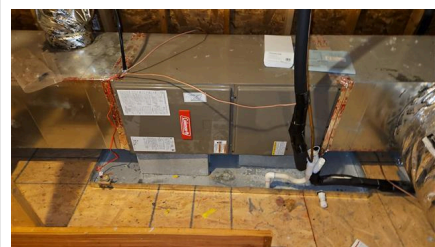
Complimentary photo of the heat pump

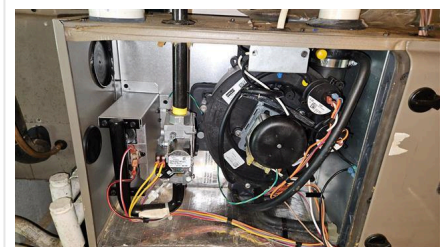
Complimentary photo of the gas furnace with the cover off

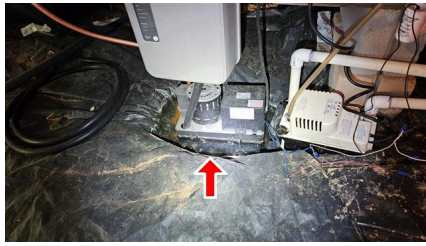
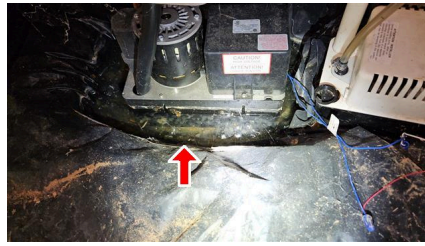
1. The condensation pump is leaking in the crawl space. Leaks can cause damage to unit or home.

Further investing and repiars are needed.

A qualified HVAC person should inspect further and repair or replace as needed.

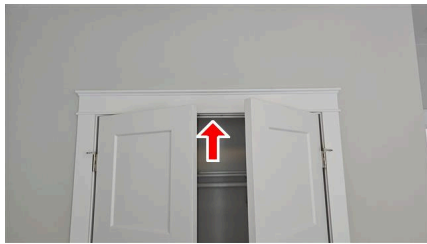
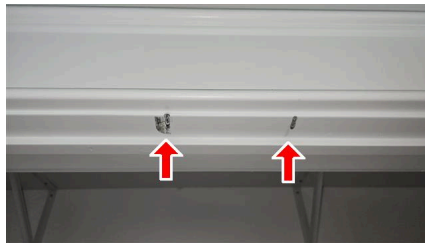
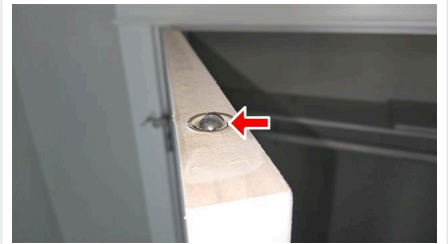
1. The closet door is missing the latch at the guest Bedroom. As a result the door will not close properly. Repairs are needed.

A qualified person should repair or replace as needed.

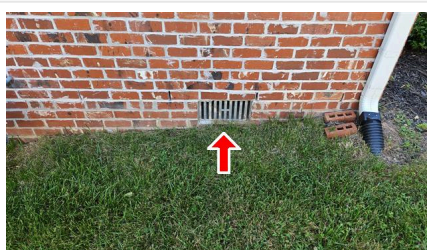
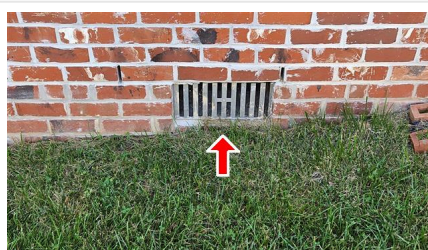
1. The foundation vent(s) at left side (facing front) is at or near ground level. Adding mulch or landscape to this area could result in water intrusion, if vent becomes lower than the ground. Should you decide to landscape, or if water intrusion was to occur through vent, I would recommend a half-round window well be installed.

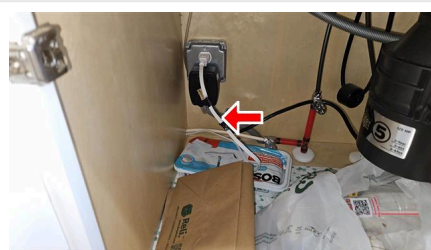
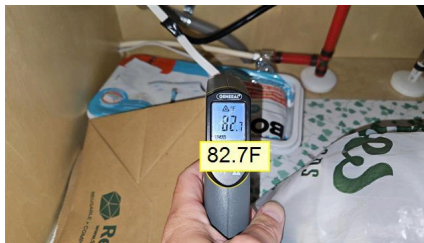
1. The power cord for dishwasher appears to be undersized and warm to the touch. This is a fire hazard. Further investigation repairs are needed.

I recommend contacting appliance repair company.
