INSPECTION REPORT  
8504 Hope Springs Ct  
Huntersville NC 28078

INSPECTED BY  
Alex Parr 3692  
Above Parr Home  
Inspections

INSPECTION DATE  
📅 4/20/2023  
🕒 09:00:00 AM

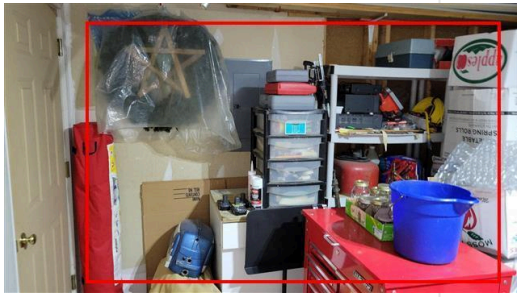
1.1 Item 1 (Picture)

1. Furniture, storage and or personal items in the garage and throughout the house. As a result the areas were not inspected. hidden damage may be present. Further investigation and repairs are needed.

We recommend having all personal items removed and these areas inspected prior to closing.

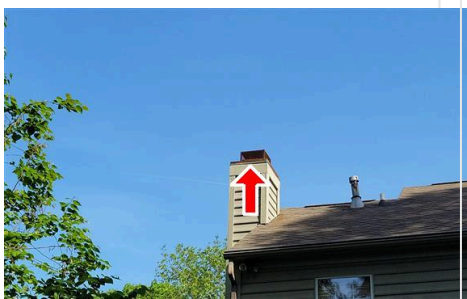
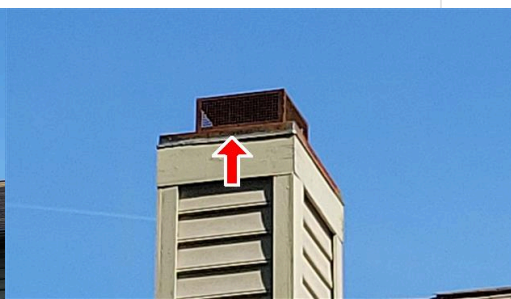
1. The cap flashing on the top of the chimney is rusted. Further deterioration can occur if not corrected. Repairs are needed.

A qualified person should repair or replace as needed.

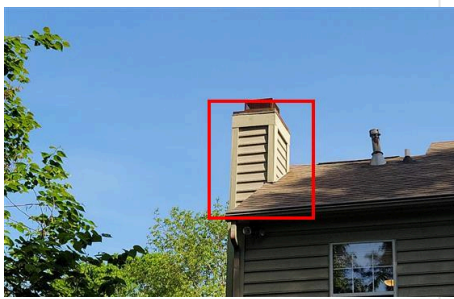
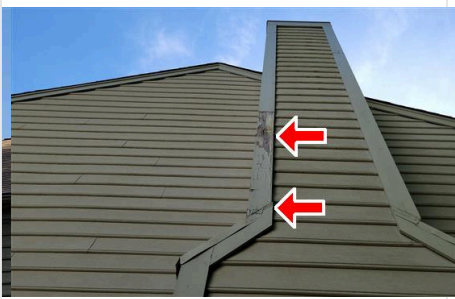
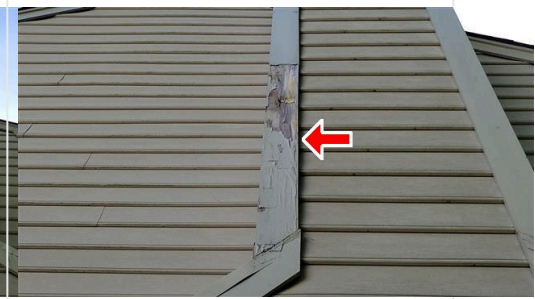
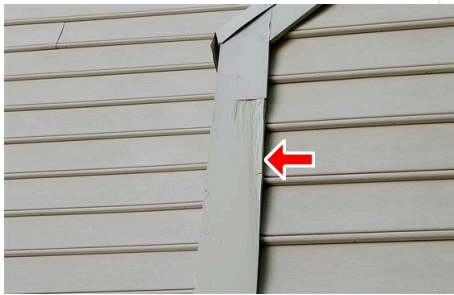
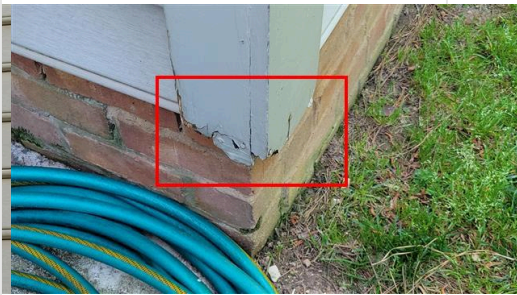
1. The wood trim at the exterior deteriorated in various areas. Further deterioration can occur if not corrected. Repairs are needed.

A qualified person should repair or replace as needed.

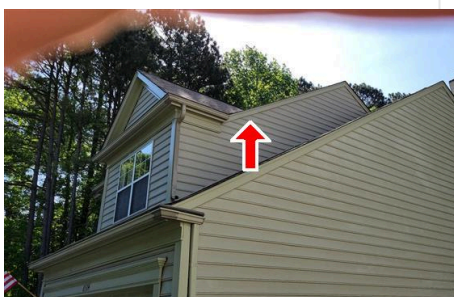
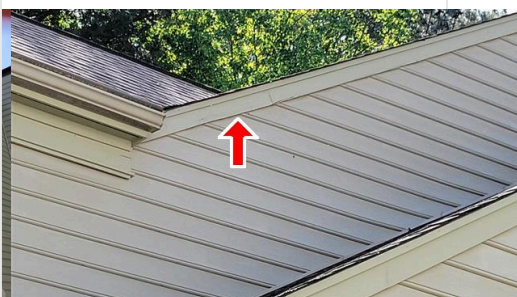
1. The wood fascia at eave on the exterior in areas is deteriorated. Further deterioration may occur if not repaired. Repairs are needed.

A qualified person should repair or replace as needed.

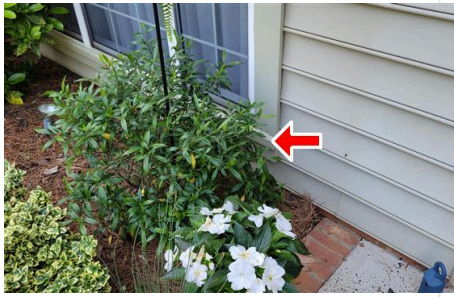
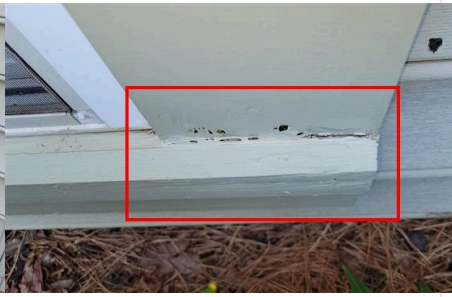
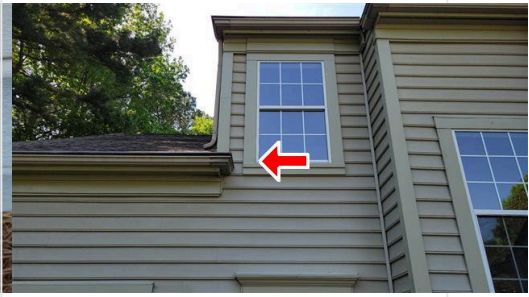
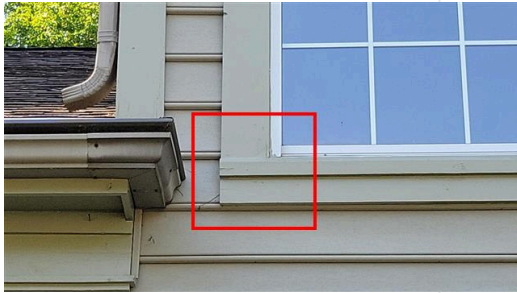
1. The wood trim is deteriorated at some windows. Further deterioration may occur if not repaired. Repairs are needed.

A qualified person should repair or replace as needed.

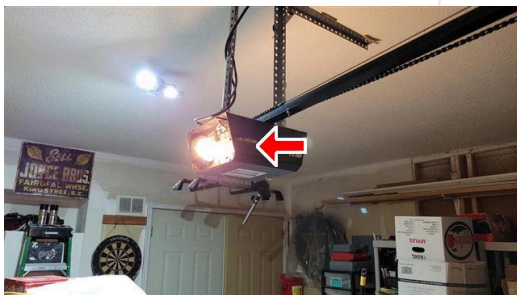
3.7 Item 1 (Picture)

1. The garage door operator safety reverse will not reverse properly when met with resistance. This is a safety issue. Further investigation and repairs are needed.

A qualified person should repair or replace as needed.

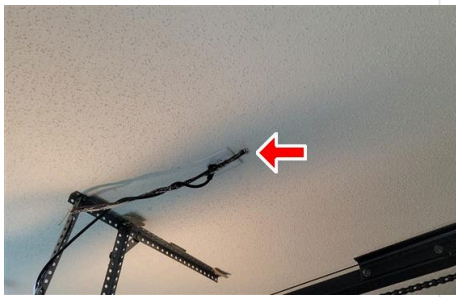
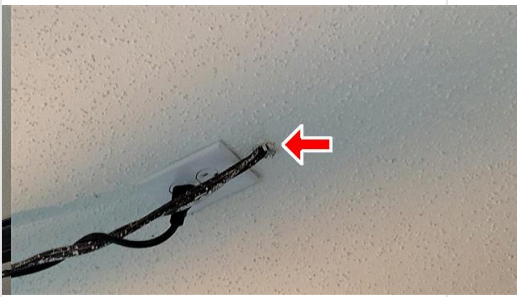
1. The fire resistance sheathing in garage is compromised. This is considered unsafe until corrected. Repairs are needed.

A qualified person should correct for safety.

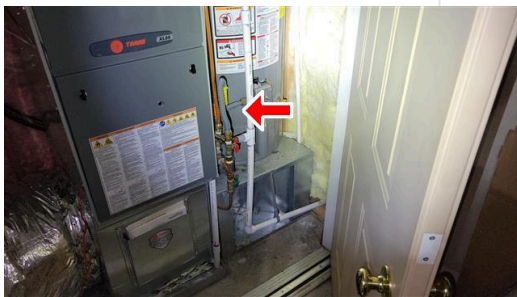
5.1 Item 1 (Picture)

1. The water heater in the closet does not appear to have enough combustion air. This is a safety issue. Further investigation is needed.

A qualified contractor should inspect and repair as needed.

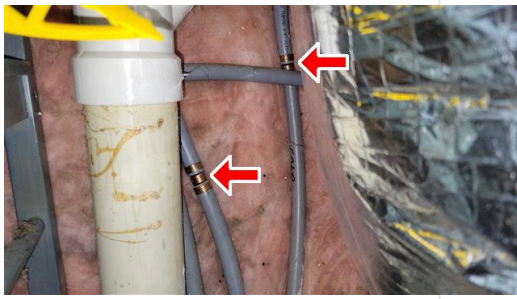
5.2 Item 1 (Picture)

1. Polybutylene plastic plumbing supply lines (PB) are installed in the subject house. Polybutylene has been used in this area for many years, but has had a higher than normal failure rate, and is no longer being widely used. Copper and Brass fittings used in later years have apparently reduced the failure rate. This subject house has copper fittings. For further details contact the Consumer Plumbing Recovery center at 1-800-392-7591 or the web at <http://www.pbpipe.com>

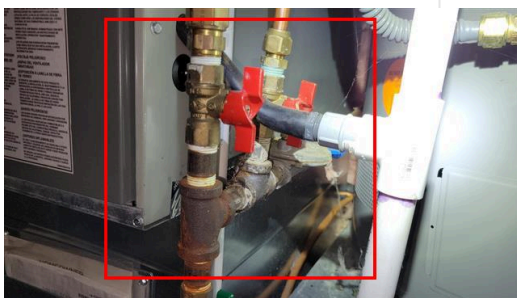
5.6 Item 1 (Picture)

1. The drip legs for the gas lines at the gas furnace is missing. As a result the gas appliance is not installed per the manufactures recommendation. Further investigation and repairs are needed.

I recommend a qualified licensed contractor inspect further and repair as needed.

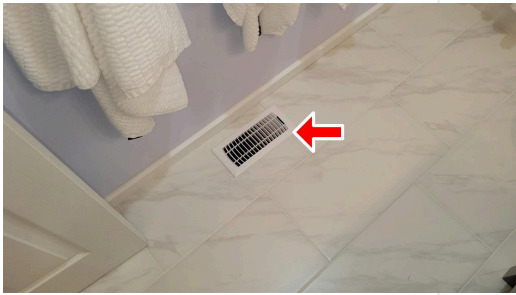
7.3 Item 1 (Picture)

1. The supply register in floor is weak (not intended for floor) in the guest bath. This is a safety issue and should be repaired. A replacement is needed.

A licensed HVAC contractor should service or repair unit.

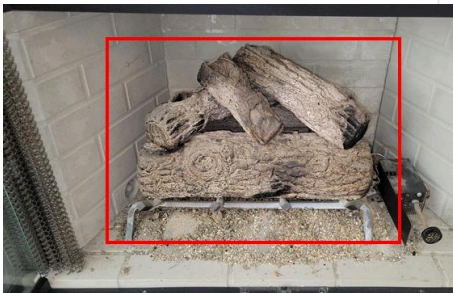
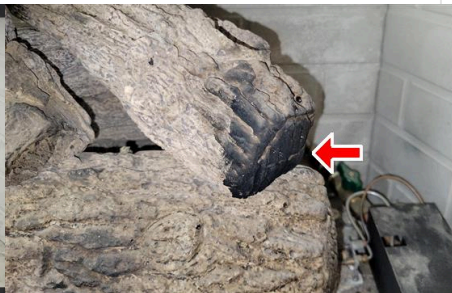
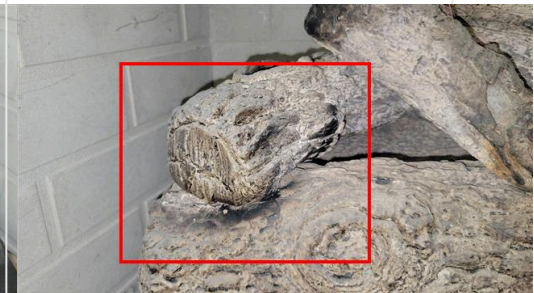
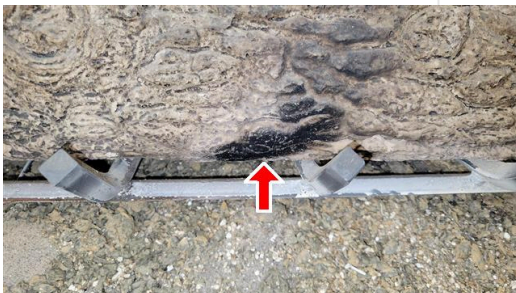
1. The black soot build-up indicates that Gas Fire logs do not appear to be arranged or positioned according to manufacturer's specs. If logs are not positioned correctly, carbon monoxide can be produced. Repairs are needed.

A licensed HVAC contractor should service or repair unit.

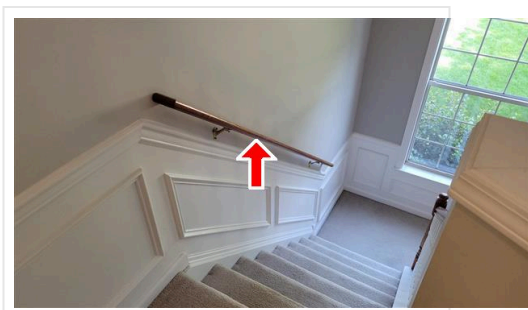
8.3 Item 1 (Picture)

1. The hand/guard rail for the upstairs is loose. A fall or injury could occur if not corrected. A repair or replacement is needed.

A qualified contractor should repair or replace as needed.

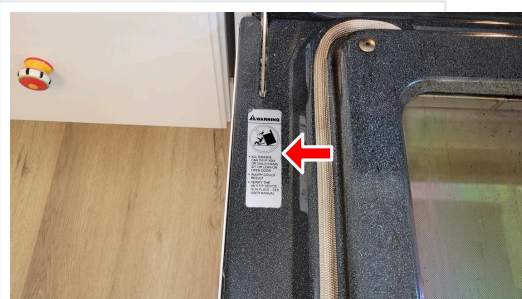
10.1 Item 1 (Picture)

1. The range/oven needs to be properly attached/anchored to the structure as to keep it from tipping over when the oven door is opened and/or oven racks are pulled out during use. This is a safety issue. Repairs are needed.

I recommend contacting appliance repair company.

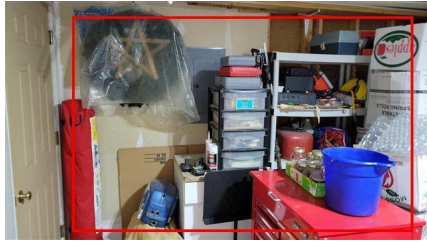
1.1 Item 1 (Picture)

1. Furniture, storage and or personal items in the garage and throughout the house. As a result the areas were not inspected. hidden damage may be present. Further investigation and repairs are needed.

We recommend having all personal items removed and these areas inspected prior to closing.

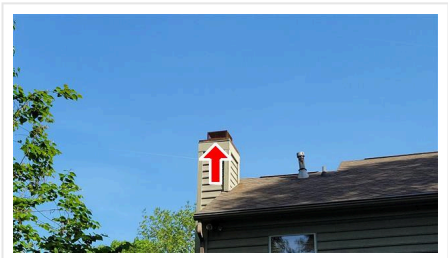
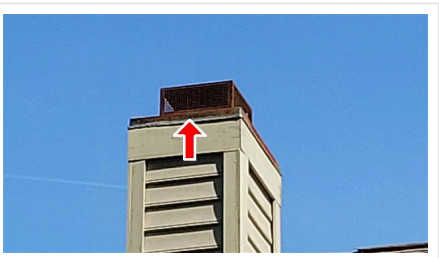
1. The cap flashing on the top of the chimney is rusted. Further deterioration can occur if not corrected. Repairs are needed.

A qualified person should repair or replace as needed.

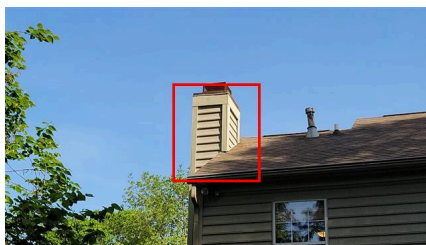
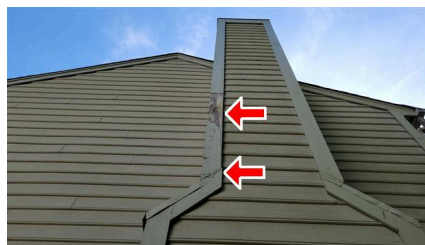
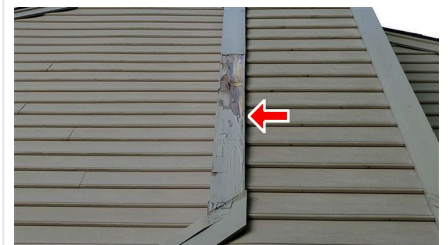
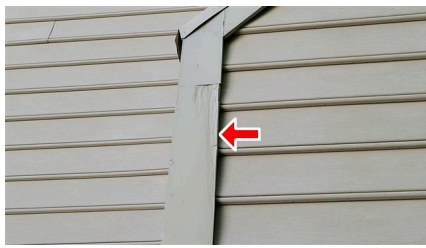
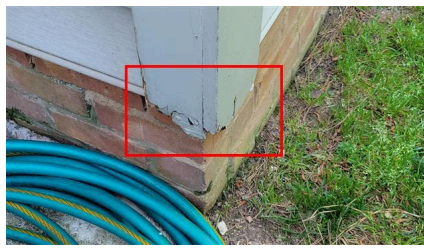
1. The wood trim at the exterior deteriorated in various areas. Further deterioration can occur if not corrected. Repairs are needed.

A qualified person should repair or replace as needed.

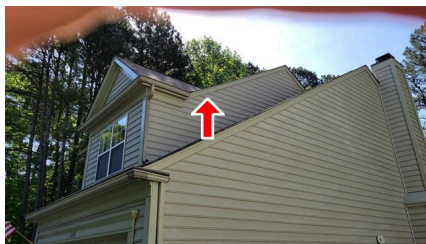
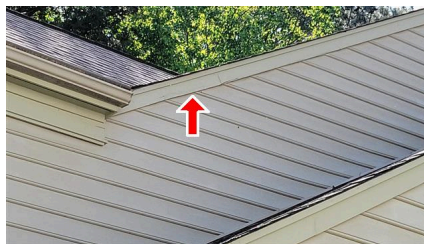
1. The wood fascia at eave on the exterior in areas is deteriorated. Further deterioration may occur if not repaired. Repairs are needed.

A qualified person should repair or replace as needed.

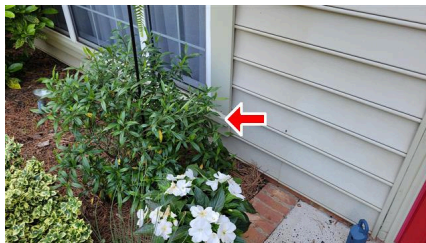
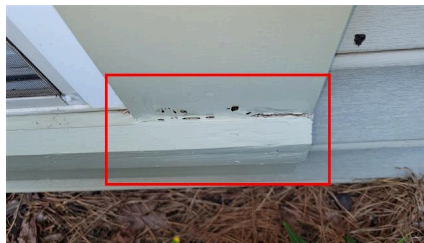
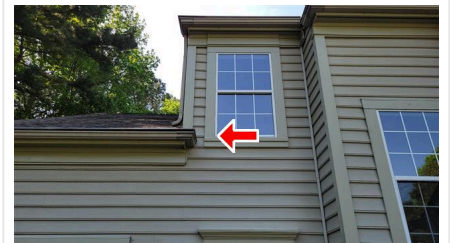
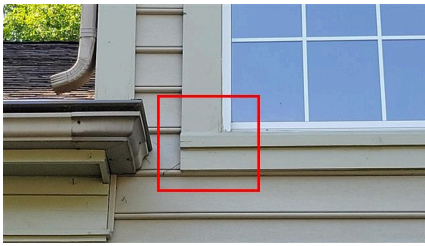
1. The wood trim is deteriorated at some windows. Further deterioration may occur if not repaired. Repairs are needed.

A qualified person should repair or replace as needed.

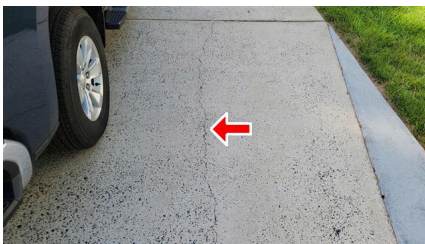
3.5 Item 1 (Picture)

1. The concrete driveway has cracks that should be sealed to prevent further damage, which is part of ongoing maintenance of a concrete driveway that will need to be performed on a regular basis. Repairs are recommended.

A qualified contractor should inspect and repair as needed.

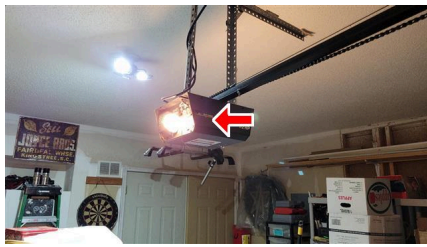
3.7 Item 1 (Picture)

1. The garage door operator safety reverse will not reverse properly when met with resistance. This is a safety issue. Further investigation and repairs are needed.

A qualified person should repair or replace as needed.

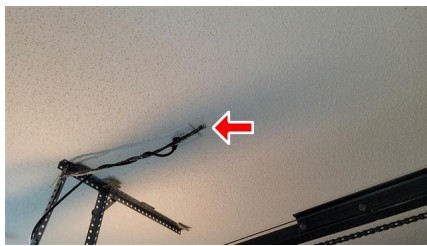
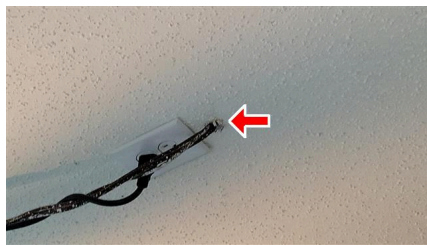
1. The fire resistance sheathing in garage is compromised. This is considered unsafe until corrected.  
Repairs are needed.

A qualified person should correct for safety.

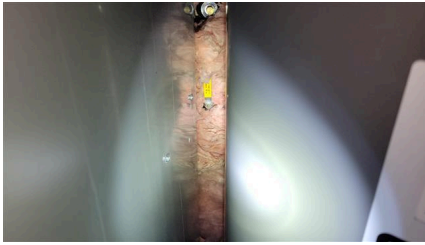
5.0 Item 1 (Picture)

The main shut off is the yellow lever located beside the water heater. This is for your information.

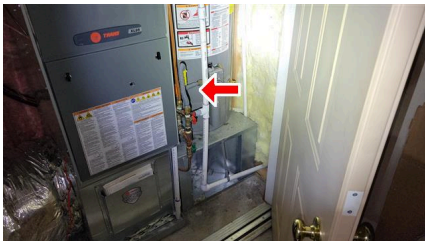
5.1 Item 1 (Picture)

1. The water heater in the closet does not appear to have enough combustion air. This is a safety issue. Further investigation is needed.

A qualified contractor should inspect and repair as needed.

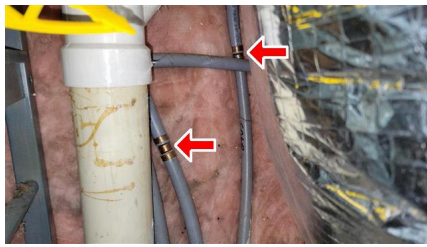
5.2 Item 1 (Picture)

1. Polybutylene plastic plumbing supply lines (PB) are installed in the subject house. Polybutylene has been used in this area for many years, but has had a higher than normal failure rate, and is no longer being widely used. Copper and Brass fittings used in later years have apparently reduced the failure rate. This subject house has copper fittings. For further details contact the Consumer Plumbing Recovery center at 1-800-392-7591 or the web at <http://www.pbpipe.com>

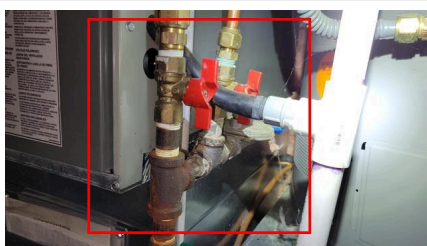
5.6 Item 1 (Picture)

1. The drip legs for the gas lines at the gas furnace is missing. As a result the gas appliance is not installed per the manufactures recommendation. Further investigation and repairs are needed.

I recommend a qualified licensed contractor inspect further and repair as needed.

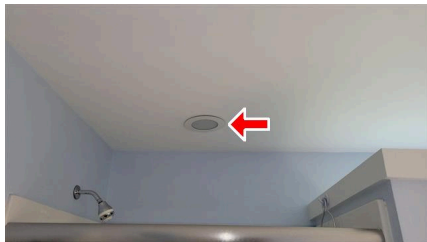
6.4 Item 1 (Picture)

1. The light fixture does not work (try bulb first) at the master bath. Repairs are needed.. A qualified licensed electrical contractor should correct as needed.

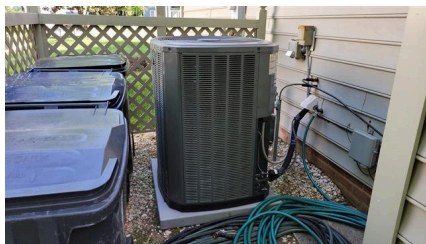
Complimentary photo of the AC unit

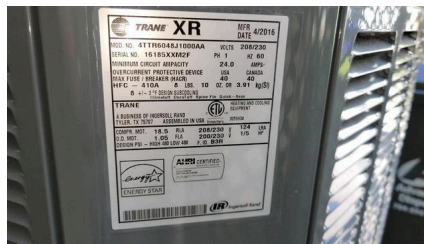
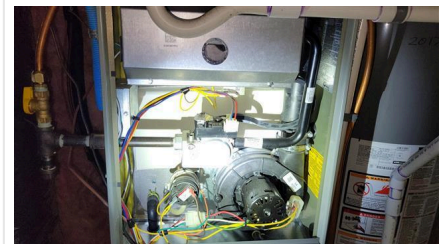
Complimentary photo of the gas furnace with the cover off

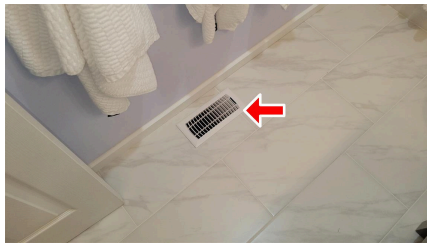
7.3 Item 1 (Picture)

1. The supply register in floor is weak (not intended for floor) in the guest bath. This is a safety issue and should be repaired. A replacement is needed.

A licensed HVAC contractor should service or repair unit.

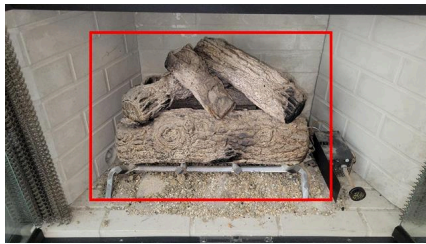
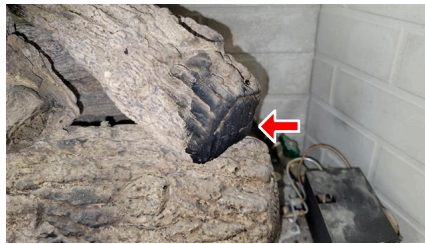
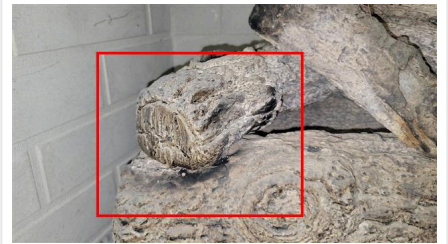
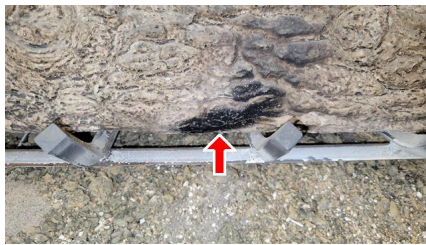
1. The black soot build-up indicates that Gas Fire logs do not appear to be arranged or positioned according to manufacturer's specs. If logs are not positioned correctly, carbon monoxide can be produced. Repairs are needed.

A licensed HVAC contractor should service or repair unit.

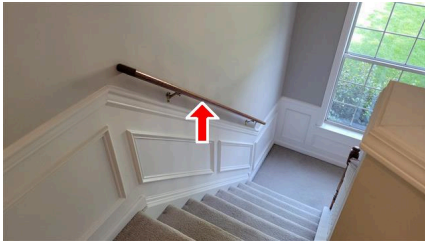
8.3 Item 1 (Picture)

1. The hand/guard rail for the upstairs is loose. A fall or injury could occur if not corrected. A repair or replacement is needed.

A qualified contractor should repair or replace as needed.

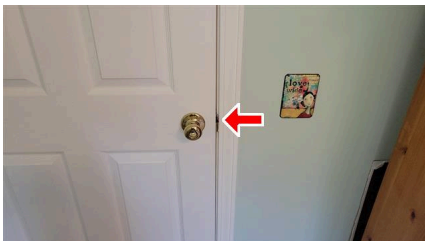
8.5 Item 1 (Picture)

1. The door at guest Bedroom will not latch properly. Evidence suggest that the door needs strike and latch adjustment to shut properly. This is a small repair.

A qualified person should repair or replace as needed.

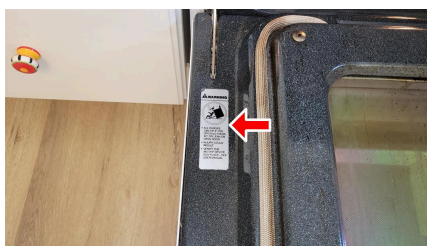
10.1 Item 1 (Picture)

1. The range/oven needs to be properly attached/anchored to the structure as to keep it from tipping over when the oven door is opened and/or oven racks are pulled out during use. This is a safety issue. Repairs are needed.

I recommend contacting appliance repair company.
