INSPECTION REPORT  
9008 Brentfield Rd  
Huntersville NC

INSPECTED BY  
Alex Parr 3692  
Above Parr Home  
Inspections

INSPECTION DATE  
📅 7/22/2024  
🕒 09:00:00 AM

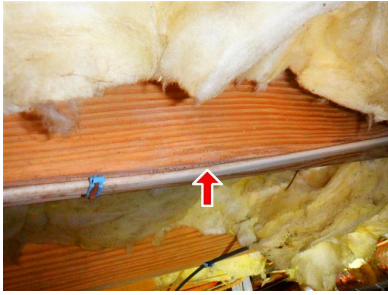
1.0 Item 1 (Picture)

1. Discoloration and some type of mold (Microbial) growth is present in the structure at several areas including but not limited to the crawl space and interior spaces. Evidence suggests that this condition is from a past or present elevated moisture conditions. We did not inspect, test or determine if this type of substance is or is not a health hazard. Further investigation is needed.

We recommend you contact a properly licensed expert for testing, investigation and or correction as deemed appropriate.

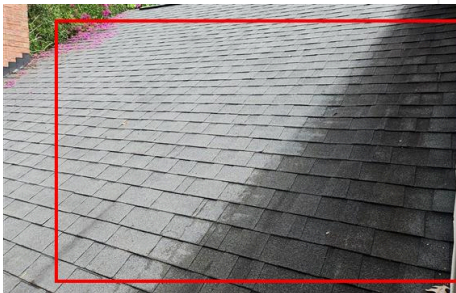
2.0 Item 1 (Picture)

1. The roof shingles is damaged/deteriorated at the at rear of home. This damage should be repaired or replaced. Further investigation and repairs are needed.

A qualified contractor should inspect and repair as needed.

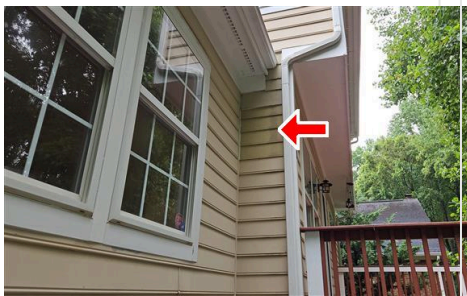
3.0 Item 1 (Picture)

1. The composite board siding at the at rear of home is deteriorated. Further deterioration can occur if

not corrected. Further investigation is damaged.  
A qualified contractor should inspect and repair as needed.

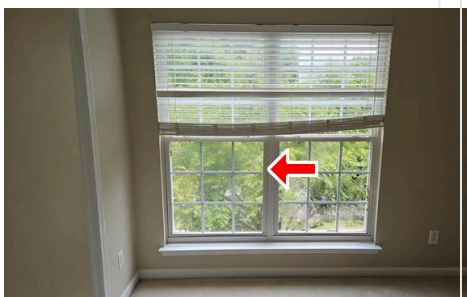
3.2 Item 1 (Picture)

1. Several windows have failed/compromised thermal seals/fogged window panes. This is indicated by the visible moisture, discoloration, calcium deposits and or crystallization visible between the glass window panes. A certified window technician should recheck all the windows throughout the home. Due to weather conditions many times compromised/failed windows cannot be identified at the time of inspection. Further investigation and repairs are needed.

We recommend contacting a properly licensed window technician/contractor regarding these conditions and have repairs made deemed appropriate

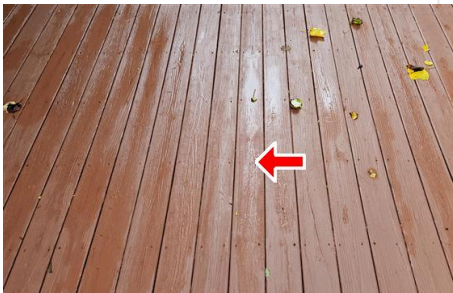
3.4 Item 1 (Picture)

1. The deck floor at the rear of home is deteriorated. Further deterioration can occur if not repaired. Further investigation and repairs are needed.

A qualified contractor should repair or replace as needed.

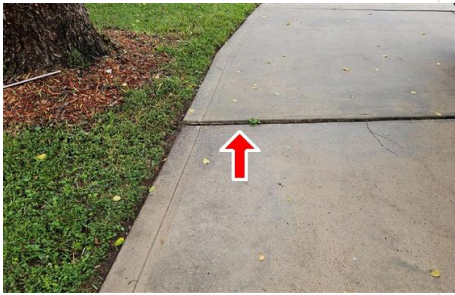
3.5 Item 1 (Picture)

1. The concrete drive at the right side (facing front) uneven, and can be a tripping hazard. A fall or injury can occur if not corrected. Further investigation and repairs are needed.

A qualified person should repair or replace as needed.

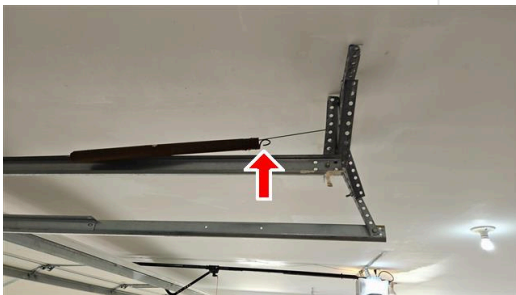
3.6 Item 1 (Picture)

1. The spring for garage door (s) at the right side (facing front) is disconnected and or damaged. This is considered unsafe and needs correcting. Further investigation and repairs are needed.

A qualified contractor should inspect and repair as needed.

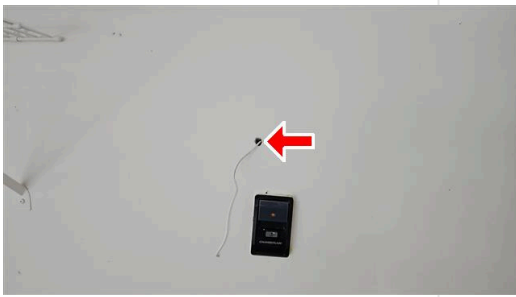
3.8 Item 1 (Picture)

1. The fire resistance sheathing that separates garage from heated space is compromised. This is considered unsafe until corrected. Repairs are needed.

A qualified person should correct for safety.

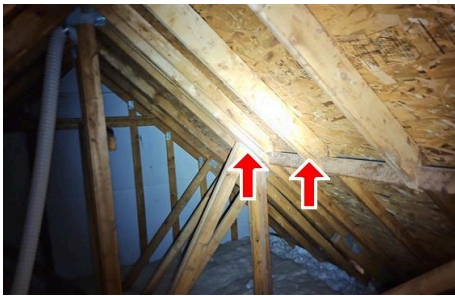
4.4 Item 1 (Picture)

1. The 2x4 roof support is damaged. Repairs may be needed to maintain the stability of roof. Further investigation and repairs are needed.

A qualified contractor should repair as needed.

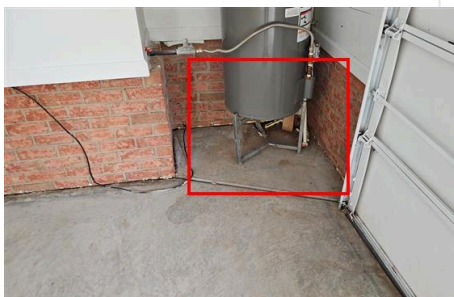
5.1 Item 1 (Picture)

1. The gas water heater water heater stand does not appear to be stable. This is a safety issue and should be repaired. Further investigation and repairs are needed.

A qualified licensed plumber should repair or correct as needed.

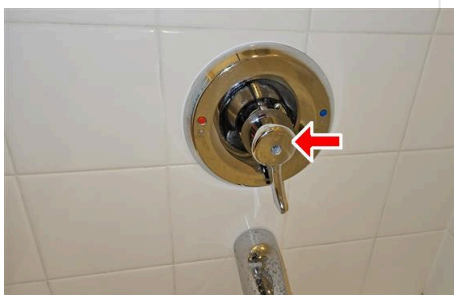
5.2 Item 1 (Picture)

1. The control lever valve stop is damage and is loose at the guest bath. Therefore it does not function as intended. Further investigation and repairs are needed.

A qualified licensed plumber should repair or correct as needed.

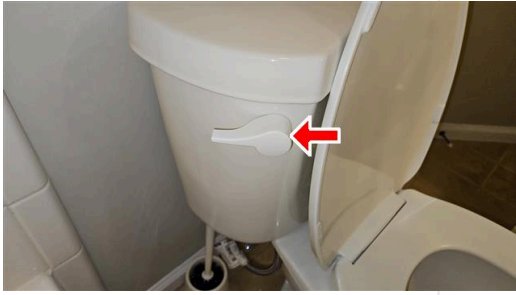
5.2 Item 3 (Picture)

1. The toilet handle it is installed upside down at the guest bath. Further investigation and repairs are needed.

A qualified licensed plumber should repair or correct as needed.

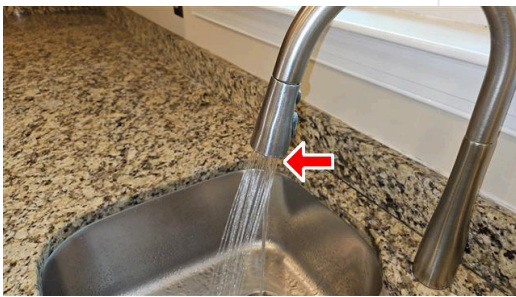
5.2 Item 4 (Picture)

1. The faucet difficult to operate at the kitchen sink. Therefore it does not function as intended. Further investigation and repairs are needed.

A qualified licensed plumber should repair or correct as needed.

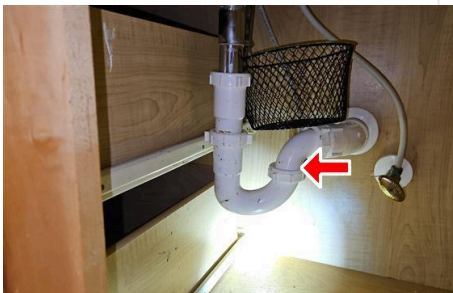
5.3 Item 1 (Picture)

1. The plumbing waste line leaks (under sink) under the master bath. Repairs are needed to prevent water damage from occurring to the home. Further investigation and repairs are needed..

A qualified licensed plumber should repair or correct as needed.

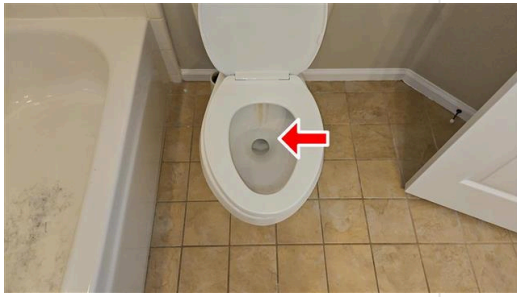
5.3 Item 3 (Picture)

1. The toilet will not stop running at the guest bath. The flapper will likely need replacing. Further investigation and repairs are needed.

A qualified licensed plumber should repair or correct as needed.

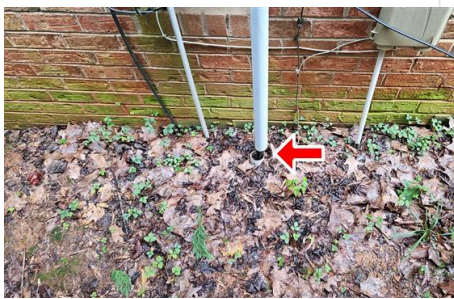
6.1 Item 1 (Picture)

1. The electrical service conduit is disconnected at the left side of the home. This could allow for water intrusion or an interruption in service. Further investigation and repairs are needed.

I recommend a licensed electrical contractor inspect further and correct as needed.

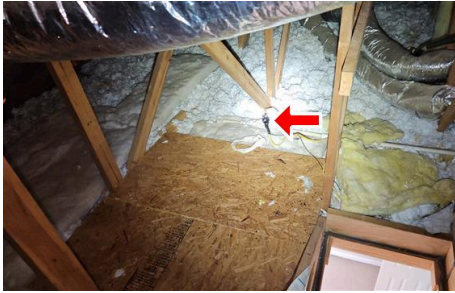
6.4 Item 1 (Picture)

1. One or more open splice needs placing inside a box with a cover-plate in the attic space. This is a safety issue. Further investigation and repairs are needed.

A qualified licensed electrical contractor should correct as needed.

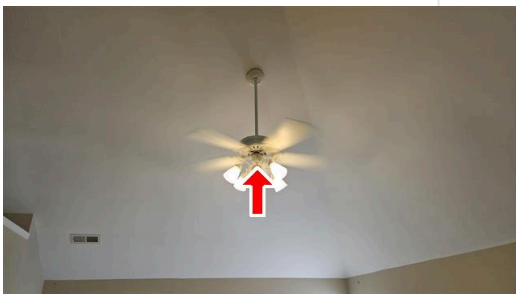
6.4 Item 3 (Picture)

1. The ceiling fan "wobbles" in the master bedroom. Some fans that wobble cannot be corrected without replacement. This is a safety issue. Repairs are needed.

A qualified licensed electrical contractor should correct as needed.

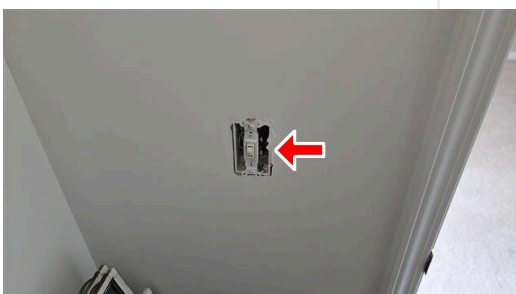
6.4 Item 4 (Picture)

1. The wall switch is missing "cover-plate" at the guest bedroom closet. This is a safety issue that needs to be corrected. Repairs are needed.

A qualified licensed electrical contractor should correct as needed.

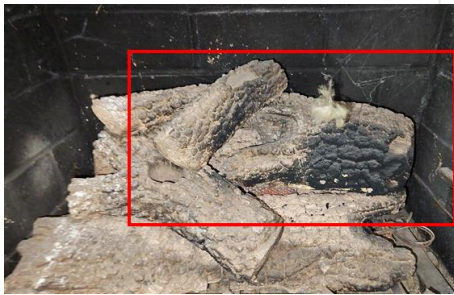
7.7 Item 1 (Picture)

according to manufacturer's specs. If logs are not positioned correctly, carbon monoxide can be produced. Further investigation and repairs are needed.

A qualified licensed HVAC (Heat/Ventilation/Air conditioning Contractor) should inspect further and repair as needed.

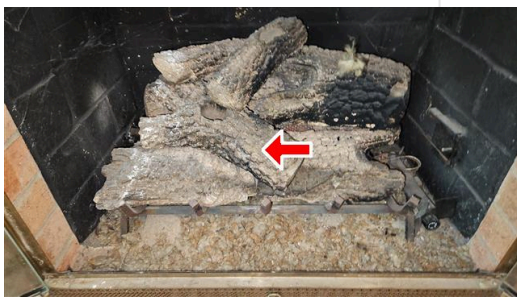
7.7 Item 4 (Picture)

1. The non-vented fire logs (natural gas) in the Living room shut off valve was in the off position. As a result I did not operate the gas logs due to safety reason. The inspector assumes that if a gas appliance shut off valve is in the off position it is for a reason. Further investigation is recommended..

A qualified licensed HVAC (Heat/Ventilation/Air conditioning Contractor) should inspect further and repair as needed.

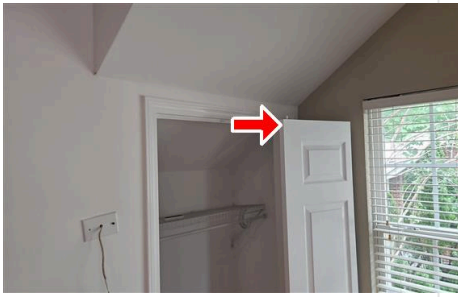
8.5 Item 1 (Picture)

1. The bifold door is out of track add the bonus room. As a result the door will not close properly. Repairs are needed.

A qualified person should repair or replace as needed.

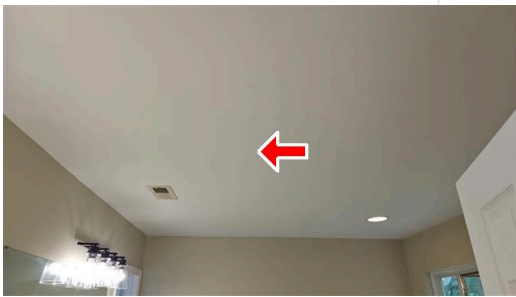
9.4 Item 1 (Picture)

1. No ventilation (window or exhaust fan) for the guest bath. Normally an exhaust fan or window is needed for proper ventilation. Adverse moisture conditions could occur if not corrected. I did not inspect to determine what steps are needed to comply. Repairs are needed.

A qualified contractor should inspect and repair as needed.

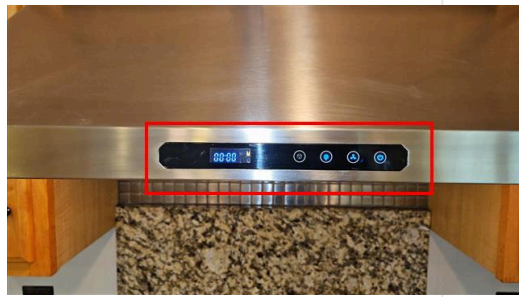
10.2 Item 1 (Picture)

1. The range hood controls did not function properly. Further investigation and repairs are needed. I recommend contacting appliance repair company.

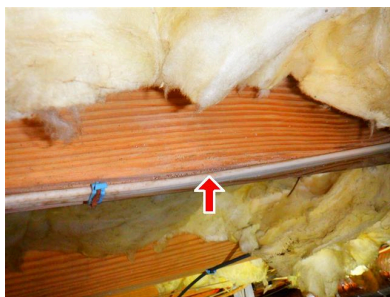
1.0 Item 1 (Picture)

1. Discoloration and some type of mold (Microbial) growth is present in the structure at several areas including but not limited to the crawl space and interior spaces. Evidence suggests that this condition is from a past or present elevated moisture conditions. We did not inspect, test or determine if this type of substance is or is not a health hazard. Further investigation is needed.

We recommend you contact a properly licensed expert for testing, investigation and or correction as deemed appropriate.

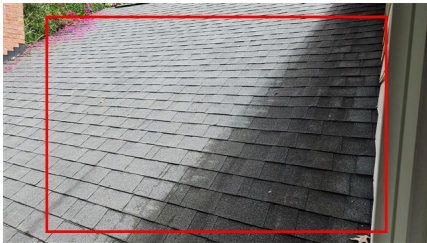
2.0 Item 1 (Picture)

1. The roof shingles is damaged/deteriorated at the at rear of home. This damage should be repaired or replaced. Further investigation and repairs are needed.

A qualified contractor should inspect and repair as needed.

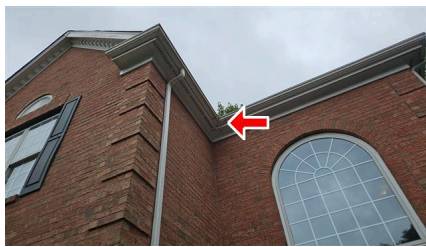
2.3 Item 1 (Picture)

1. The gutter leaks at seam (s) at the virtually all areas where gutters are installed. Gutters that drain poorly or clogged can lead to many costly problems such as deterioration of fascia, soffit or roof edge. It can also cause gutters to pull loose and lead to possible water intrusion. Repairs are needed.

A qualified person should repair or replace as needed.

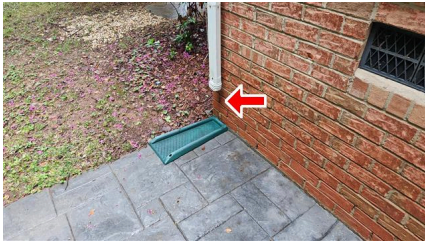
**2.3 Item 5 (Picture)**

1. The downspout missing part (S) at the left corner (facing rear). This can lead to water intrusion.

Repairs are needed.

A qualified person should repair or replace as needed.

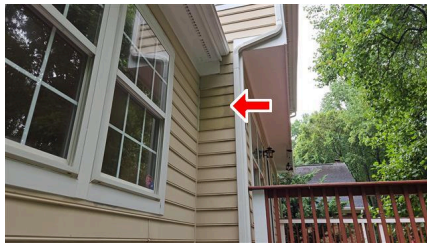
**3.0 Item 1 (Picture)**

1. The composite board siding at the rear of home is deteriorated. Further deterioration can occur if not corrected. Further investigation is damaged.

A qualified contractor should inspect and repair as needed.

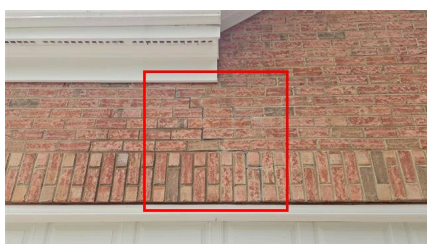
**3.0 Item 5 (Picture)**

1. I observed small cracks in the brick veneer at the exterior. These are typical in nature due to age and normal masonry shrinkage. Although the cracks in the brick veneer are typical, these areas should be re sealed to prevent any water penetration or damage. Further evaluation by a qualified masonry contractor is recommended for this entire condition.

I recommend repair or replace using a qualified contractor.

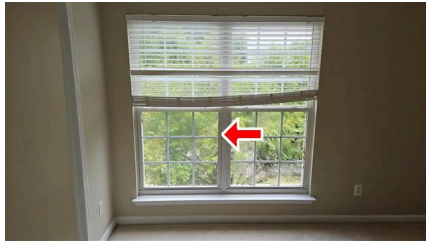
3.2 Item 1 (Picture)

1. Several windows have failed/compromised thermal seals/fogged window panes. This is indicated by the visible moisture, discoloration, calcium deposits and or crystallization visible between the glass window panes. A certified window technician should recheck all the windows throughout the home. Due to weather conditions many times compromised/failed windows cannot be identified at the time of inspection. Further investigation and repairs are needed.

We recommend contacting a properly licensed window technician/contractor regarding these conditions and have repairs made deemed appropriate

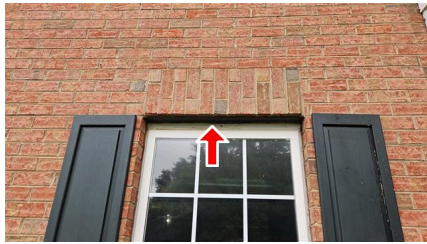
3.2 Item 5 (Picture)

1. The steel lintels around the exterior of the home are beginning to rust or have rust present. A lintel is a horizontal architectural member or steel beam support placed over a wall opening to carry the weight of the masonry placed over it. In most situation, the lintel above you windows and doors will be steel angle iron or I beam. Either due to age or improper rust proofing or weep chord and flashing placement during installation, lintels will begin to rust. Rusting lintels can expand to become mush thicker then their original size. The expansive forces of rusting steel can shift entire multi-story elevations. If your lintels are currently rusting, a telltale sign of expansion is diagonal "step" pattern cracks, which can be found on either end of the window or door opening. Repairs are needed to prevent further damage to the structure. Further deterioration may occur if not repaired.

I recommend a qualified contractor inspect and repair as needed.

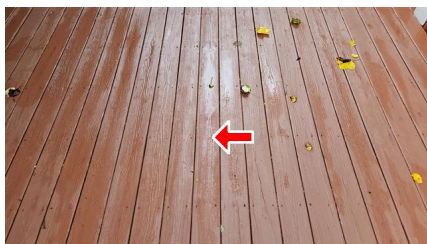
3.4 Item 1 (Picture)

1. The deck floor at the at rear of home is deteriorated. Further deterioration can occur if not repaired. Further investigation and repairs are needed.

A qualified contractor should repair or replace as needed.

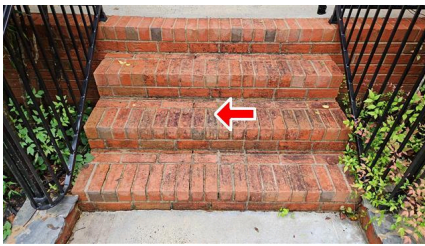
3.4 Item 7 (Picture)

1. The brick steps at the front entry is deteriorated. Further deterioration can occur. Further investigation and repairs are needed..

A qualified contractor should repair or replace as needed.

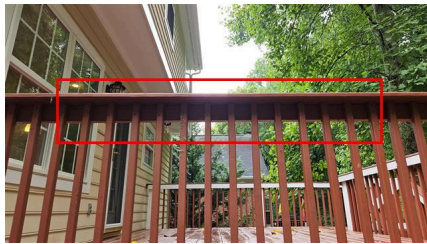
3.4 Item 11 (Picture)

1. The balusters on deck, rear of home are attached improperly. Attached balusters are top and bottom (1) #8 wood screw or (2) 8d post frame threaded nails. A repair is needed to ensure stability or an injury might occur. Repairs are needed.

A qualified person should repair or replace as needed.

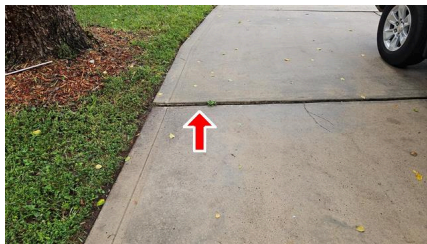
3.5 Item 1 (Picture)

1. The concrete drive at the right side (facing front) uneven, and can be a tripping hazard. A fall or injury can occur if not corrected. Further investigation and repairs are needed.

A qualified person should repair or replace as needed.

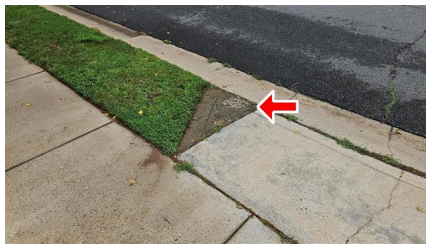
3.5 Item 5 (Picture)

1. The concrete drive at the front of home deteriorated in areas. Water can cause further deterioration if not repaired and sealed properly. Repairs are needed.

A qualified person should repair or replace as needed.

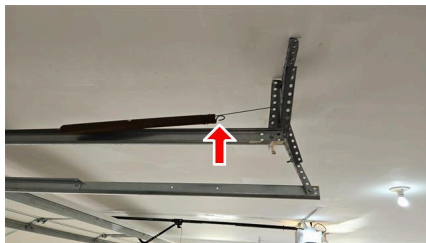
3.6 Item 1 (Picture)

1. The spring for garage door (s) at the right side (facing front) is disconnected and or damaged. This is considered unsafe and needs correcting. Further investigation and repairs are needed.

A qualified contractor should inspect and repair as needed.

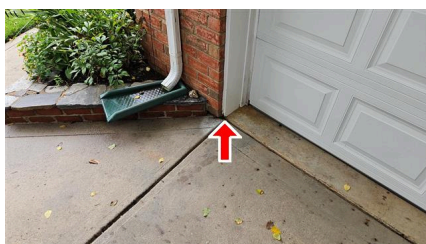
3.6 Item 2 (Picture)

1. The two-door garage at the right side (facing front) shows deterioration on bottom of side jams. Further deterioration may occur if not repaired.

A qualified person should repair or replace as needed.

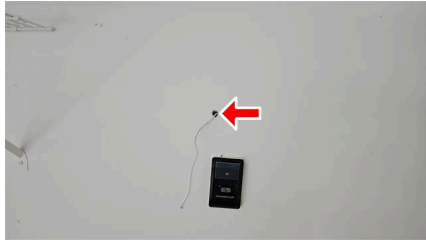
3.8 Item 1 (Picture)

1. The fire resistance sheathing that separates garage from heated space is compromised. This is considered unsafe until corrected. Repairs are needed.

A qualified person should correct for safety.

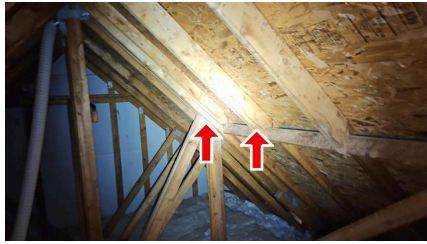
4.4 Item 1 (Picture)

1. The 2x4 roof support is damaged. Repairs may be needed to maintain the stability of roof. Further

investigation and repairs are needed.  
A qualified contractor should repair as needed.

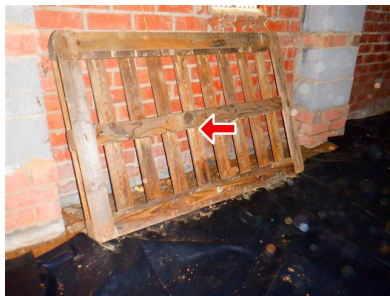
4.5 Item 1 (Picture)

1. Wood debris is in contact with the crawl space floor in numerous areas. This can attract wood destroying organisms. Removal is needed.

A qualified contractor should inspect and repair as needed.

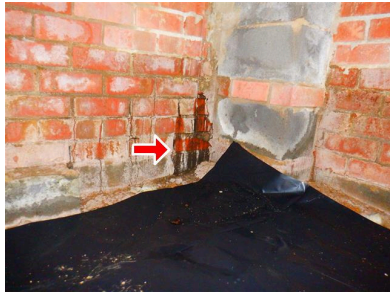
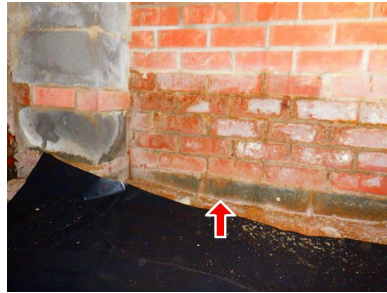
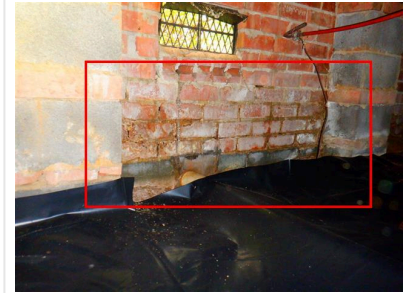
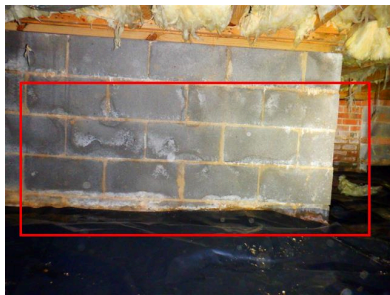
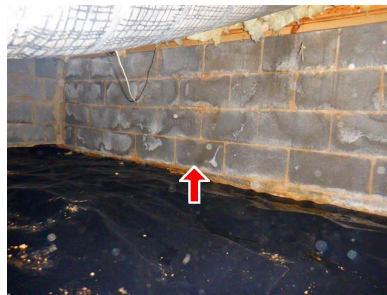
1. Dark stains on the CMU (Concrete Masonry Unit) Indicated that water is inside the block. Dark stains and white efflorescence (powder substance) on block wall indicates moisture is in contact with the masonry. This does not necessarily indicate that intrusion will occur. Efflorescence is found on many homes without water intrusion occurring inside the home. But, it should alert you to the possibility that future steps may be needed. Further investigation and repairs are needed.

I recommend contact a licensed water intrusion specialist regarding these conditions.

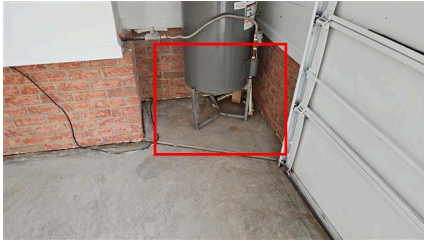
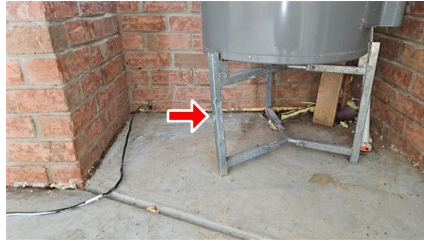
1. The gas water heater water heater stand does not appear to be stable. This is a safety issue and should be repaired. Further investigation and repairs are needed.

A qualified licensed plumber should repair or correct as needed.

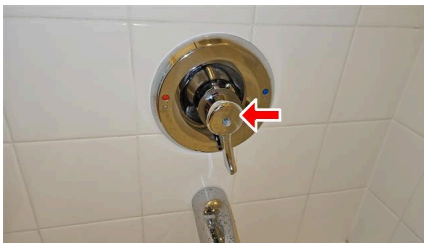
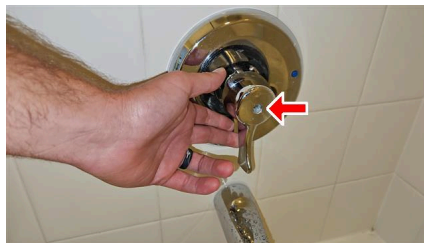
1. The control lever valve stop is damage and is loose at the guest bath. Therefore it does not function as intended. Further investigation and repairs are needed.

A qualified licensed plumber should repair or correct as needed.

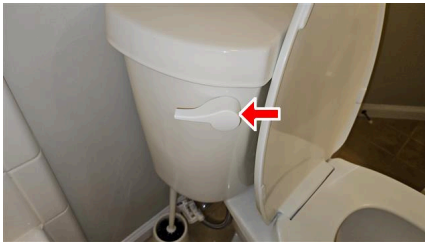
5.2 Item 3 (Picture)

1. The toilet handle it is installed upside down at the guest bath. Further investigation and repairs are needed.

A qualified licensed plumber should repair or correct as needed.

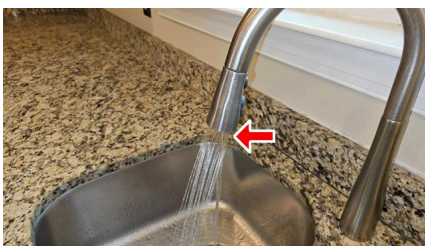
5.2 Item 4 (Picture)

1. The faucet difficult to operate at the kitchen sink. Therefore it does not function as intended. Further investigation and repairs are needed.

A qualified licensed plumber should repair or correct as needed.

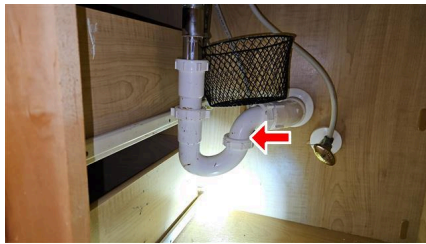
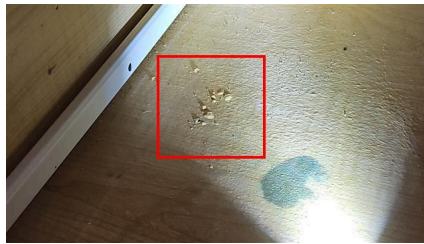
5.3 Item 1 (Picture)

1. The plumbing waste line leaks (under sink) under the master bath. Repairs are needed to prevent water damage from occurring to the home. Further investigation and repairs are needed..

A qualified licensed plumber should repair or correct as needed.

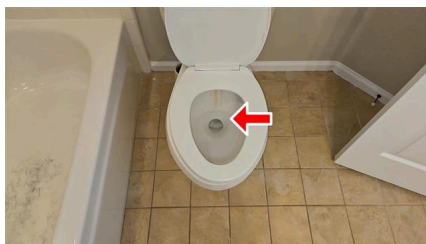
5.3 Item 3 (Picture)

1. The toilet will not stop running at the guest bath. The flapper will likely need replacing. Further investigation and repairs are needed.

A qualified licensed plumber should repair or correct as needed.

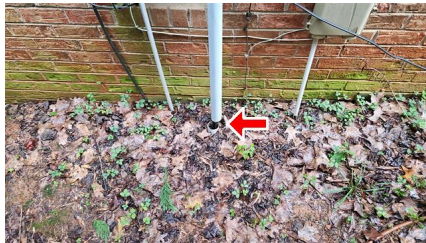
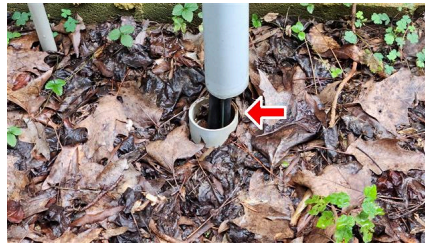
6.1 Item 1 (Picture)

1. The electrical service conduit is disconnected at the left side of the home. This could allow for water intrusion or an interruption in service. Further investigation and repairs are needed.

I recommend a licensed electrical contractor inspect further and correct as needed.

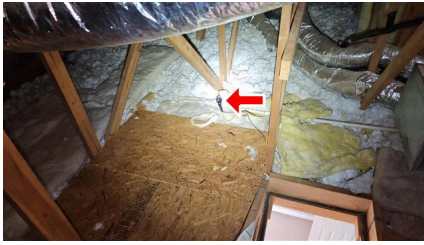
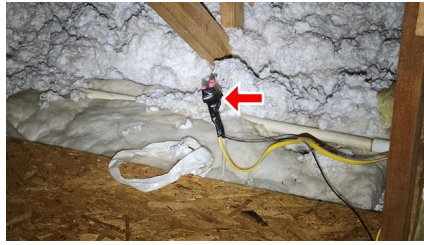
6.4 Item 1 (Picture)

1. One or more open splice needs placing inside a box with a cover-plate in the attic space. This is a safety issue. Further investigation and repairs are needed.

A qualified licensed electrical contractor should correct as needed.

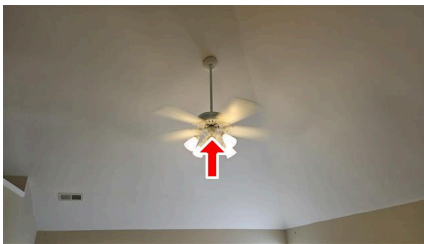
6.4 Item 3 (Picture)

1. The ceiling fan "wobbles" in the master bedroom. Some fans that wobble cannot be corrected without replacement. This is a safety issue. Repairs are needed.

A qualified licensed electrical contractor should correct as needed.

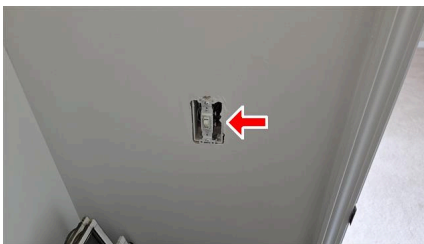
6.4 Item 4 (Picture)

1. The wall switch is missing "cover-plate" at the guest bedroom closet. This is a safety issue that needs to be corrected. Repairs are needed.

A qualified licensed electrical contractor should correct as needed.

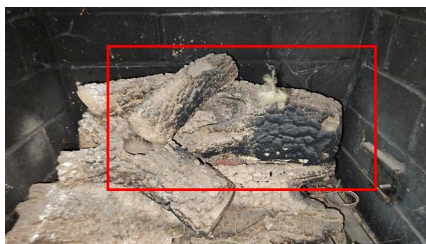
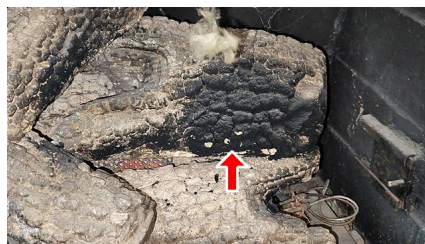
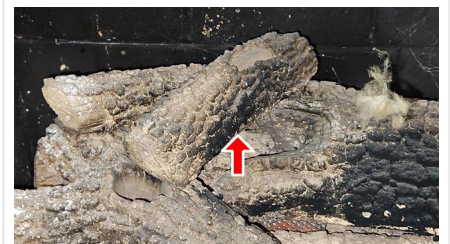
7.7 Item 1 (Picture)

1. The black soot build-up indicates that Gas Fire logs do not appear to be arranged or positioned according to manufacturer's specs. If logs are not positioned correctly, carbon monoxide can be produced. Further investigation and repairs are needed.

A qualified licensed HVAC (Heat/Ventilation/Air conditioning Contractor) should inspect further and repair as needed.

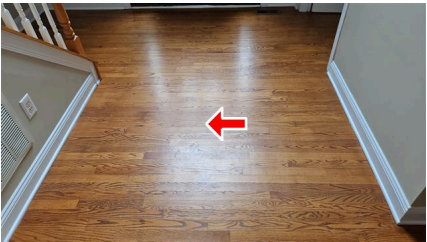
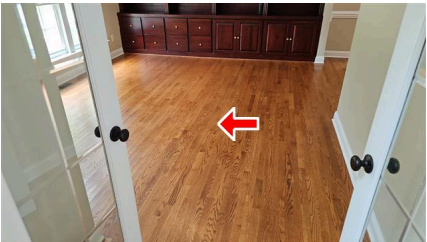
8.2 Item 1 (Picture)

1. The wood floor warped or buckled indicating moisture absorption at the downstairs. This is a cosmetic issue for your information.

A qualified person should repair or replace as needed.

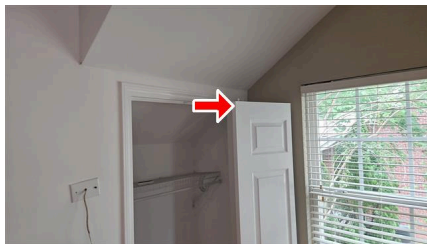
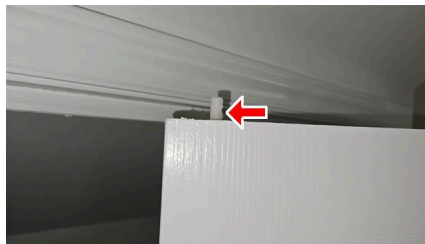
8.5 Item 1 (Picture)

1. The bifold door is out of track add the bonus room. As a result the door will not close properly. Repairs are needed.

A qualified person should repair or replace as needed.

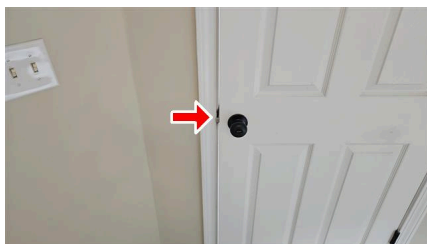
8.5 Item 3 (Picture)

1. The door at guest Bedroom will not latch properly. Evidence suggest that the door needs strike and latch adjustment to shut properly. This is a small repair.

A qualified person should repair or replace as needed.

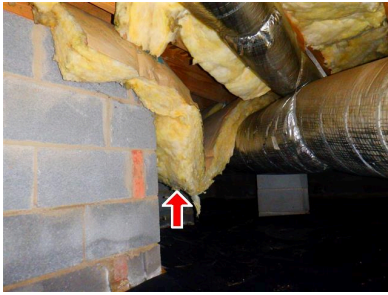
9.3 Item 1 (Picture)

1. The insulation is loose/fallen in the crawlspace. Heat loss can occur more on this home than one that is properly insulated. Repairs are needed.

A qualified person should repair or replace as needed.

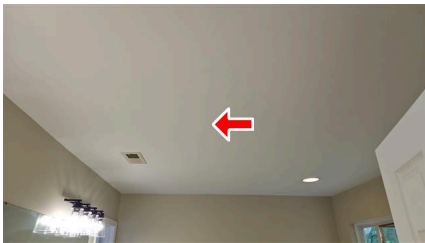
9.4 Item 1 (Picture)

1. No ventilation (window or exhaust fan) for the guest bath. Normally an exhaust fan or window is needed for proper ventilation. Adverse moisture conditions could occur if not corrected. I did not inspect to determine what steps are needed to comply. Repairs are needed.

A qualified contractor should inspect and repair as needed.

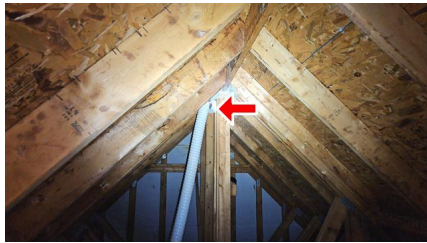
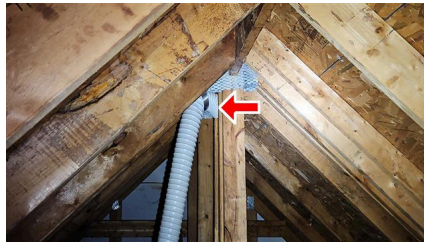
9.4 Item 2 (Picture)

1. The exhaust fan does not vent to outside at the guest bath and master bath. Vent pipes should terminate outside and not in the attic. Many homes have their vent pipe poised at the roof vent such as yours. It is up to you to determine whether or not this is a concern or needs further consideration from a general contractor. Repairs are needed.

A qualified person should repair or replace as needed.

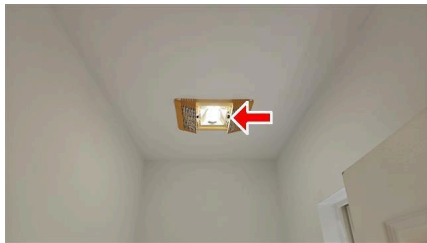
9.4 Item 4 (Picture)

1. The exhaust fan is missing light cover at the master bath. This is for informational purpose to you.

A qualified person should repair or replace as needed.

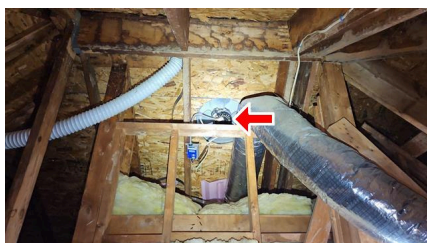
9.5 Item 1 (Picture)

1. Thermostatically controlled vent fan in the attic was not reachable. Therefore I did not inspect. Further investigation and repairs are needed.

A qualified person should repair or replace as needed.

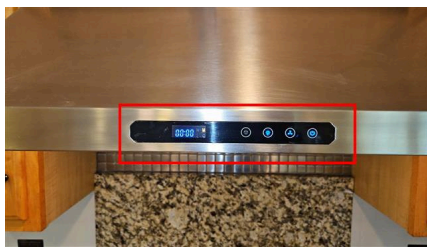
10.2 Item 1 (Picture)

1. The range hood controls did not function properly. Further investigation and repairs are needed. I recommend contacting appliance repair company.
