INSPECTION REPORT  
413 Bay Harbour Rd  
Mooresville NC 28117

INSPECTION DATE  
📅 10/30/2023  
🕒 09:00:00 AM

Inspection Date: 10/30/2023  
Report ID: 103023AP1

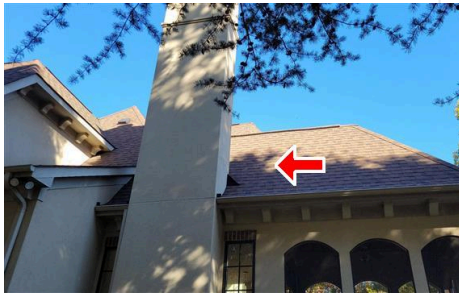
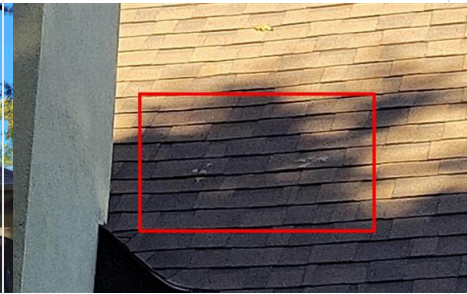
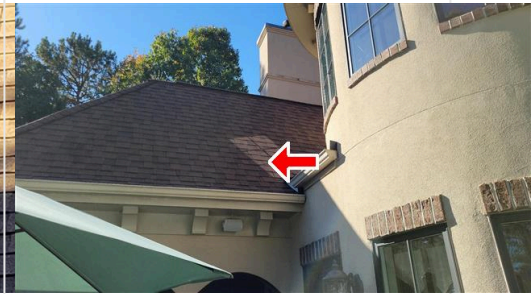
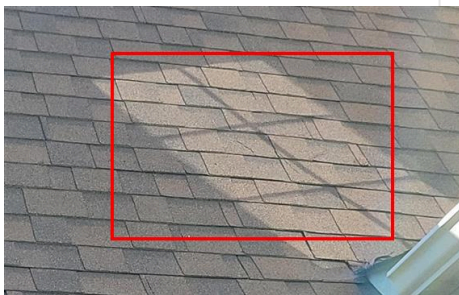
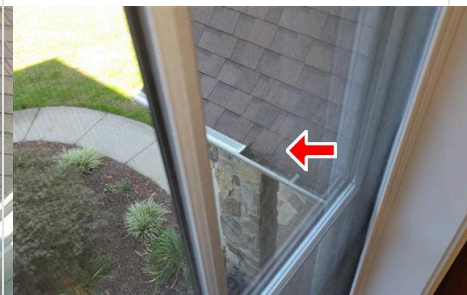
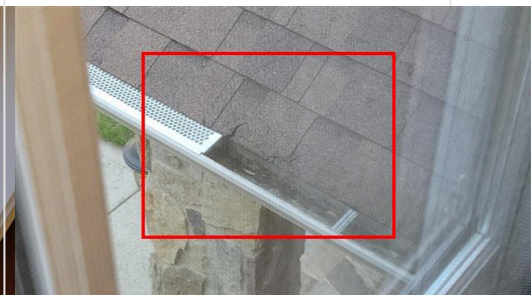
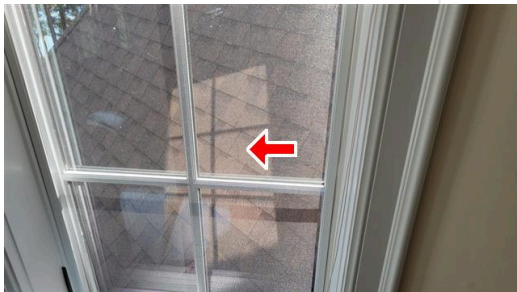
1. The roof shingles is damaged. This damage should be repaired or replaced. Further investigation and repairs are needed.

I recommend having the entire roof evaluated.

A qualified contractor should inspect and repair as needed.

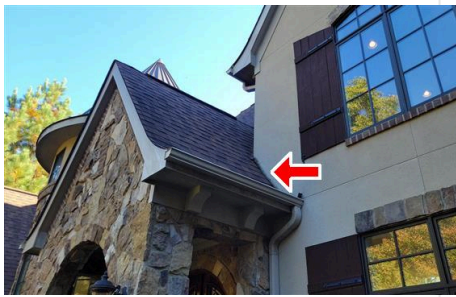
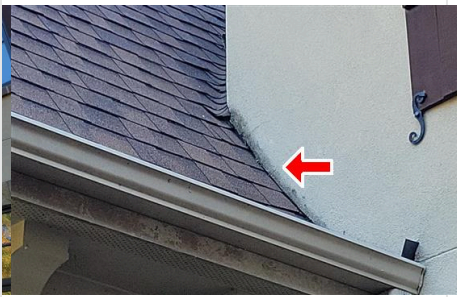
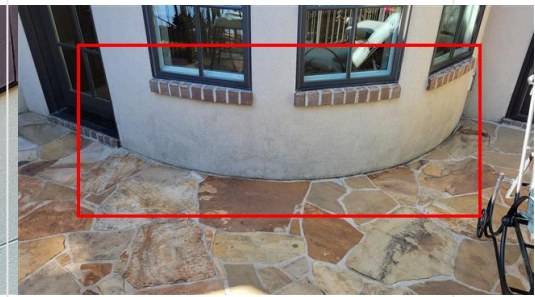
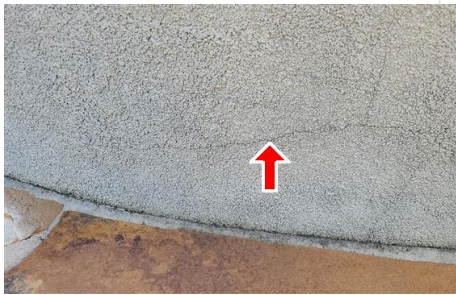
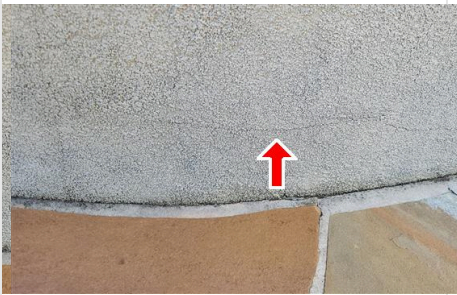
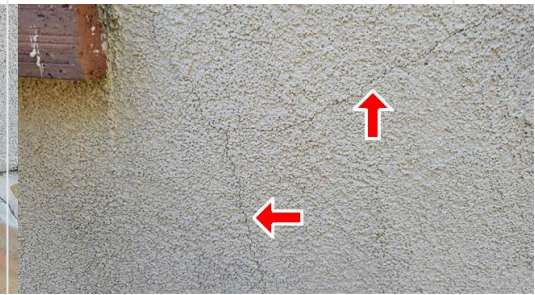
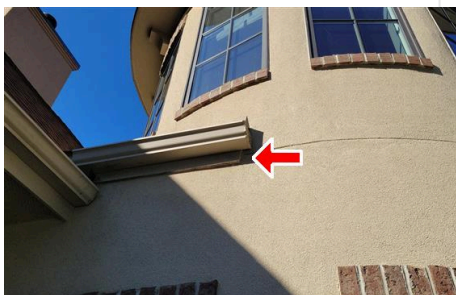
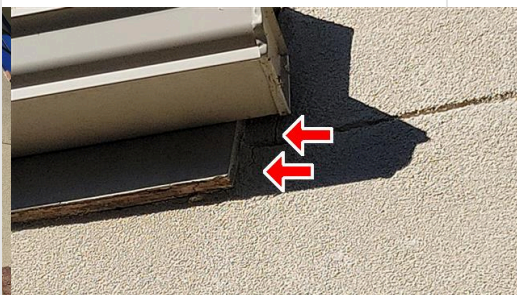
1. The stucco coating at the exterior in areas is damaged. Further deterioration can occur if not corrected. Further investigation and repairs are needed.

A qualified contractor should inspect and repair as needed.

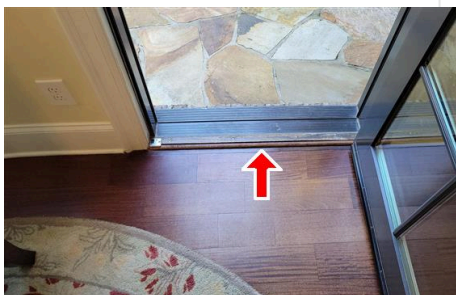
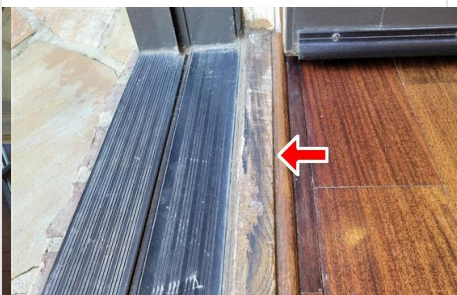
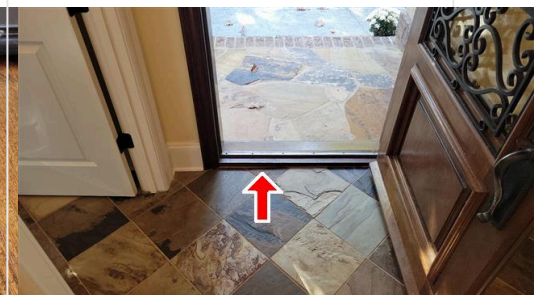
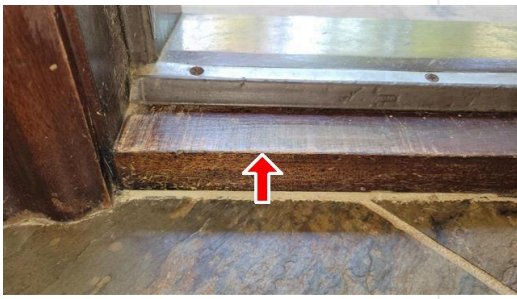
1. Several exterior doors rubs floor when closed. As a result the door will not close properly. Further investigation and repairs are needed.

A qualified person should repair or replace as needed.

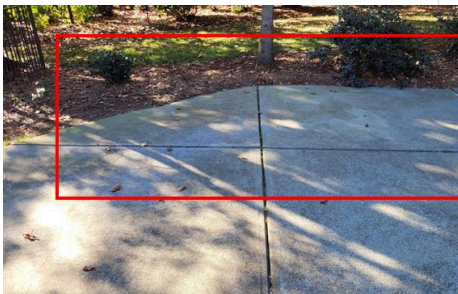
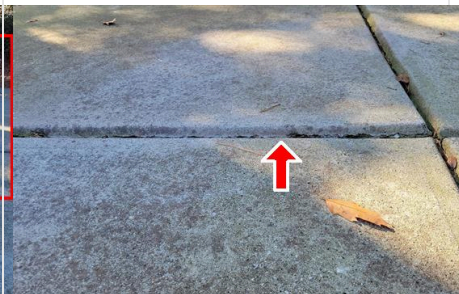
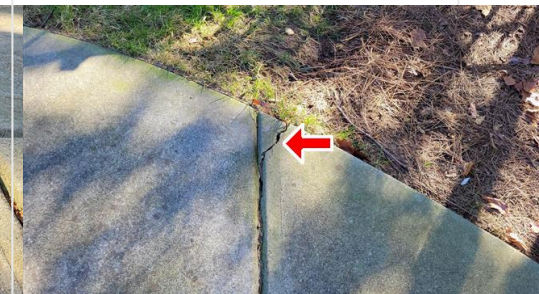
1. The concrete drive at the right side (facing front) uneven, and can be a tripping hazard. Water can cause further deterioration if not repaired and sealed properly. A fall or injury can occur if not corrected. Repairs are needed.

A qualified person should repair or replace as needed.

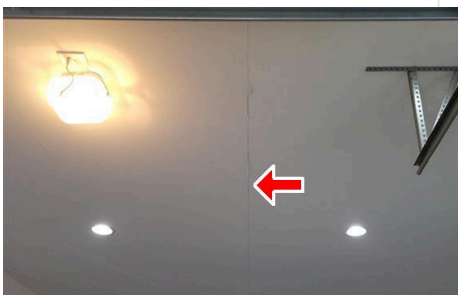
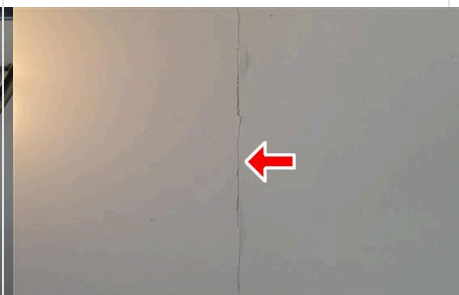
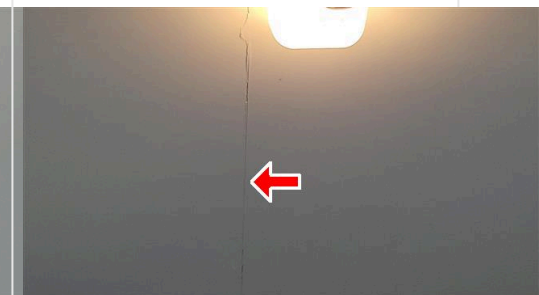
1. The fire resistance sheathing in garage is compromised. This is considered unsafe until corrected. Repairs are needed.

A qualified person should correct for safety.

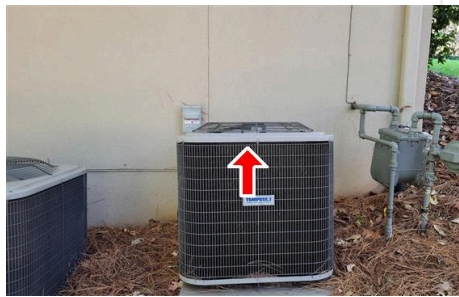
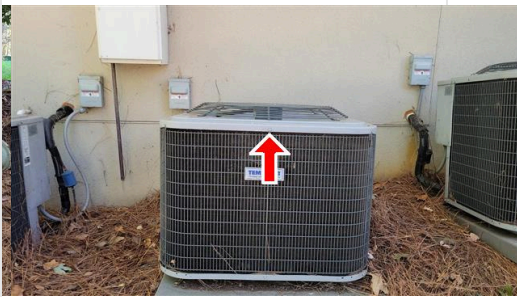
1. The condenser units are not level. This can cause damage to the unit or shorten its life span. Further investigation and repairs are needed.

A qualified HVAC person should inspect further and repair or replace as needed.

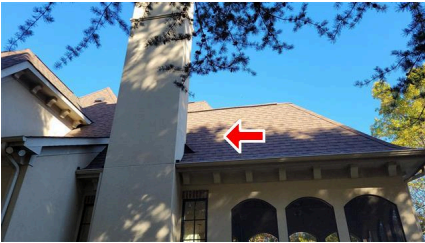
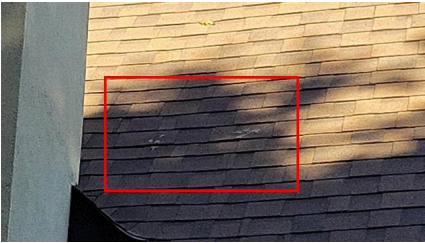
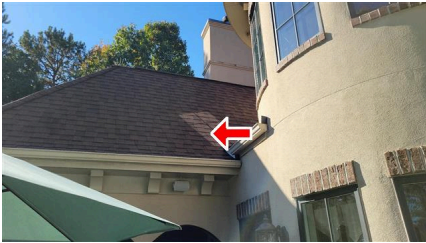
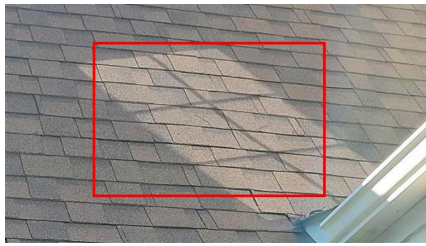
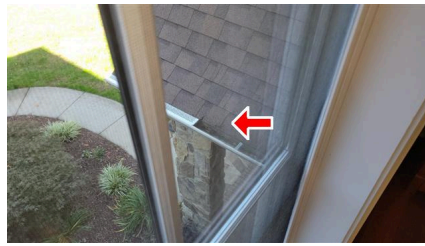
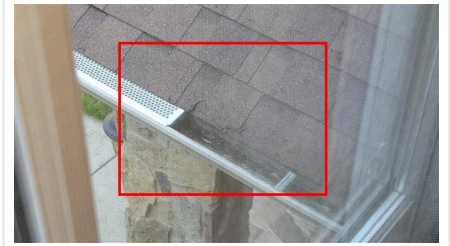
1. The roof shingles is damaged. This damage should be repaired or replaced. Further investigation and repairs are needed.

I recommend having the entire roof evaluated.

A qualified contractor should inspect and repair as needed.

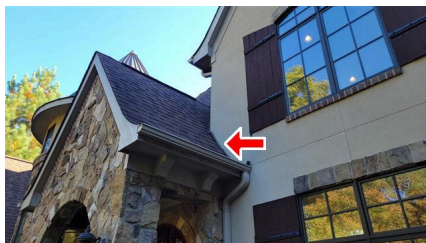
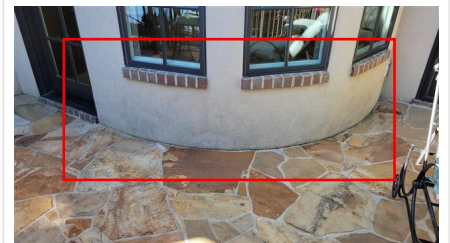
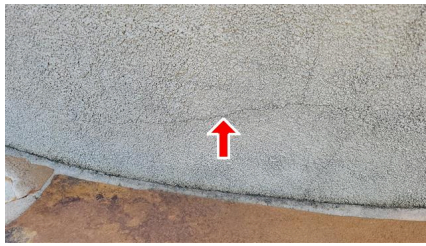
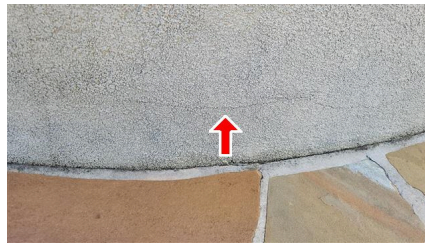
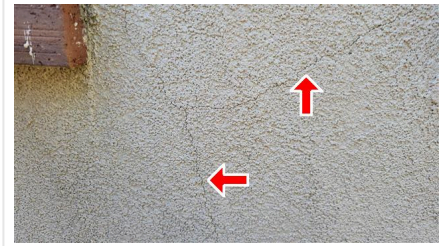
1. The stucco coating at the exterior in areas is damaged. Further deterioration can occur if not corrected. Further investigation and repairs are needed.

A qualified contractor should inspect and repair as needed.

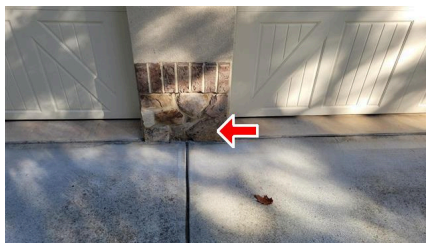
3.0 Item 9 (Picture)

1. The stone veneer at the right of home is loose. Further deterioration can occur if not corrected. Further investigation and repairs are needed.

A qualified contractor should inspect and repair as needed.

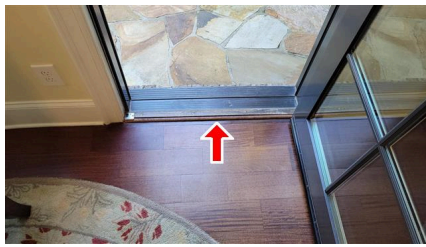
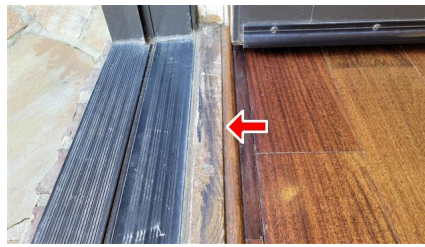
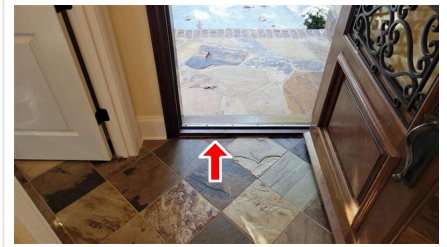
1. Several exterior doors rubs floor when closed. As a result the door will not close properly. Further investigation and repairs are needed.

A qualified person should repair or replace as needed.

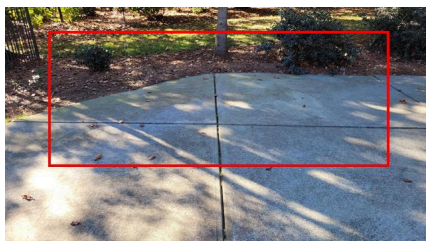
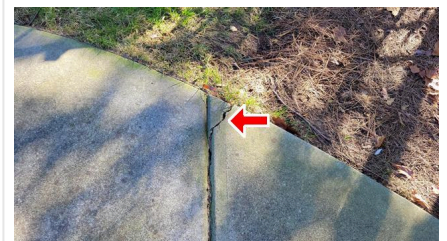
1. The concrete drive at the right side (facing front) uneven, and can be a tripping hazard. Water can cause further deterioration if not repaired and sealed properly A fall or injury can occur if not corrected. Repairs are needed.

A qualified person should repair or replace as needed.

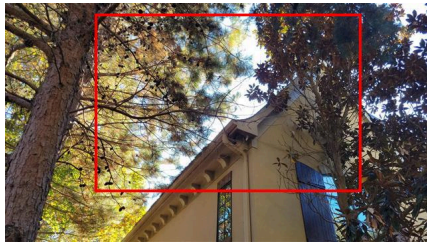
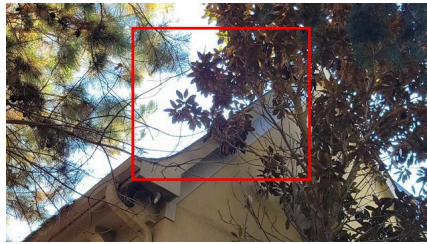
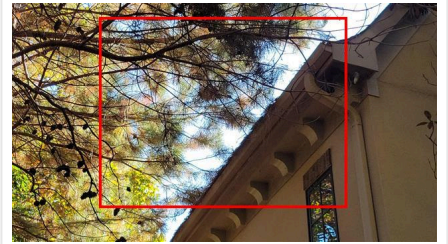
1. The tree limbs that are in contact with roof or hanging near roof should be trimmed.

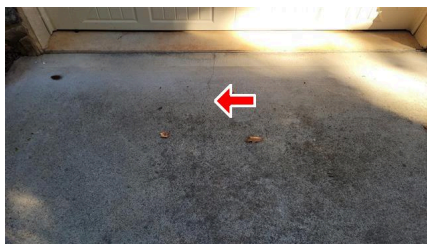
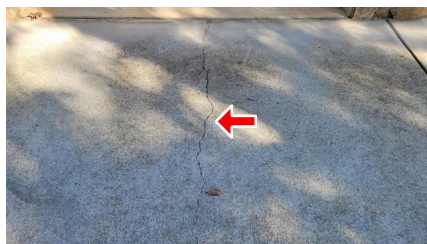
1. The concrete driveway has cracks that should be sealed to prevent further damage, which is part of ongoing maintenance of a concrete driveway that will need to be performed on a regular basis. Repairs are recommended.

A qualified contractor should inspect and repair as needed.

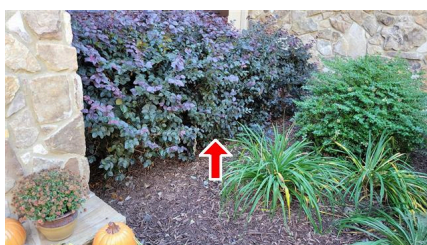
3.5 Item 9 (Picture)

1. There is a negative slope at the front of home and can cause or contribute to water intrusion or deterioration. I recommend correcting landscape to drain water away from home.

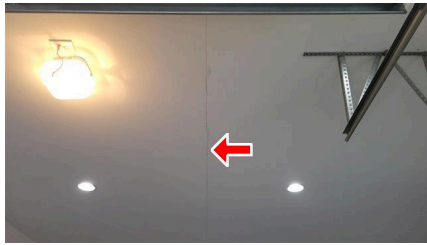
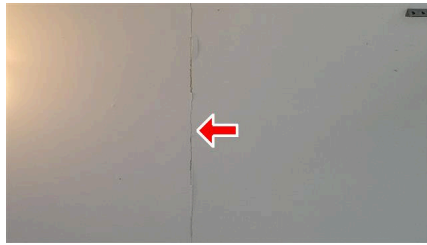
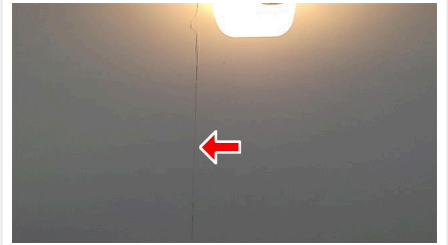
1. The fire resistance sheathing in garage is compromised. This is considered unsafe until corrected.  
Repairs are needed.

A qualified person should correct for safety.

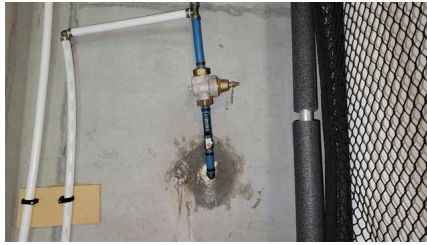
5.0 Item 1 (Picture)

The main shut off is the green lever located in the basement. This is for your information.

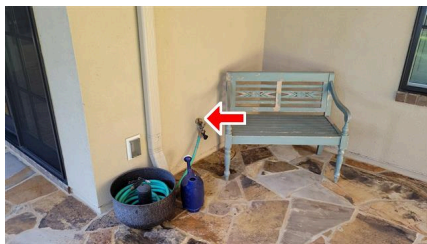
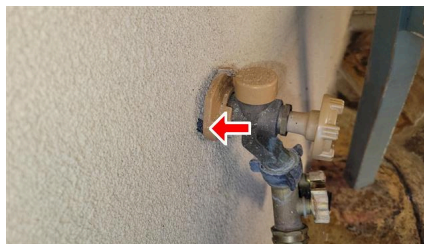
1. The outside water faucet loose, and needs securing to wall at the rear of home. This can allow undue stress to occur on supply lines allowing leaks to occur. Repairs are needed.

A qualified licensed plumber should repair or correct as needed.

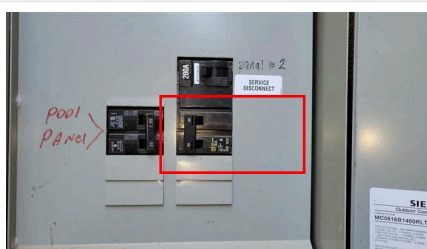
**6.2 Item 1 (Picture)**

1. Some labels are present, but are illegible or confusing for the electrical panel. This is a safety issue. Repairs are recommended.

A qualified licensed electrical contractor should correct as needed.

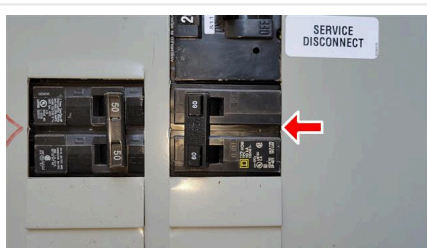
**6.2 Item 2 (Picture)**

1. One or more circuit in main/sub panel is of a different brand than panel manufacturer. The manufacture requires that in order for the panel to be safe, only their brand is allowed to be used inside the panel. Even though these circuit breaker are all "UL approved," they are not approved to be used in panels of different manufactures unless so indicated on the panel label. Further investigation is needed.

A qualified licensed electrical contractor should correct as needed.

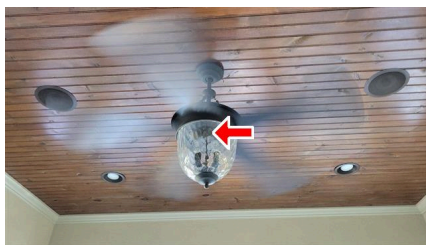
6.4 Item 1 (Picture)

1. The ceiling fan does work, but "wobbles" . Some fans that wobble cannot be corrected without replacement. Further investigation and repairs are needed.

A qualified licensed electrical contractor should correct as needed.

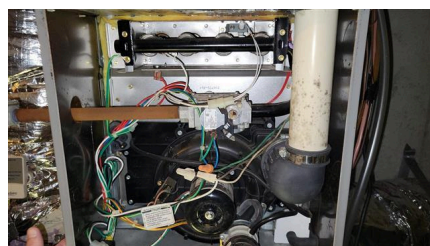
Complimentary photo of the gas furnace with the cover off

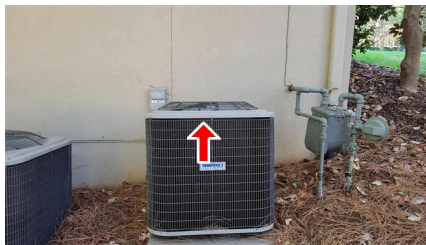
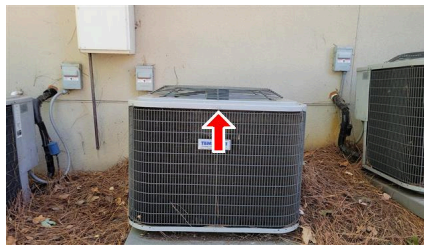
1. The condenser units are not level. This can cause damage to the unit or shorten its life span. Further investigation and repairs are needed.

A qualified HVAC person should inspect further and repair or replace as needed.

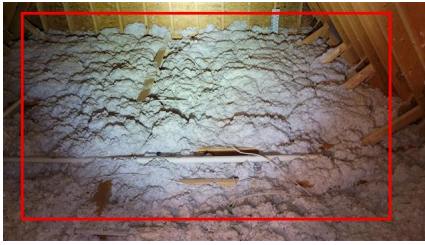
9.2 Item 1 (Picture)

1. Fiberglass (loose-fill) insulation is old and has settled, and less than six inches in thickness remains. in attic. Heat loss can occur more on this home than one that is properly insulated Repairs are needed..

A qualified person should repair or replace as needed.
